# PROTECTED INDIGENOUS TREE REPORT

FOREST LAWN MEMORIAL-PARKS  
CITY OF GLENDALE  
LOS ANGELES COUNTY, CALIFORNIA

LSA Project No. FLN1301

June 2015

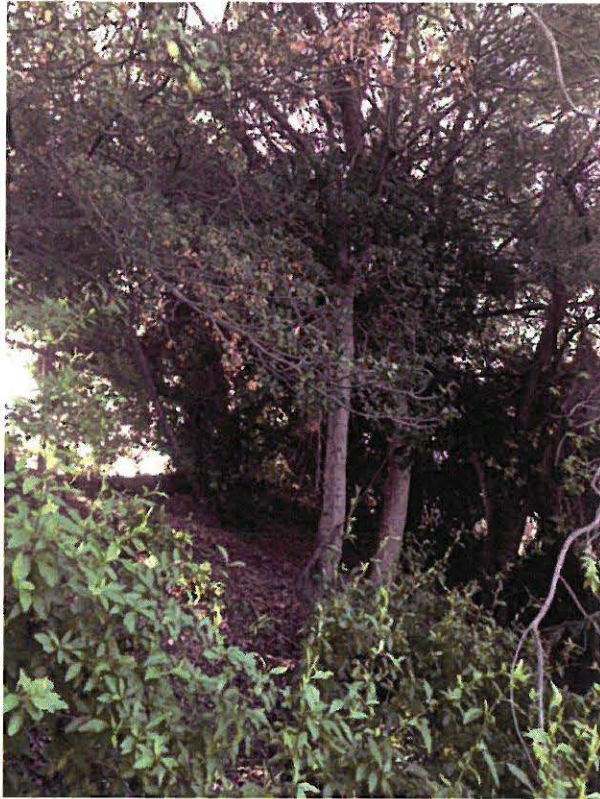
**Oak No. 1.** View looking south at 25' tall multi-trunk (5.5" and 6" stems = 11.5" diameter at breast height [DBH]) California live oak. Tree appears to be in good health.

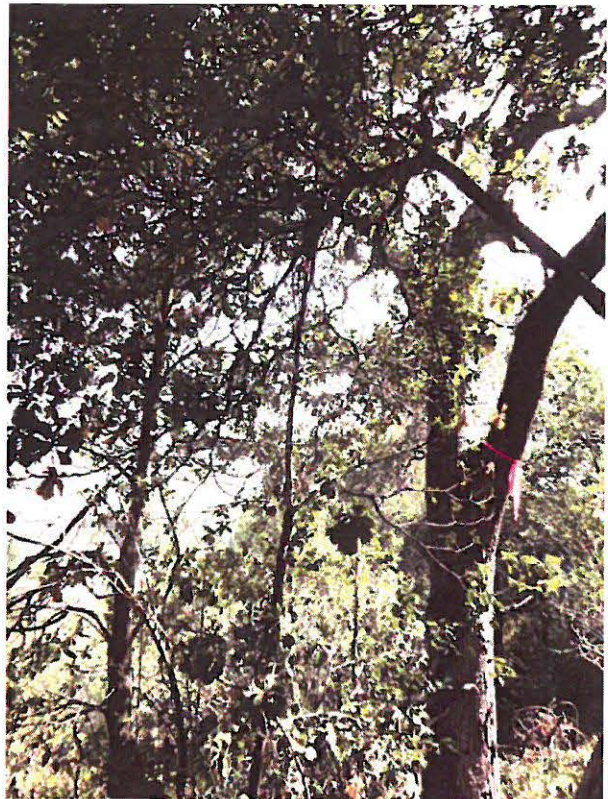
**Oak No. 2.** View looking in northerly direction at 50' tall single trunk (15" DBH) California live oak. Tree appears to be disease free and in good health.

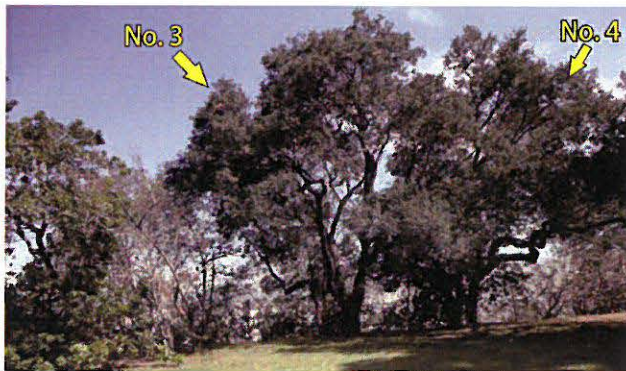
**Oak Nos. 3 and 4.** View looking north across lawn at two oak trees. Oak No. 3 is a 40' tall multi-trunk (4", 8", and 12" stems = 24" DBH) that appears to be disease free and in good health. Oak No. 4 is 70' tall single trunk (33" DBH) California live oak that appears disease free and in good health.

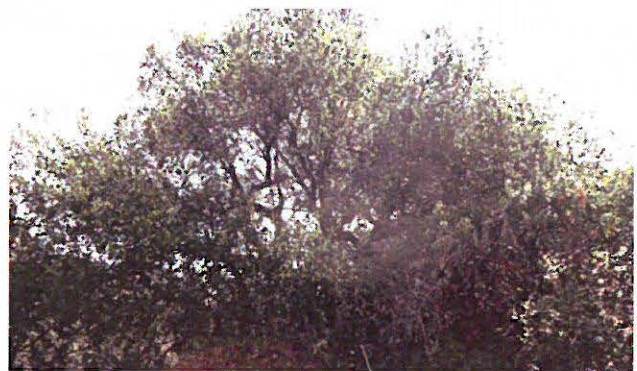
**Oak No. 5.** View looking in southerly direction at 50' tall multi-trunk (8", 9", 11", 11", and 13" stems = 52" DBH) California live oak. Tree is in fair health with included bark and some decay with multi-branching in response of past fire damage.

- 1, 2, 3, and 4 Trees appear to be disease-free and in good health.  
 5, 6, 7, and 9 Trees in fair health with included bark and decay associated with past fire damage.  
 8 Tree appears stressed and in poor health with 30 percent crown dieback and decay associated with past fire damage.

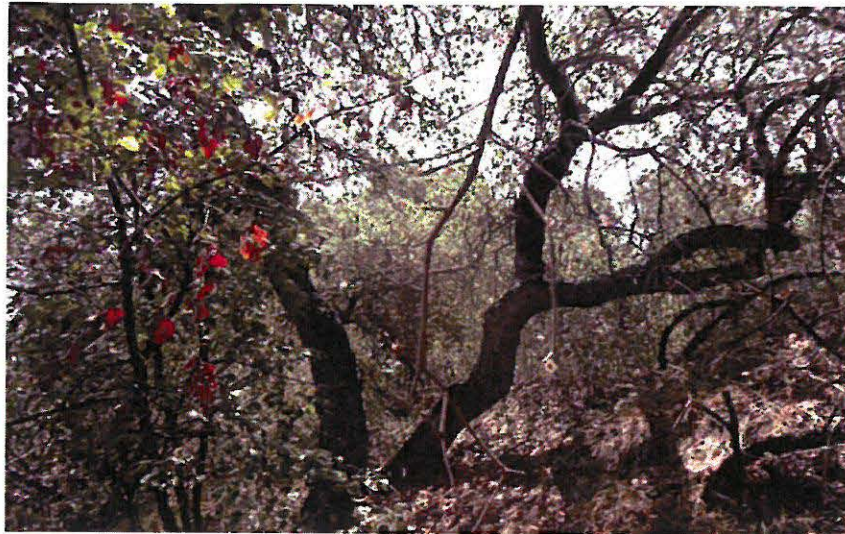
**Oak No. 6.** View looking in southerly direction at 40' tall multi-trunk (8", 9", and 12" stems = 29" DBH) California live oak. Tree is in fair health with horizontal branching, included bark, and some decay with multi-branching in response of past fire damage.

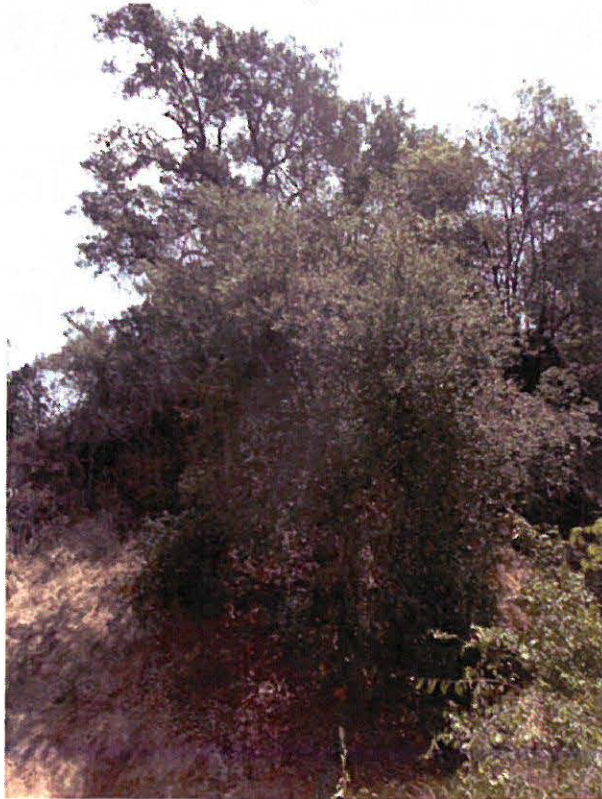
**Oak Nos. 7 and 9.** View looking in southerly direction at two oak trees. Oak No. 7 is a 20' tall multi-trunk (4", 5" and 7" stems = 16" DBH) and oak No. 9 is a 18' tall multi-trunk (5" and 7" stems = 12" DBH). Both trees are in fair health with included bark and some decay with multi-branching in response to past fire damage.

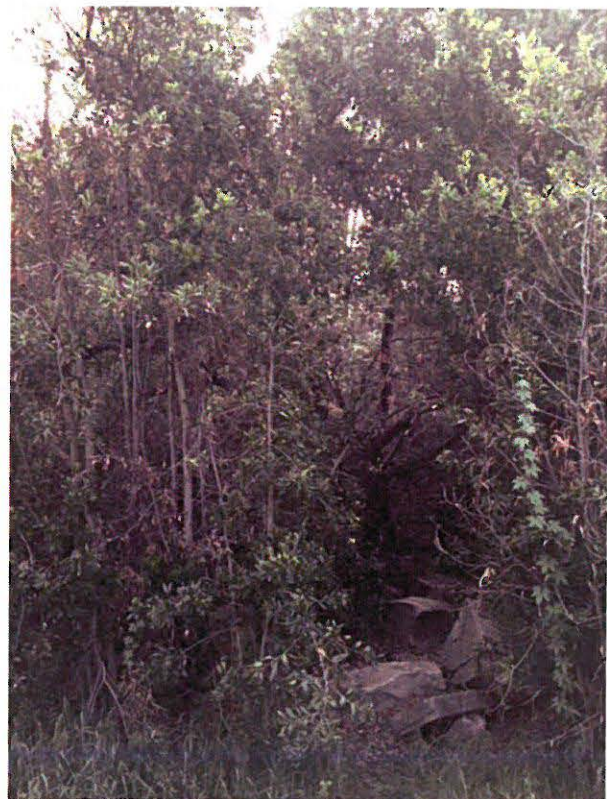
**Oak No. 8.** View looking south at 30' tall single trunk (20" DBH) California live oak. Tree appears to be stressed and in poor health with significant dieback to 1/3 of tree crown. Decay with multi-branching in response of past fire damage is evident.

All nine of the protected indigenous trees located within the project footprint will likely be encroached upon by excavation of the Sunset Grove Gardens project. Tree Nos. 1, 2, 3, and 4 were healthy and vigorous at the time of the survey and did not exhibit signs of infestation, disease, or structural defects. Tree Nos. 5, 6, 7, and 9 are in fair health, with decay and included bark among multi-branching in response to past fire damage. Tree No. 8 appears to be stressed and in poor health with significant dieback to 30 percent of the tree crown. Decay with multi-branching in response to past fire damage is also evident.
