Julie Bush
Certified Arborist # WE-7770A
12202 Foster Road
Los Alamitos, CA 90720

February 19, 2016

Report for:
3160 Linda Vista rd.
Glendale, CA 91206

INDIGENOUS TREE REPORT

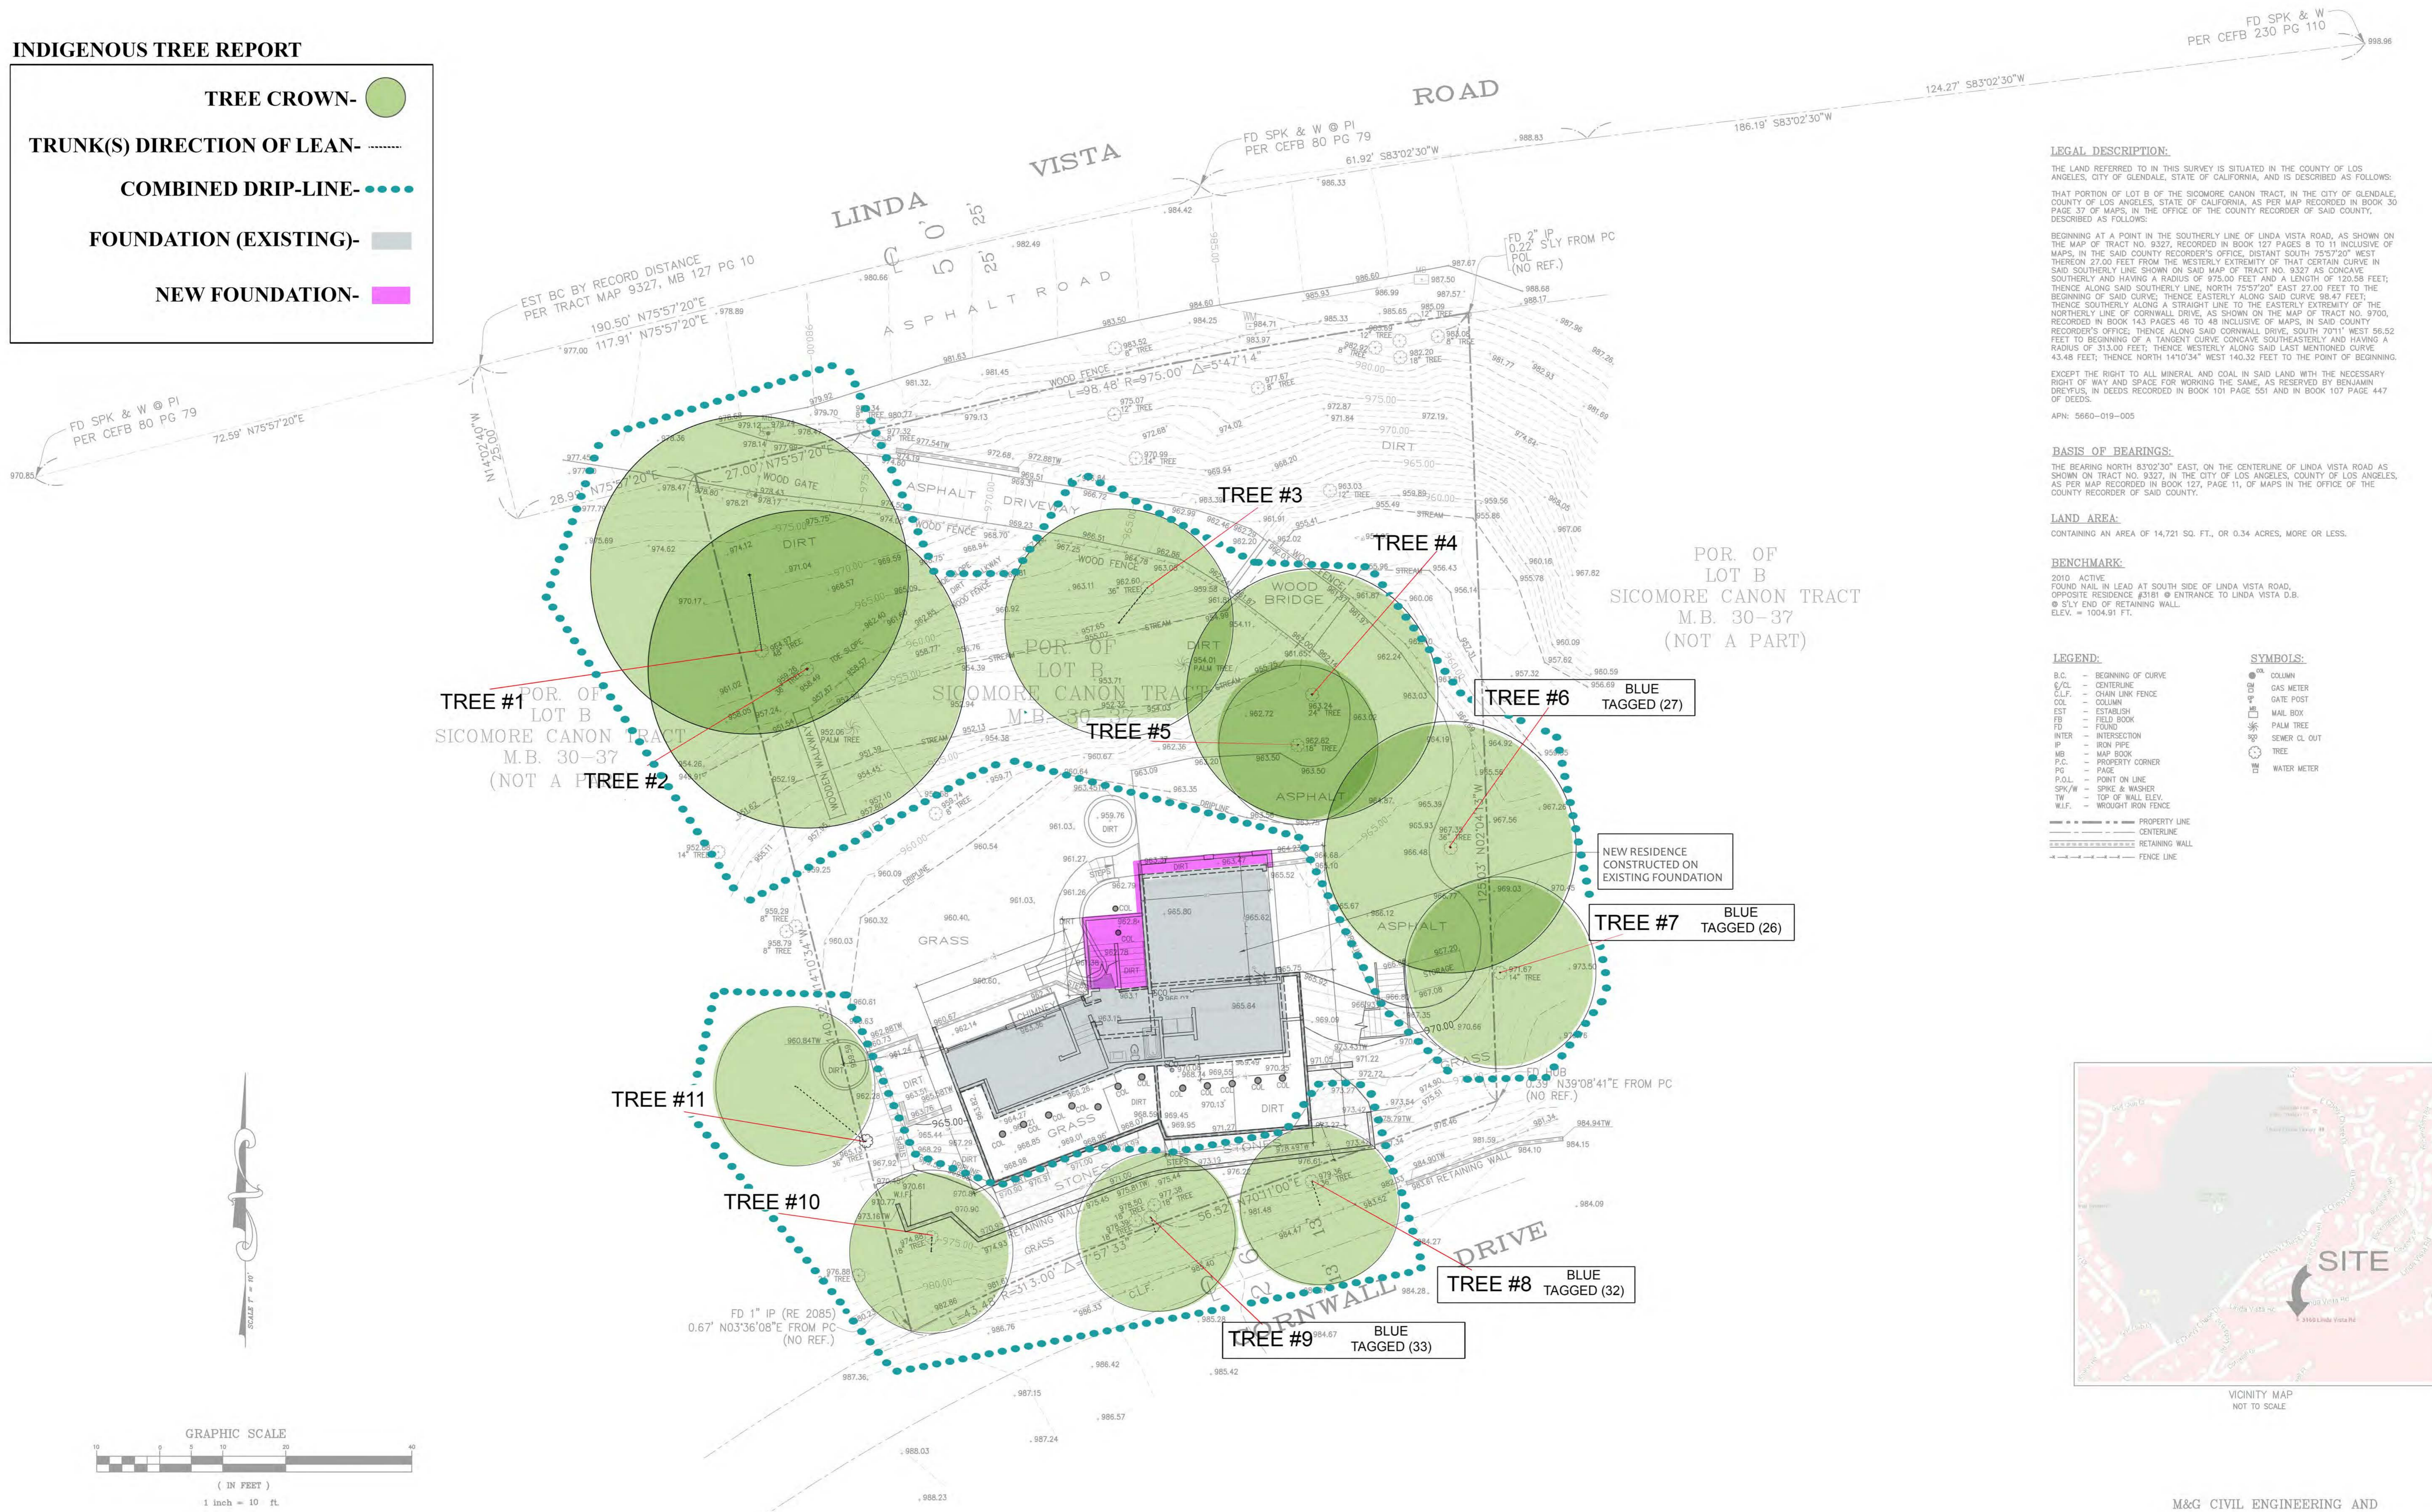
Little or no impacts will occur to the indigenous trees surrounding the foundation due to repair or replacement in the existing foundation location (Trees 8,9,10). The new targeted area for adding additional footings will cause little or no impact on nearby trees (Trees 4 & 5) Caution is recommended on the northeastern side of the foundation where any possible utilities may be excavated.

- **No parking or any storage on the root zone within the drip lines**
- **No change to the existing grades**
- **Fence around protected trees using Snow Fencing to prevent wounds to the tree and soil compaction within the root zone.**
- **Indicate protected trees on construction plans.**
- **Excavation in close proximity to protected trees shall be done either manually or through the use of an air spade to preserve the tree's roots.**
- **The minimum distance between an open trench and any tree shall be (1') for every inch of trunk diameter**
- **In the event root pruning is required to accommodate grade changes or the installation of hardscape features the root pruning procedures shall be directed by Community Forest Operations staff or Certified Arborist.**

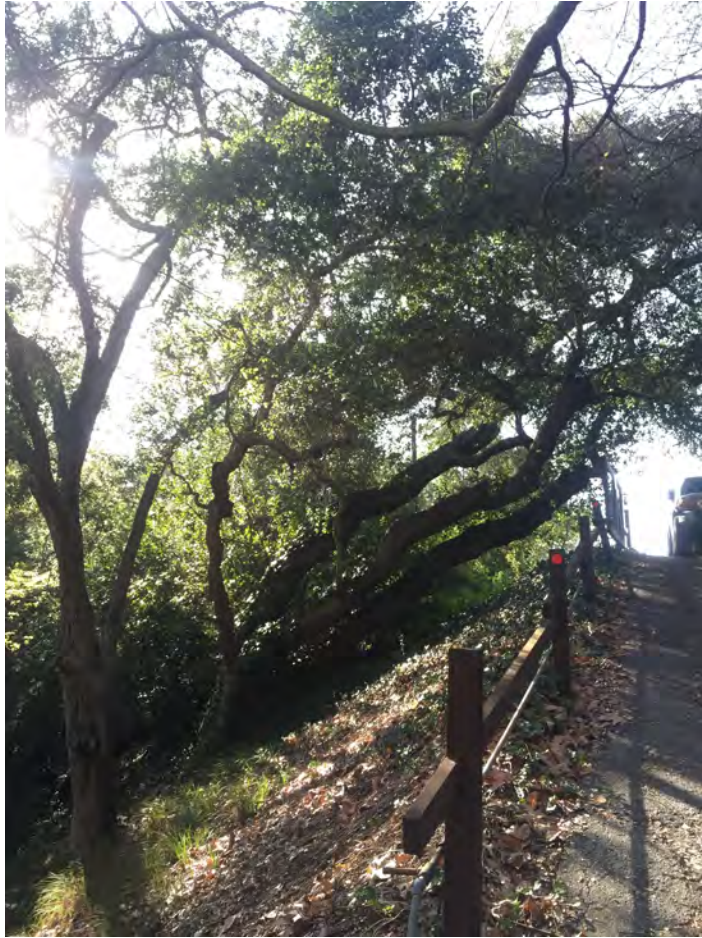
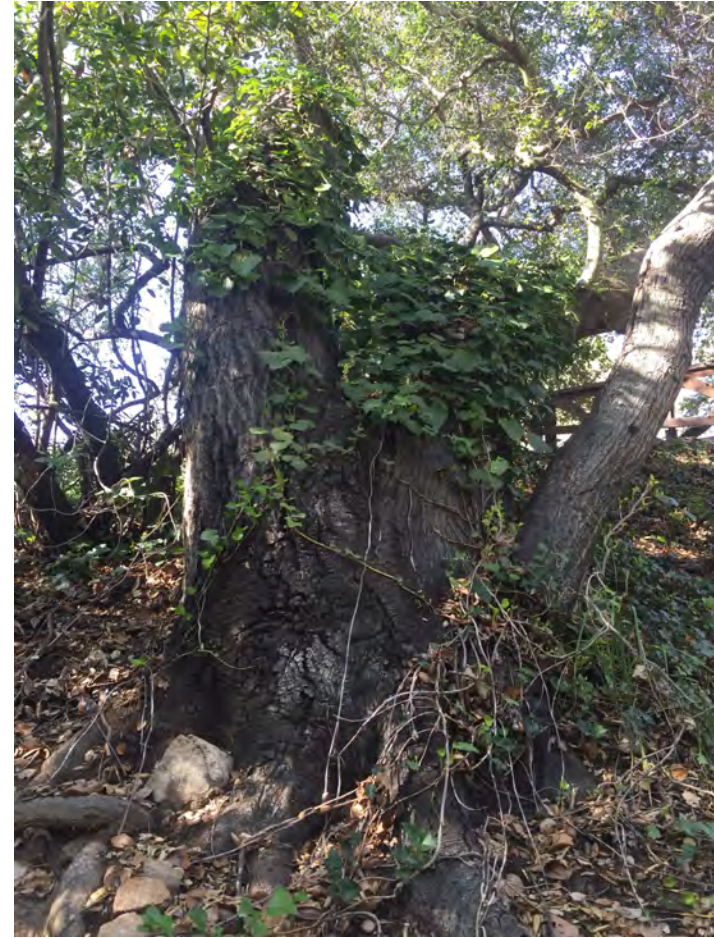
TREE #1

Observations: Multilimbed, oak has a severe lean towards driveway.

Recommendations: Pruning near driveway access, remove Ivy growth.

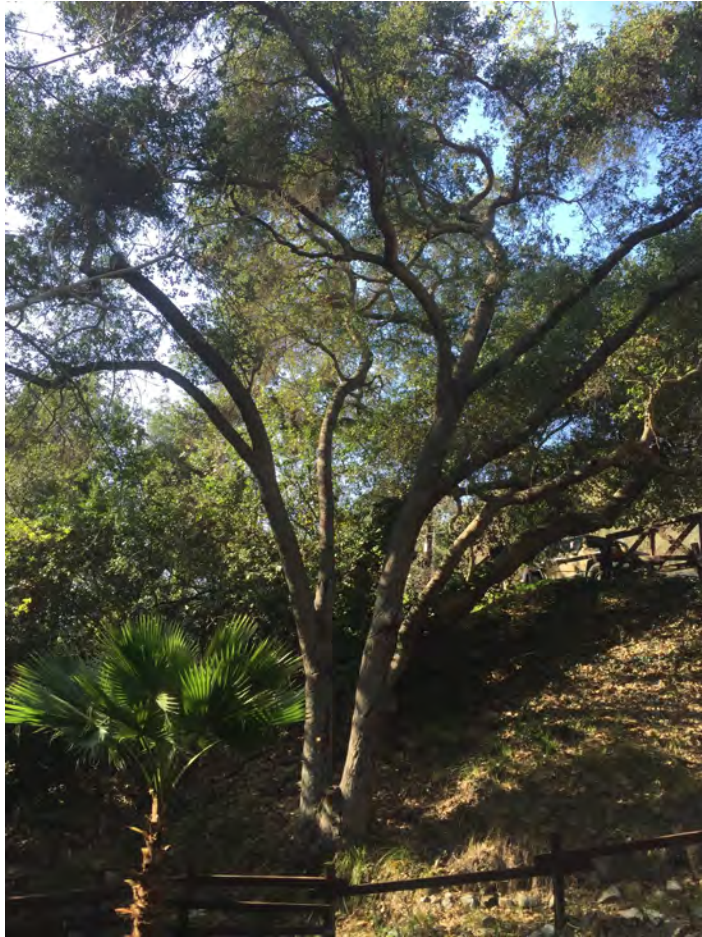
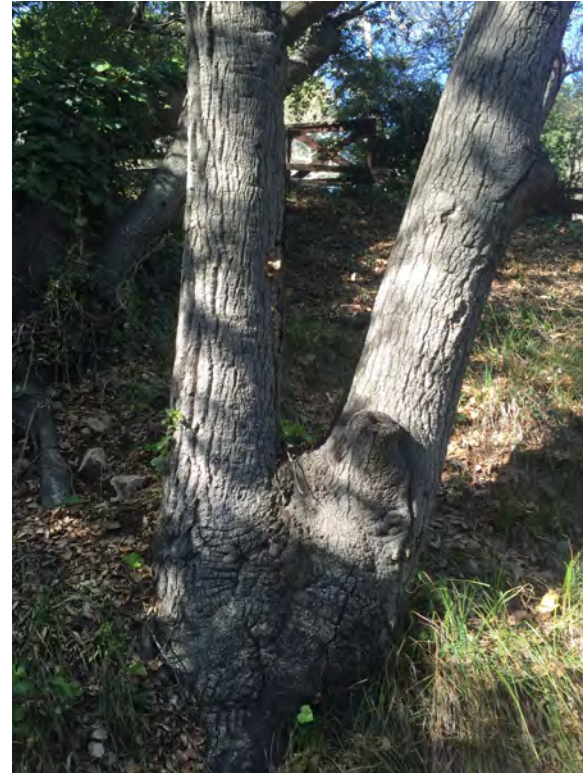
TREE #2

Observations: Multilimbed, Good Health.

Recommendations: Minor Pruning

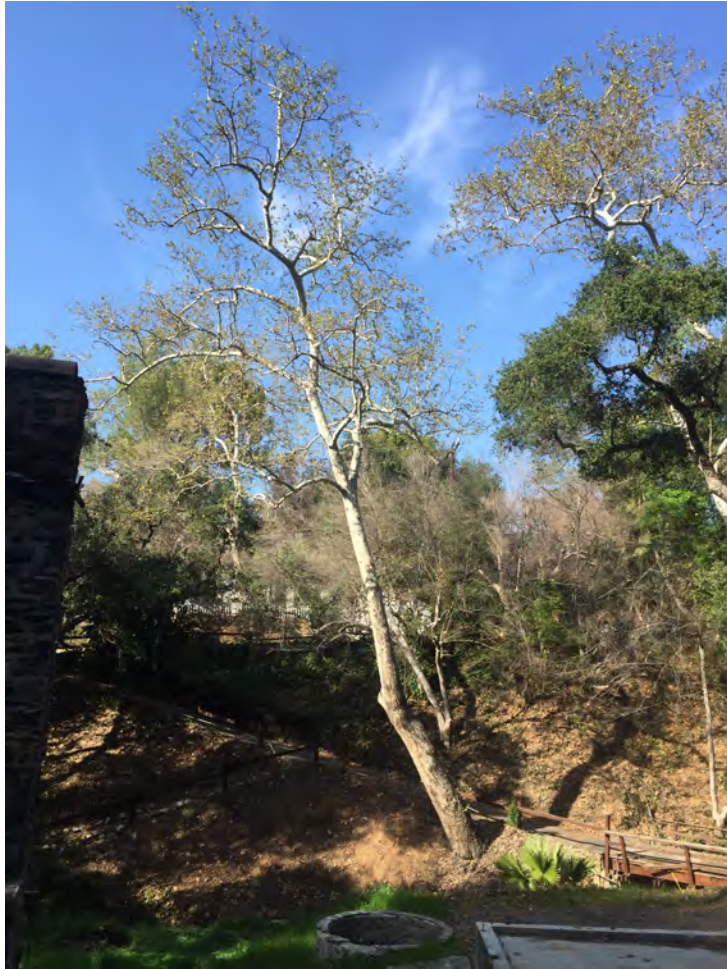
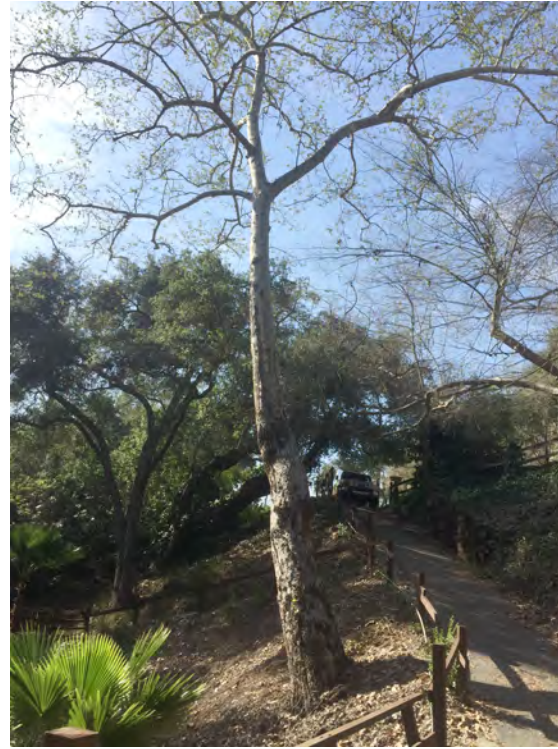
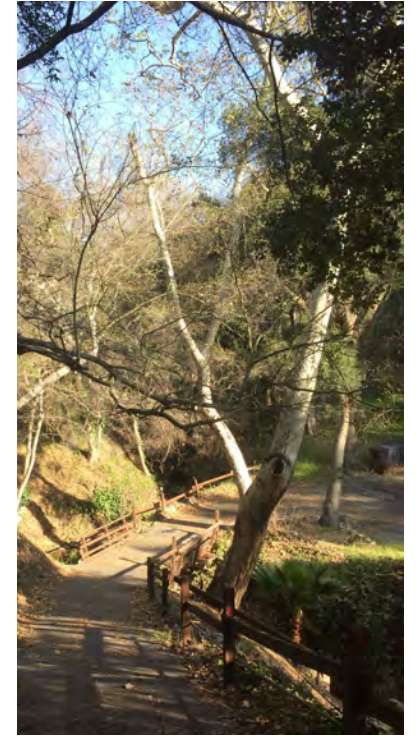
TREE #3

Good Health, Tree is close to driveway 20 degree lean.

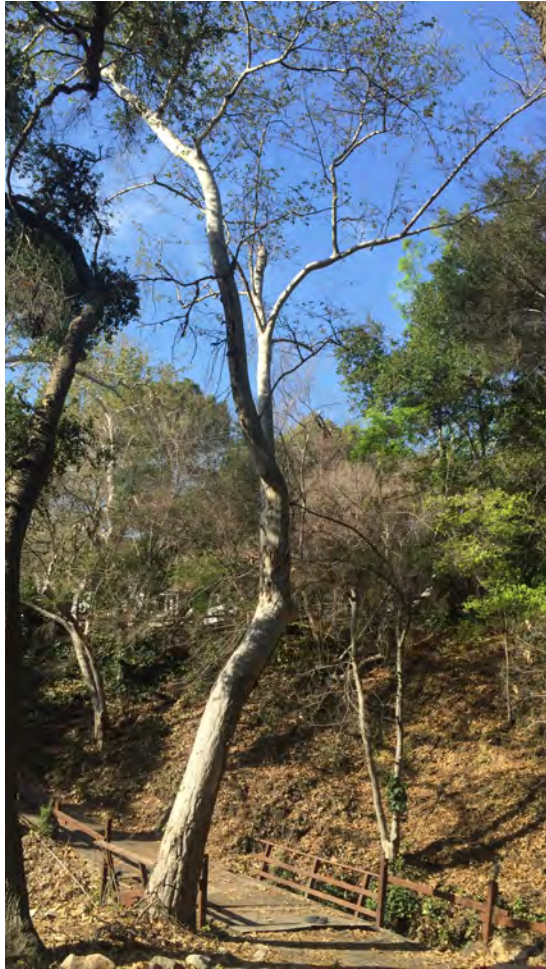
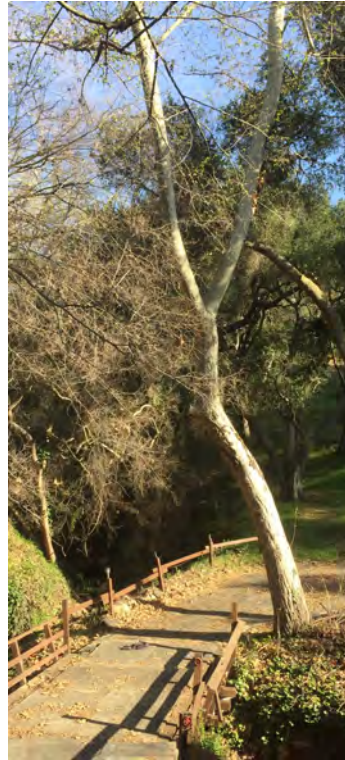
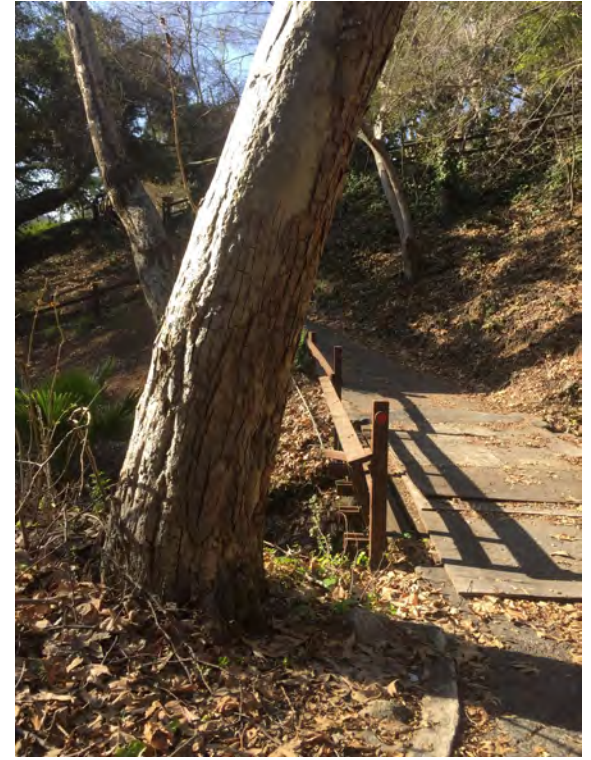
TREE #4

Good Health, Tree is close to driveway and bridge , slight lean towards driveway.

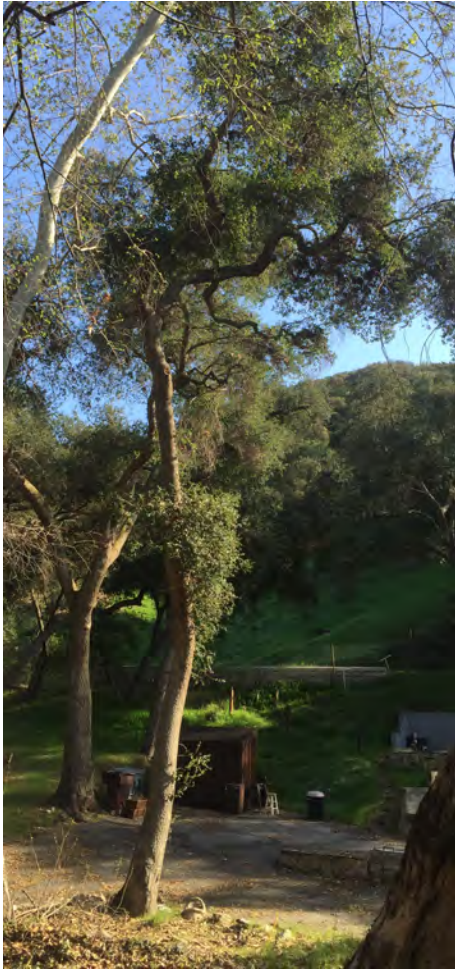
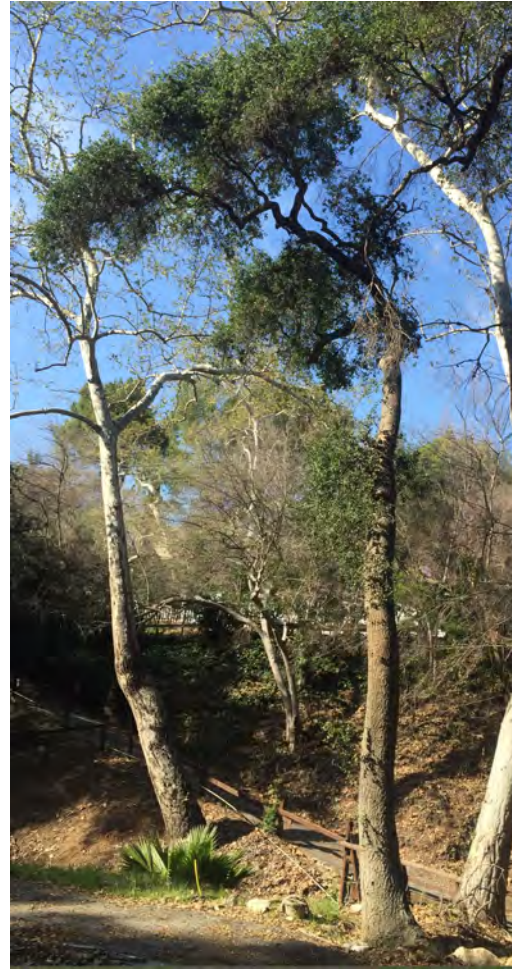
TREE #5

Good Health, Tree is close to driveway, sparse foliage

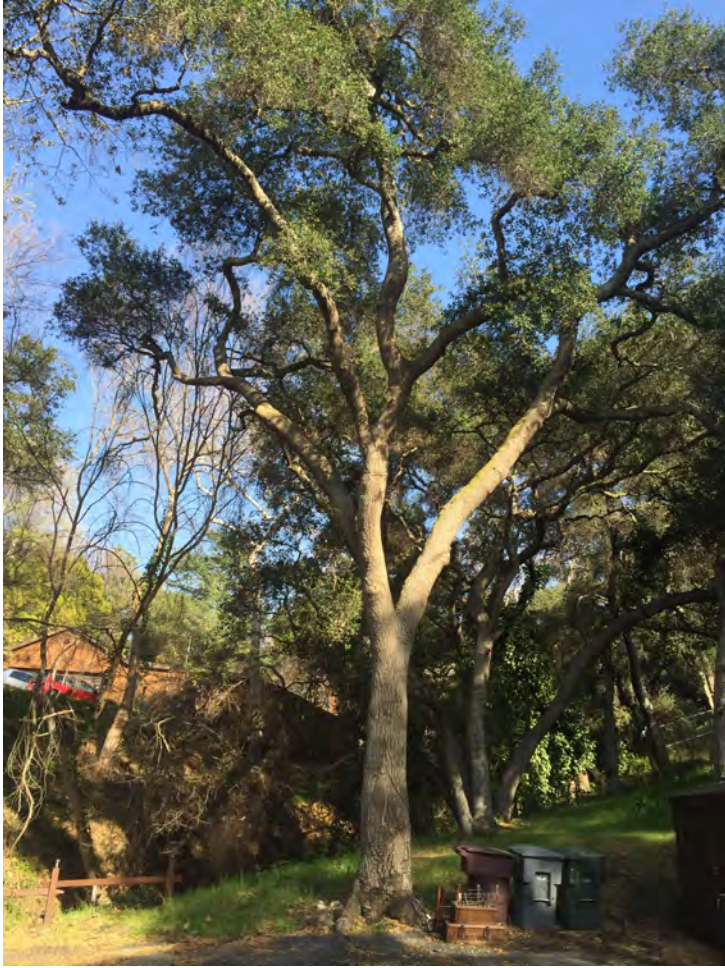
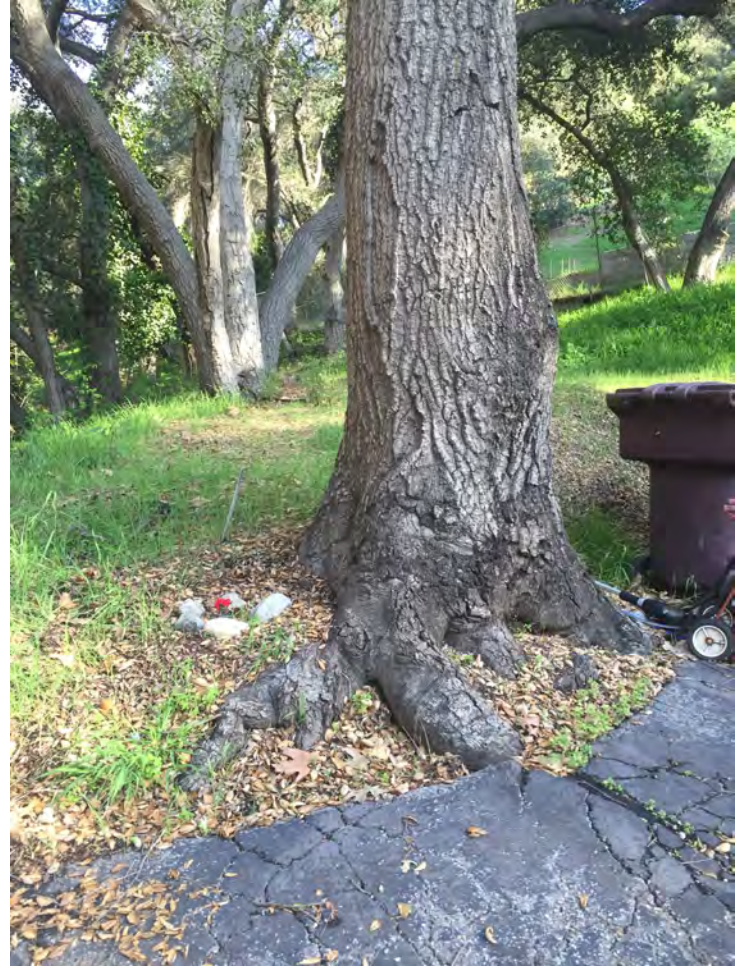
TREE #6
Blue Tag (27)

Observations: Good Health, Tree is close to driveway

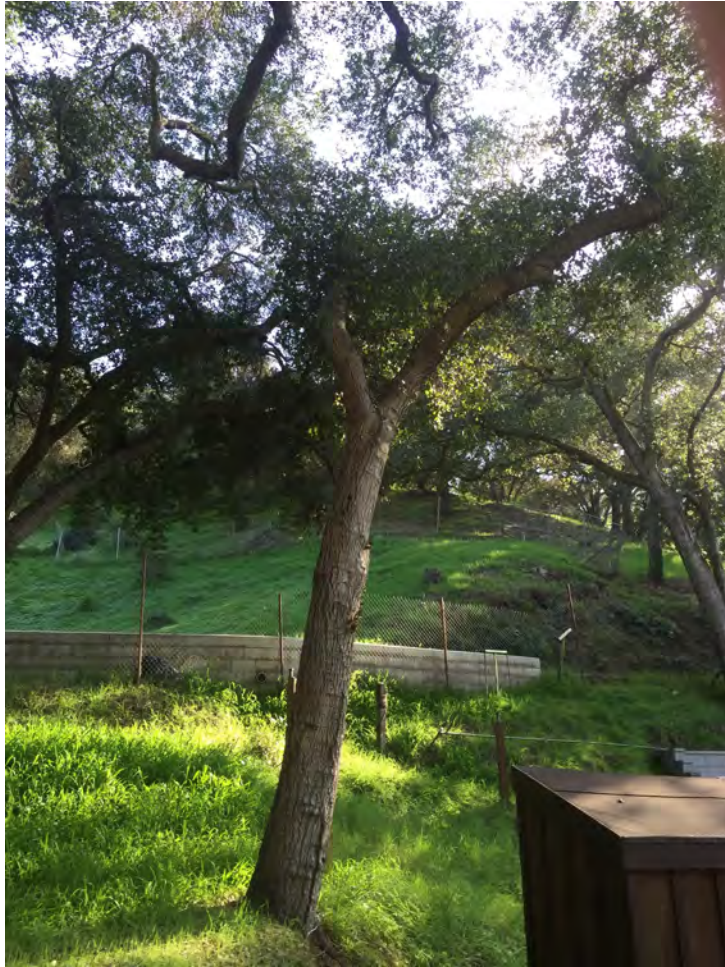
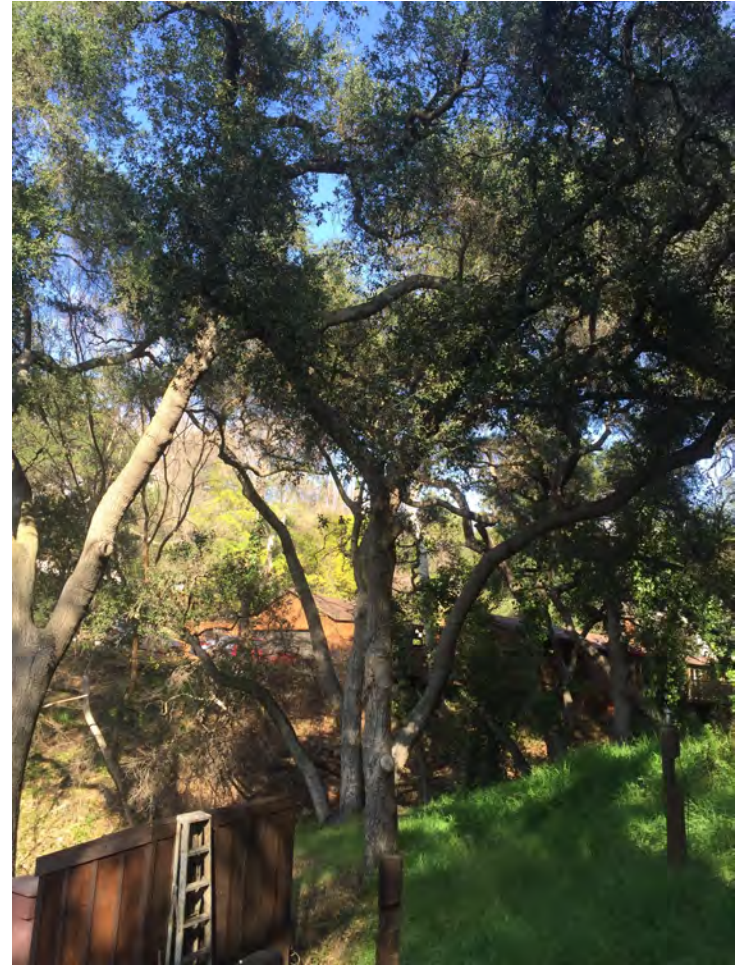
TREE #7
Blue Tag (26)

Observations: Good Health,

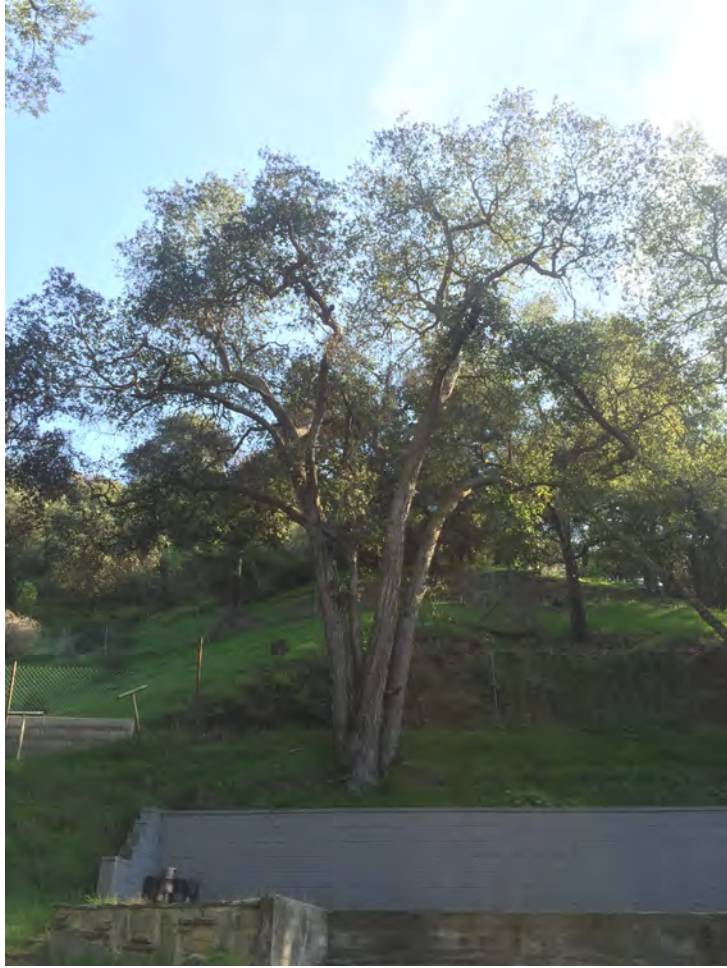
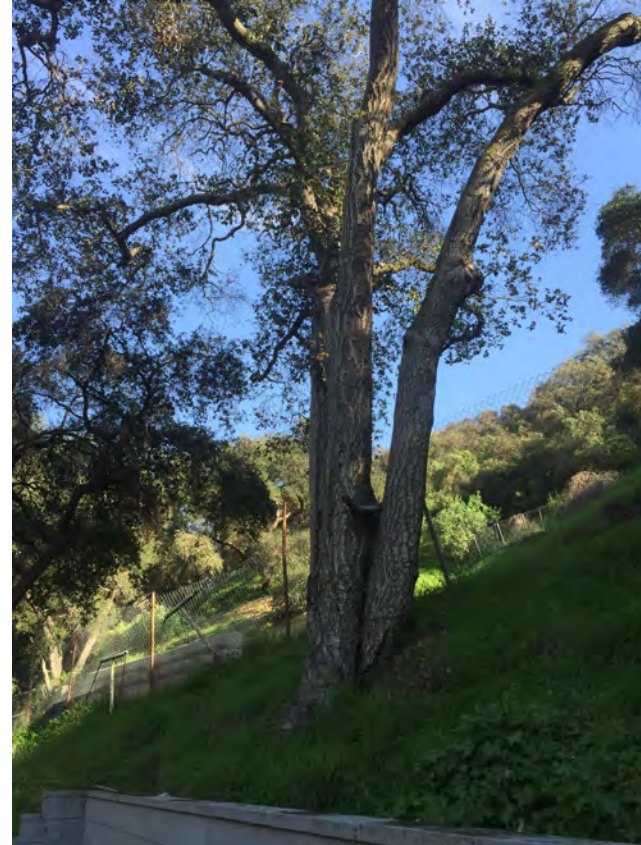
TREE #8
Blue Tag (32)

Observations: Good Health, Multilimbed, Tree is just outside property line.

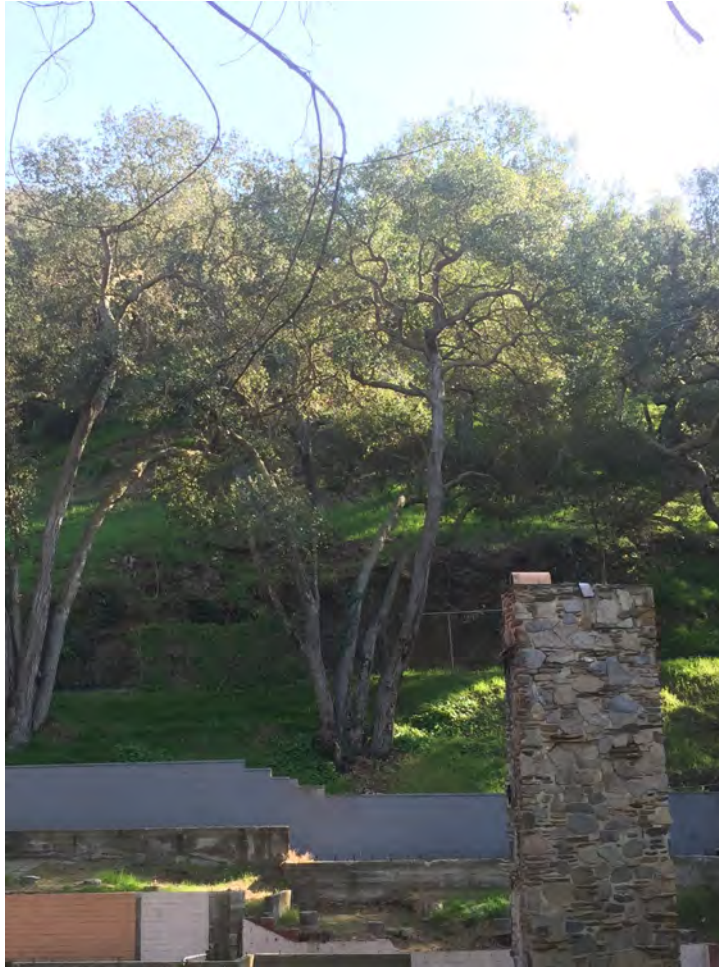
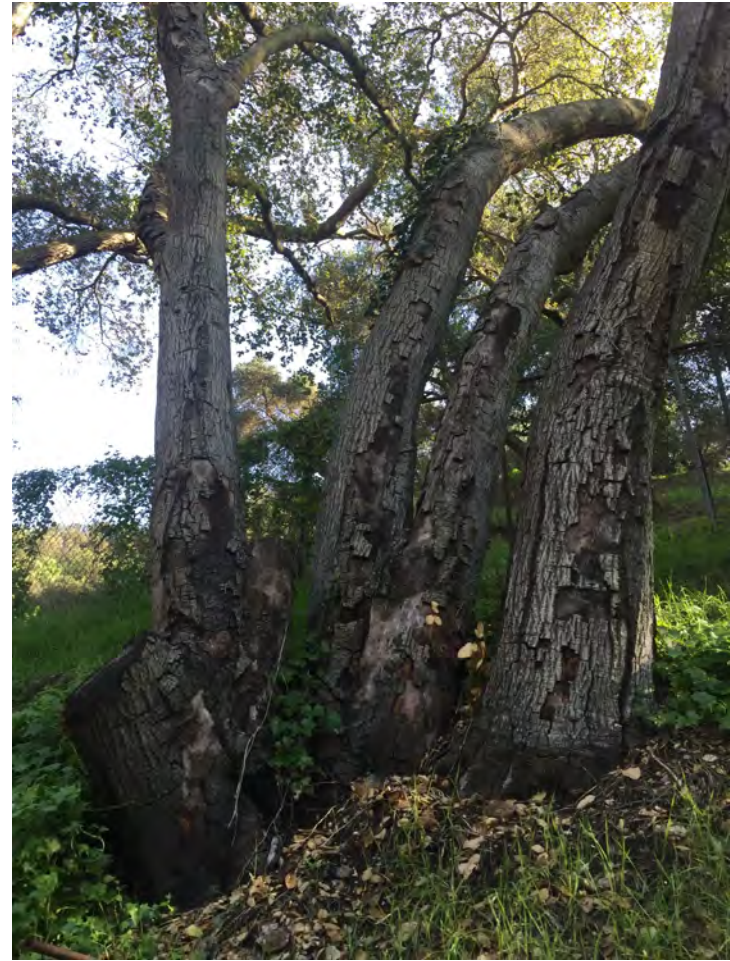
TREE #9
Blue Tag (33)

8	Quercus agrifolia	Coastal Live Oak	36 in	48	25	X		Good	4	Multi-trunk, Slight lean, Good structure,
9	Quercus agrifolia	Coastal Live Oak	18 in	50	25	X		Moderate	3	Multi-trunk, Slight lean, fire damage
10	Quercus agrifolia	Coastal Live Oak	18 in	45	20	X		Good	4	Multi-trunk, Slight lean, Good structure,
11	Quercus agrifolia	Coastal Live Oak	36 in	40	25	X		Moderate	3	Strong curve in upper trunk, wound at base

Observations: Generally good Health although evidence of being scorched from fire, Limbs have been removed, Multilimbed tree.

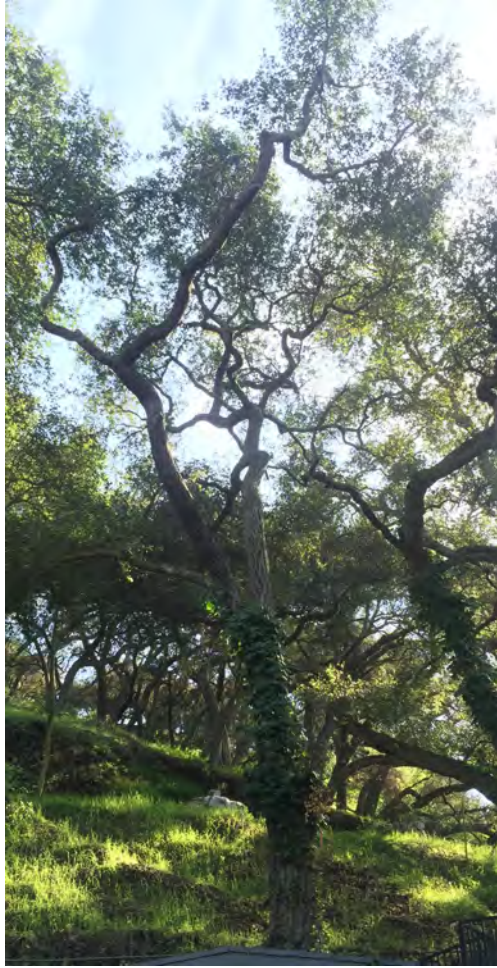
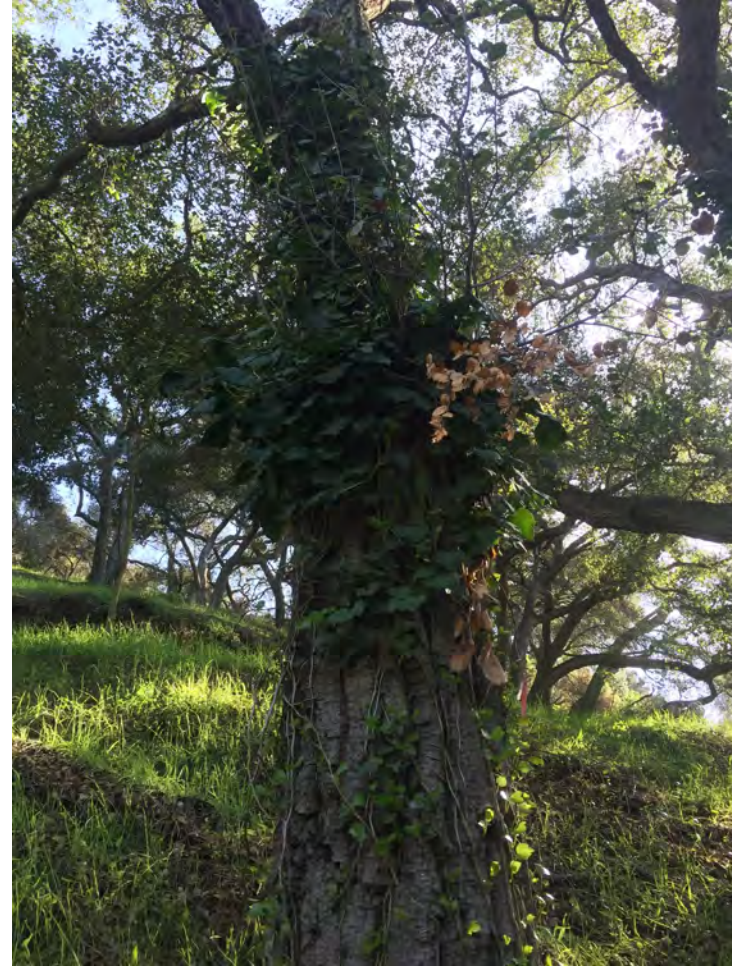
TREE #10

Observations: Good Health

Recommendations: Remove Ivy growth

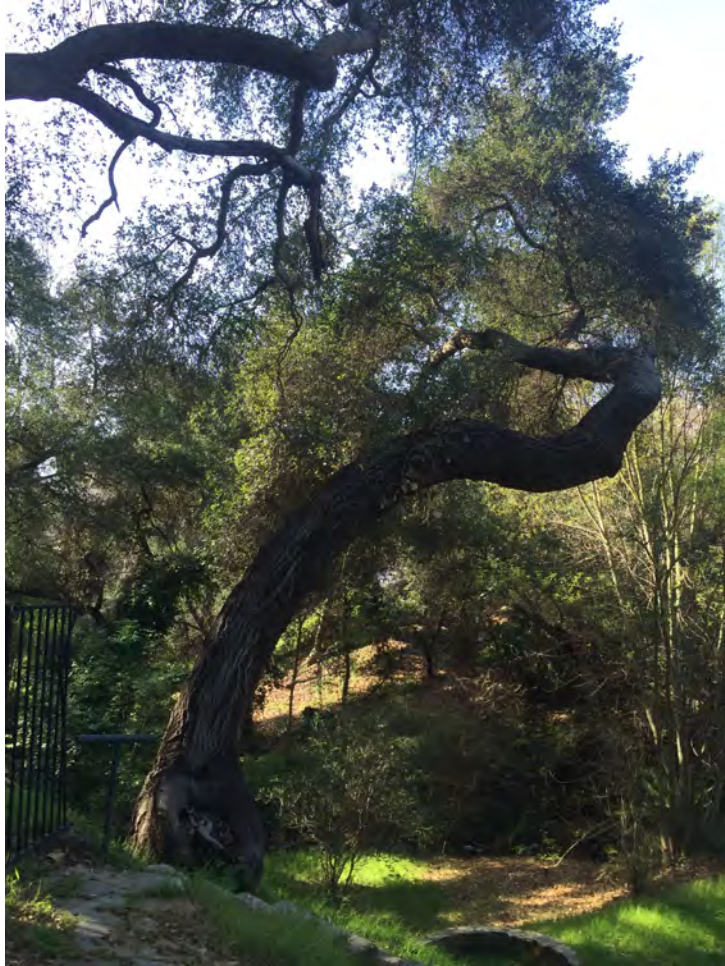
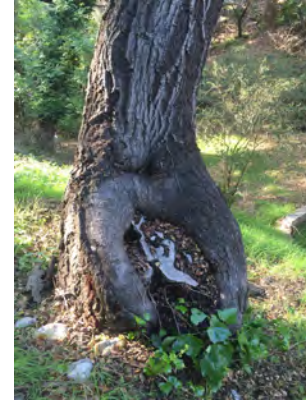
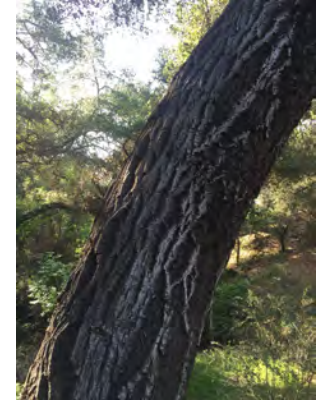
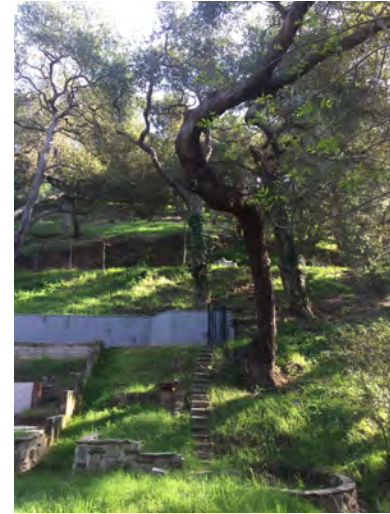
TREE #11

Observations: Generally good Health although evidence of being scorched from fire, Limbs have been removed, Slight Lean, Multilimbed tree. Strong curve in upper trunk.
