INDIGENOUS TREE REPORT
for
Property
at
1829 Kirkby Road
Glendale, CA 91208

November 24, 2017

Arsen Margossian, Consulting Arborist
Bardez Landscape Services, Inc.
ISA Certified Arborist # WE-7233A
Member, American Society of Consulting Arborists
ISA Tree Risk Assessment Qualified (TRAQ)
California Licensed Pest Control Adviser #071429
3512 Rosemary Avenue
Glendale, CA 91208
818 669 6469
arsenm@pacbell.net

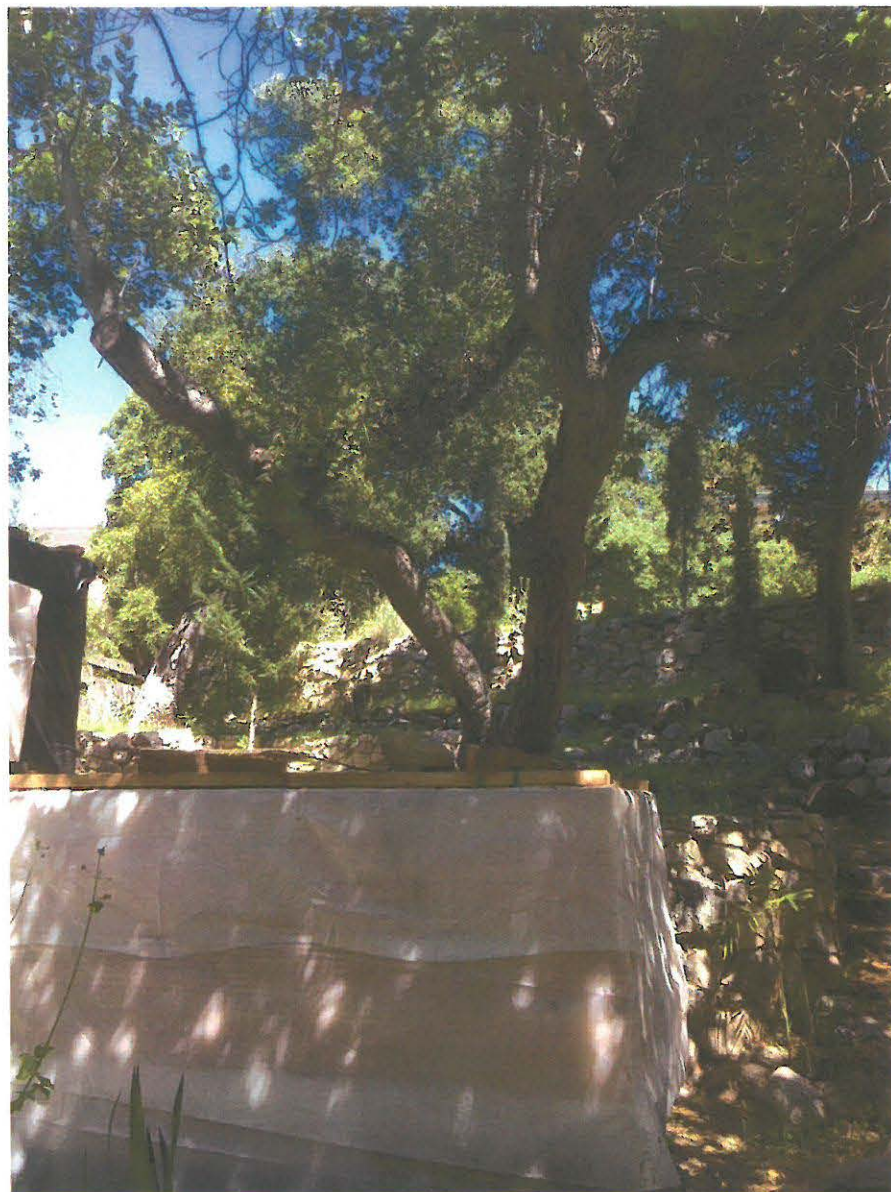
Tree #85.

The smaller trunk has been cut back and a single branch has emerged from it. Most of the crown is on the other trunk. There is extensive **deadwood**, which is normal for a tree that has not been maintained.

The **foliage** is typical of this species. **Leaf scorch**, a fungal disease, is present in parts of the canopy, and **shot holes** are also observed on the leaves.

On a 0 to 5 scale (0 being dead and 5 being excellent), the **condition rating** for this tree is 3 (Average).

This tree is within the footprint of the construction site. It has to be removed.

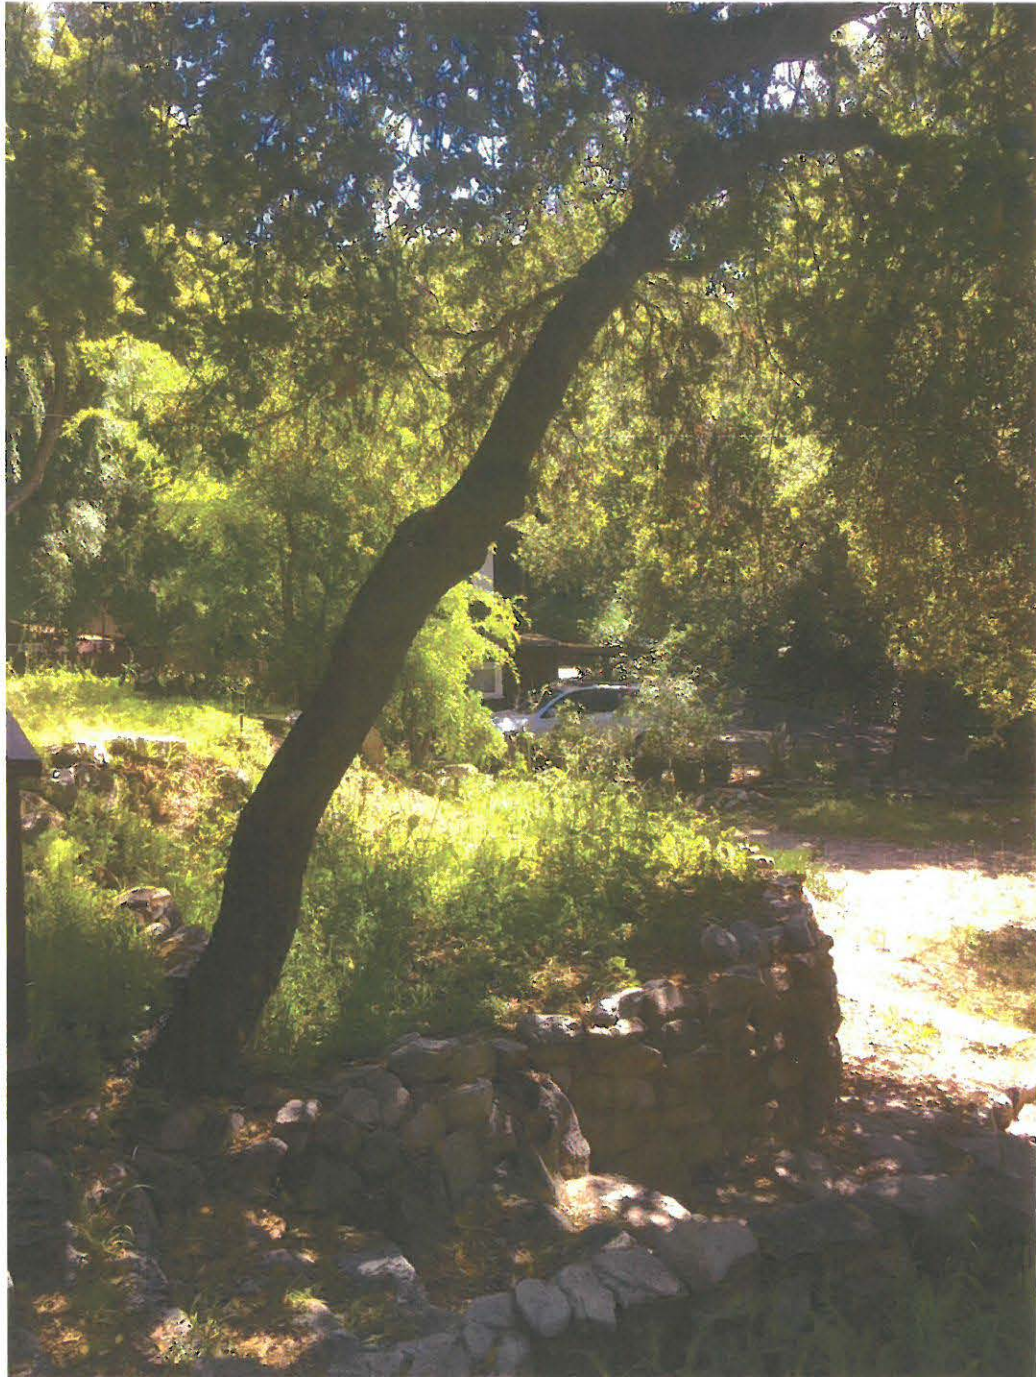
Tree #86.

The twisted trunk of the tree has a south lean, and as a result, the entire canopy is completely away from the base of the tree trunk. The farthest spread of the canopy is 24 feet.

This is a poorly-structured tree, under the canopy of Tree #87.

Same characteristics of Tree #85 apply to this tree also, with considerable deadwood and uneven crown. No buttress roots are visible on this tree also.

On a 0 to 5 scale (0 being dead and 5 being excellent), the condition rating for this tree is 3 (Average).

This tree is within the footprint of the construction site. It has to be removed.

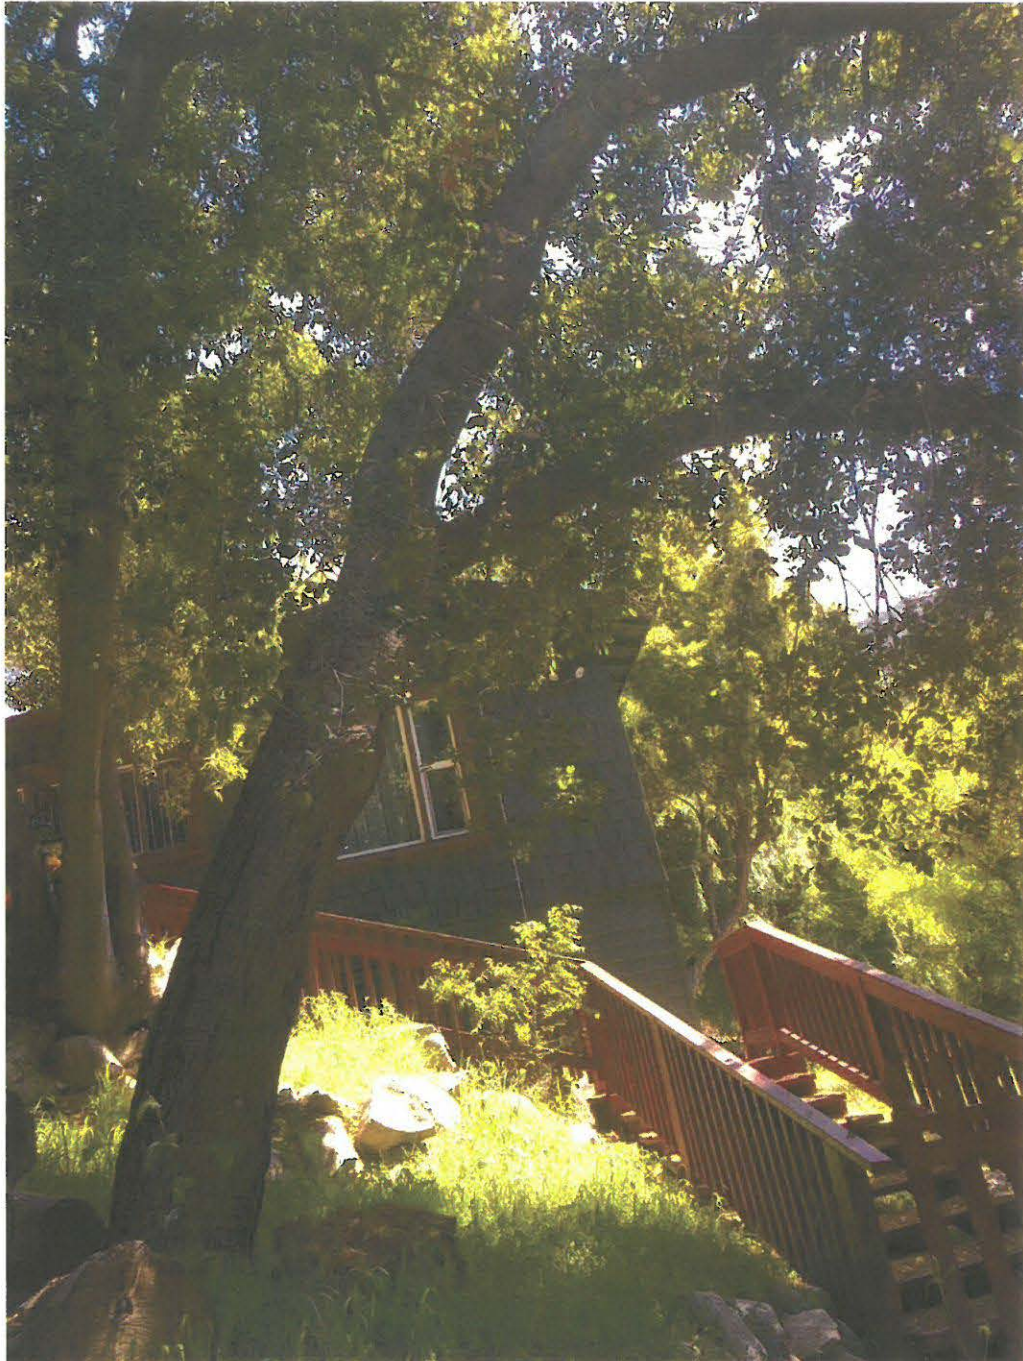
Tree #87.

The single trunk of the tree is leaning, because of its location under the canopy of a pittosporum tree and oak Tree #91.

The trunk divides to two at nine feet from grade, and both secondary trunks head southward in considerable lean.

This tree sends its branches over Tree #85 and Tree #86. Deadwood is present in the undergrowth of the tree, and same characteristics as the previous trees is visible on this tree also.

On a 0 to 5 scale (0 being dead and 5 being excellent), the condition rating for this tree is 3 (Average).

This tree also is within the footprint of the proposed new dwelling and it has to be removed.

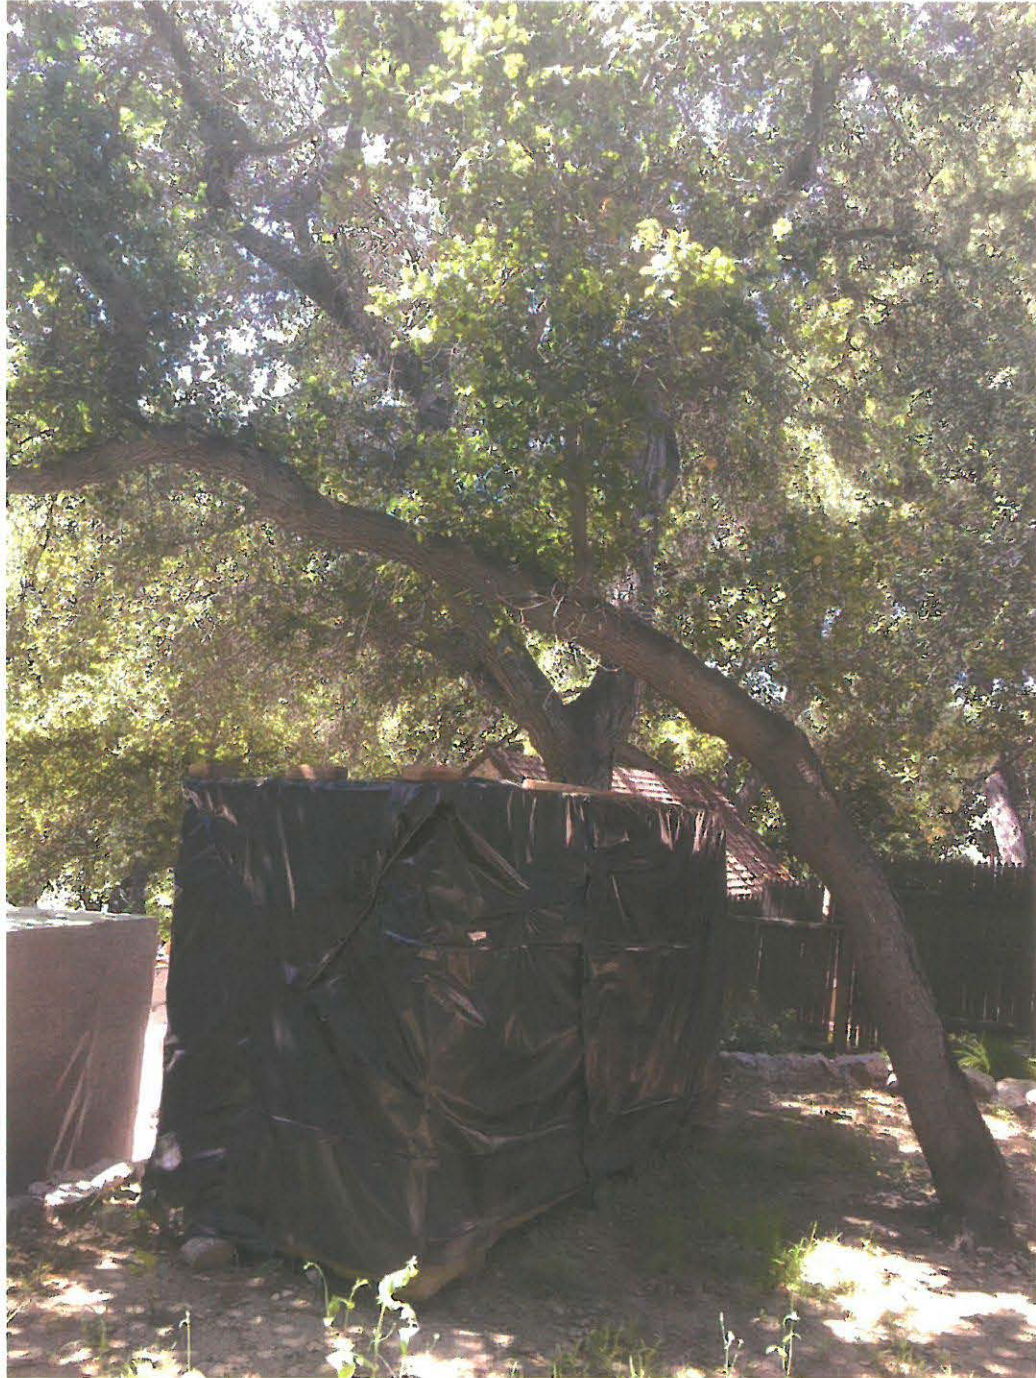
Tree #88.

The single trunk of the tree, as all the previous trees, is leaning south. The crown of the tree extends up to 25 feet away from the base of the trunk.

This tree has some **cavities** on the main trunk, an indication of failed branches.

As the previous trees, this tree also has leaf scorch, deadwood and poor structure.

On a 0 to 5 scale (0 being dead and 5 being excellent), the condition rating for this tree is also 3 (Average).

This tree is close to the footprint of the proposed new dwelling but it can be preserved. Some pruning will be necessary to provide clearance.

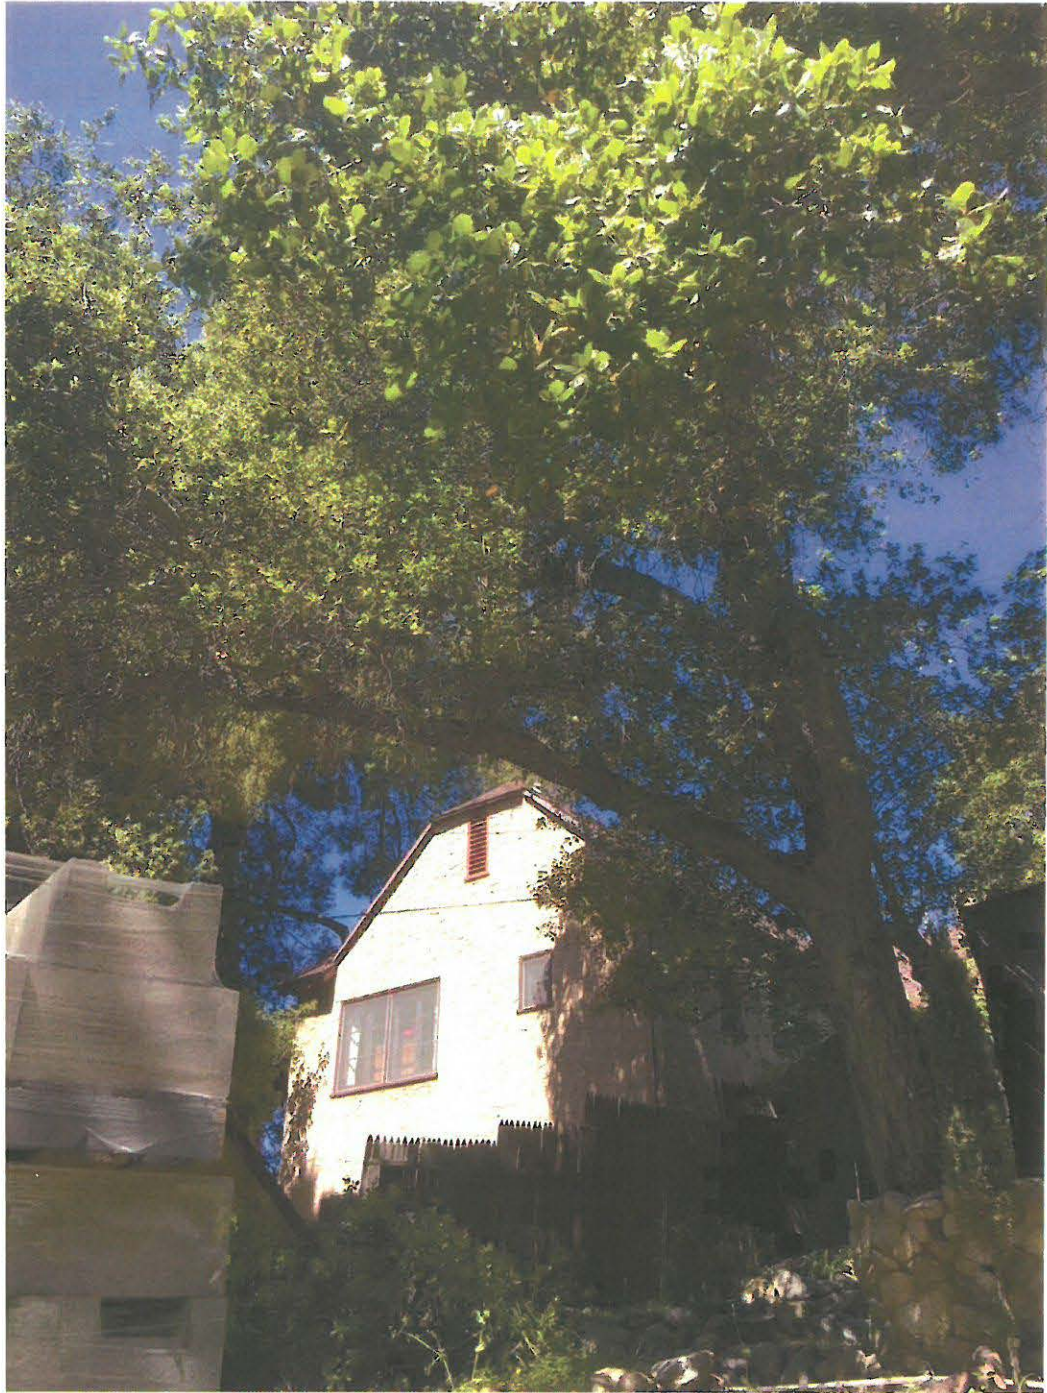
Tree #89.

This tree is in better condition, with somehow more evenly spread crown, because of well-balanced **scaffold branches**. The branches spread up to 30 feet from the base of the trunk.

Some leaf scorch and deadwood are visible on the tree, but no major health issues or structural weaknesses are present.

On a 0 to 5 scale (0 being dead and 5 being excellent), the condition rating for this tree is 4 (Good).

This tree is about ten feet from the edge of the proposed new house, and should not be impacted substantially. Some pruning will be needed for clearance.

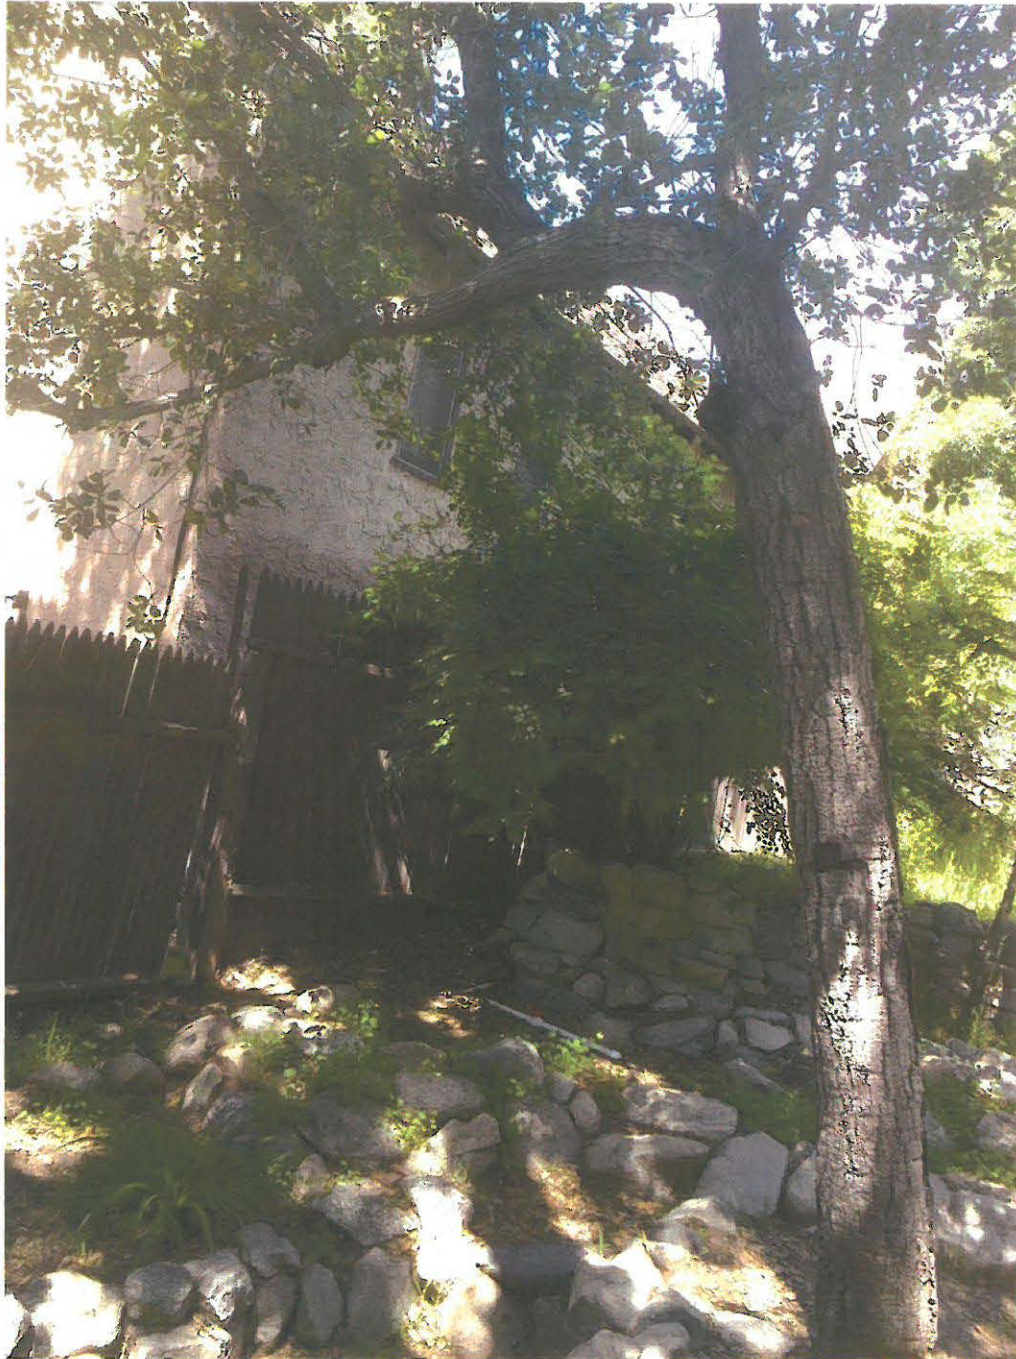
Tree #90.

The single trunk has a DBH of 9.5 inches and it leans considerably toward the west side.

Over the years, the main branches have been cut back away from the neighboring property, and as a result, the canopy spread is only of 12 feet in that direction.

The thin crown of the tree due to its presence under the crown of Tree #89.

On a 0 to 5 scale (0 being dead and 5 being excellent), the condition rating for this tree is 3 (Average).

This tree is outside the footprint of the proposed new dwelling and it can be preserved in place.

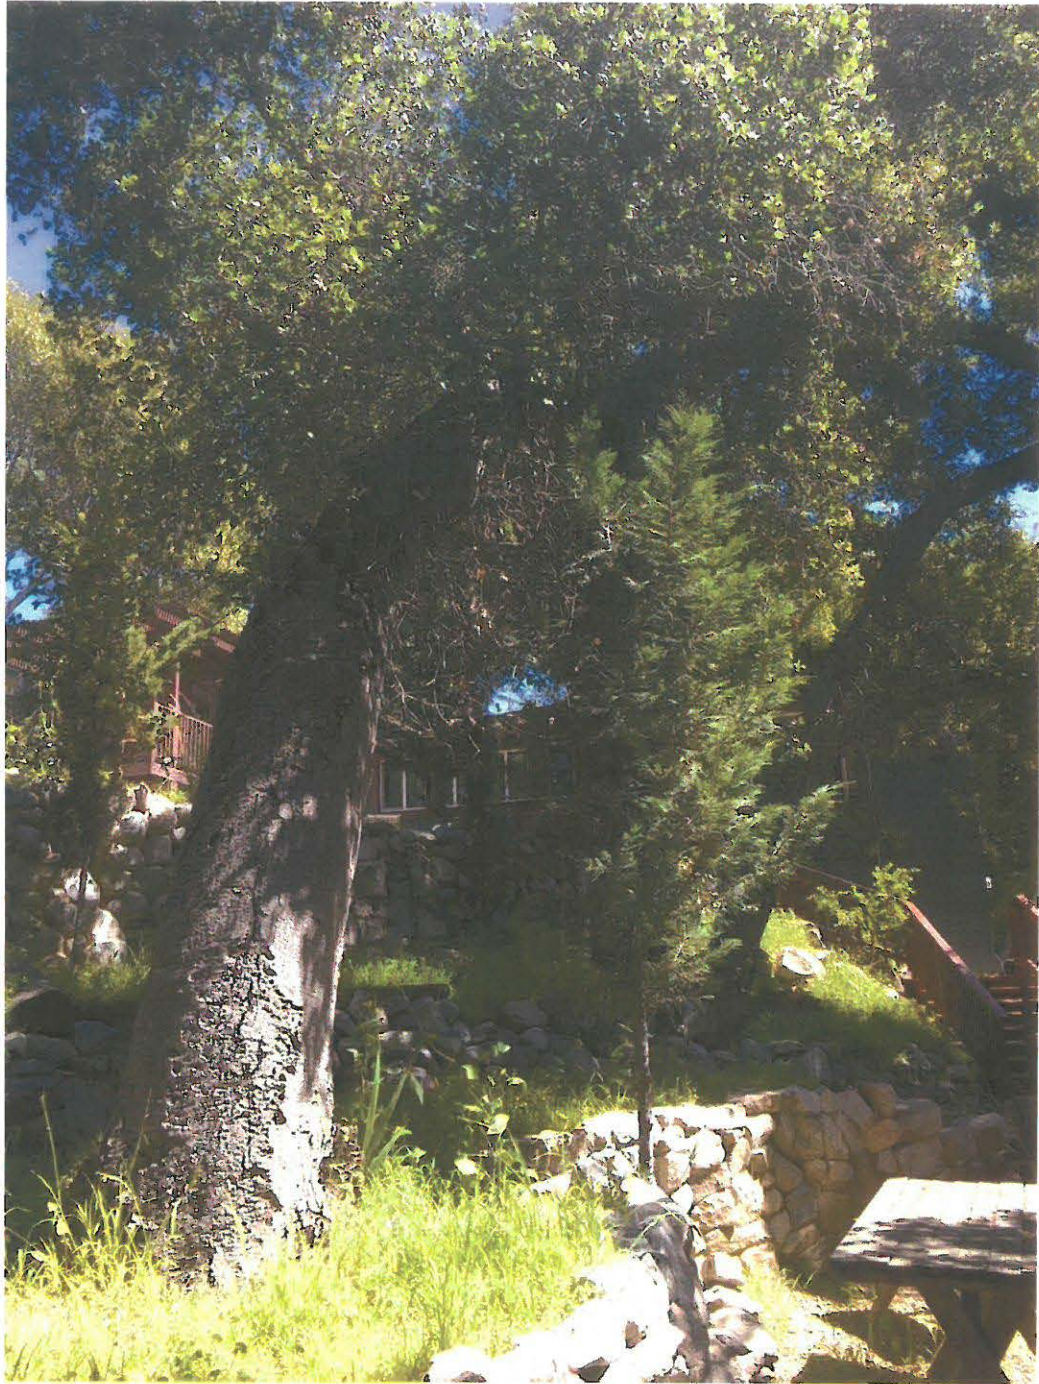
Tree # 91.

The main trunk leans toward the east side and extends almost up to 25 feet with no main scaffold branches. At the end of the main trunk, there are only two main branches that form the principal crown. The rest of the dripline consists of small branches of four to five feet length.

Some leaf scorch and deadwood are visible on this tree too.

On a 0 to 5 scale (0 being dead and 5 being excellent), the condition rating for this tree is 1 (Poor).

Although this tree can be preserved, since it is away from the construction footprint, but given its health condition, it is advised to be removed.

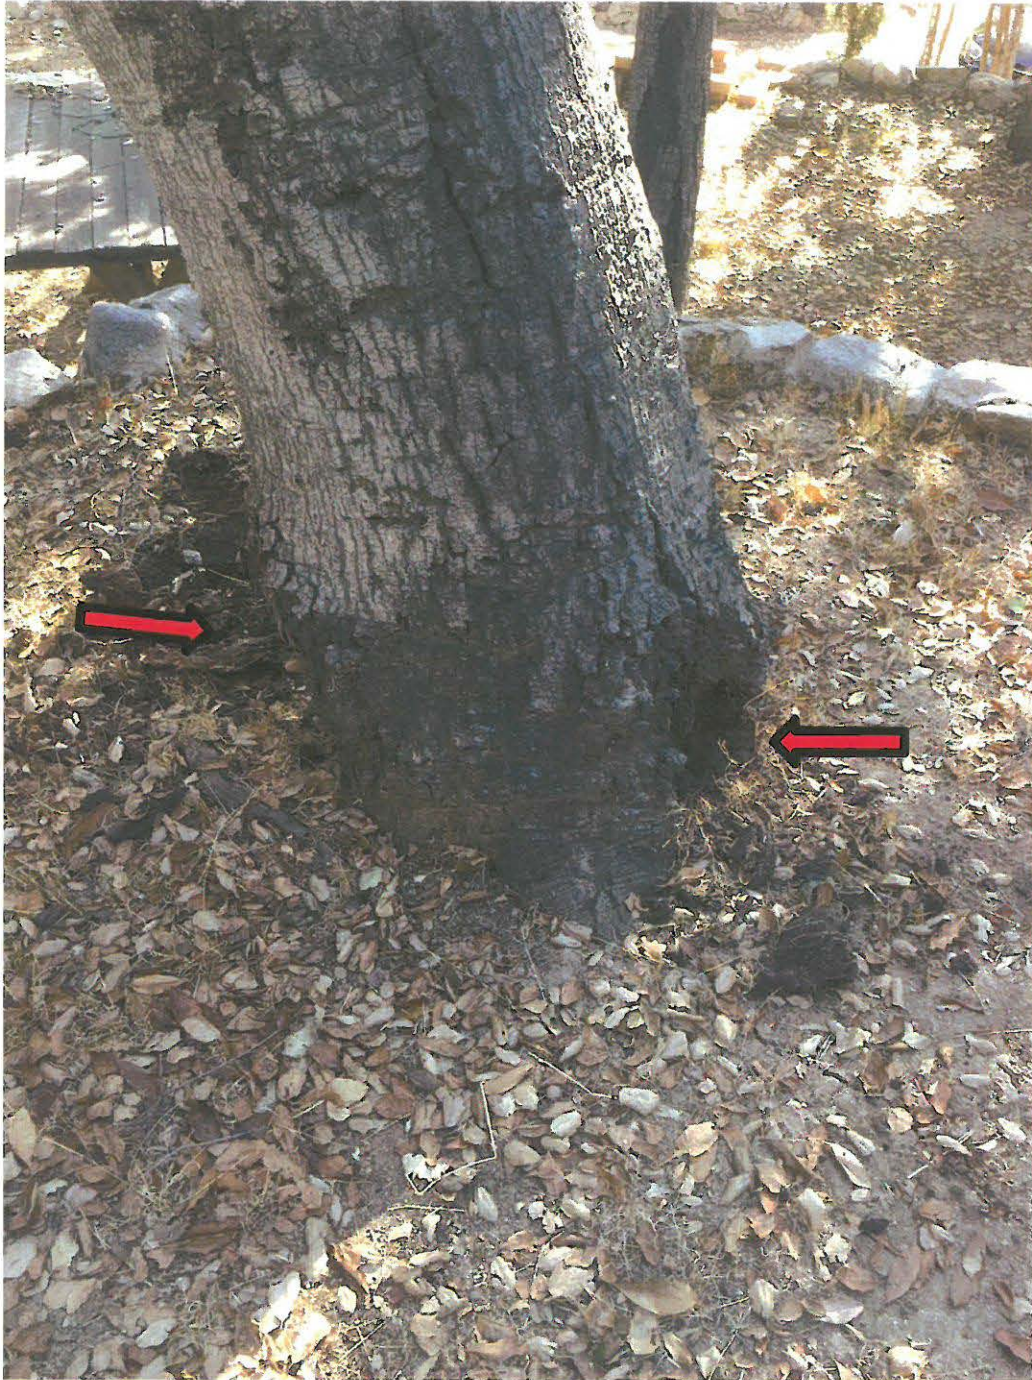
Apparently, in the past year, some surface **decay** has progressed at the trunk flare; an eight inches deep cavity is seen on the southeast side and another three inches deep cavity on the northwest side. Since the diameter of the trunk flare is about 25 inches, the sum of the two cavities, which adds up to 11 inches, is above the accepted threshold of 33%. Therefore, the structural stability of this tree will be greatly reduced in the coming years, especially that the tree's single trunk has substantial lean toward the southeast side.

Tree #91 is in poor structural form, because of decay cavity at the base of the trunk, and it is being proposed to be removed.

Red arrows indicate decay cavities at trunk flare of Tree #91.

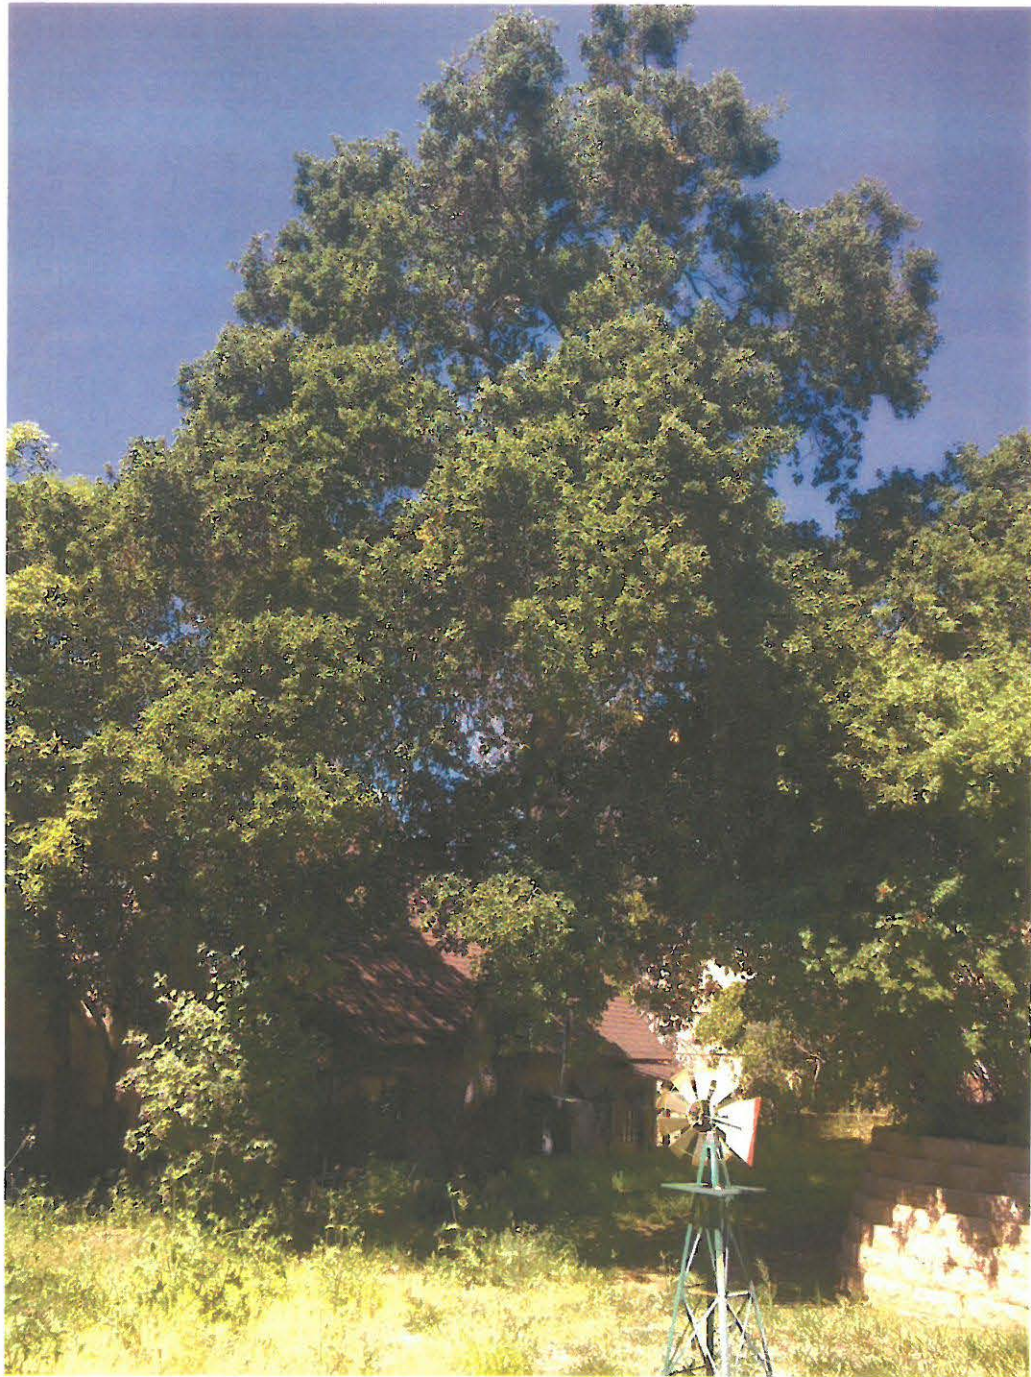
Tree #92.

The main trunk has a DBH of 26 inches, and the height of the tree is about 38 feet. The main trunk extends vertically up, branching out evenly and creating almost an evenly spread crown.

The tree is in good condition and its vigor also is good.

On a 0 to 5 scale (0 being dead and 5 being excellent), the condition rating for this tree is 4 (Good).

This tree is outside the footprint of the proposed new dwelling and it can be preserved in place.

A small section of the pool's surrounding hardscape is within the drip line. Since it is being proposed to use paving stones for this area, impact will be minimal to the tree.

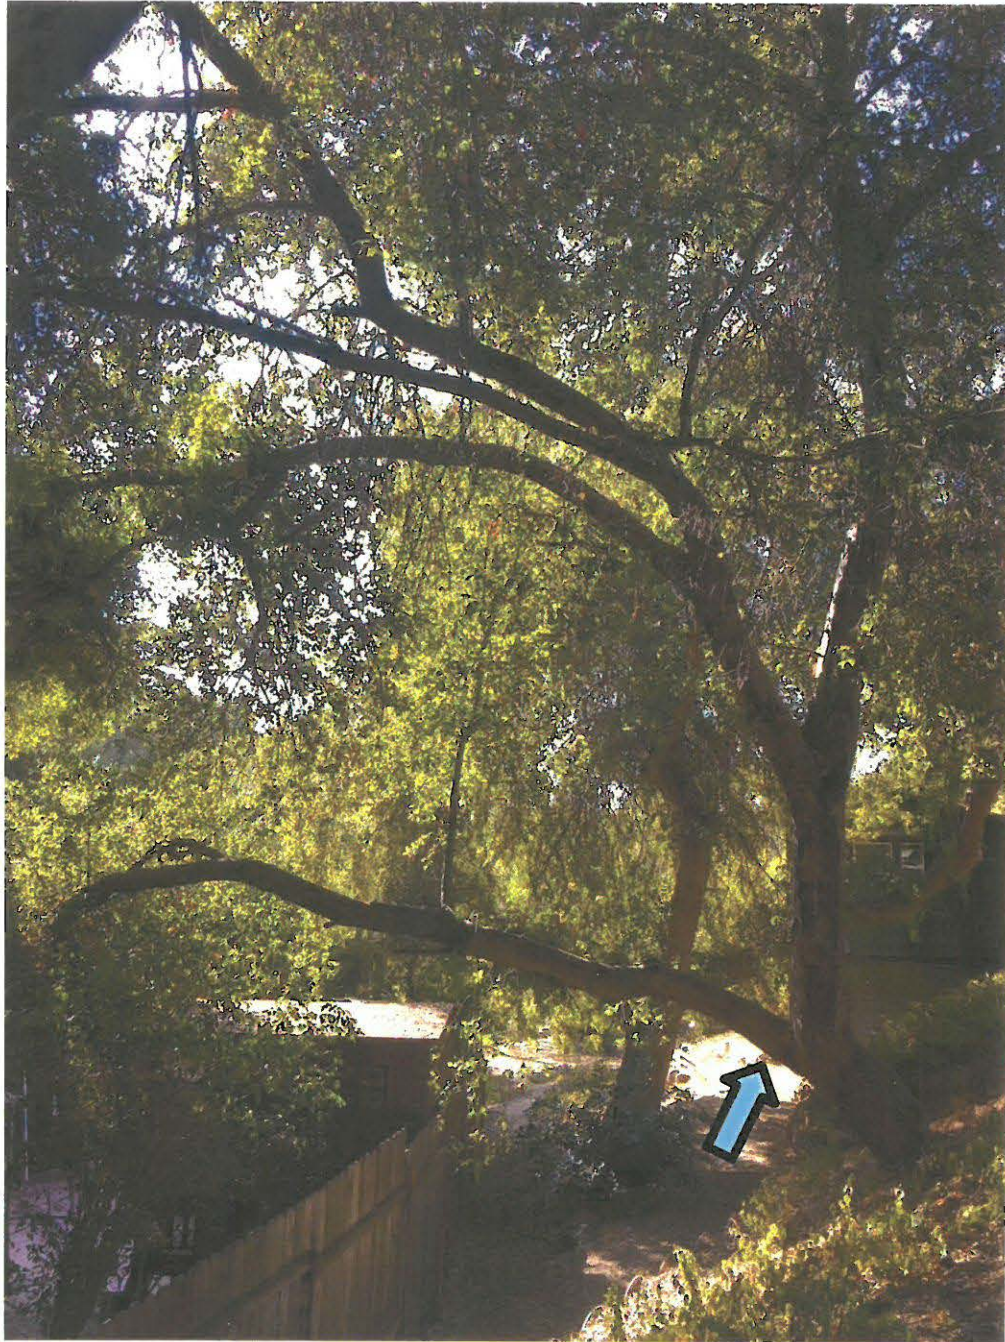
This tree is located on the east side of the property, south of the existing driveway. It has a single trunk that has a considerable lean toward the southeast side and its DBH is of 24 inches.

This tree also has the same characteristics of the other trees on site with leaning trunks; thin foliage, some deadwood, a poor structural form.

On a 0 to 5 scale (0 being dead and 5 being excellent), the condition rating for this tree is 3 (Average).

The main trunk of the tree divides to two at about five feet from grade. The smaller secondary trunk, which has a starting diameter of 12 inches, extends with the same lean of the main trunk over the neighboring property, which has the 1841 Kirkby Road address. Although this secondary trunk looks healthy, but for the property owner, it is a concern, and he requested its removal.

Tree #93.
Blue arrow indicates location of cut of leaning stem.

It is my opinion that cutting back this stem will not jeopardize the stability and structural integrity of the tree, while damage to property and injury to people will be eliminated.

And a secondary trunk of Tree #93 is being proposed to cut back, for fear of substantial property damage and personal injury in case of its failure.

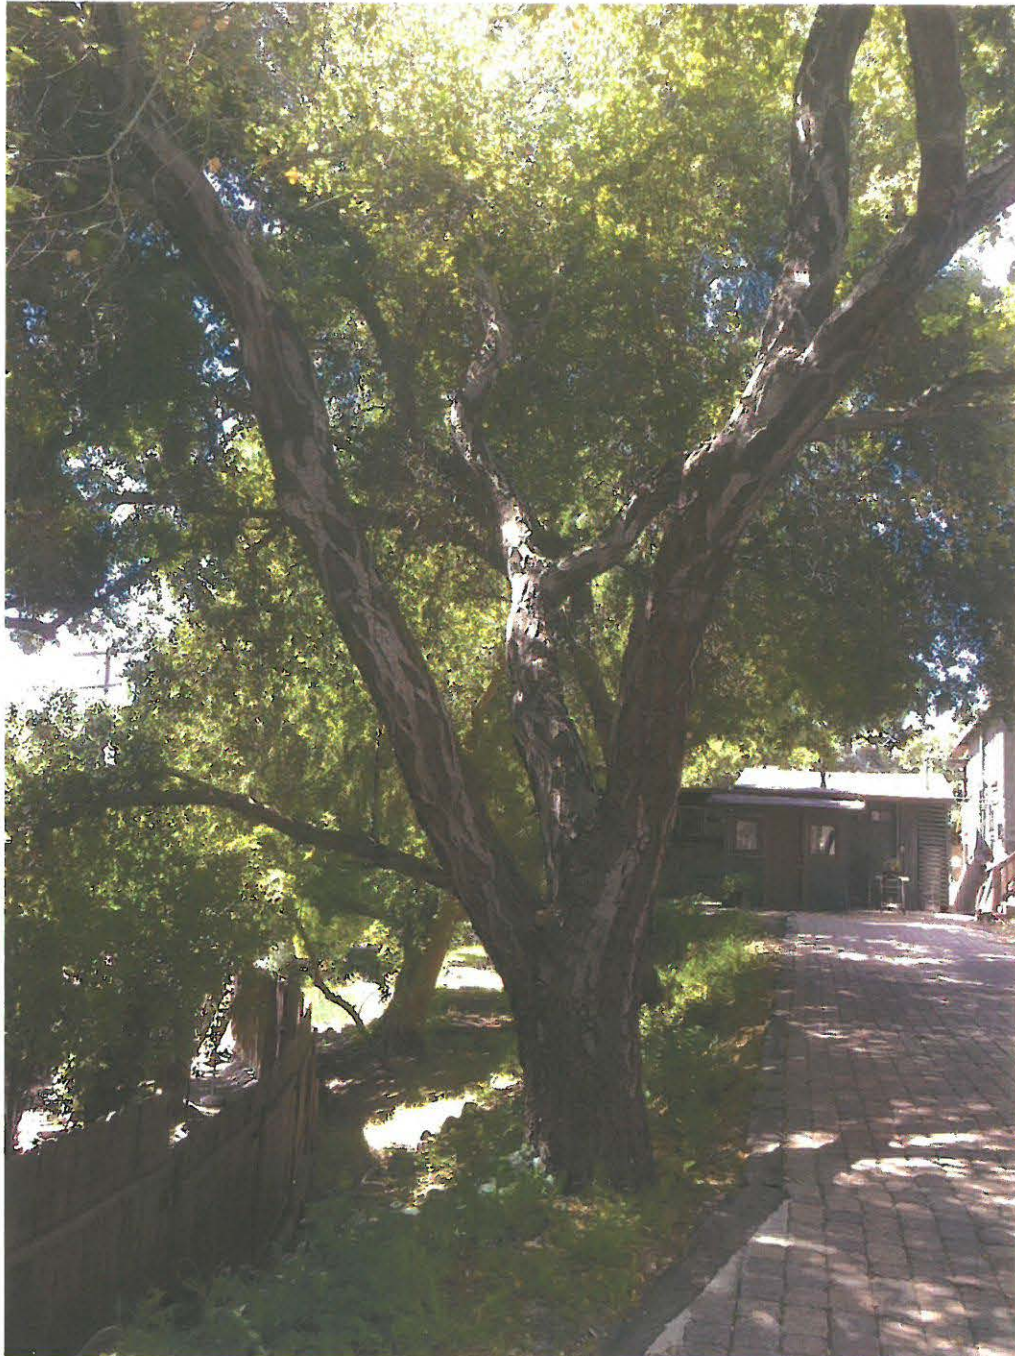
Tree #94.

This tree is well structured, with well-spaced scaffold branches and almost evenly spread crown.

The tree is healthy, with no signs of disease or structural weaknesses. Only some light deadwood in the upper canopy and some leaf scorch are visible.

On a 0 to 5 scale (0 being dead and 5 being excellent), the condition rating for this tree is 4 (Good).

This tree is outside the footprint of the proposed new dwelling and it can be preserved in place.

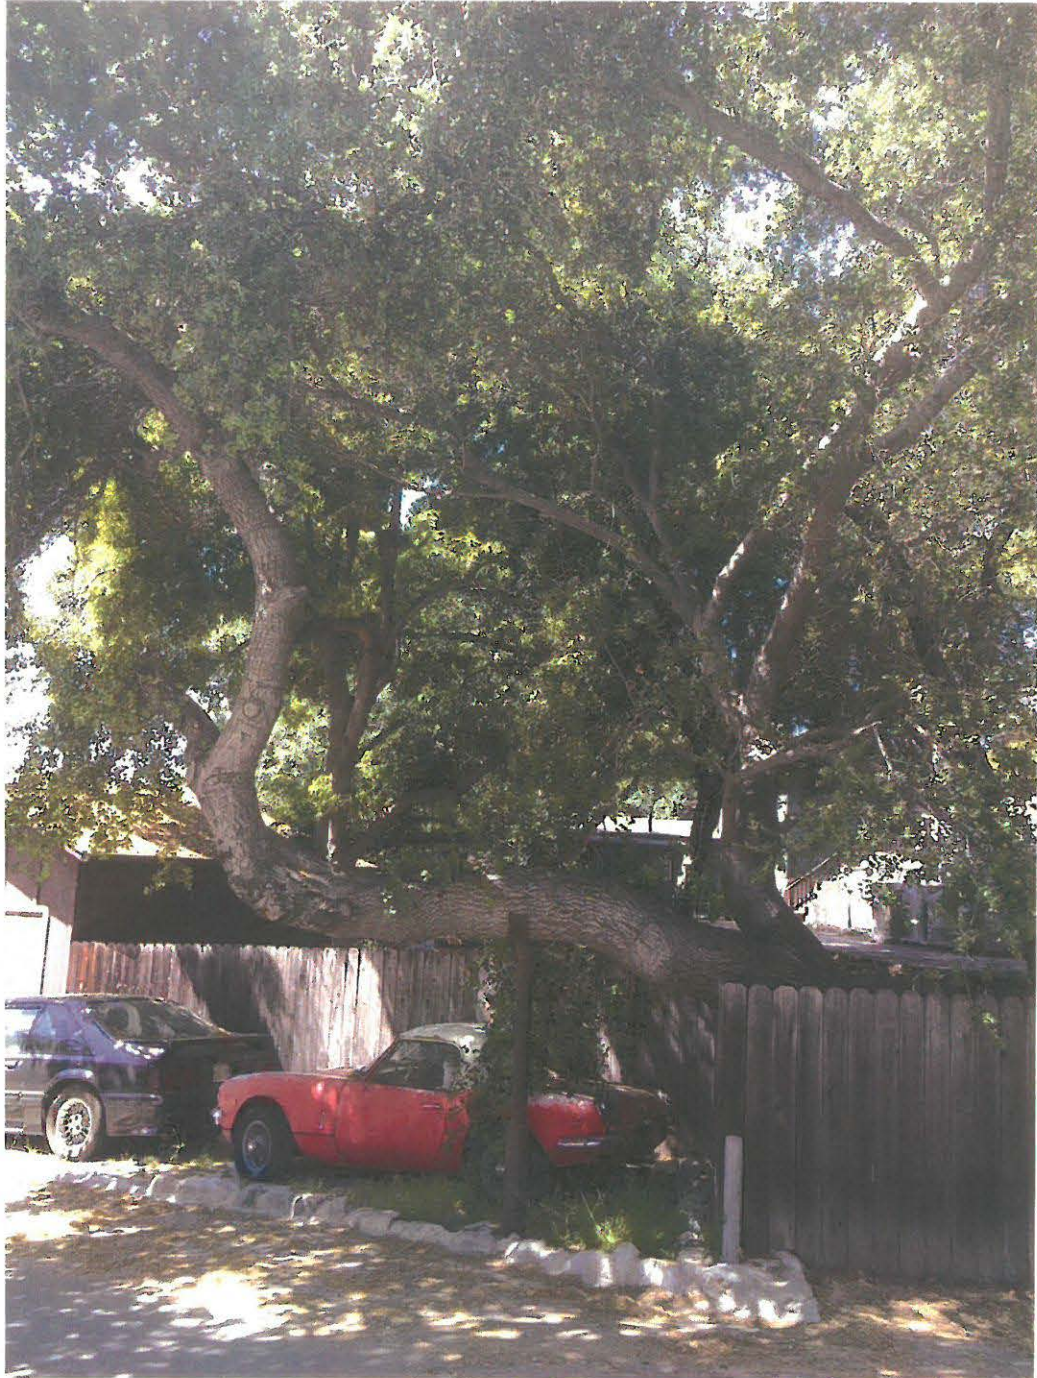
Tree #95

The tree is supported by two **props**, because of the lean of the main and one of the secondary trunks.

The crown spread is quite uneven, extending 33 feet toward the south side, only 8 feet toward the west side, 14 feet toward the north side and 23 feet toward the east side.

On a 0 to 5 scale (0 being dead and 5 being excellent), the condition rating for this tree is 3 (Average).

This tree is outside the footprint of the proposed new dwelling and it can be preserved in place.

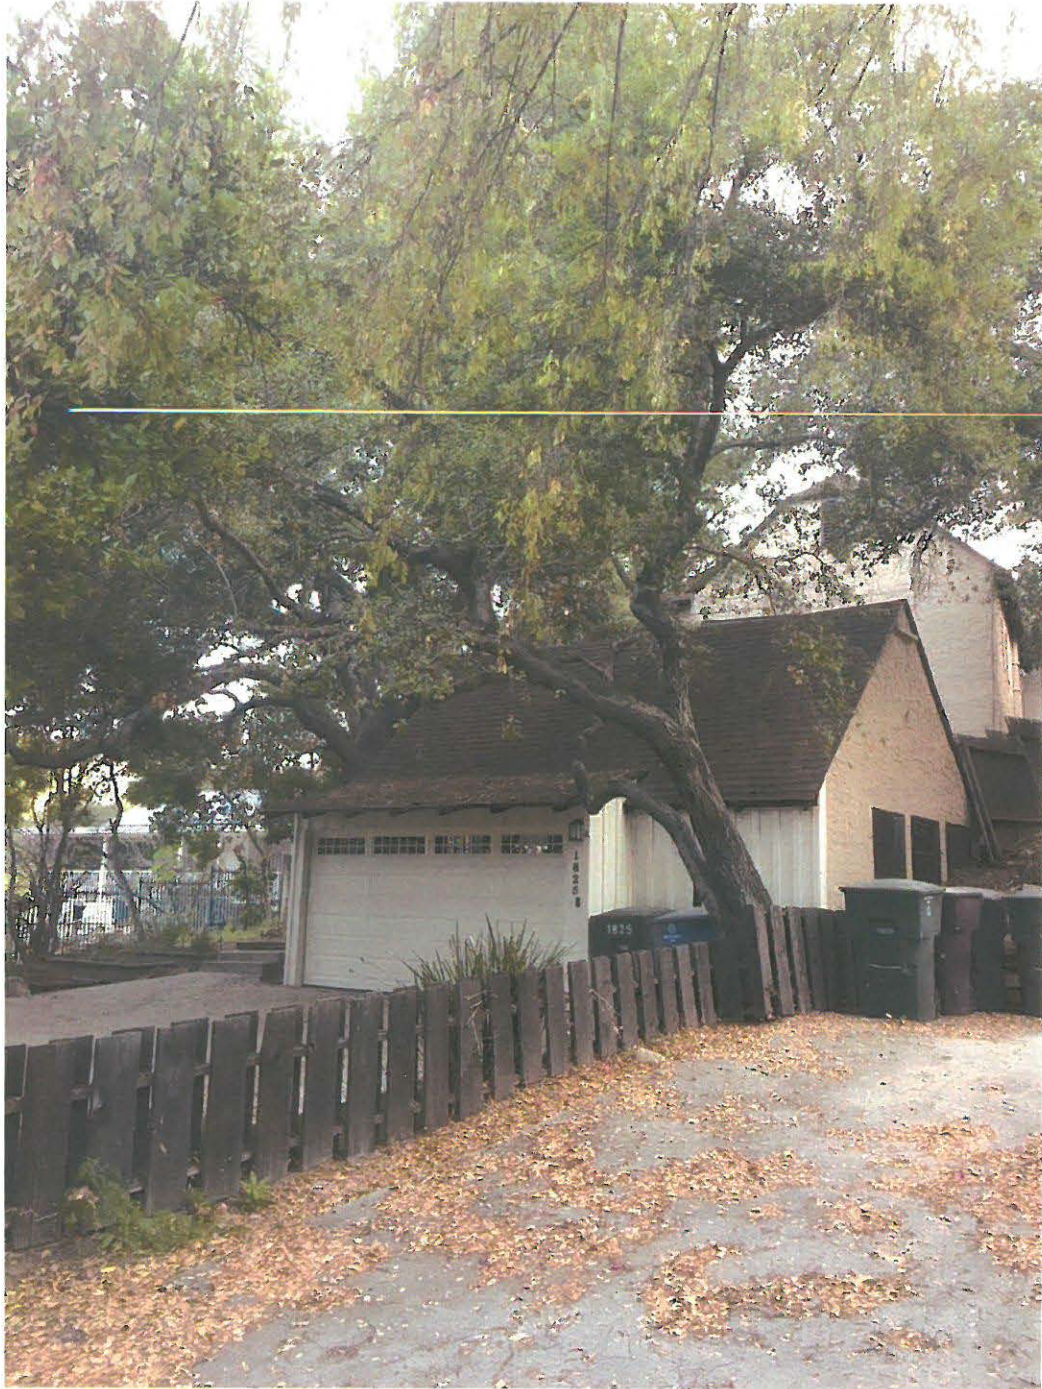
Off-Site Tree #1.

OS Tree #1 is located next to the property line between the two driveways of both properties. The grade on the 1825 Kirkby side is lower than the grade of 1829 Kirkby Rd.

As proposed, the existing driveway is being replaced with new landscaped area, therefore, no construction impact should happen to this tree, except when planting shrubs. The location of the latter can be slightly moved in order not to sever roots of the oak tree.

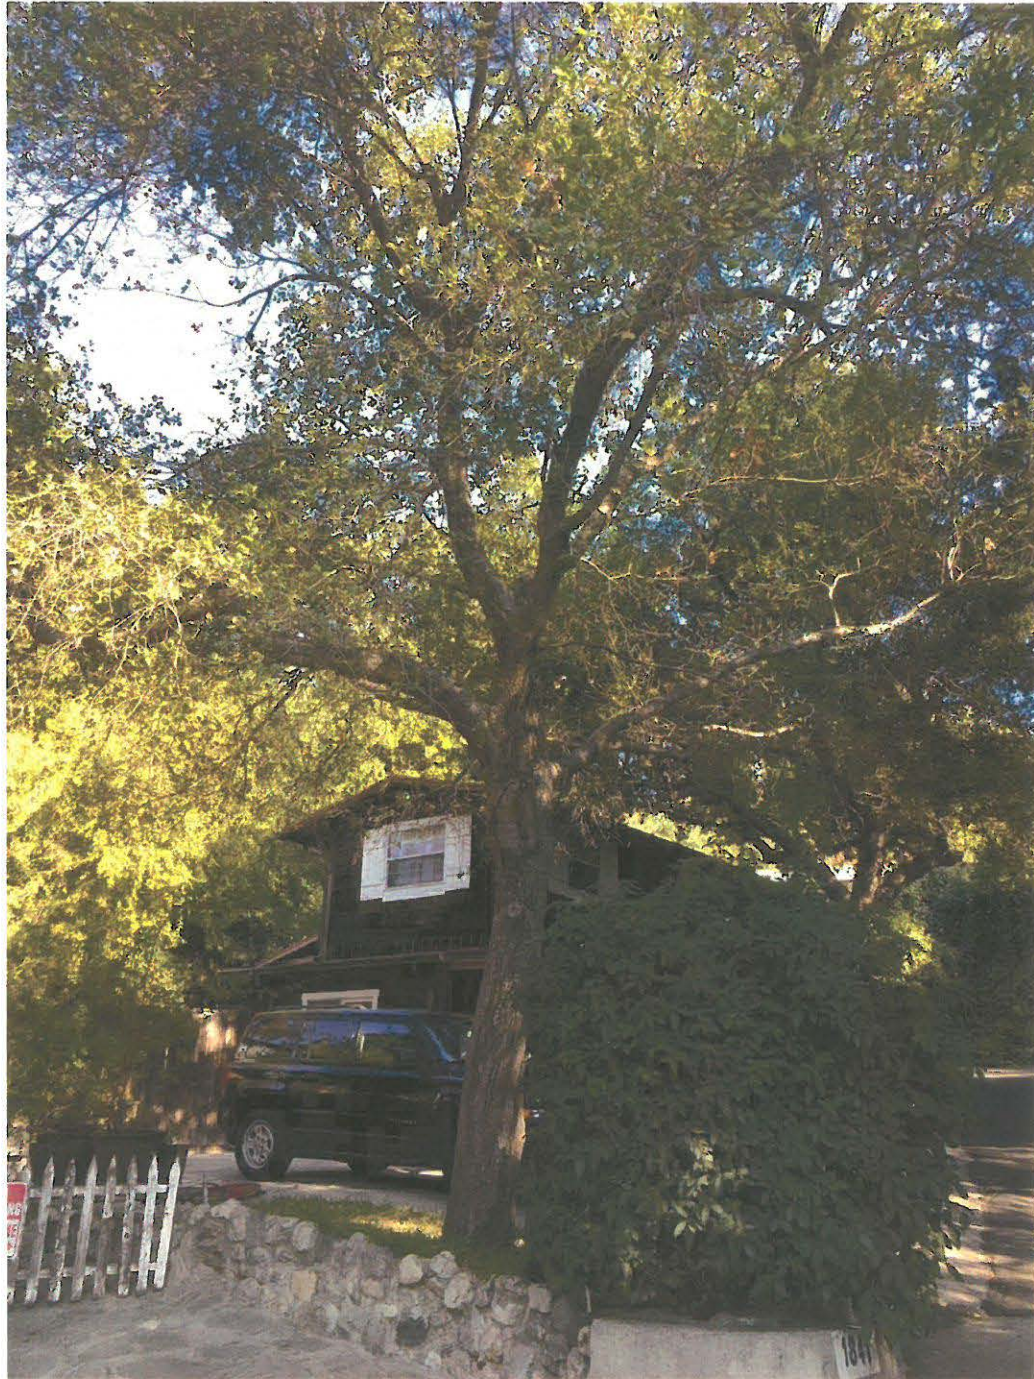
Off-Site Tree #2.

OS Tree #2 is far from any construction footprint and should not be impacted.
