May 19, 2017  
Job Number: 2186-002  
Design Review and Rehabilitation Plan for  
534 N. Kenwood Street, Glendale, CA 91203

**MEMORANDUM FOR THE RECORD**

SUBJECT: Design Review and Rehabilitation Plan for 534 N.  
Kenwood Street, Glendale, CA 91201

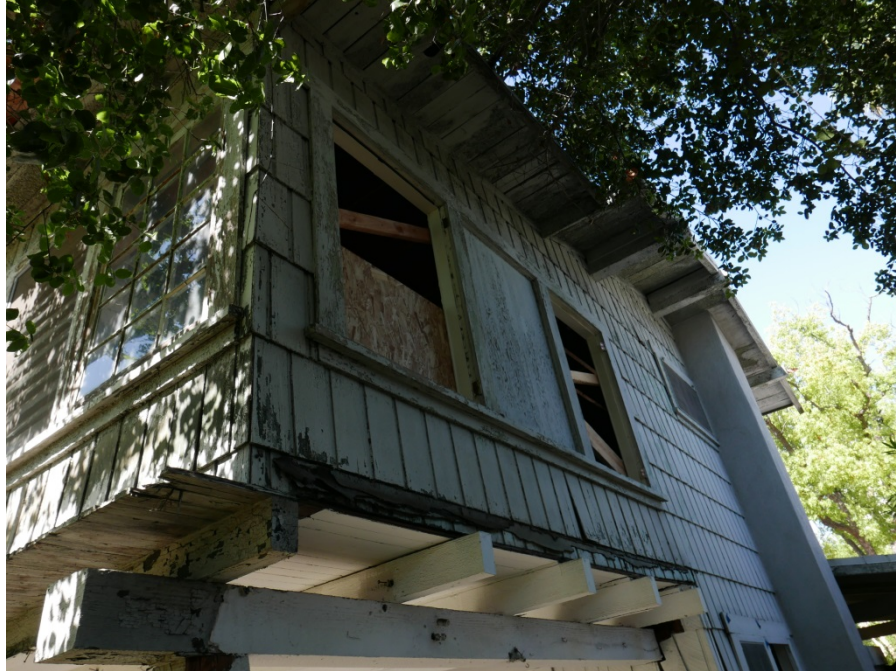
**Figure 3. Detail of Rear Second Floor Addition, 534 N. Kenwood**  
SOURCE: *Sapphos Environmental, Inc., 2017*

The project would repair damaged members to the extent feasible or would replace in kind. The project would remove a 15-light casement window and six window openings in order to convert the rear second floor addition to a bathroom. The replacement materials are in keeping with the existing. Therefore, the building would not be changed in a manner that creates a false sense of historical development which is consistent with Standard for Rehabilitation No. 3.

Although the rear second floor addition is not visible from the public right-of-way, it will be retained and rehabilitated to a different use which is in keeping with Standard for Rehabilitation No. 4.

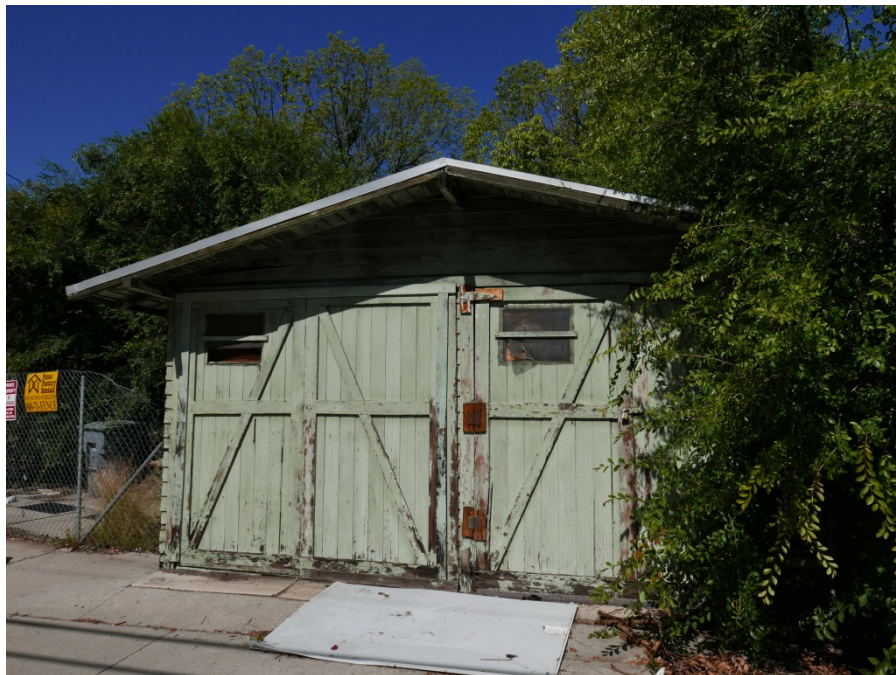
**Figure 4. Detached Garage, 534 N. Kenwood Street**  
SOURCE: *Sapphos Environmental, Inc., 2017*

A detached garage was identified in the 2007 Craftsman Survey on this property; however, it is not considered to be a contributing feature of the property and is in poor condition (Figure 4, *Detached Garage, 534 N. Kenwood Street*).

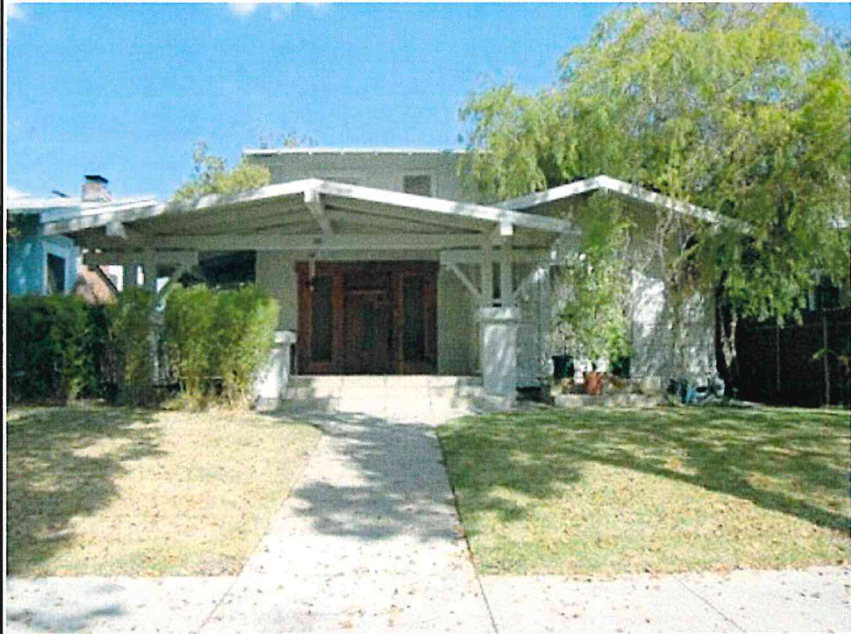
P5b. Description of Photo:  
Front facade

The condition of the building is good. Alterations to the building include a boarded-up window on the north elevation.
