601 and 603 Bohlig Rd. Arborist Report

Prepared for Camille Neagu
601 Bohlig Road
Glendale, CA 91207

Prepared by James Komen
BCMA WE-9909B
RCA #555

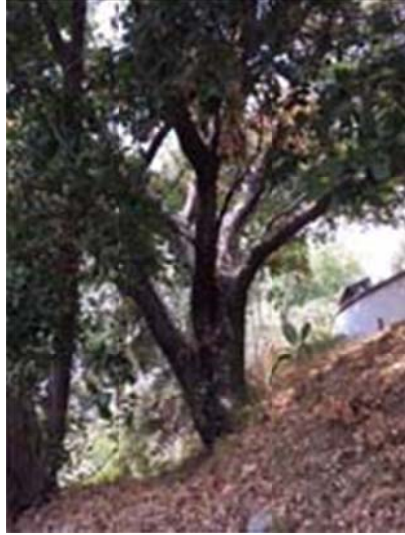
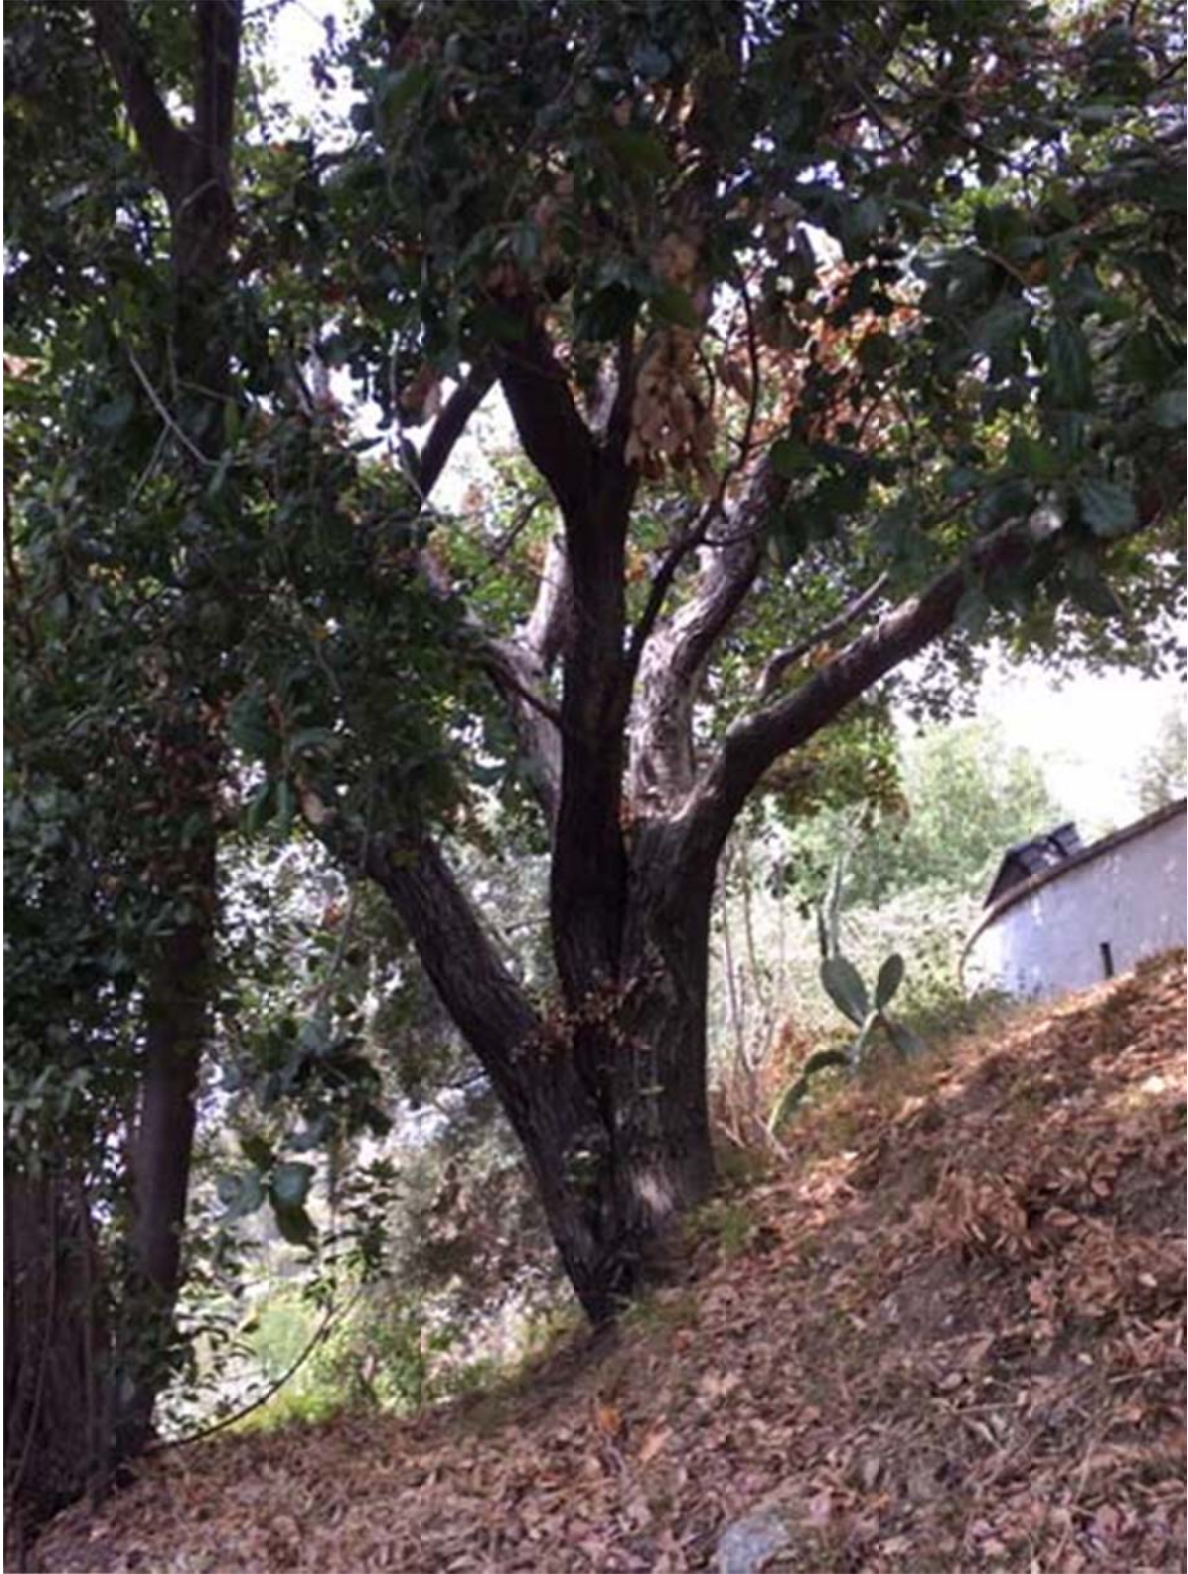
Tree 4

This multi-stem oak tree is growing on the hillside above the existing structure on the subject property. The foliage appears healthy, and this naturally-occurring tree only has the common defect of narrow branch unions. No mitigation action is necessary.

Grading for a retaining wall will encroach upon the drip line of this tree at the bottom of the hill. Although some of the soil from within the drip line of the tree will be removed, the proposed grading is unlikely to significantly affect the health of the tree because the linear distance from the trunk is much further than the horizontal distance shown on the map.

This tree will not likely be significantly impacted by the proposed construction project if the tree protection fencing is not crossed.

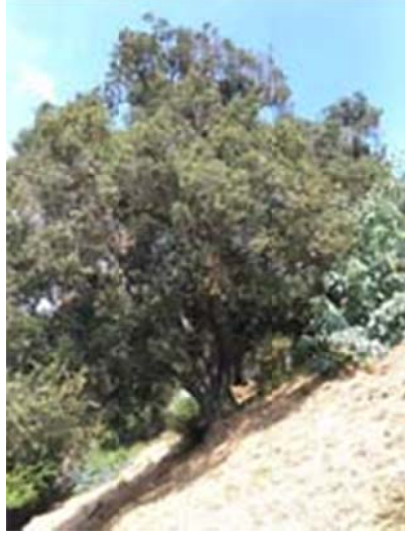
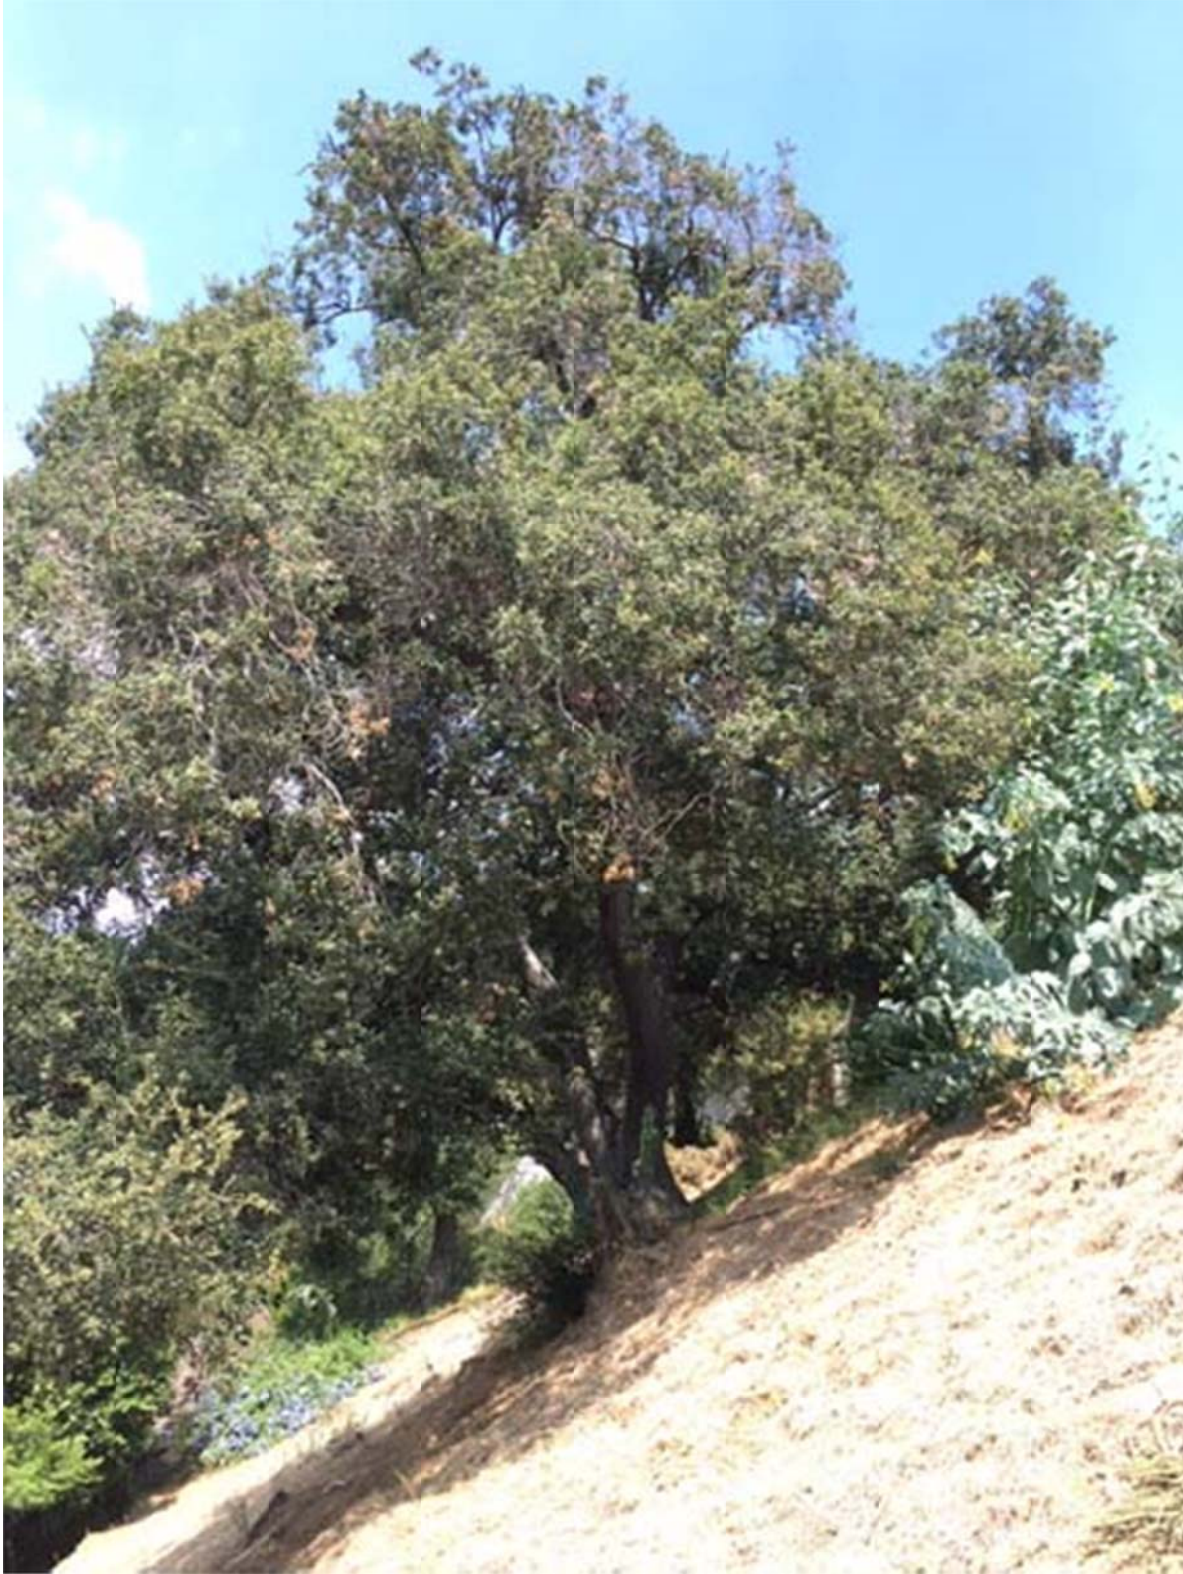
This protected mature Coast Live Oak is in very good condition. It is growing on the hillside to the west of the existing structure, slightly below the finished grade of the driveway. It has a full, healthy canopy with no apparent defects.

A retaining wall will be constructed along the southwestern quadrant of the dripline to retain the soil for the house proposed to be built at 603 Bohlig. According to the soils report, the soil in which Tree 7 is growing consists of loose fill that was pushed over the top of the hill when the pad for the existing structure was being constructed many years ago. As a result, the soil requires substantial structural support. The retaining wall is a necessity for the safety of the proposed structures. The proposed footprint of the retaining wall is the least damaging to Tree 7 while still allowing the reasonable development of the subject property. Every effort will be made to preserve the remainder of its root system, but these root cuts are unavoidable if the proposed new structures and retaining wall will be constructed.

The impact to the most important roots of Tree 7 will be minimal. Since the tree is growing on a slope, it likely developed tensile buttress roots to apply tension force to hold the tree up. These roots form on the uphill (east) side of the trunk. A concrete deck is proposed in this area, cantilevered over natural grade within the dripline of Tree 7. The footprint of the house will remain outside the drip line of the tree. Anticipated root cutting for the footprint of the house is minimal. All excavation for the proposed deck should be performed with hand tools only within 5 feet of the drip line of Tree 7.

Figure 8: Tree 7 will be encroached from the east (right) and southwest (foreground). It will be retained in the landscape.

This tree is intended for preservation through the anticipated construction. No treatment is necessary for this tree at this time. Along the eastern half of the canopy, the proposed tree protection fencing will follow the path of an existing fence on site.

<p>Tree 7 continued...</p> <p>If roots are encountered when excavating within 5 feet of the drip line, the project arborist should decide whether they should be preserved or may be severed. If it is feasible, the locations of the support posts should be adjusted to avoid any large roots that are uncovered. If roots must be severed, they should be cut cleanly with a sharp cutting tool, minimizing the cross sectional area of heartwood exposed.</p> <p>The branches of Tree 7 over the proposed house to the southwest and the patio to the east will be pruned for minimum vertical clearance. Pruning should be performed by a crew directly supervised by a Certified Arborist and should only remove the minimum amount of foliage necessary to achieve the clearance objective.</p> <p>Although some roots and branches of Tree 7 will be cut, the tree has a good chance of being able to tolerate the impacts of construction.</p>

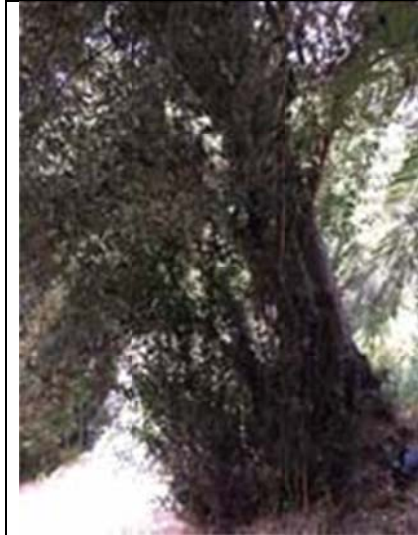
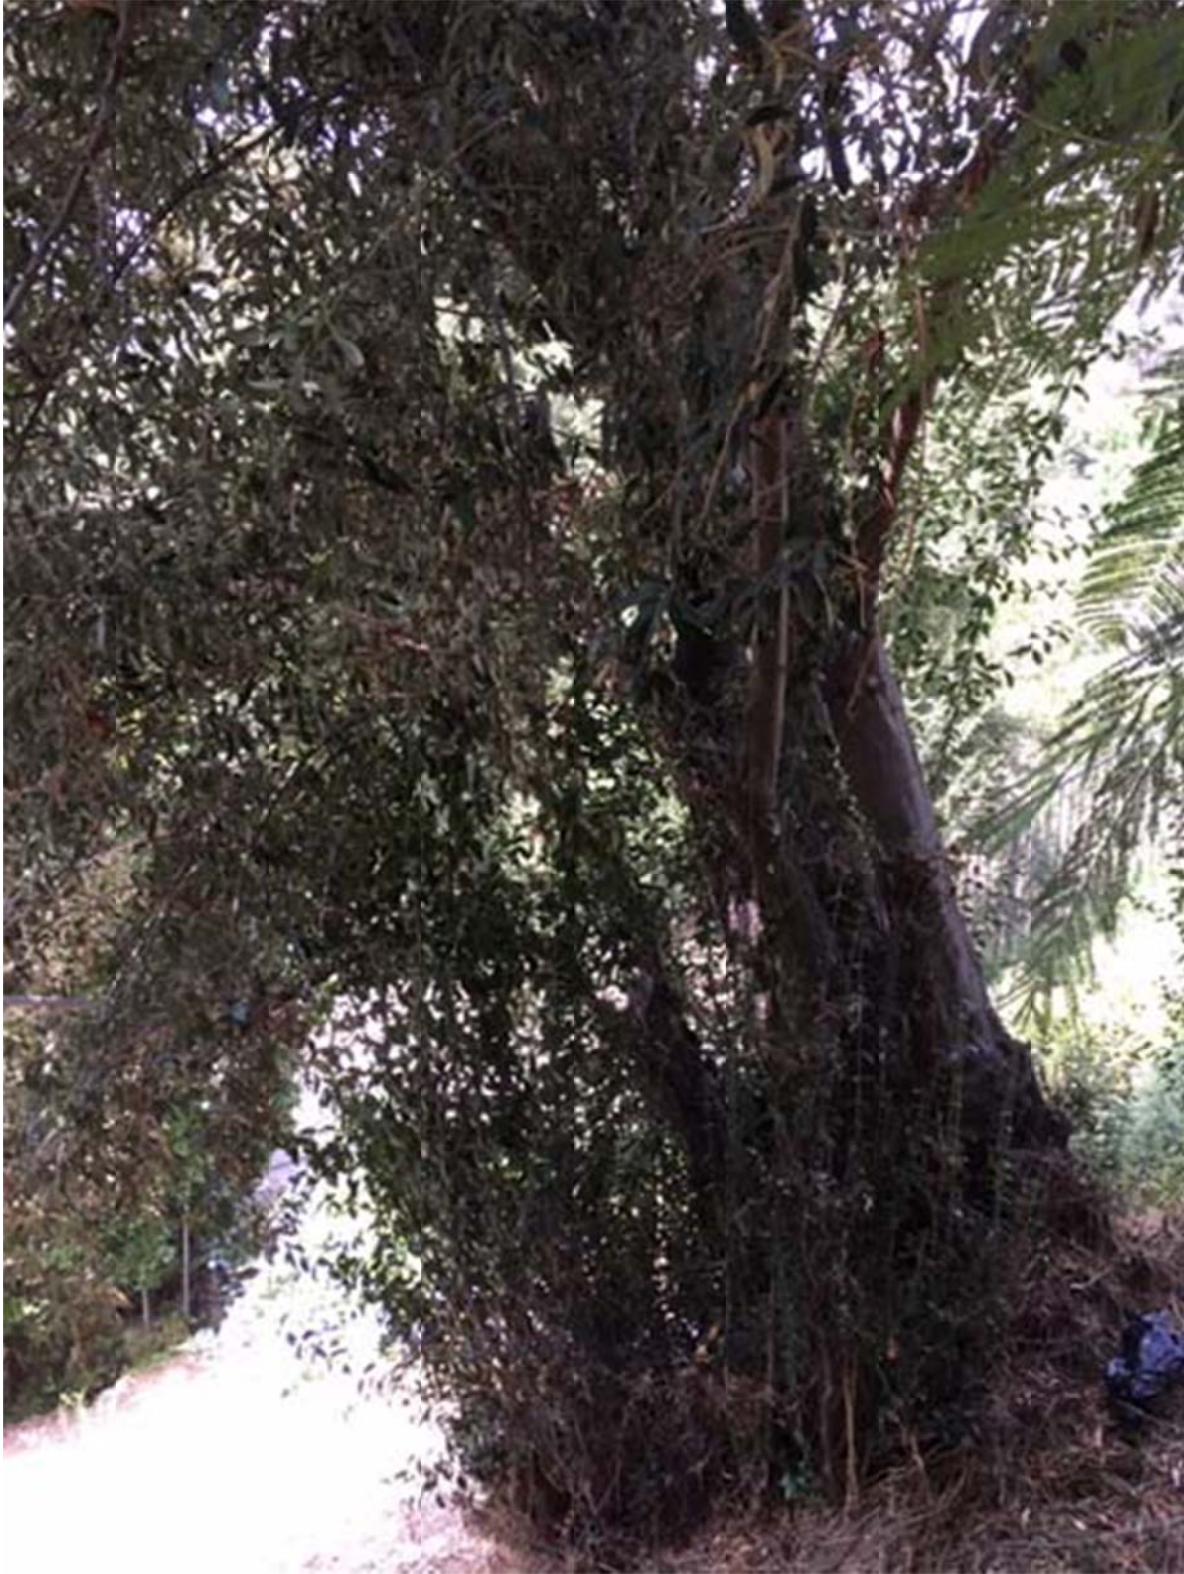
Tree 9

There is a prevailing lean to the west that is currently not problematic. A branch with a diameter of approximately 4” broke out of the upper canopy a few years ago, presumably in a windstorm. Since then, the tree has produced substantial response growth. No mitigation action is necessary at this time.

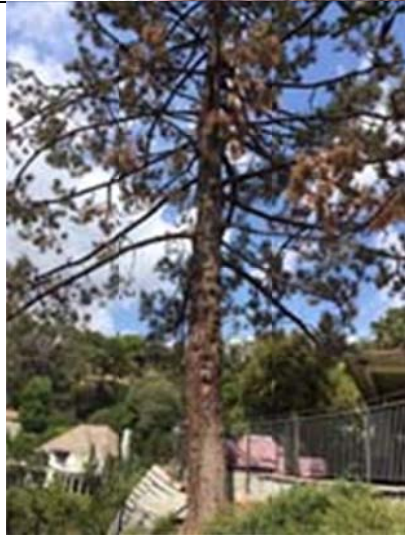
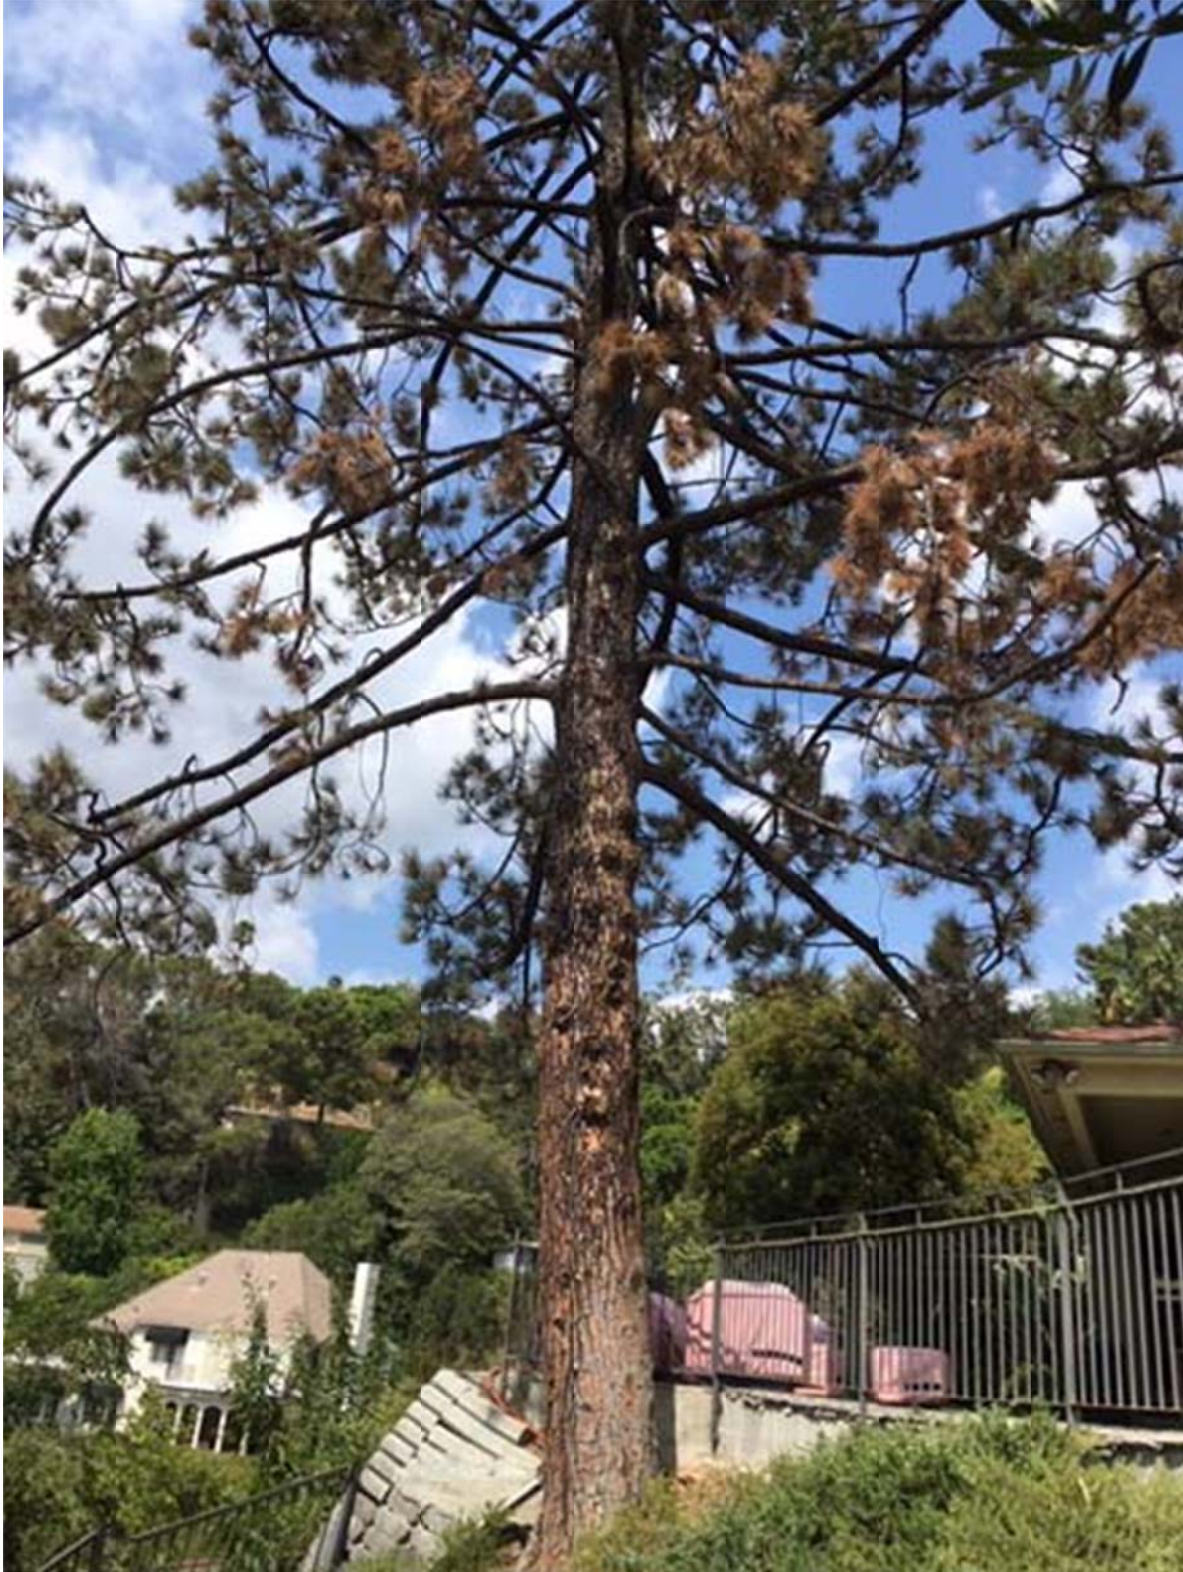
This tree is not protected by the City of Glendale Indigenous Tree Protection Ordinance. It is dead. Since it is growing on the neighboring property to the north, it will not be removed as part of this project. I recommend the neighbor remove the tree.

Figure 11: Tree OP10 is dead and recommended for removal. It is growing on the neighboring property.

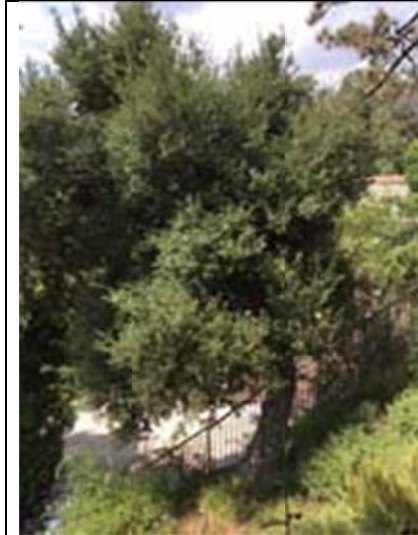
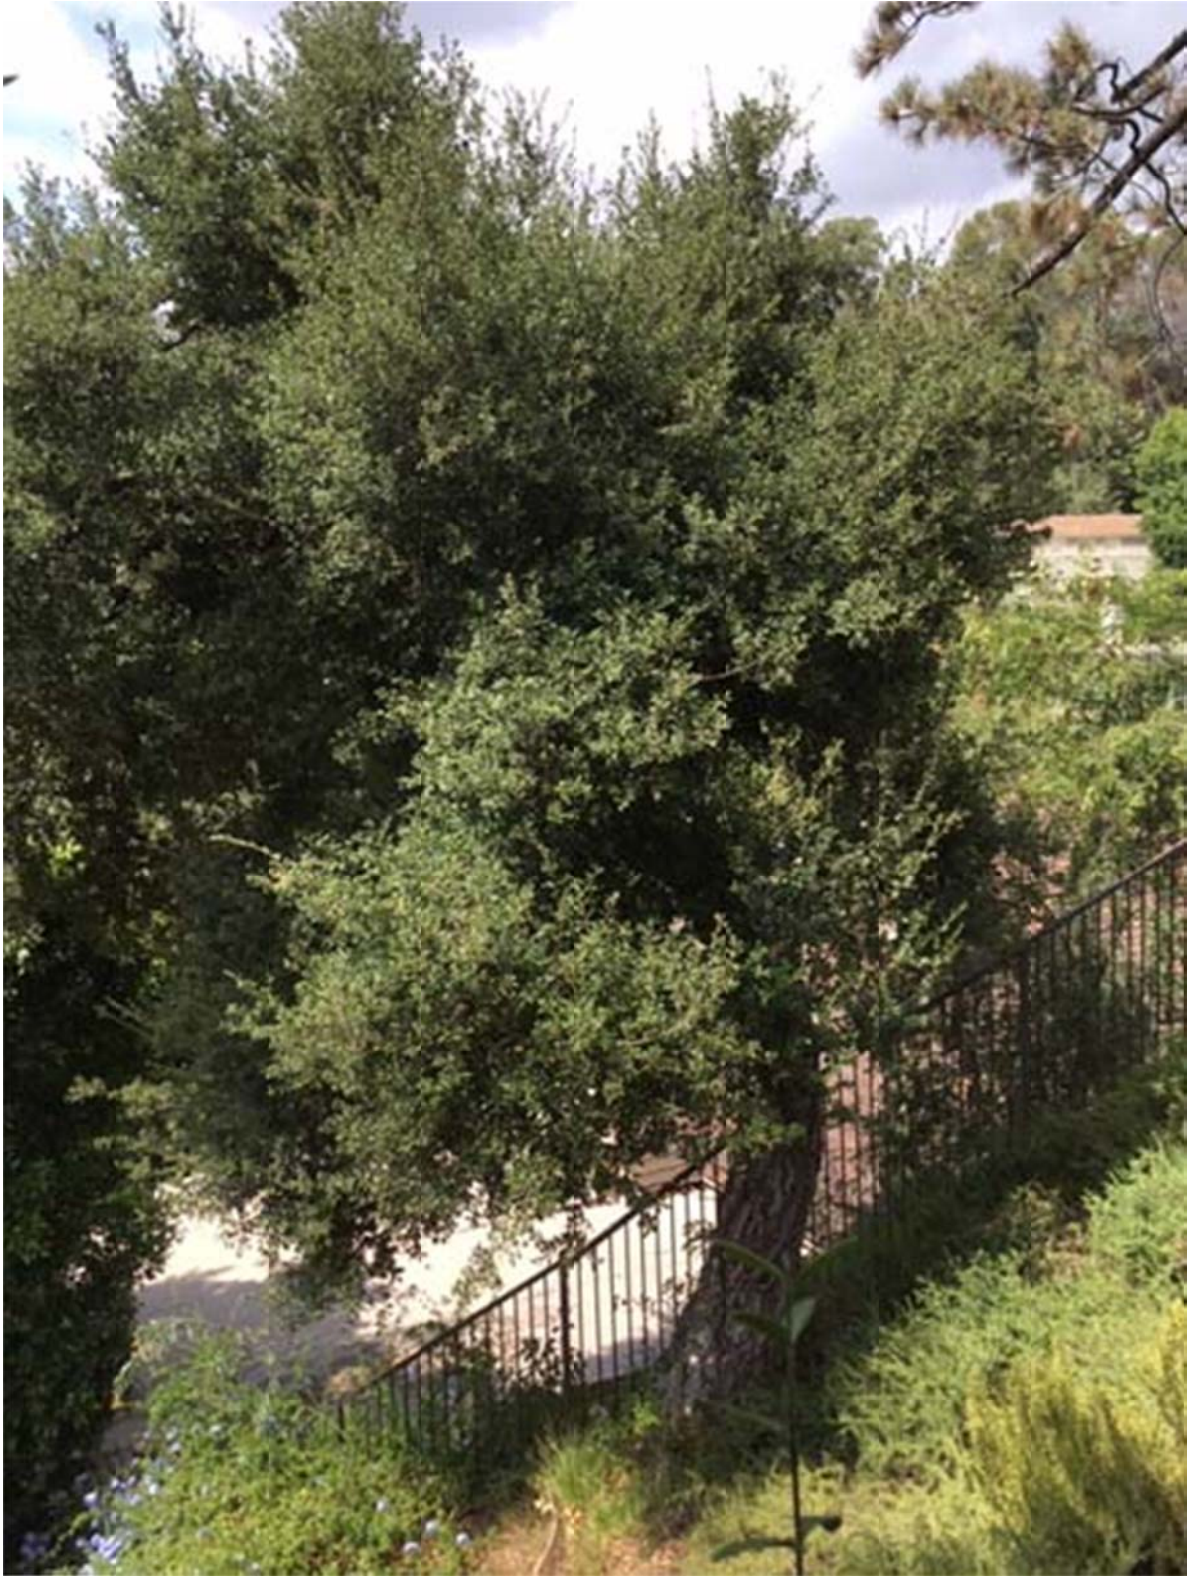
Tree OP12

The foliage appears healthy. The whole tree has a prevailing lean to the west, but no mitigation action is necessary. Coast Live Oaks growing on hillsides are able to tolerate a substantial amount of cantilevered crown; this tree has an improbable likelihood of whole-tree failure within the next four years.

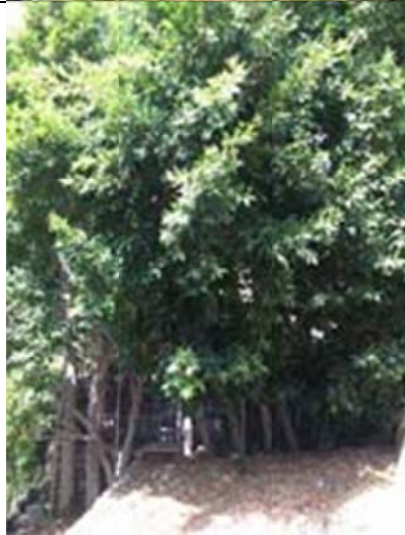
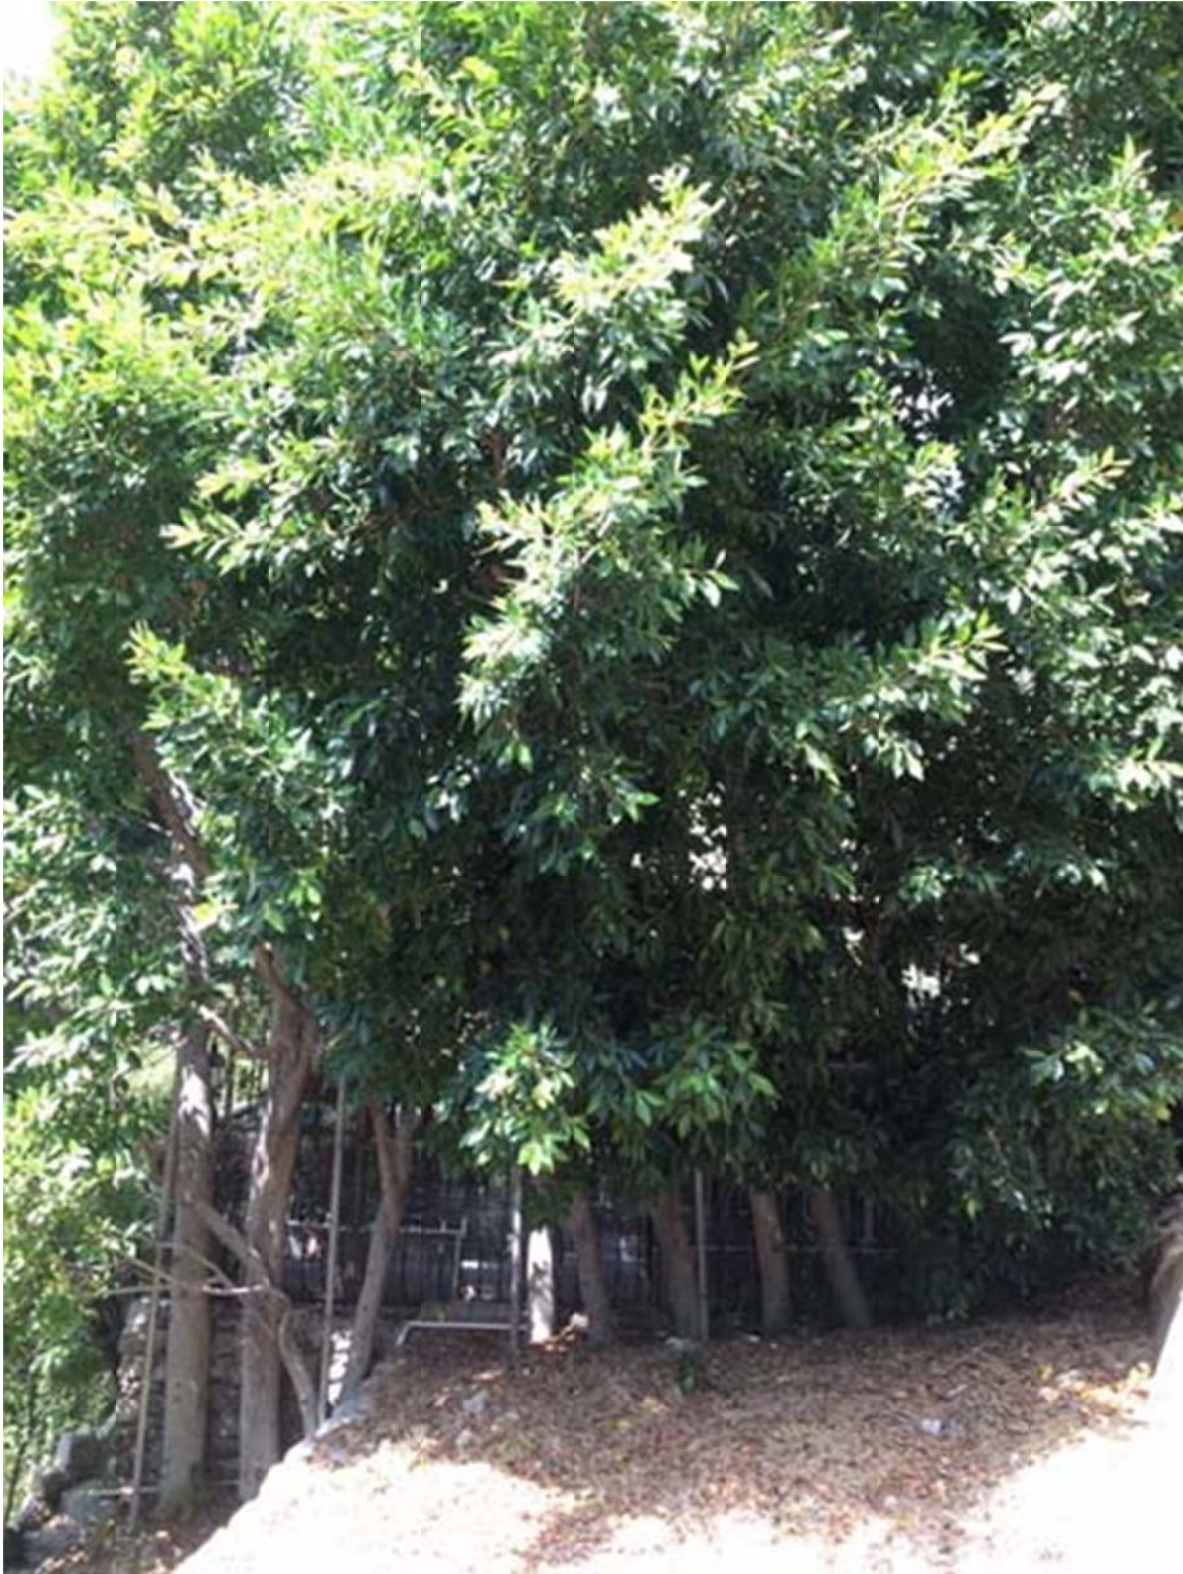
Tree OP13

This hedge of *Ficus* trees was planted with the intention of giving a privacy screen to the patio of the neighbor to the north. They appear to be experiencing moderate water stress, and they would benefit from irrigation.

Figure 14: Asset OP13 is comprised of a row of small *Ficus* trees.

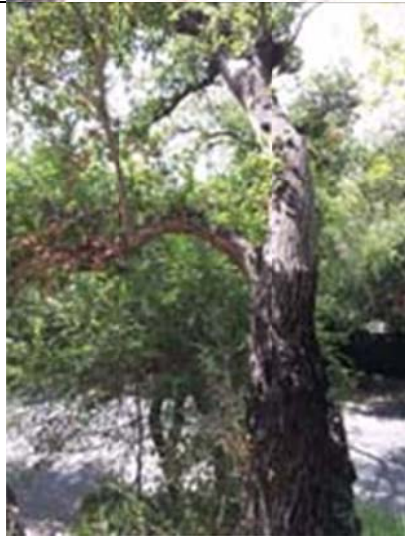
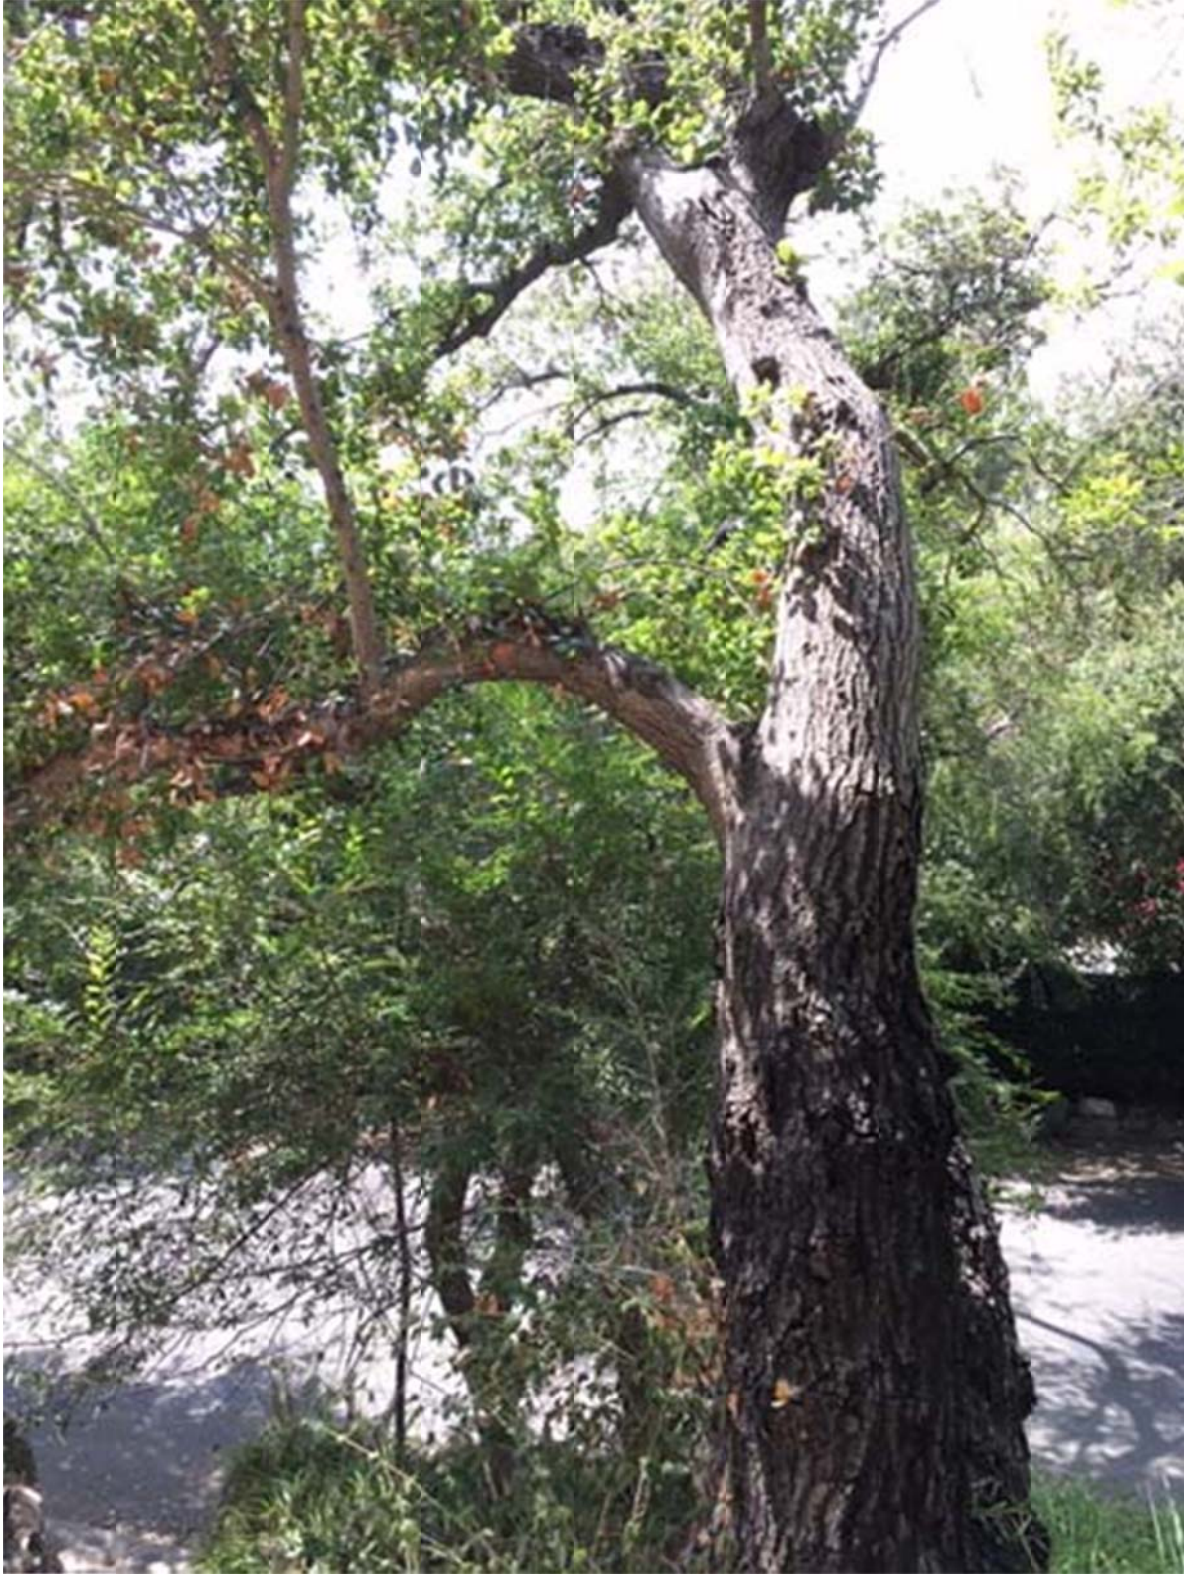
Tree OP14

This oak tree is growing on the neighboring property to the north. It is showing signs of bark borer damage. There is evidence of dark frass recently deposited along the outer layer of bark on the lower trunk. There is a prevailing lean to the west, but it does not appear to pose an elevated risk in the landscape.

The bark borer infestation should be monitored, but no mitigation action is recommended at this time. If the proposed tree protection fencing is not crossed, this tree is not likely to be impacted by construction activity.

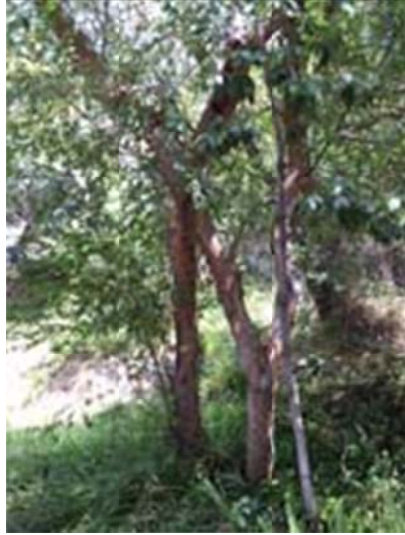
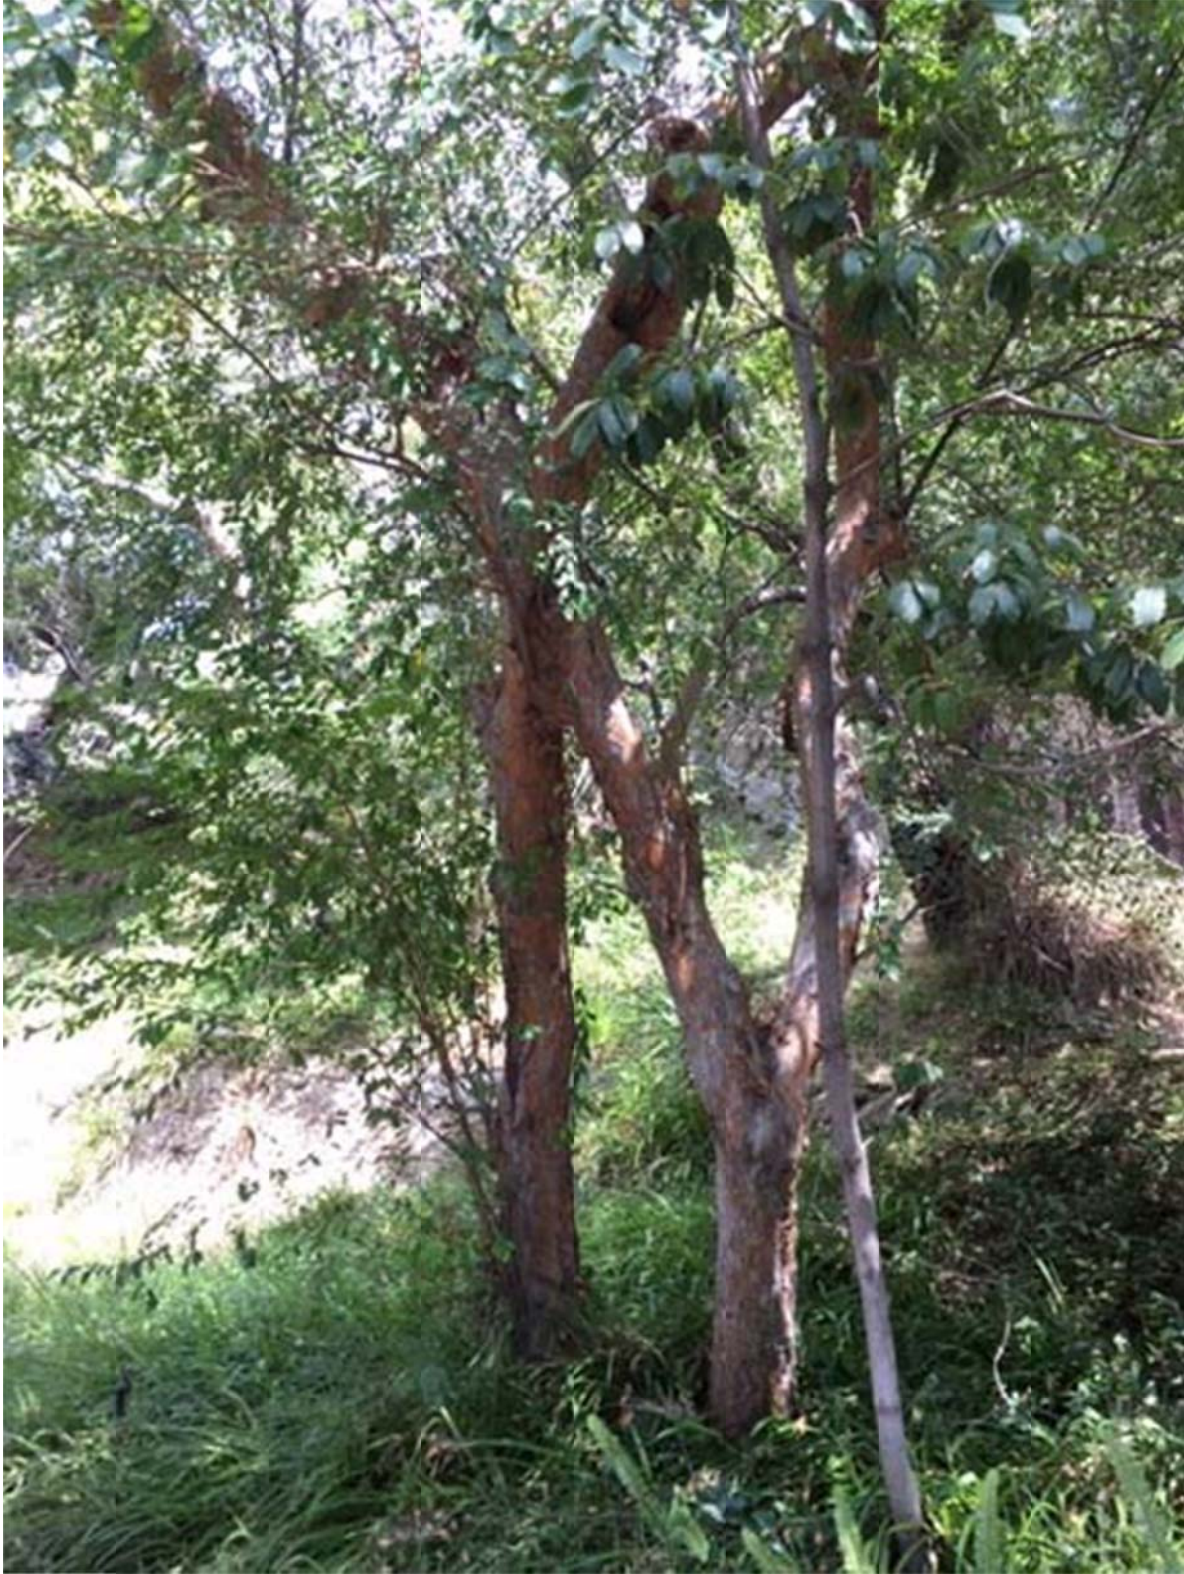
Tree OP15
Ulmus parvifolia – Chinese Elm

This tree is growing on the neighboring property to the north. It is not protected by the City of Glendale Indigenous Tree Protection Ordinance. Its canopy is partially suppressed by the neighboring oak to the east, but the amount of canopy cantilever is not problematic at this time.

It shows evidence of Chinese Elm anthracnose canker. This is a target-canker that prevents annual rings from completing the deposition of a protective barrier to cover the wound created by the fungus. At this time, there is no need to take action to mitigate this condition. Chinese Elm anthracnose fungus is common for this species. If the target canker becomes larger within the next five years, the tree may be considered for removal. Otherwise, it can be retained in the landscape.

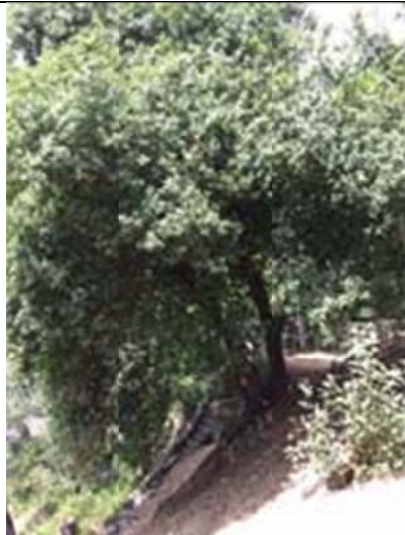
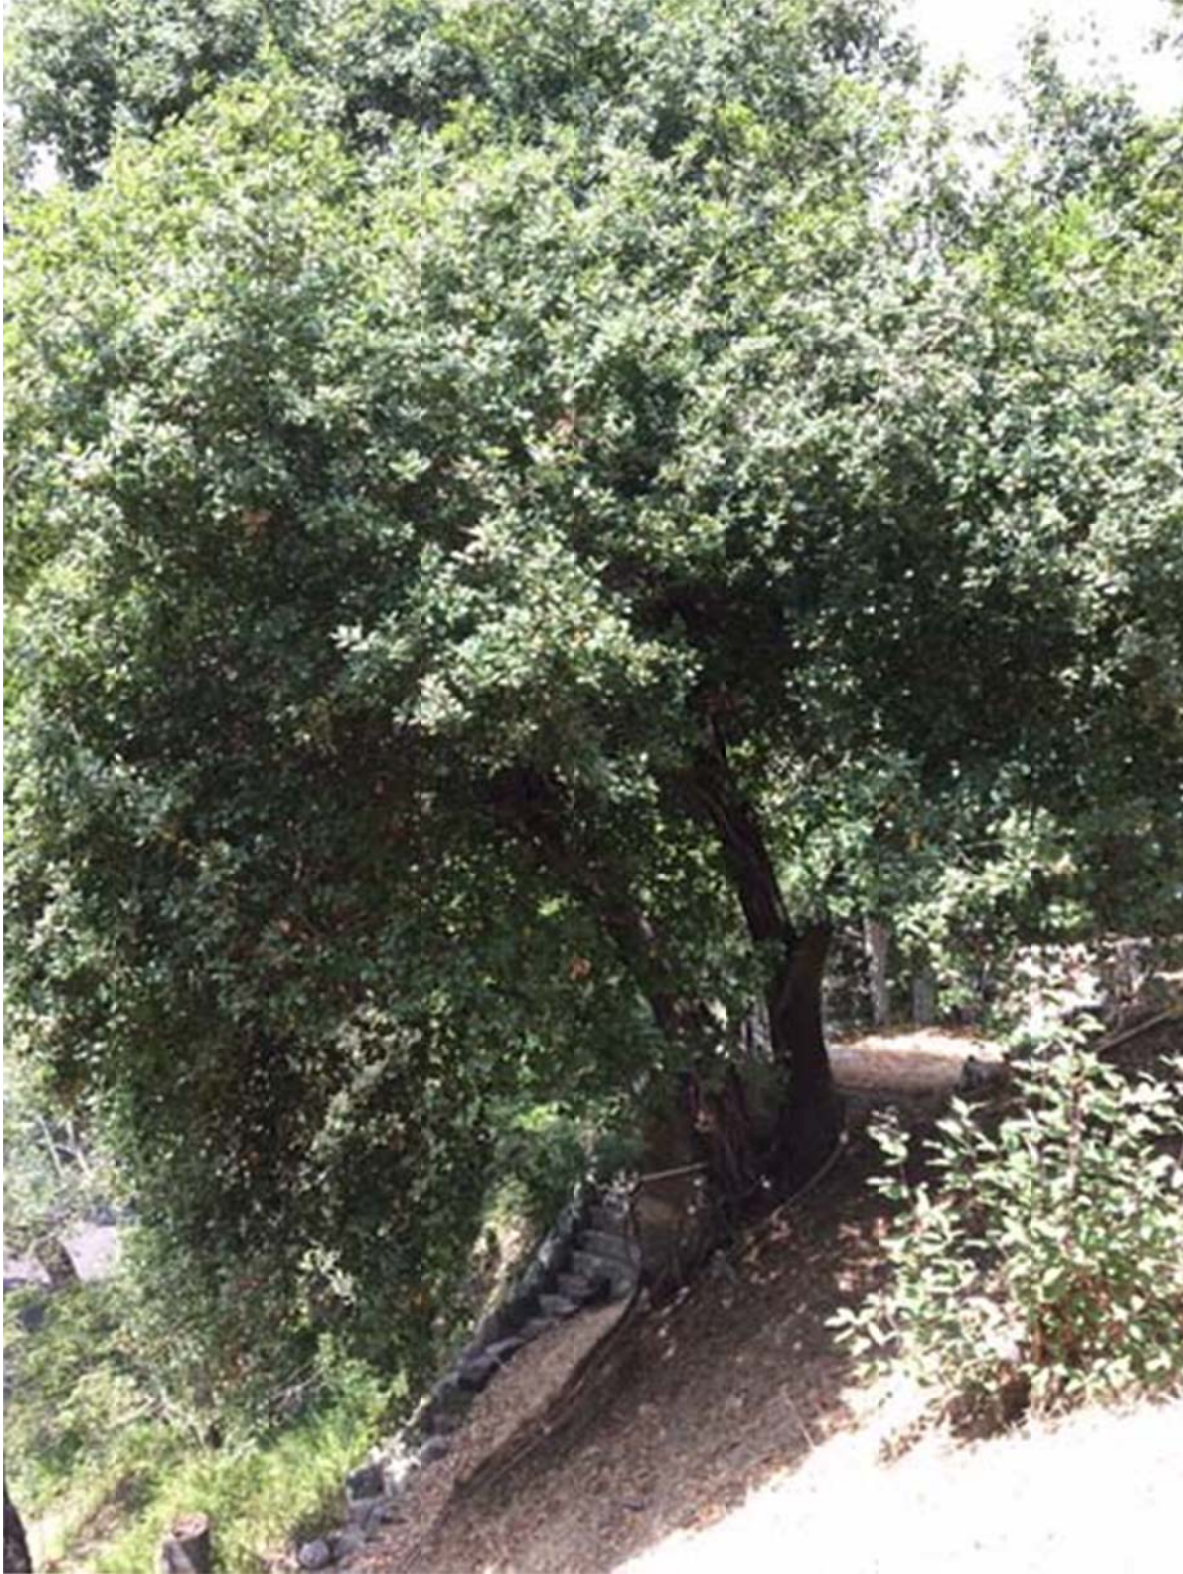
Tree 16
Quercus agrifolia – Coast Live Oak

This tree is growing next to an old stone wall growing along the northern property line. The canopy is dense and healthy. I did not observe any defects in this tree.

This tree will be retained through construction. A retaining wall will be constructed along the eastern edge of its drip line, possibly impacting some of its roots. Like with Tree 7, these roots are on the uphill side, so they are more important for the structural stability of the tree. Excavation for the retaining wall will take place outside the drip line, so the amount of impact to the roots will likely be low.

The proposed retaining wall is necessary because the soil on this western slope is comprised of loosely packed fill with the potential to slide down the slope.

If the proposed tree protection fencing is not crossed, the tree will be likely to survive construction activity.

Figure 17: Tree 16 will be encroached by construction of a retaining wall along the eastern edge of its drip line (out of frame, right).

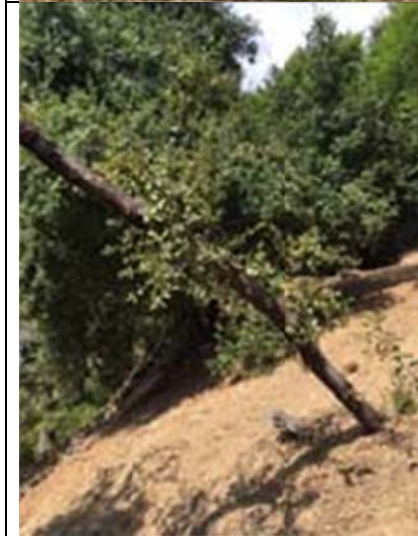
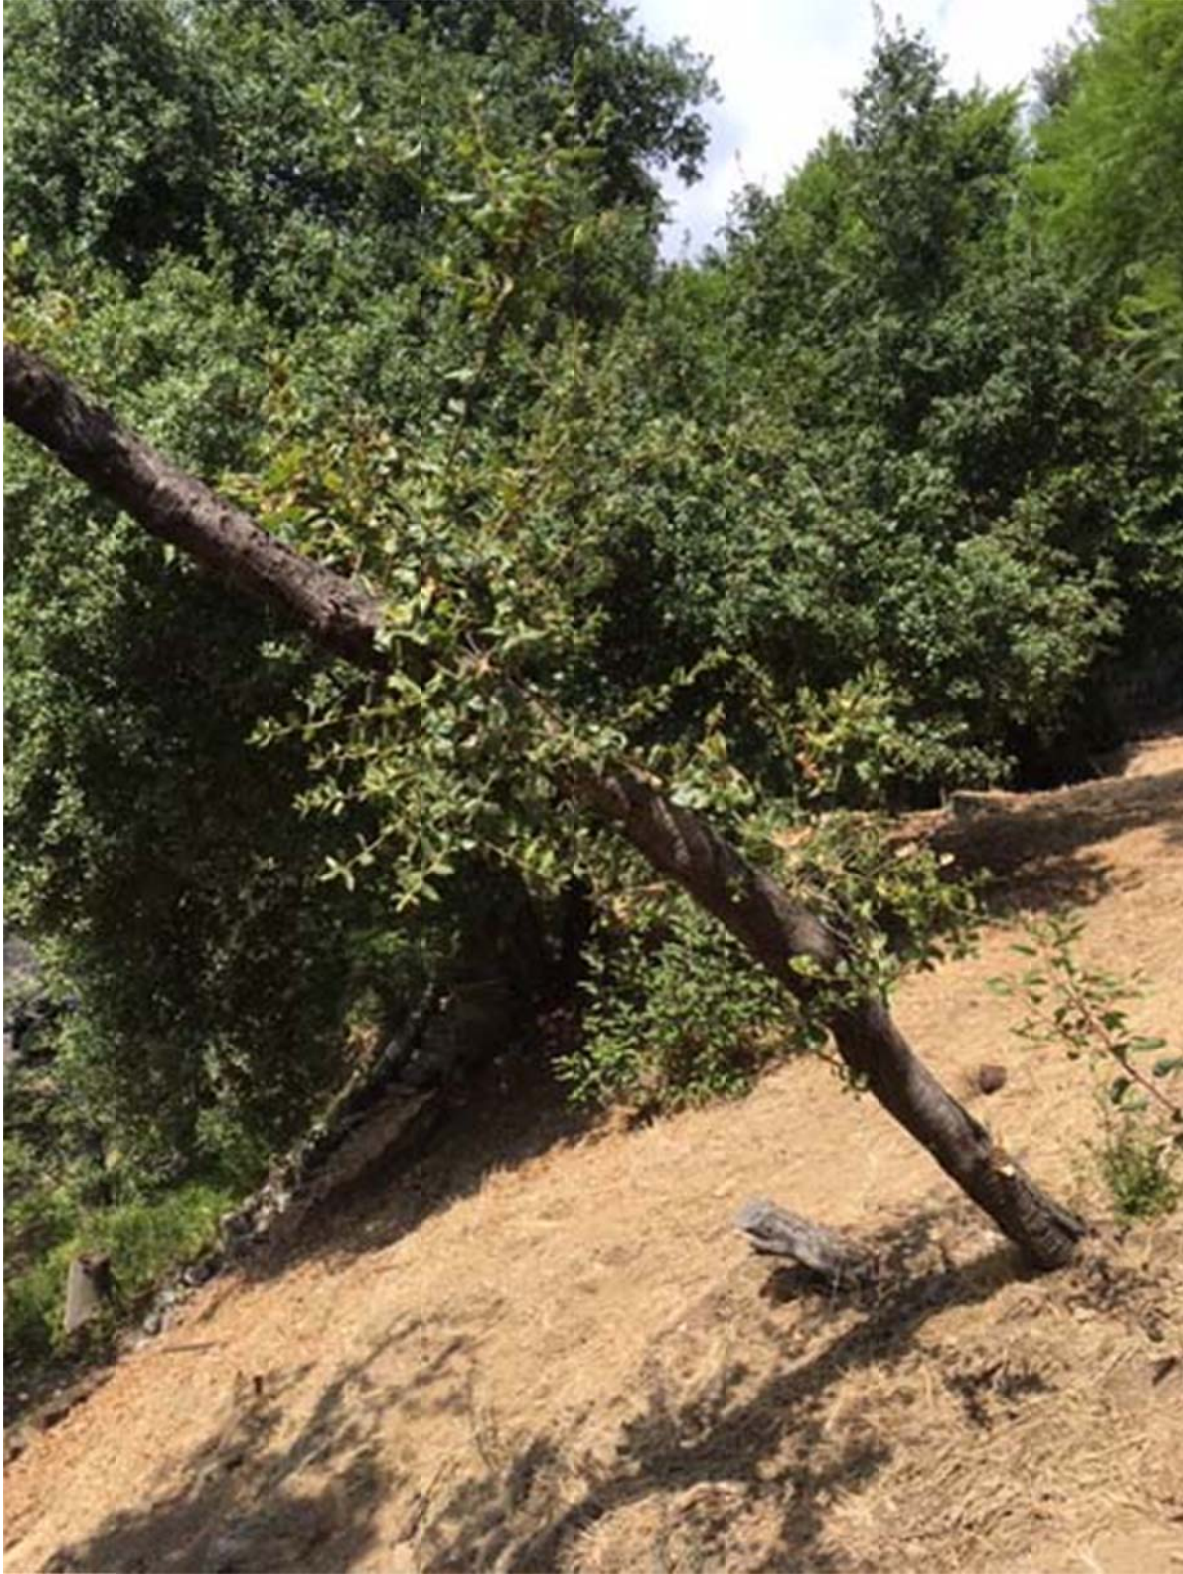
This tree is not protected by the City of Glendale Indigenous Tree Protection Ordinance because it is smaller than the minimum of 6” DBH. It is showing signs of drought stress, but there is no need to take action to mitigate it at this time.

There is evidence of moderately severe sunburn damage on the upper side of the trunk. This sunburn is likely a result of the neighboring Tree 23 dying – Tree 22 subsequently experienced an increase in solar exposure.

Figure 23: Tree 22 is not large enough to be protected. It will be removed.

This tree will be removed because it is growing within the footprint of the proposed retaining wall.
