601 and 603 Bohlig Rd. Arborist Report

Prepared for Camille Neagu
601 Bohlig Road
Glendale, CA 91207

Prepared by James Komen
BCMA WE-9909B
RCA #555

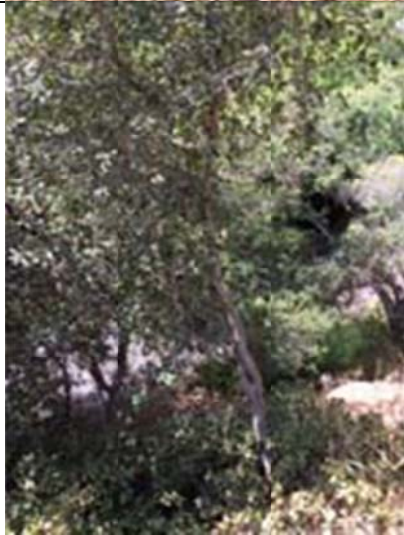
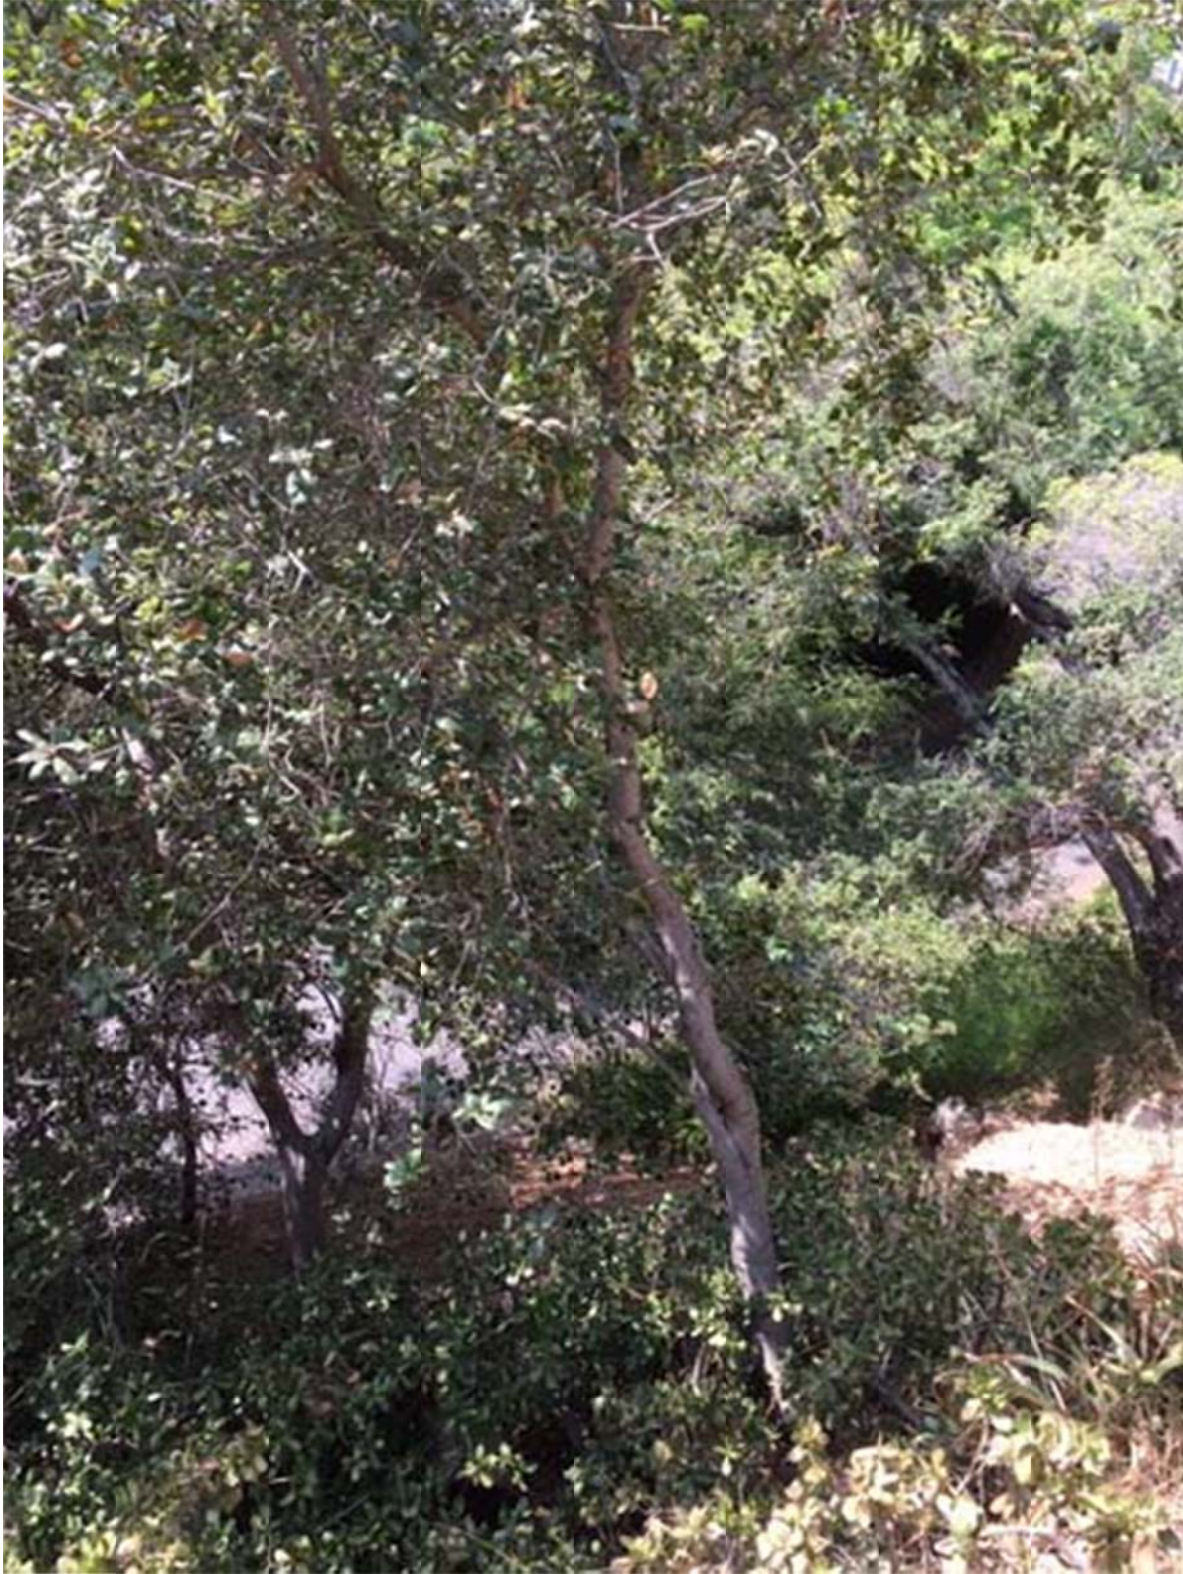
This tree is not protected by the City of Glendale Indigenous Tree Protection Ordinance because it is smaller than the minimum of 6” DBH. It is showing signs of drought stress, but there is no need to take action to mitigate it at this time.

This tree appears to have been suppressed by the neighboring trees to the east. It may increase its growth rate now that Tree 23 has been removed and it has more space to grow.

Figure 25: Tree 24 is not large enough to be protected. It will be removed.

This tree will be removed because it is growing within the footprint of the proposed grading activity on Lot 2.

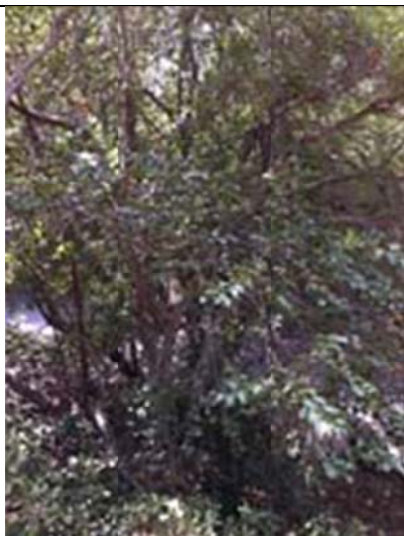
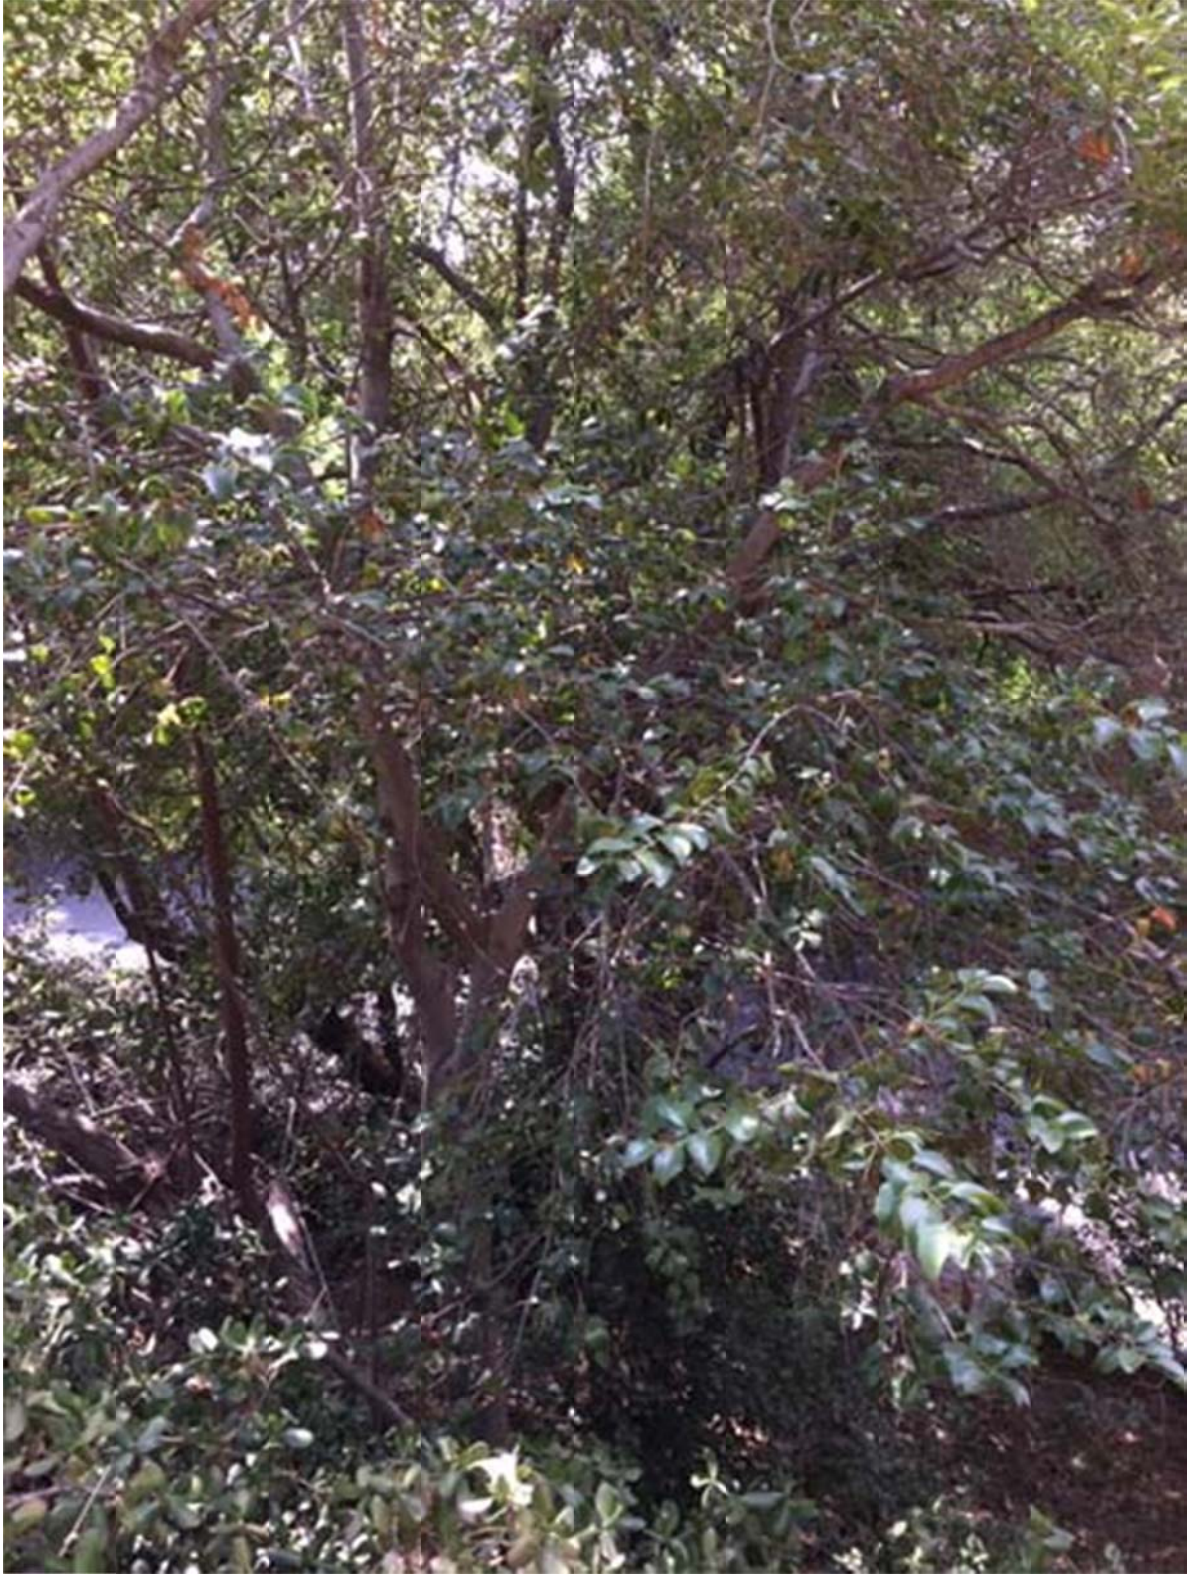
This tree is protected by the City of Glendale Indigenous Tree protection ordinance. It is reasonably healthy, but it appears to have a history of being partially suppressed by the neighboring trees.

Figure 26: Tree 25 is protected. It will be retained in the landscape.

This tree will be retained in the landscape. An access staircase will be built outside the drip line of this tree. If the proposed tree protection fencing is not crossed, then this tree will not likely be negatively impacted by the proposed construction project.
