Photo Report
Fremont
Programs, Services, and Activities

Finding: The Fremont Park, located at 600 West Hahn Avenue in Glendale California, was inspected by Disability Access Consultants, Inc., on June 7, 2007.

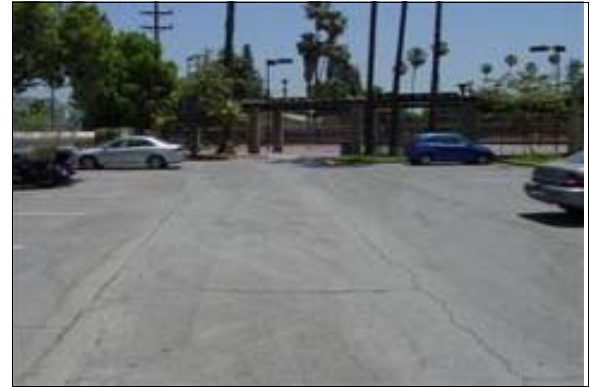
Parking Lot Next to the Tennis Courts

Finding: Paved parking is provided next to the tennis courts. There are no accessible parking spaces designated out of 25 total parking spaces provided in the parking lot.

Full Rec: One out of the 25 total number of marked parking spaces is required to be designated exclusively for accessible parking, as required by CBC 1129B and ADAAG. Create one van-accessible parking space measuring at least 108 inches wide and 216 inches long with an access aisle measuring at least 96 inches wide (8 feet) located on the passenger side (right side) of the parking space (see CBC 1129B). Add the words NO PARKING in 12 inch high white letters at the entrance to the accessible parking access aisle.

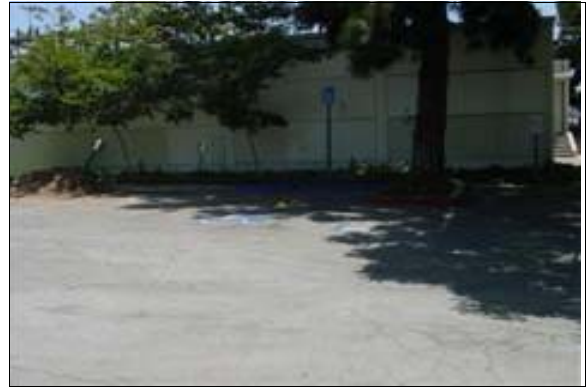
Parking Lot Outside of the Maintenance Building

Finding: There is one accessible parking space out of 12 parking spaces marked, which is sufficient for compliance. The accessible parking space measures 149 inches wide and 178 inches long. There is no access aisle provided adjacent to the accessible parking space. There is no van-accessible parking space provided in the parking lot.

Full Rec: One out of the 12 total number of marked parking space meets the number required to be designated exclusively for accessible parking, according to ADAAG and CBC 1129B. Restripe the existing parking space marked accessible to create one van-accessible parking space measuring at least 108 inches wide and 216 inches long with an access aisle measuring at least 96 inches wide (8 feet) located on the passenger side (right side) of the parking space (see CBC 1129B). Add the words NO PARKING in 12 inch high white letters at the entrance to the accessible parking access aisle.

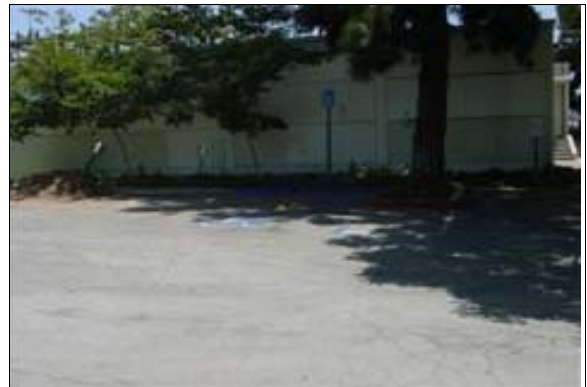
Parking Lot Outside of the Maintenance Building

Finding: The surface of the accessible parking space in the parking lot has a slope greater than 2%.

Full Rec: Pave the parking lot at the accessible spaces to provide a level surface. Parking surfaces and access aisles shall be located in areas not exceeding 2% slope in all directions (see CBC 1129B and ADAAG 4.6.3).

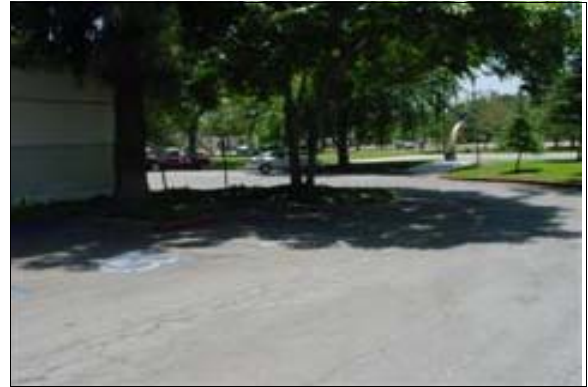
Parking Lot Outside of the Maintenance Building

Finding: There is no crosswalk provided on the path of travel from the accessible parking space to the facility. The required accessible route crosses a vehicular way.

Full Rec: Stripe a crosswalk not less than 48 inches wide on the path of travel to the accessible entrance. Provide a level surface that does not exceed a slope greater than 5%. Cross slopes shall not exceed 2%. Detectable warnings should be placed at the entrance and exit of the crosswalk.

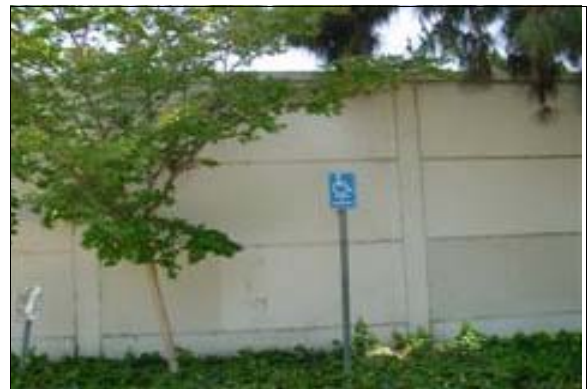
Parking Lot Outside of the Maintenance Building

Finding: The vertically-mounted signage at the designated accessible parking space in the parking lot showing the International Symbol of Accessibility uses the word "handicapped". The bottom edge of the post-mounted signage designating the accessible parking space is less than 80 inches above the level of the parking space and cannot be viewed when a vehicle is parked in the space.

Full Rec: Install a permanently posted reflectorized sign measuring 70 square inches that includes an ISA symbol adjacent to and visible from the accessible parking space (see CBC 1129B.5). The bottom edge of the sign must be mounted 80 inches from the ground surface so that it cannot be obscured by a parked vehicle (see CBC 1129B.5). The "van-accessible" parking space shall provide an additional sign marked "van-accessible" mounted below the sign (see CBC 1129B.5 and ADAAG 4.6.4).

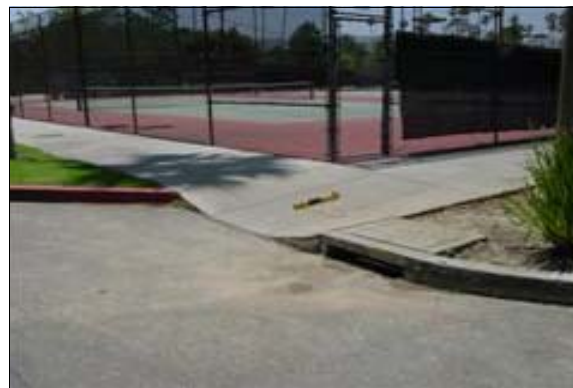
Curb Ramp Next to the Tennis Courts

Finding: The width of the curb-cut ramp is less than 48 inches. The slope of the side flares is greater than 10%. The curb ramp does not provide a grooved border along the top and sides of the ramp at the level of the sidewalk. The concrete curb ramp does not provide a detectable warning surface which includes truncated domes.

Full Rec: Replace the curb ramp with a compliant curb ramp at least 48 inches in width that provides a slope no greater than 8.33%. Install a detectable warning surface which extends the full length and width of the concrete curb ramp and its side flares with truncated domes that contrast visually by either light on dark or dark on light which is an integral part of the concrete curb ramp. The truncated domes may be cast in place or stamped or of a prefabricated surface treatment (see CBC 1127B.5.8).

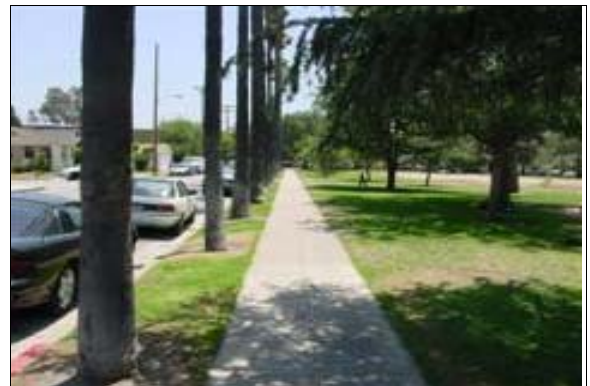
Accessible Route from the Public Right of Way

Finding: There is no accessible route from the public right of way to the accessible entrance of the facility.

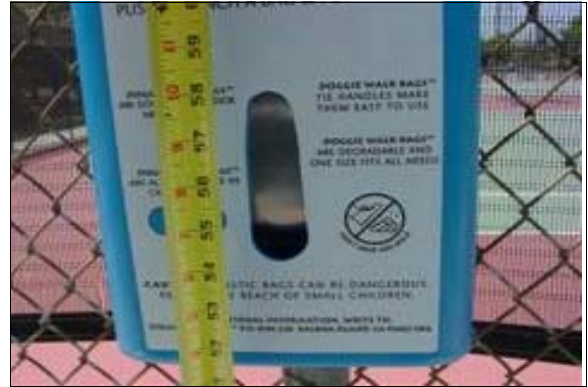
Dog Walk Bags

Finding: The highest operable part of the dog walk bags exceeds the forward reach range of 48 inches.

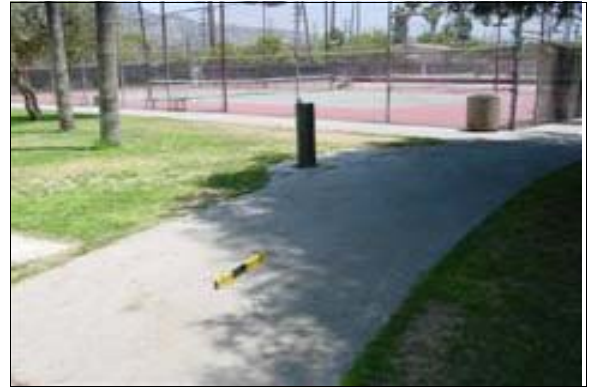
Finding: There are slopes greater than 5% on the primary path of travel from Patterson to the tennis courts.

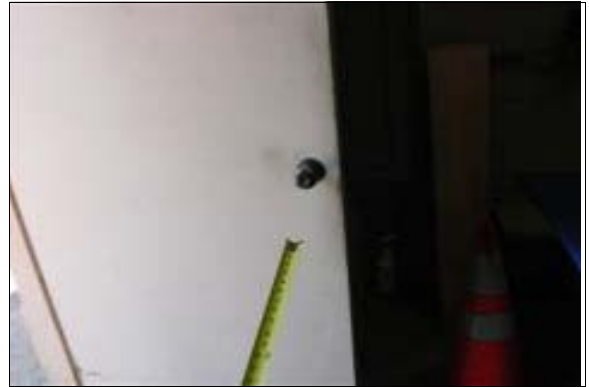
Maintenance Building

Finding: The exterior passage door has a round doorknob, which requires twisting of the wrist to operate.

Full Rec: Replace the existing door hardware with accessible hardware (see ADAAG 4.13.9).

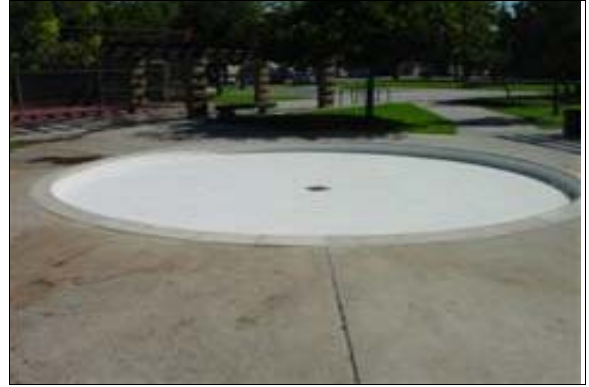
Wading Pool

Finding: The wading pool is not accessible by a hydraulic chair, ramp, transfer tier, or other means. During periods when the pools do not contain water they may become a tripping hazard.
