Photo Report
Glorietta Park
Programs, Services, and Activities

Finding: Glorietta Park, located at 2801 North Verdugo in Glendale California, was inspected by Disability Access Consultants, Inc., on June 7, 2007.

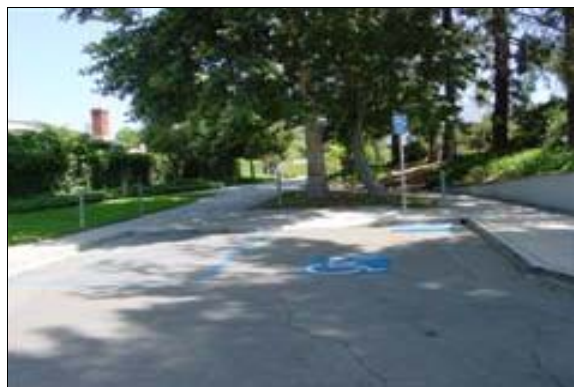
Finding: There is one accessible parking space out of 16 parking spaces marked, which is sufficient for compliance. The accessible parking space measures 160 inches wide and 211 inches long. The access aisle, located on the driver's side (left side) of the parking space, measures 135 inches wide. The parking space is not "van-accessible". The access aisle does not contain "NO PARKING" in 12" high white letters.

Full Rec: One out of the 16 total number of marked parking space meets the number required to be designated exclusively for accessible parking, according to ADAAG and CBC 1129B. Restripe the existing parking space marked accessible to create one van-accessible parking space measuring at least 108 inches wide and 216 inches long with an access aisle measuring at least 96 inches wide (8 feet) located on the passenger side (right side) of the parking space (see CBC 1129B). Add the words NO PARKING in 12 inch high white letters at the entrance to the accessible parking access aisle.

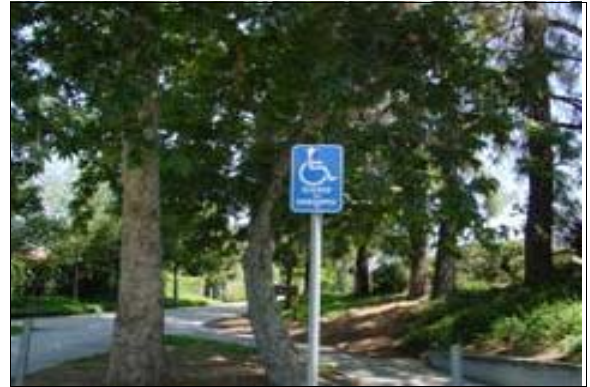
Finding: The vertically-mounted signage at the designated accessible parking space in the parking lot showing the International Symbol of Accessibility uses the word "handicapped".

Full Rec: Install a permanently posted reflectorized sign measuring 70 square inches that includes an ISA symbol adjacent to and visible from the accessible parking space (see CBC 1129B.5). The bottom edge of the sign must be mounted 80 inches from the ground surface so that it cannot be obscured by a parked vehicle (see CBC 1129B.5). The "van-accessible" parking space shall provide an additional sign marked "van-accessible" mounted below the sign (see CBC 1129B.5 and ADAAG 4.6.4).

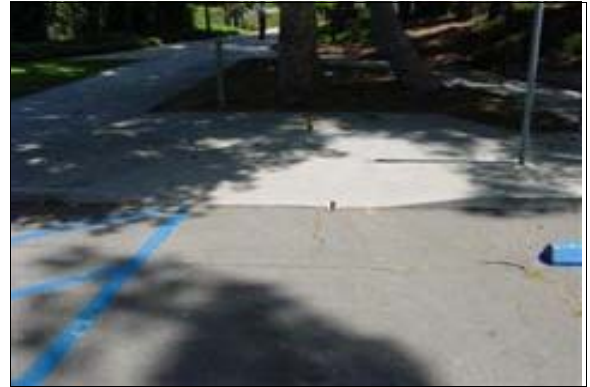
Curb Ramp at the Accessible Parking Space

Finding: The curb ramp is not wholly contained within the access aisle lines. The slope at the top landing is greater than 2%. The concrete curb ramp does not provide a detectable warning surface which includes truncated domes.

Full Rec: Replace the curb ramp with a compliant curb ramp at least 48 inches in width that provides a slope no greater than 8.33%. Install a detectable warning surface which extends the full length and width of the concrete curb ramp and its side flares with truncated domes that contrast visually by either light on dark or dark on light which is an integral part of the concrete curb ramp. The truncated domes may be cast in place or stamped or of a prefabricated surface treatment (see CBC 1127B.5.8).

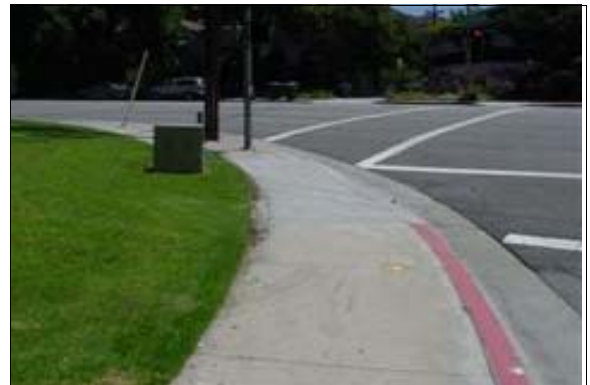
Curb Ramp at the Corner of Glorietta and Verdugo

Finding: The slope of the right side of the concrete sidewalk curb ramp is greater than 8.33%. The concrete curb ramp does not provide a detectable warning surface which includes truncated domes.

Full Rec: Replace the curb ramp with a compliant curb ramp at least 48 inches in width that provides a slope no greater than 8.33%. Install a detectable warning surface which extends the full length and width of the concrete curb ramp and its side flares with truncated domes that contrast visually by either light on dark or dark on light which is an integral part of the concrete curb ramp. The truncated domes may be cast in place or stamped or of a prefabricated surface treatment (see CBC 1127B.5.8).

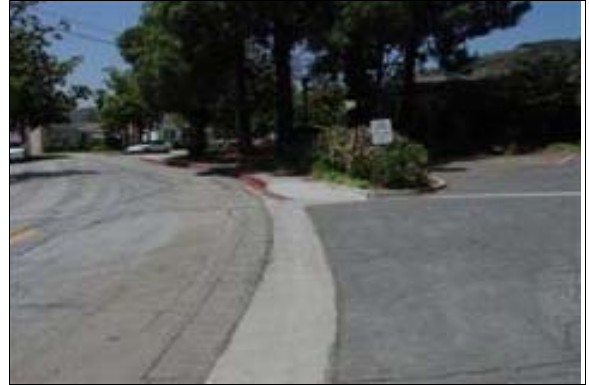
Curb Ramp off of Glorietta (Left)

Finding: The cross slope of the curb ramp is greater than 2%. The concrete curb ramp does not provide a detectable warning surface which includes truncated domes.

Full Rec: Replace the curb ramp with a compliant curb ramp at least 48 inches in width that provides a slope no greater than 8.33%. Install a detectable warning surface which extends the full length and width of the concrete curb ramp and its side flares with truncated domes that contrast visually by either light on dark or dark on light which is an integral part of the concrete curb ramp. The truncated domes may be cast in place or stamped or of a prefabricated surface treatment (see CBC 1127B.5.8).

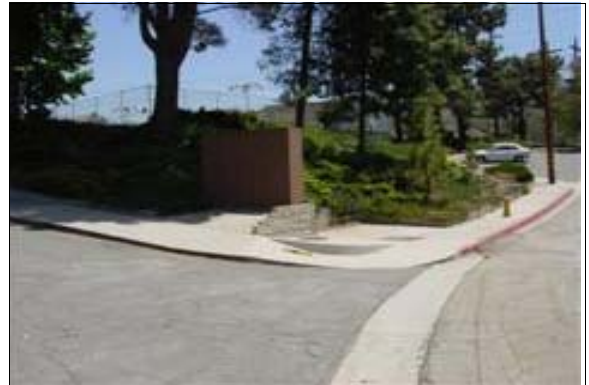
Curb Ramp off of Glorietta (Right)

Finding: The slope of each side of the concrete sidewalk curb ramp is greater than 8.33%. The concrete curb ramp does not provide a detectable warning surface which includes truncated domes.

Full Rec: Replace the curb ramp with a compliant curb ramp at least 48 inches in width that provides a slope no greater than 8.33%. Install a detectable warning surface which extends the full length and width of the concrete curb ramp and its side flares with truncated domes that contrast visually by either light on dark or dark on light which is an integral part of the concrete curb ramp. The truncated domes may be cast in place or stamped or of a prefabricated surface treatment (see CBC 1127B.5.8).

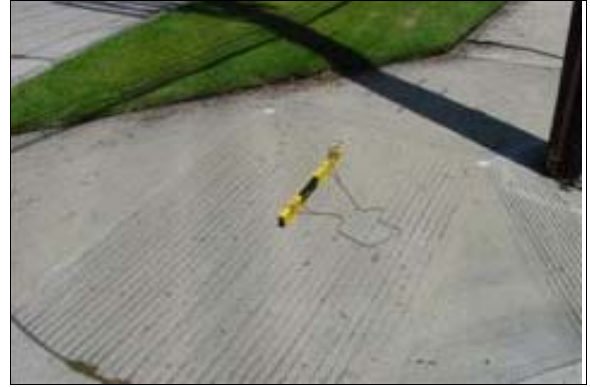
Curb Ramp off of Verdugo (Center Left)

Finding: The slope of the curb ramp is greater than 8.33%. There is less than 48 inches in length of maneuvering clearance at the top landing. The concrete curb ramp does not provide a detectable warning surface which includes truncated domes.

Full Rec: Replace the curb ramp with a compliant curb ramp at least 48 inches in width that provides a slope no greater than 8.33%. Install a detectable warning surface which extends the full length and width of the concrete curb ramp and its side flares with truncated domes that contrast visually by either light on dark or dark on light which is an integral part of the concrete curb ramp. The truncated domes may be cast in place or stamped or of a prefabricated surface treatment (see CBC 1127B.5.8).

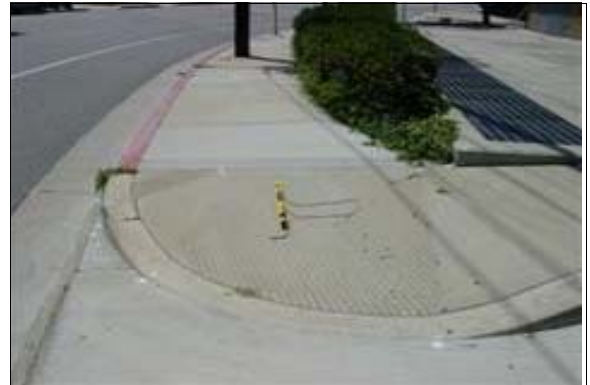
Curb Ramp off of Verdugo (Center Right)

Finding: The slope of the curb ramp is greater than 8.33%. The concrete curb ramp does not provide a detectable warning surface which includes truncated domes.

Full Rec: Replace the curb ramp with a compliant curb ramp at least 48 inches in width that provides a slope no greater than 8.33%. Install a detectable warning surface which extends the full length and width of the concrete curb ramp and its side flares with truncated domes that contrast visually by either light on dark or dark on light which is an integral part of the concrete curb ramp. The truncated domes may be cast in place or stamped or of a prefabricated surface treatment (see CBC 1127B.5.8).

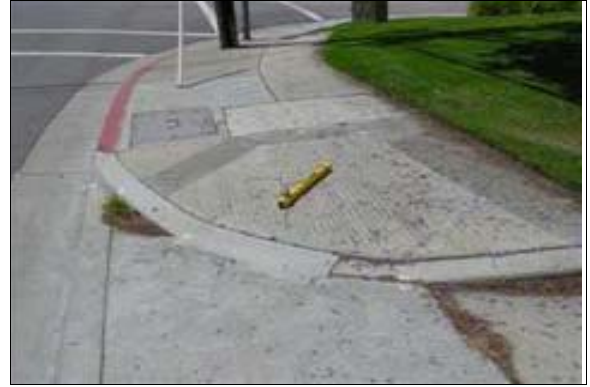
Curb Ramp off of Verdugo (Left)

Finding: The slope of the curb ramp is greater than 8.33%. The slope at the top landing is greater than 2%. The concrete curb ramp does not provide a detectable warning surface which includes truncated domes.

Full Rec: Replace the curb ramp with a compliant curb ramp at least 48 inches in width that provides a slope no greater than 8.33%. Install a detectable warning surface which extends the full length and width of the concrete curb ramp and its side flares with truncated domes that contrast visually by either light on dark or dark on light which is an integral part of the concrete curb ramp. The truncated domes may be cast in place or stamped or of a prefabricated surface treatment (see CBC 1127B.5.8).

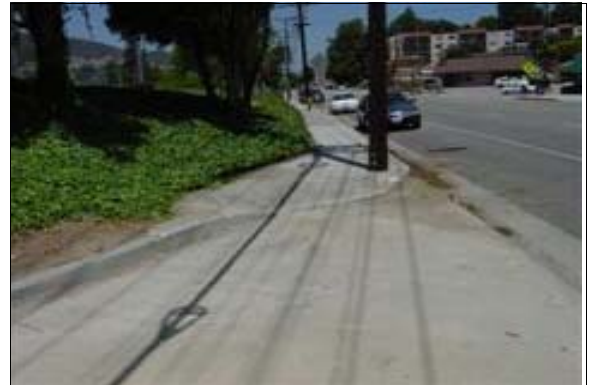
Curb Ramp off of Verdugo (Right)

Finding: There is less than 48 inches in length of maneuvering clearance at the top landing. The concrete curb ramp does not provide a detectable warning surface which includes truncated domes.

Full Rec: Replace the curb ramp with a compliant curb ramp at least 48 inches in width that provides a slope no greater than 8.33%. Install a detectable warning surface which extends the full length and width of the concrete curb ramp and its side flares with truncated domes that contrast visually by either light on dark or dark on light which is an integral part of the concrete curb ramp. The truncated domes may be cast in place or stamped or of a prefabricated surface treatment (see CBC 1127B.5.8).

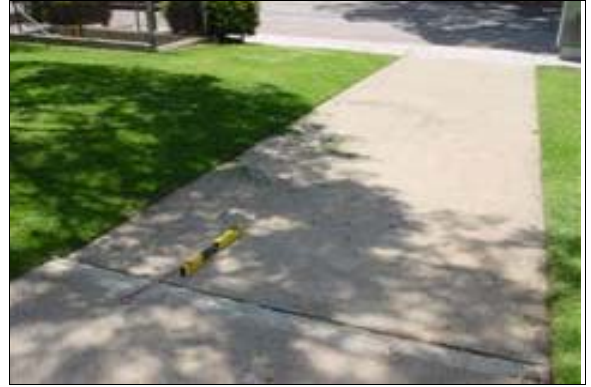
Path of Travel to the Baseball Field

Finding: There are slopes greater than 5% on the primary path of travel from the public right of way to the baseball field.

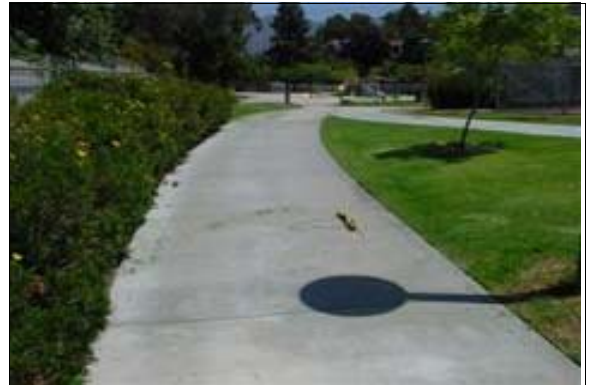
Path of Travel to the Park

Finding: There are slopes greater than 5% on the primary path of travel from the accessible parking space to the park.

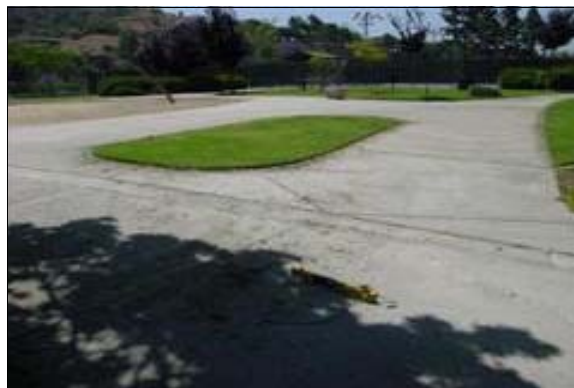
Finding: There are slopes greater than 5% on the primary path of travel from the public right of way to the play equipment.

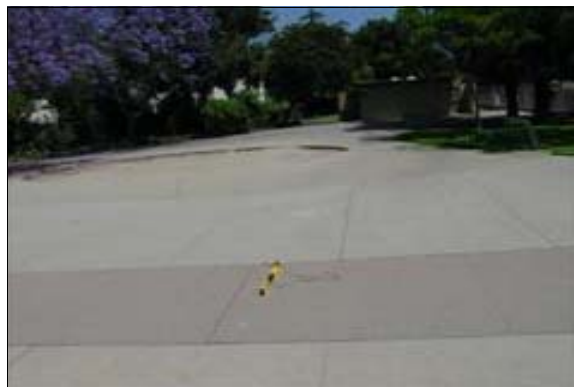
Finding: There are slopes greater than 5% on the primary path of travel to the restrooms.

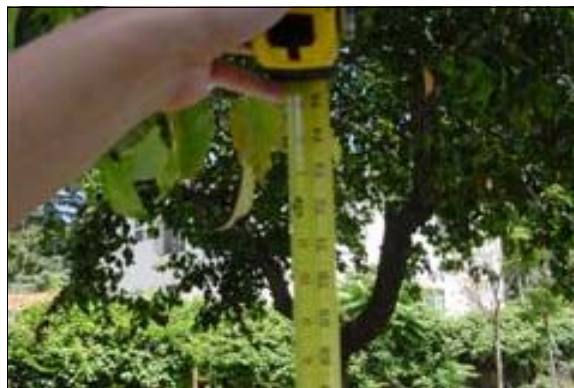
Finding: At the time of inspection, vegetation encroached into the primary path of travel to the women's restroom, obstructing passage by reducing the vertical clearance height to less than 80 inches.

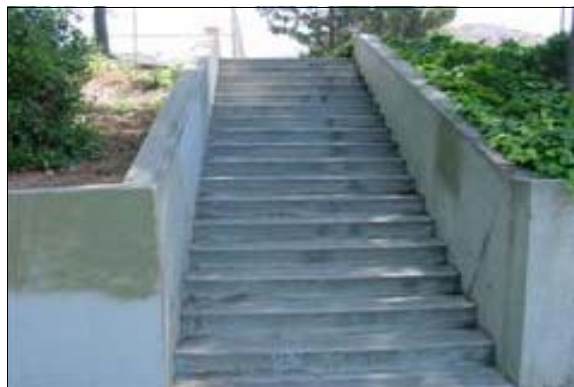
Finding: There is no detectable striping on each tread of the exterior stairway from the accessible parking to the tennis courts.

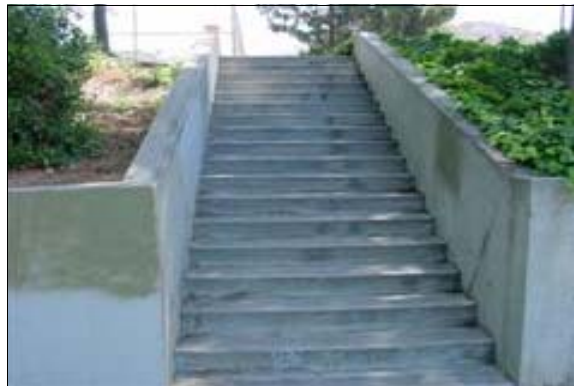
Exterior Stairs to the Tennis Courts

Finding: There are no handrails provided on the stairway.

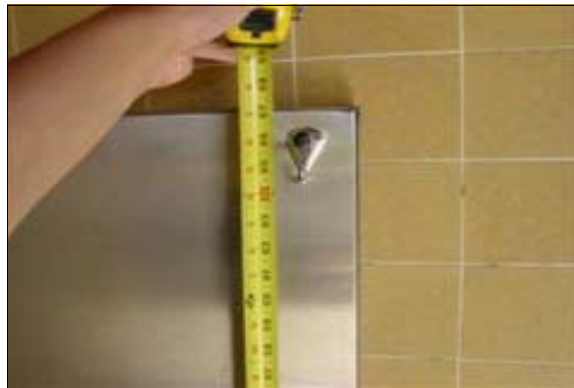
Finding: The height of the coat hook on the stall door designated to be accessible in the restroom is greater than 48 inches above the floor surface.

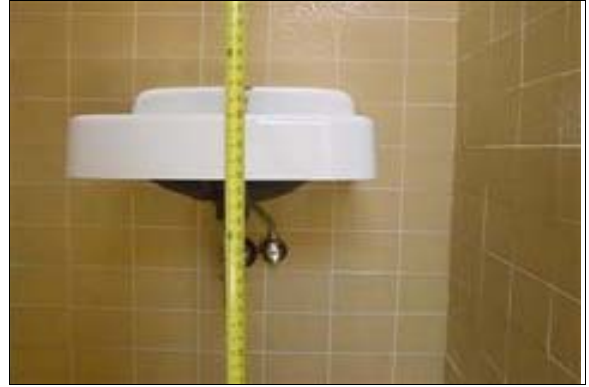
Men's Restroom

Finding: The knee clearance space under the lavatory designated to be accessible in the restroom is less than 29 inches. The knee depth space under the lavatory designated to be accessible in the restroom is less than 27 inches at 8 inches under the lavatory apron.

Full Rec: Replace the lavatory designated to be accessible in the restroom to provide at least 29 inches of clear knee space between the finished floor and bottom of the lavatory apron. Make sure to provide at least 27 inches at 8 inches under the apron (see ADAAG 4.19.2).

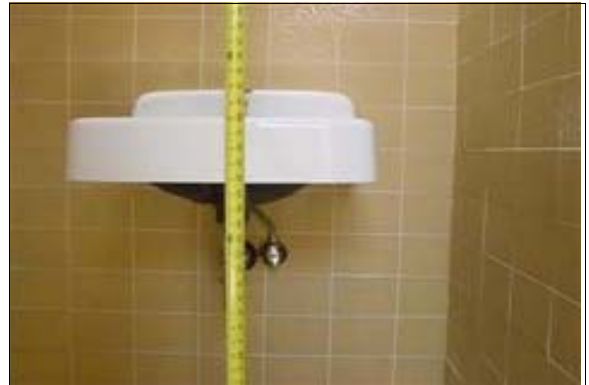
Men's Restroom

Finding: The pipes under the lavatory in the restroom do not provide protection against contact.

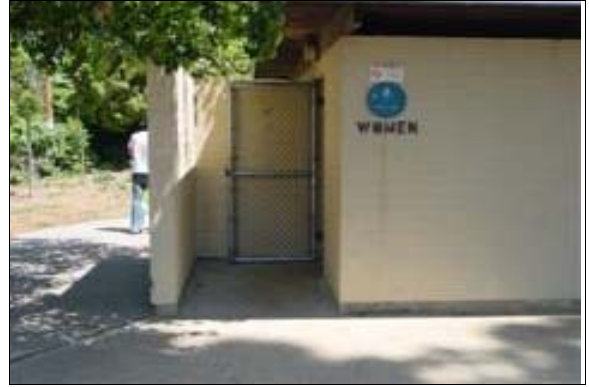
Women's Restroom

Finding: There is no signage indicating accessibility on the latch side of the entry door of the restroom. The gender use signage is not mounted on the entrance door.

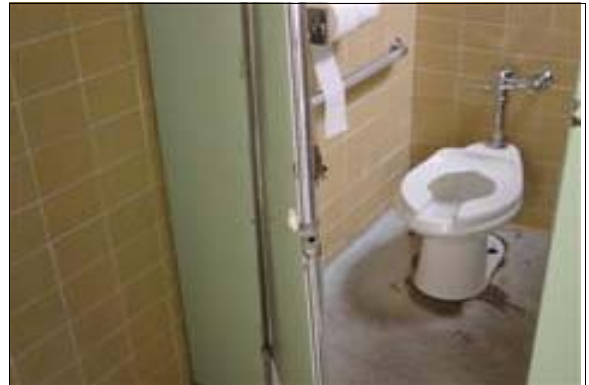
Women's Restroom

Finding: There is insufficient clear floor space in the stall designated to be accessible in the restroom. The door to the stall designated to be accessible in the restroom does not close automatically or have accessible hardware.

Full Rec: Modify or replace the stall designated to be accessible in the restroom so that it complies with ADAAG 4.17.3, CBC 1115B and CBC Figures 11B-1A and 1B. Standard accessible stalls require 60 inches in width with 56 inches depth for wall-mounted toilets or 59 inches depth for floor-mounted toilets to accommodate individuals in wheelchairs. The minimum width of a front-approach doorway shall provide at least 32 inches and a side-approach doorway shall provide at least 34 inches. The door shall swing outward, close automatically and provide accessible hardware.

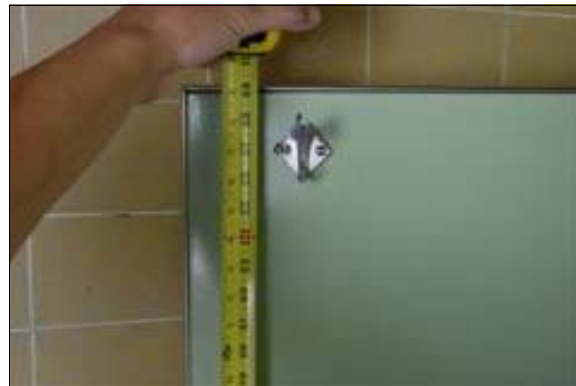
Finding: The height of the coat hook on the stall door designated to be accessible in the restroom is greater than 48 inches above the floor surface.

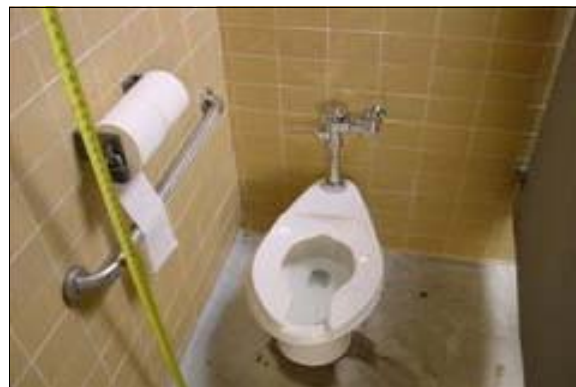
Finding: There is no back grab bar in the stall designated to be accessible in the restroom.

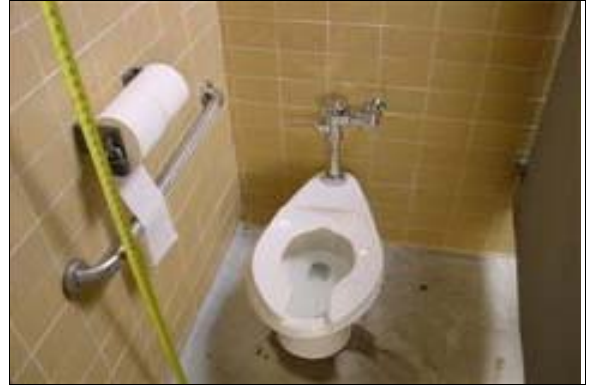
Women's Restroom

Finding: The height of the side grab bar in the stall designated to be accessible of the restroom is less than 33 inches above the finished floor.

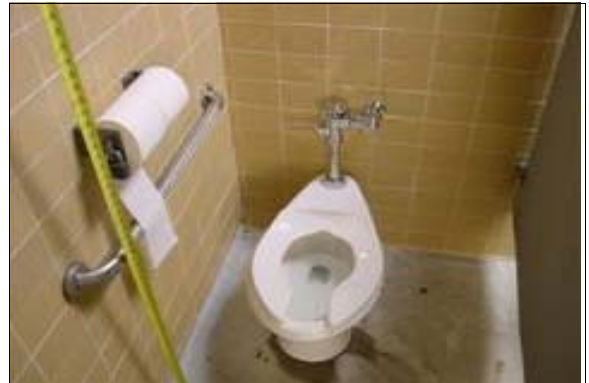
Women's Restroom

Finding: The length of the side grab bar in the stall designated to be accessible in the restroom is less than 42 inches. The side grab bar in the stall designated to be accessible in the restroom does not extend 54 inches from the back wall.

Full Rec: Replace the side grab bar in the stall designated to be accessible in the restroom with a 42-inch/ 48 -inch side grab bar complying with ADAAG 4.26 and CBC 1115B.8. The front end of the grab bar shall extend at least 54 inches from the back wall and the back end of the grab bar shall be mounted within 12 inches from the back wall. Grab bars must be able to support a point load of at least 250 pounds and shall be less than the allowable shear stress of the grab bar material.

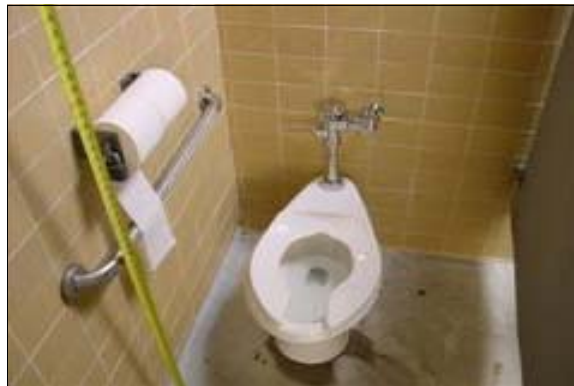
Women's Restroom

Finding: The toilet paper dispenser in the stall designated to be accessible in the restroom interferes with the use of the side grab bar.

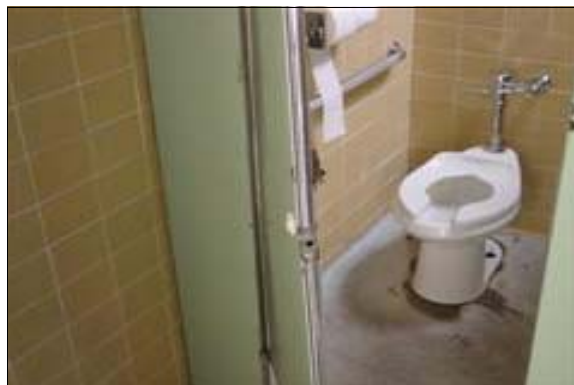
Women's Restroom

Finding: The flush control on the toilet in the stall designated to be accessible in the restroom is not on the wide (approach) side of the toilet.

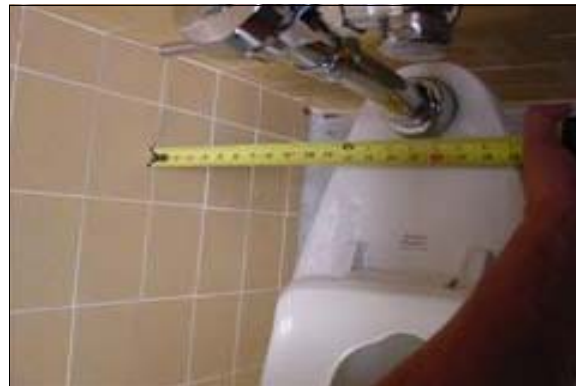
Finding: The distance from the center of the toilet to the nearest side wall in the stall designated to be accessible in the restroom is greater than 18 inches.

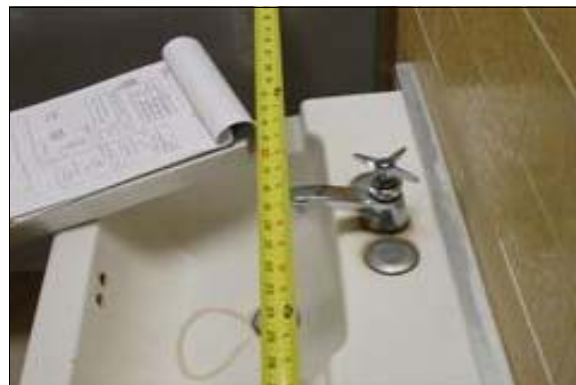
Finding: The faucet controls on the lavatory in the restroom require tight grasping, pinching, or twisting of the wrist and are not accessible.
