Photo Report
Griffith Manor Park
Programs, Services, and Activities

Finding: The Griffith Manor Park, located at 1551 Flower Street in Glendale California, was inspected by Disability Access Consultants, Inc., on June 12 and 14, 2007.

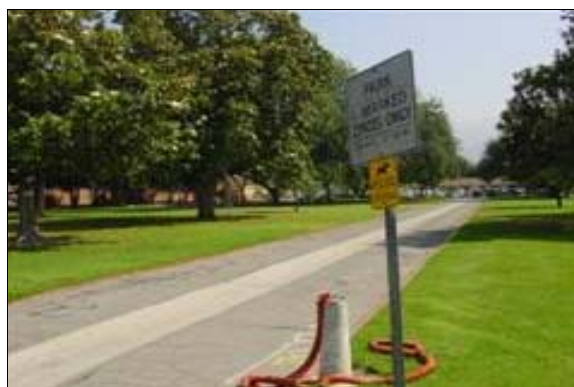
Parking Lot Next to the Community Center

Finding: There is no warning signage posted at the entrance to the parking lot regarding unauthorized use of accessible parking spaces in the parking lot.

Full Rec: Post a sign in a conspicuous place to the entrance of the parking lot, or immediately adjacent to and visible from each accessible parking space. The warning sign shall measure at least 17 inches by 22 inches in size and consist of lettering at least 1 inch in height that clearly and conspicuously states the following; "Unauthorized vehicles parked in designated accessible spaces not displaying distinguishing placards or license plates issued for persons with disabilities may be towed away at owner's expense. Towed vehicles may be reclaimed at ____ or by telephoning ____ ." Fill in the blank spaces with appropriate information as a permanent part of the sign and maintain the currency of the information (see CBC 1129B.5). Be sure to add the CVC 22511.8(a)(d) to the sign.

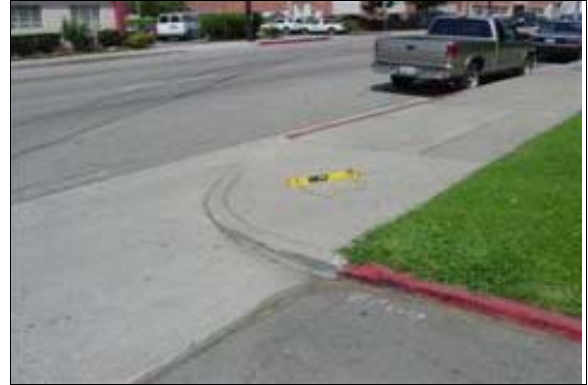
Curb Ramp off of Flower Street (Left)

Finding: The slope of the curb ramp is greater than 8.33%. The slope of the side flares is greater than 10%. There is less than 48 inches in length of maneuvering clearance at the top landing. The curb ramp does not provide a grooved border along the top and sides of the ramp at the level of the sidewalk. The concrete curb ramp does not provide a detectable warning surface which includes truncated domes. The curb ramp is not parallel with the direction of pedestrian traffic.

Full Rec: Replace the curb ramp with a compliant curb ramp at least 48 inches in width that provides a slope no greater than 8.33%. Install a detectable warning surface which extends the full length and width of the concrete curb ramp and its side flares with truncated domes that contrast visually by either light on dark or dark on light which is an integral part of the concrete curb ramp. The truncated domes may be cast in place or stamped or of a prefabricated surface treatment (see CBC 1127B.5.8).

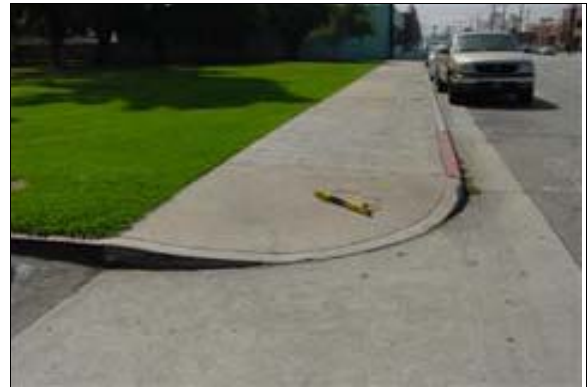
Curb Ramp off of Flower Street (Right)

Finding: The slope of the curb ramp is greater than 8.33%. The slope at the bottom landing is greater than 2%. There is less than 48 inches in length of maneuvering clearance at the top landing. The slope of the side flares is greater than 10%. The curb ramp does not provide a grooved border along the top and sides of the ramp at the level of the sidewalk. The concrete curb ramp does not provide a detectable warning surface which includes truncated domes.

Full Rec: Replace the curb ramp with a compliant curb ramp at least 48 inches in width that provides a slope no greater than 8.33%. Install a detectable warning surface which extends the full length and width of the concrete curb ramp and its side flares with truncated domes that contrast visually by either light on dark or dark on light which is an integral part of the concrete curb ramp. The truncated domes may be cast in place or stamped or of a prefabricated surface treatment (see CBC 1127B.5.8).

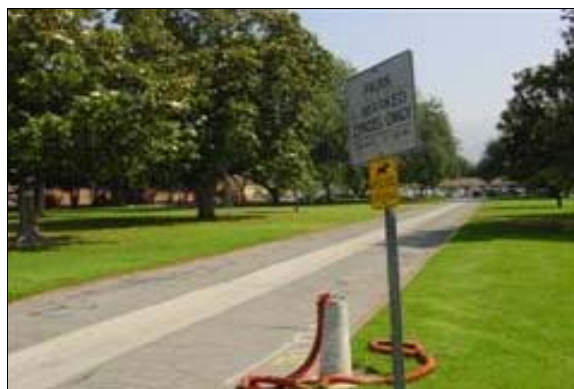
Accessible Route from the Public Right of Way

Finding: There is no accessible route from the public right of way to the accessible entrance of the facility. The accessible route crosses vehicular traffic.

Alternative Post directional signage.
Rec:
(Where Available)

Full Rec: Provide at least one accessible route from the public right of way to the accessible entrance of the facility. Make certain to post signage indicating the direction to accessible building entrances at every major junction along the accessible route. Signs shall include the International Symbol of Accessibility.

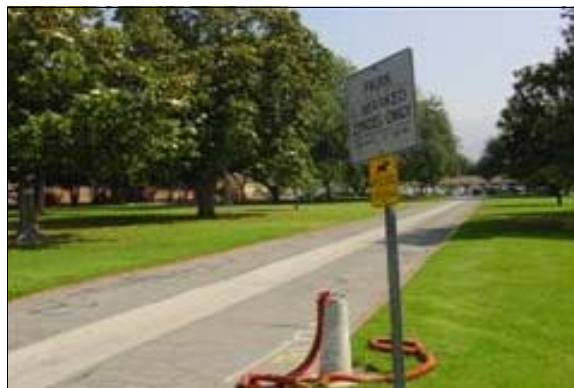
Accessible Route from the Public Right of Way

Finding: There is no crosswalk provided on the path of travel from the public right of way to the facility. The required accessible route crosses a vehicular way.

Full Rec: Stripe a crosswalk not less than 48 inches wide on the path of travel to the accessible entrance of the facility. Provide a level surface that does not exceed a slope greater than 5%. Cross slopes shall not exceed 2%. Detectable warnings should be placed at the entrance and exit of the crosswalk.

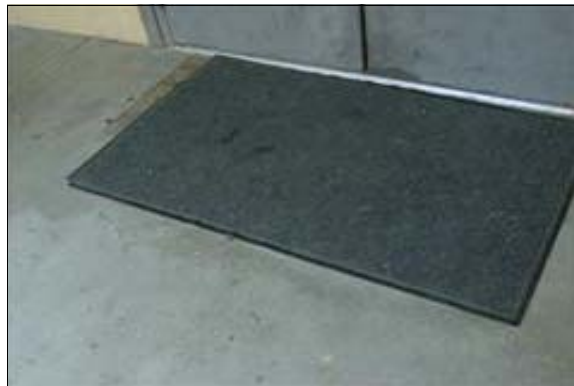
Path of Travel to the Community Center

Finding: The mat at the entrance does not adhere to the underlying floor surface and creates a hazardous path of travel.

Full Rec: Securely fasten the mats or replace with a mat that grips to the underlying floor surface to provide a firm, stable, continuous and relatively smooth path of travel surface (see CBC 1124B.3 and ADAAG 4.5.3). Mats along the primary path of travel shall provide beveled edges on all sides to prevent roll over.

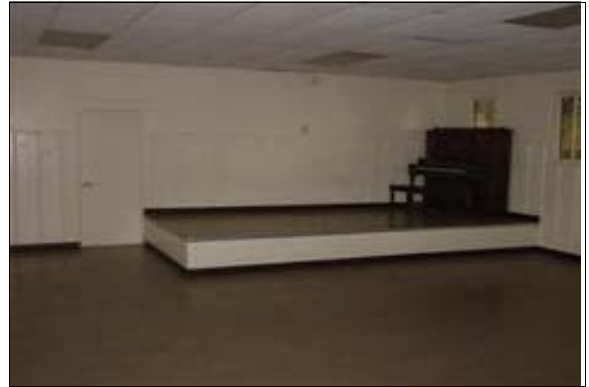
Path of Travel to the Stage in the Community Center

Finding: There is a step to the primary functions provided on the stage in the Community Center, preventing access to individuals with mobility impairments.

Full Rec: Install a vertical platform lift to provide a direct path between the stage and level seating area in the Community Center, allowing individuals with mobility impairments to participate in programs, services and activities provided by the facility on the stage. The ADA mandates accessibility to programs, services and activities which serve the public.

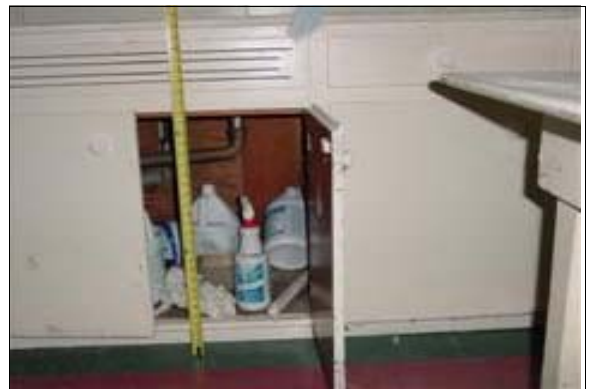
Sink in the Community Center

Finding: The sink in the Kitchen is in an enclosed cabinet, thereby preventing an accessible forward approach. The height of the counter surface of the sink is greater than 34 inches above the finished floor.

Full Rec: Sinks in rooms must provide clear floor space in front of the sink for an accessible forward approach and shall provide at least 27 inches clear knee space and a minimum of nine inches clear toe space (see ADAAG 4.19.2). If neither clear floor space and knee and toe clearance can be provided, remove the sink cabinet and replace with an accessible wall-mounted sink unit.

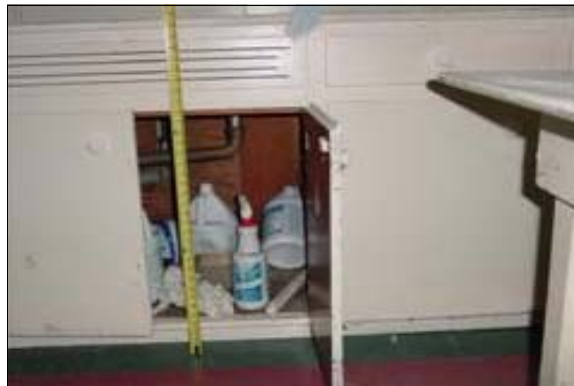
Sink in the Community Center

Finding: The pipes under the sink in the Kitchen do not provide protection against contact.

Full Rec: Insulate or otherwise configure pipes under the sink designated to be accessible in the room to protect against contact (see ADAAG 4.19.4). Make certain there are no sharp or abrasive surfaces under the sink.

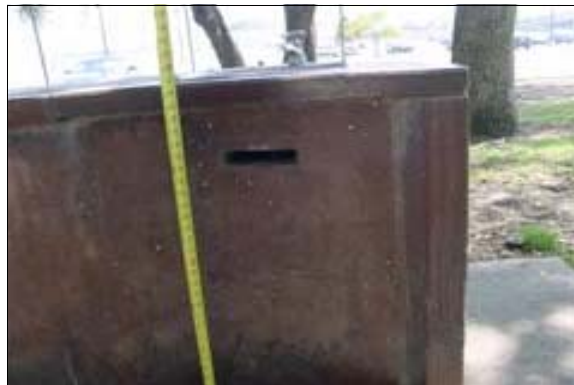
Sinks at the Covered Outdoor Dining Area

Finding: The sink at the outdoor dining area does not provide an accessible forward approach.

Full Rec: Sinks must provide clear floor space in front of the sink for an accessible forward approach and shall provide at least 27 inches clear knee space and a minimum of nine inches clear toe space (see ADAAG 4.19.2). If neither clear floor space and knee and toe clearance can be provided, remove the sink and replace with an accessible wall-mounted sink unit.

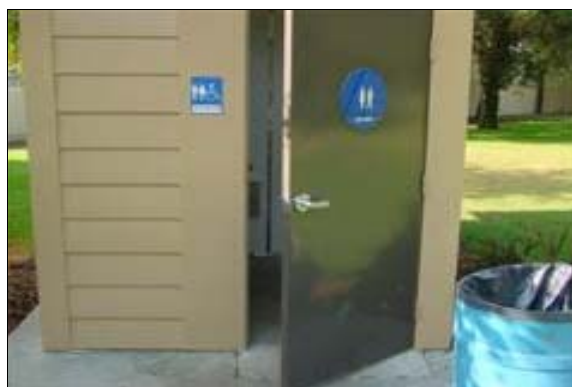
Unisex Restroom Next to the Community Center

Finding: The signage indicating accessibility on the latch side of the entry door of the restroom is not centered at 60 inches above the floor surface. The gender use signage on the entrance door is not centered at 60 inches above the floor surface.

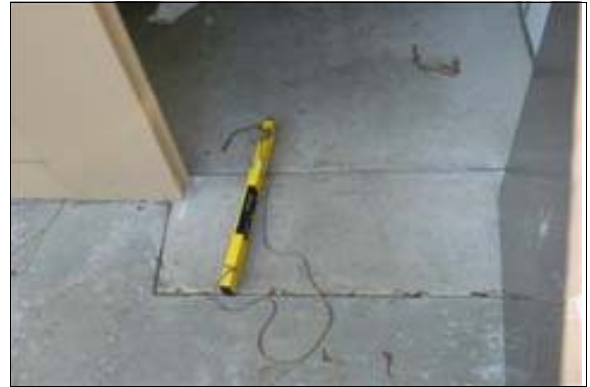
Unisex Restroom Next to the Community Center

Finding: There is no level landing provided at the entrance door.

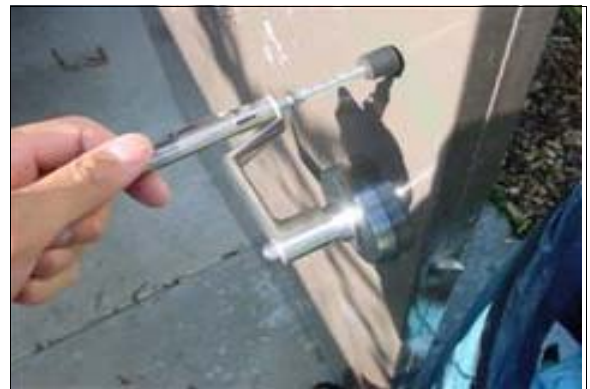
Unisex Restroom Next to the Community Center

Finding: The door opening force for the exterior door is greater than 5 pounds of force.

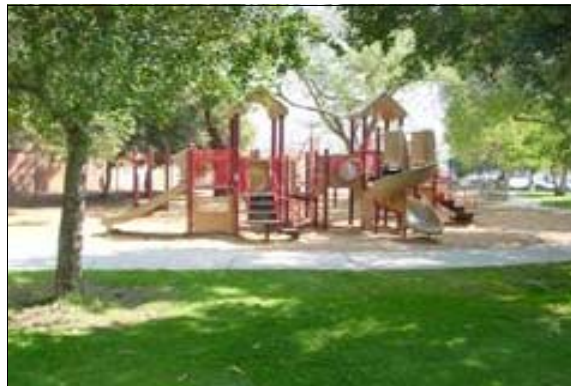
Finding: There are slopes greater than 6.33% along the path of travel to the play equipment. The surface beneath the play area is wood chips, making the area nonaccessible to individuals with mobility impairments.

Full Rec: Provide an accessible route to the play area (CBC 1104B.1.2 and ADAAG 4.3.2). The minimum width of the path of travel is 48 inches with 60 inch by 60 inch passing spaces provided every 200 feet and shall not exceed a slope greater than 6.33%. Provide a maneuvering space with an accessible resilient surface beneath the play components and adjacent to the play components where technically feasible. An adequate maneuvering space has an accessible surface and is not less than 60 inches by 60 inches where an individual with a mobility impairment can be a part of the activities provided at the play components.
