Photo Report
Harvard Mini Park
Programs, Services, and Activities

Finding: The Harvard Mini Park, located at 425 West Harvard in Glendale California, was inspected by Disability Access Consultants, Inc., on June 7, 2007.

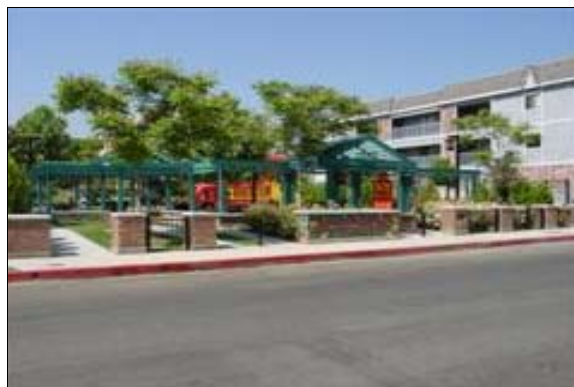
Accessible Route from the Public Right of Way

Finding: There is an accessible route from the public right of way to the accessible entrance of the facility.

Full Rec: Post directional signage. Make certain to post signage indicating the direction to accessible building entrances at every major junction along the accessible route. Signs shall include the International Symbol of Accessibility.

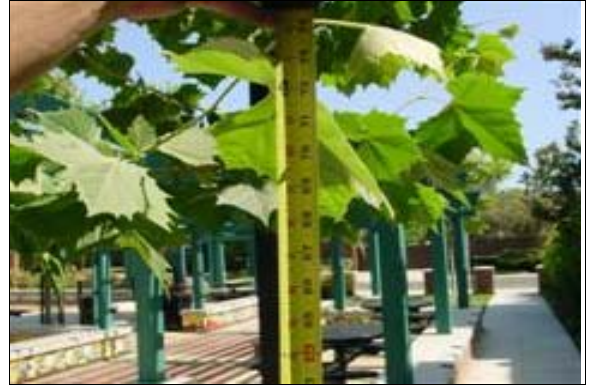
Path of Travel Throughout the Park

Finding: At the time of inspection, vegetation encroached into the primary path of travel, obstructing passage by reducing the vertical clearance height to less than 80 inches along the accessible route.

Full Rec: Maintain grass or landscaping adjacent to primary path of travel walkways to eliminate any encroachment into the accessible route.

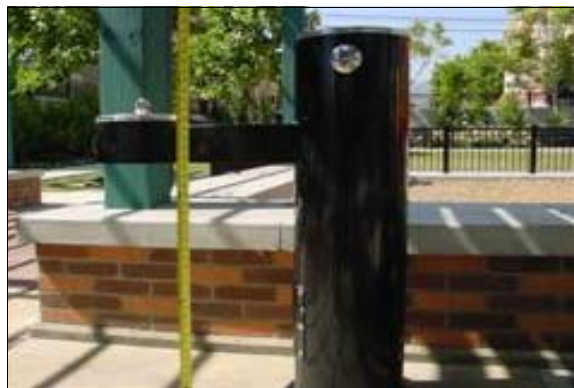
Finding: All drinking fountains were found to comply with CBC and ADAAG requirements.

Full Rec: Since all the drinking fountains are accessible, no physical improvement needs to be made at this time.

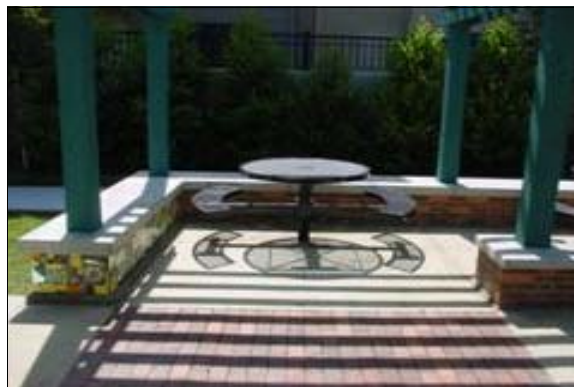
Outdoor Dining Area

Finding: The knee space at the tables in the outdoor dining area is less than 19 inches deep.

Full Rec: Modify or replace one of the tables in the outdoor dining area to provide knee clearance of at least 27 inches in height, 30 inches in width and 19 inches in depth (see CBC 1122B.3, ADAAG 4.32.2 and ADAAG Figure 45). The table top height shall not exceed 34 inches above the finished floor.

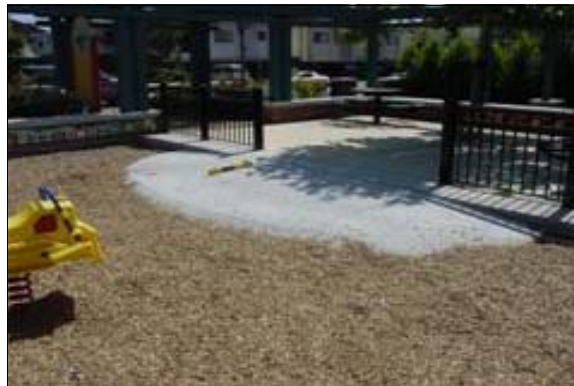
Play Equipment

Finding: There are slopes greater than 6.33% along the path of travel to the play area.

Full Rec: Provide an accessible route to the play area (CBC 1104B.1.2 and ADAAG 4.3.2). The minimum width of the path of travel is 48 inches with 60 inch by 60 inch passing spaces provided every 200 feet and shall not exceed a slope greater than 6.33%. No protruding objects are permitted on the accessible path of travel. Accessible surfaces shall comply with CBC 1124B.1 and ADAAG 4.5 and shall be firm, stable and slip resistant.

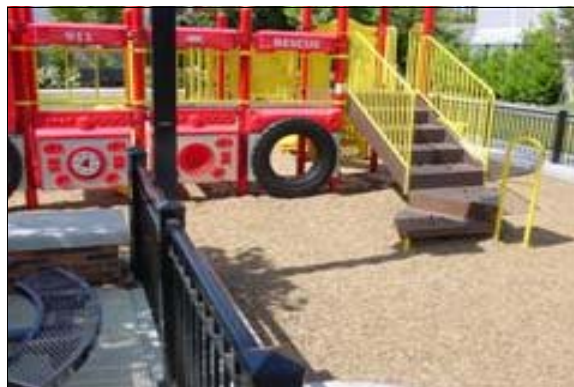
Play Equipment

Finding: The surface beneath the play equipment is wood chips, making the area nonaccessible to individuals with mobility impairments.

Full Rec: The play area should be made an accessible play area for the facility. Provide a maneuvering space with an accessible resilient surface beneath the play components and adjacent to the play components where technically feasible. An adequate maneuvering space has an accessible surface and is not less than 60 inches by 60 inches where an individual with a mobility impairment can be a part of the activities provided at the play components.
