Photo Report
Lower Scholl Canyon Park
Programs, Services, and Activities

17-Jul-07

Finding: The Lower Scholl Canyon Park, located at 2849 East Glenoaks in Glendale California, was inspected by Disability Access Consultants, Inc., on June 12, 2007.

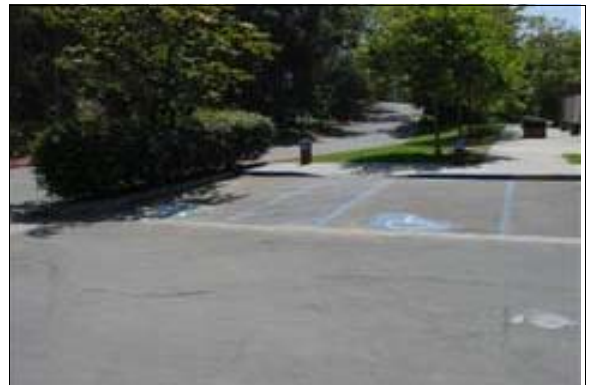
Finding: There is no device at the head of the accessible parking space at the right to prevent vehicles from encroaching into the minimum width of the accessible walkway.

Full Rec: Install a wheelstop at the head of the accessible parking space at the right. Wheelstops shall be used to prevent vehicles from encroaching into accessible aisles or walkways, but shall not present addition encroachment into those areas (see CBC 1129B.4.3).

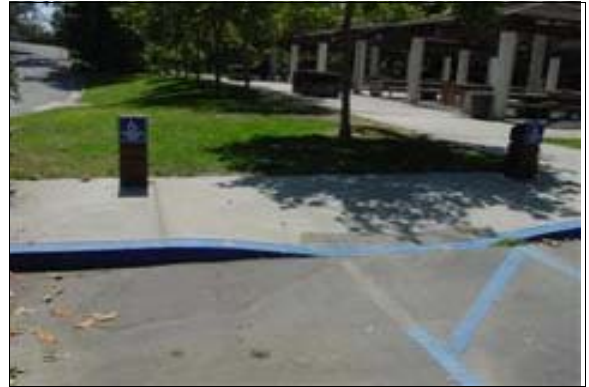
Finding: The bottom edge of the post-mounted signage designating the accessible parking spaces is less than 80 inches above the level of the parking space and cannot be viewed when a vehicle is parked in the space.

Full Rec: Modify the height or replace the post-mounted signage designating the accessible parking spaces to provide at least 80 inches from the parking space finished grade to the bottom edge of the sign. The sign shall be located so that it cannot be obscured by a vehicle parked in the space (see CBC 1129B.5).

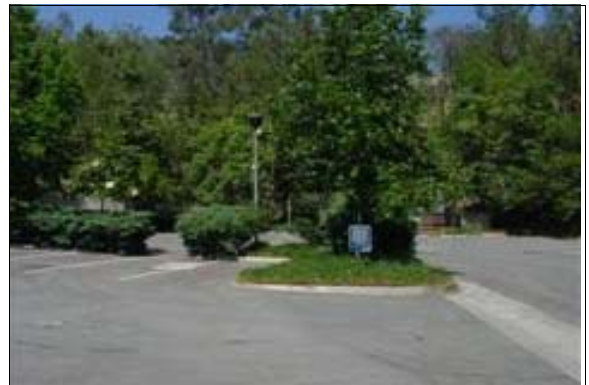
Finding: There is warning signage posted at the entrance to the parking lot regarding unauthorized use of accessible parking spaces in the parking lot, though the blank spaces which should furnish the point of contact and telephone number for reclaiming towed vehicles have been left blank.

Full Rec: Fill in the blank spaces which are required to furnish the point of contact and telephone number for reclaiming towed vehicles with the appropriate information as a permanent part of the sign and maintain the currency of the information (see CBC 1129B.5). Make sure to add the CVC22511.8(a)(d) to the sign.

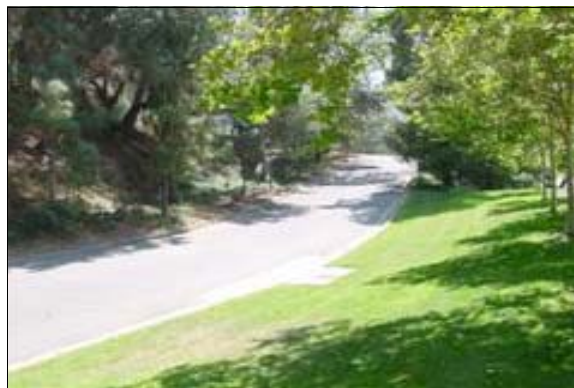
Accessible Route from the Public Right of Way

Finding: There is no accessible route from the public right of way to the accessible entrance of the facility. The required accessible route crosses a vehicular way.

Alternative Post directional signage.

Full Rec: Provide at least one accessible route from the public right of way to the accessible entrance of the facility. Make certain to post signage indicating the direction to accessible building entrances at every major junction along the accessible route. Signs shall include the International Symbol of Accessibility.

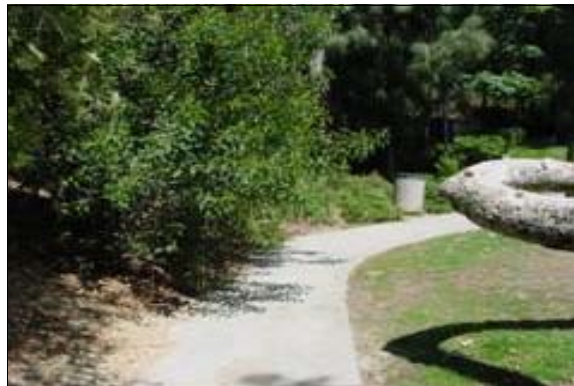
Path of Travel at the Lower Outdoor Dining Area

Finding: At the time of inspection, vegetation encroached into the primary path of travel, obstructing passage by reducing the clear width along the accessible route.

Full Rec: Maintain grass or landscaping adjacent to primary path of travel walkways to eliminate any encroachment into the accessible route.

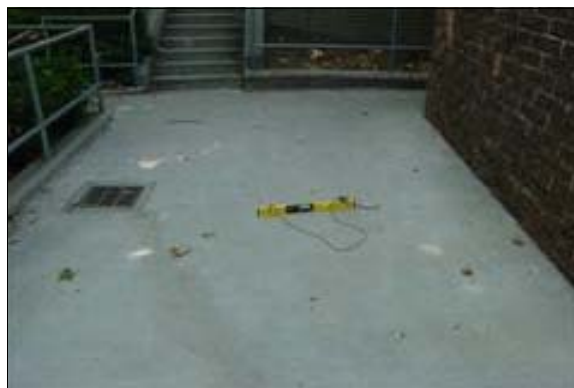
Path of Travel Between the Men's and Women's Restrooms

Finding: There are cross slopes greater than 2% on the primary path of travel between the men's and women's restrooms.

Full Rec: Resurface the path of travel to provide a level surface that does not exceed a slope greater than 5%. Cross slopes shall not exceed 2%.

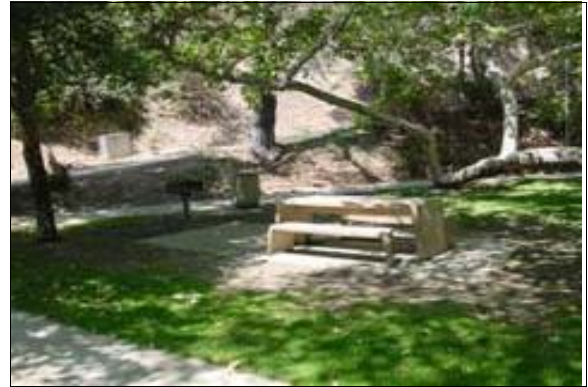
Path of Travel to the Lower Outdoor Dining Area

Finding: There are only stairs to the primary functions provided, preventing access to individuals with mobility impairments.

Full Rec: Since programs, services and activities to staff and the public (volunteers, etc.) are provided in this location, those programs, services and activities are required to be made accessible. It is recommended that a ramp be installed or other means of vertical access.

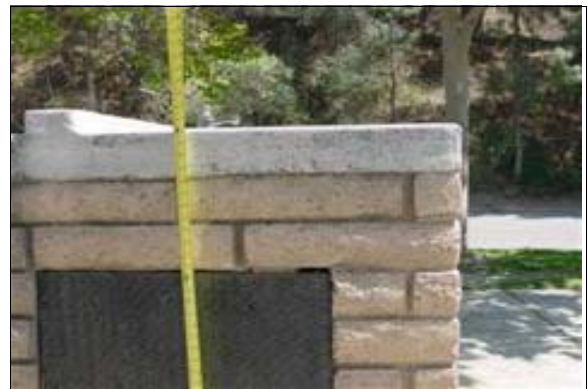
Sink at the Outdoor Dining Area

Finding: The sink at the outdoor dining area next to the parking lot does not provide an accessible forward approach. The height of the counter surface of the sink is greater than 34 inches above the finished floor.

Full Rec: Sinks must provide clear floor space in front of the sink for an accessible forward approach and shall provide at least 27 inches clear knee space and a minimum of nine inches clear toe space (see ADAAG 4.19.2). If neither clear floor space and knee and toe clearance can be provided, remove the sink and replace with an accessible wall-mounted sink unit.

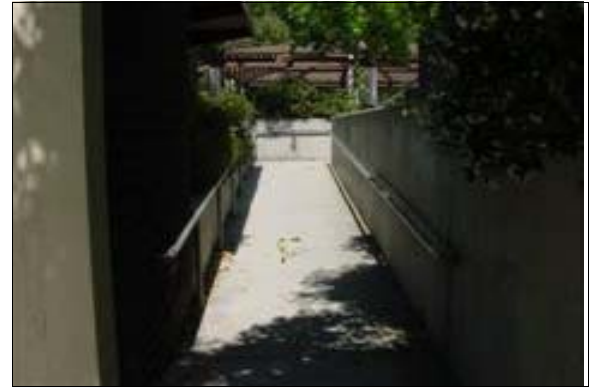
Exterior Ramp Next to the Restrooms

Finding: The slope of the bottom run of the concrete ramp is greater than 8.33%.

Full Rec: Modify the bottom run of the concrete ramp to provide a slope no greater than 8.33% with a cross slope not exceeding 2% (see CBC 1133B.5.3 and ADAAG 4.8.2).

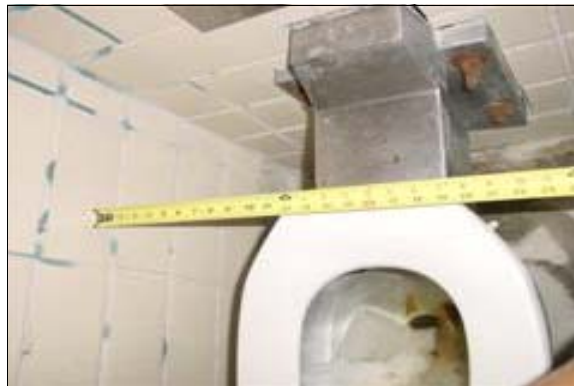
Men's Restroom

Finding: The distance from the center of the toilet to the nearest side wall in the stall designated to be accessible in the restroom is less than 18 inches.

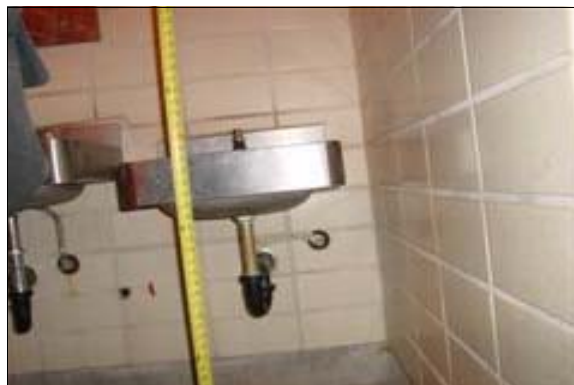
Men's Restroom

Finding: The knee clearance space under the lavatory designated to be accessible in the restroom is less than 29 inches. The knee depth space under the lavatory designated to be accessible in the restroom is less than 27 inches at 8 inches under the lavatory apron.

Full Rec: Replace the lavatory designated to be accessible in the restroom to provide at least 29 inches of clear knee space between the finished floor and bottom of the lavatory apron. Make sure to provide at least 27 inches at 8 inches under the apron (see ADAAG 4.19.2).

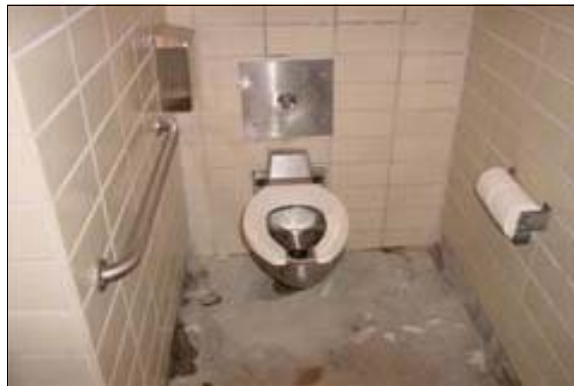
Women's Restroom

Finding: There is no back grab bar in the stall designated to be accessible in the restroom.

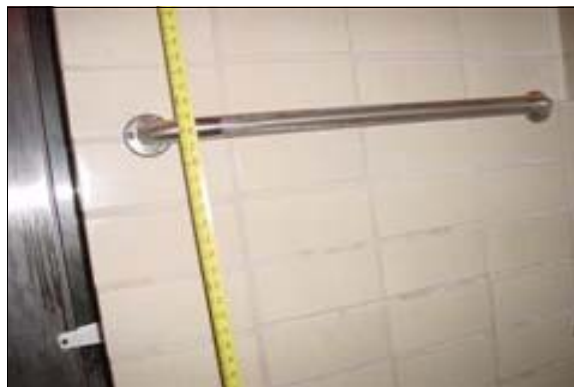
Women's Restroom

Finding: The height of the side grab bar in the stall designated to be accessible of the restroom is greater than 33 inches above the finished floor.

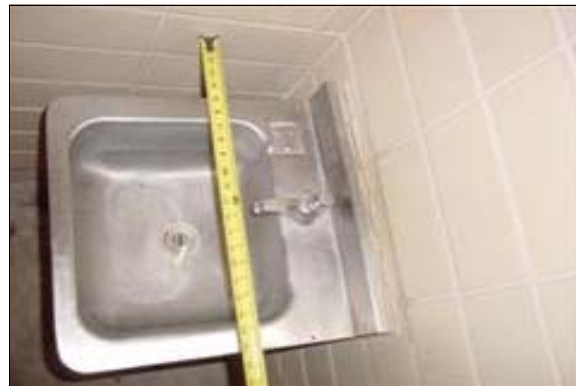
Women's Restroom

Finding: The distance from the center of the lavatory to the adjacent side wall in the restroom is less than 18 inches.

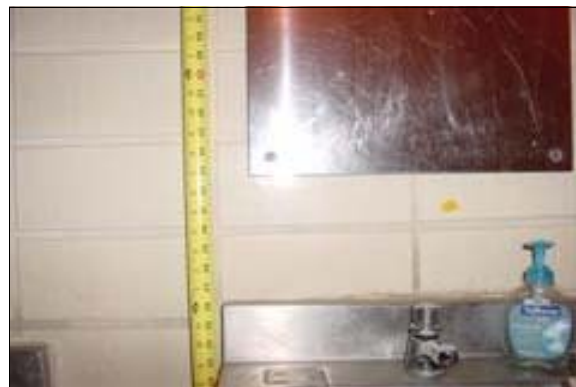
Women's Restroom

Finding: The bottom edge of the reflecting surface of the mirror in the restroom is greater than 40 inches above the finished floor.

Full Rec: Lower the mirror in the restroom so that the bottom edge of the reflecting surface is no higher than 40 inches above the finished floor and the topmost portion of the reflecting surface extends at least 74 inches above the finished floor (see ADAAG A4.19.6). A single, full-length mirror is recommended since it can accommodate all people. Make certain to provide a minimum clear floor space in front of the mirror of 30 inches in width and 48 inches in length.

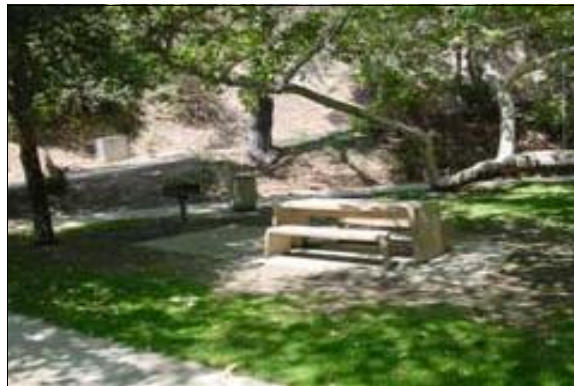
Lower Outdoor Dining Area

Finding: There is no accessible route to the picnic tables in the outdoor dining area. The surface around the outdoor dining area picnic tables is grass, preventing access of individuals with mobility impairments.
