Photo Report
Milford Mini Park
Programs, Services, and Activities

Milford Mini Park

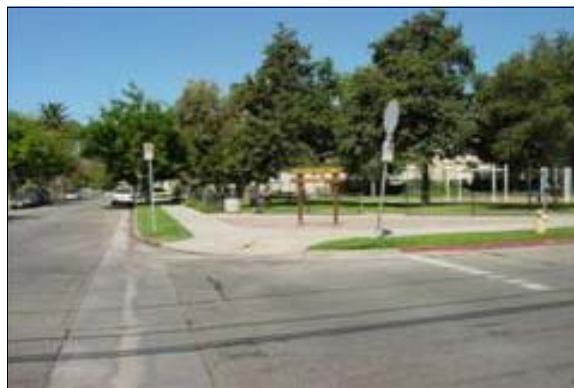
Finding: Milford Mini Park, located at 601 West Milford in Glendale California, was inspected by Disability Access Consultants, Inc., on August 13, 2007.

Full Rec: Any renovation or new construction that occurred after January 26, 1992, is subject to meet full code specifications for the California Building Code and ADAAG requirements. All recommendations in this report are based on ADAAG and CBC title 24 requirements. Consult with your design professional to determine which elements are affected by these requirements. It is recommended that Disability Access Consultants, Inc. is consulted for inspection of any new construction or renovation at the facility.

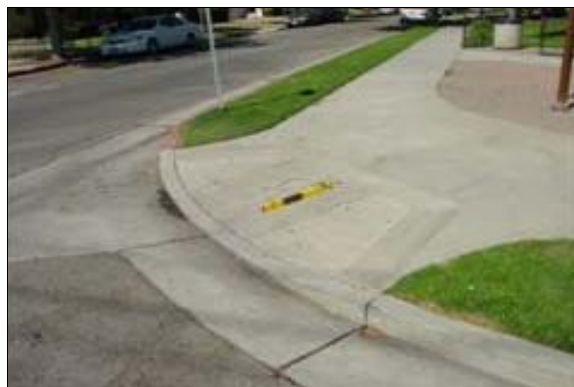
Curb Ramp at the Corner of Milford and Kenliworth
 Citations: CBC 1127B.5.3; ADAAG 4.7.2 & 4.29
 Minimum Quantity: 1
 Maximum Quantity: 1
Minimum Estimated Cost: \$1,033.00
Maximum Estimated Cost: \$1,033.00
 Record Number: 945
 Priority:

Finding: The slope of the curb ramp is greater than 8.33%. The slope at the top landing is greater than 2%. The slope of the side flares is greater than 10%. The transition at the bottom landing is abrupt. The concrete curb ramp does not provide a detectable warning surface which includes truncated domes.

Full Rec: Replace the curb ramp with a compliant curb ramp at least 48 inches in width that provides a slope no greater than 8.33%. Install a detectable warning surface which extends the full length and width of the concrete curb ramp and its side flares with truncated domes that contrast visually by either light on dark or dark on light which is an integral part of the concrete curb ramp. The truncated domes may be cast in place or stamped or of a prefabricated surface treatment (see CBC 1127B.5.8).

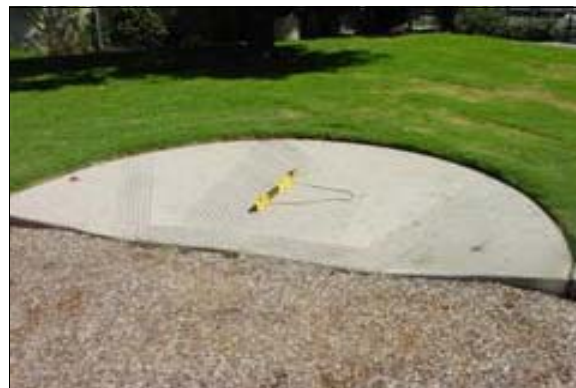
Curb Ramp at the Play Equipment

Finding: The slope of the curb ramp is greater than 8.33%. The top landing is grass, preventing access to individuals with mobility impairments. The bottom landing is woodchips, preventing access to individuals with mobility impairments. The concrete curb ramp does not provide a detectable warning surface which includes truncated domes.

Full Rec: Replace the curb ramp with a compliant curb ramp at least 48 inches in width that provides a slope no greater than 8.33%. Install a detectable warning surface which extends the full length and width of the concrete curb ramp and its side flares with truncated domes that contrast visually by either light on dark or dark on light which is an integral part of the concrete curb ramp. The truncated domes may be cast in place or stamped or of a prefabricated surface treatment (see CBC 1127B.5.8).

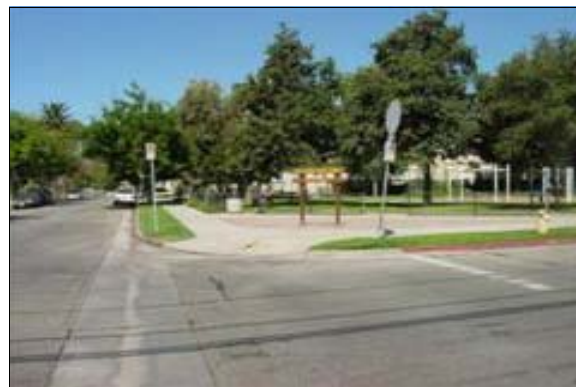
Accessible Route from the Public Right of Way

Finding: There is an accessible route from the public right of way to the accessible entrance of the facility.

Full Rec: Post directional signage. Make certain to post signage indicating the direction to accessible building entrances at every major junction along the accessible route. Signs shall include the International Symbol of Accessibility.

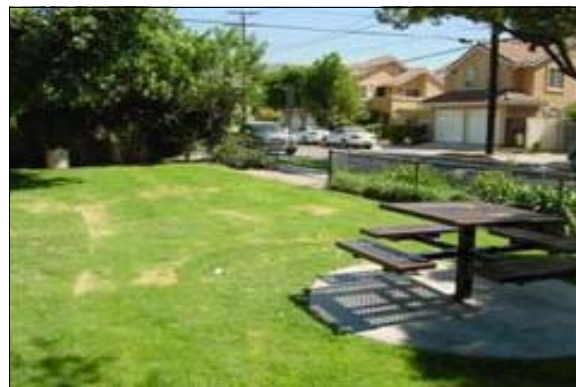
Outdoor Dining Area

Finding: There is no accessible route to the picnic tables in the outdoor dining area. The surface around the outdoor dining area is grass, preventing access of individuals with mobility impairments.

Full Rec: Install a 48-inch wide path to the picnic tables in the outdoor dining area that provides a smooth, stable, firm and slip resistant surface. Provide a maneuvering space sufficient to provide a 60-inch diameter turning radius adjacent to at least one of the picnic tables in the outdoor dining area.

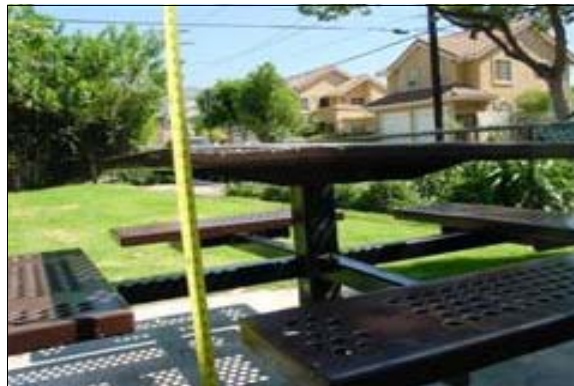
Outdoor Dining Area

Finding: The knee space at the tables in the outdoor dining area is less than 19 inches deep.

Full Rec: Modify or replace one of the tables in the outdoor dining area to provide knee clearance of at least 27 inches in height, 30 inches in width and 19 inches in depth (see CBC 1122B.3, ADAAG 4.32.2 and ADAAG Figure 45). The table top height shall not exceed 34 inches above the finished floor.

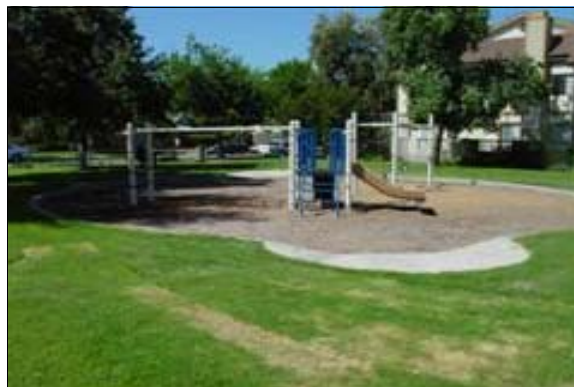
Play Equipment

Finding: The path of travel to the play area consists of grass, making the area nonaccessible to individuals with mobility impairments. The surface beneath the play area is wood chips, making the area nonaccessible to individuals with mobility impairments.

Full Rec: Provide an accessible route to the play area (CBC 1104B.1.2 and ADAAG 4.3.2). The minimum width of the path of travel is 48 inches that provides a firm, stable and slip resistant surface. Provide a maneuvering space with an accessible resilient surface beneath the play components and adjacent to the play components where technically feasible. An adequate maneuvering space has an accessible surface and is not less than 60 inches by 60 inches where an individual with a mobility impairment can be a part of the activities provided at the play components.
