Photo Report
New York Park
Programs, Services, and Activities

Finding: The New York Park, located at 4525 New York Avenue in Glendale California, was inspected by Disability Access Consultants, Inc., on August 14, 2007.

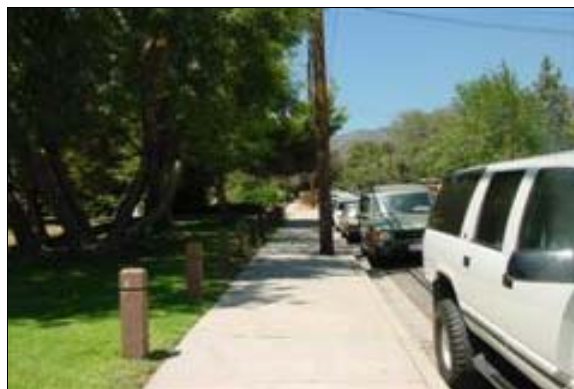
Accessible Route from the Public Right of Way

Finding: There is an accessible route from the public right of way to the accessible entrance of the facility.

Full Rec: Post directional signage. Make certain to post signage indicating the direction to accessible building entrances at every major junction along the accessible route. Signs shall include the International Symbol of Accessibility.

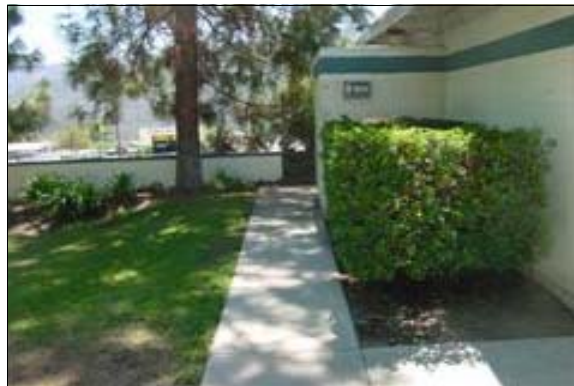
Path of Travel to the Men's Restroom

Finding: The concrete walkway serves as a primary path of travel. The width of the concrete walkway is less than 48 inches in width.

Full Rec: Modify the exterior primary path of travel by extending the width of the concrete walkway to at least 48 inches (see CBC 1118B.2 and ADAAG 4.3.3). Since the accessible route is less than 60 inches in width, provide passing spaces at least 60 inches by 60 inches at reasonable intervals every 200 feet.

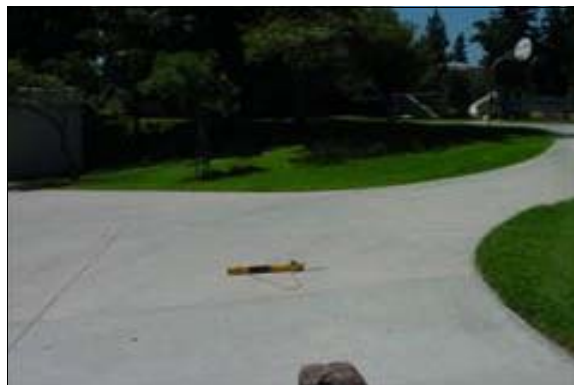
Path of Travel to the Play Equipment

Finding: There are cross slopes greater than 2% on the primary path of travel from the public right of way to the basketball courts and play equipment.

Full Rec: Resurface the path of travel to provide a level surface that does not exceed a slope greater than 5%. Cross slopes shall not exceed 2%.

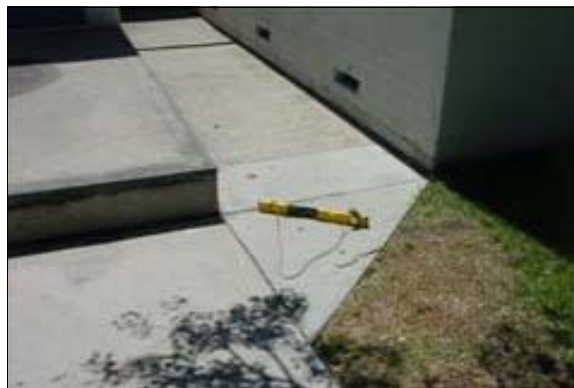
Path of Travel to the Women's Restroom

Finding: The concrete walkway serves as a primary path of travel. The width of the concrete walkway is less than 48 inches in width. There are slopes greater than 5% along the path of travel.

Full Rec: Modify the exterior primary path of travel by extending the width of the concrete walkway to at least 48 inches (see CBC 1118B.2 and ADAAG 4.3.3). Since the accessible route is less than 60 inches in width, provide passing spaces at least 60 inches by 60 inches at reasonable intervals every 200 feet. Provide a level surface that does not exceed a slope greater than 5%. Cross slopes shall not exceed 2%.

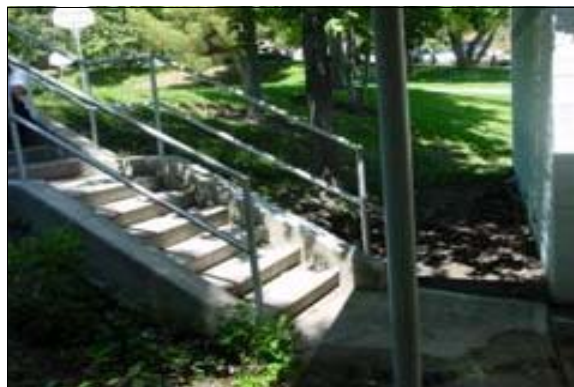
Exterior Stairs Next to the Women's Restroom

Finding: There is no detectable striping on each tread of the exterior stairway.

Full Rec: Affix detectable contrasting striping to each tread of the stairway that clearly contrasts in color from the tread and is at least 2 inches in width placed no more than 1 inch from the tread nose or landing.

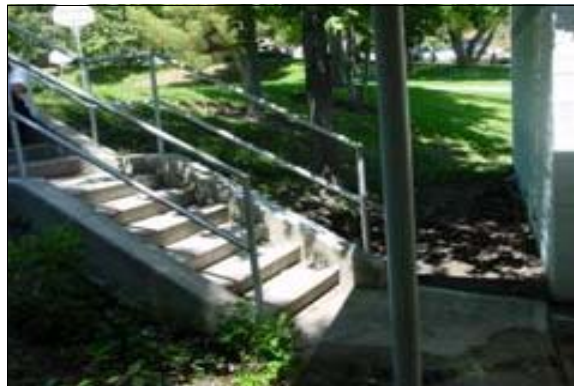
Exterior Stairs Next to the Women's Restroom

Finding: The width of the exterior stairway is less than 48 inches.

Full Rec: Install an exterior stairway with a minimum width of 48 inches (see CBC 1006.2).

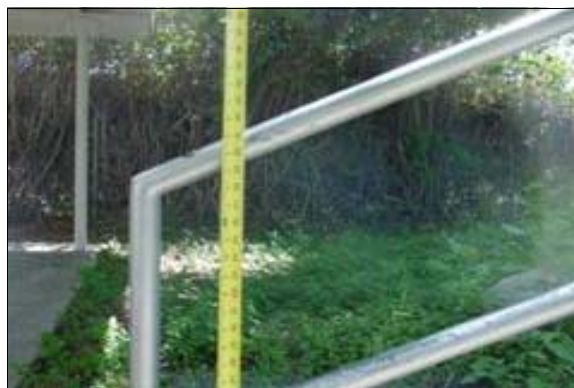
Exterior Stairs Next to the Women's Restroom

Finding: The handrails do not provide 12-inch extensions beyond the top and bottom treads. The handrails are mounted at a height greater than 38 inches.

Full Rec: Install handrails on each side of stairway that provide 12-inch top and bottom handrail extensions that extend beyond the top and bottom treads of the stairway which are parallel to the ground surface and return smoothly to the post or wall. Handrails shall be mounted at a height between 34 and 38 inches.

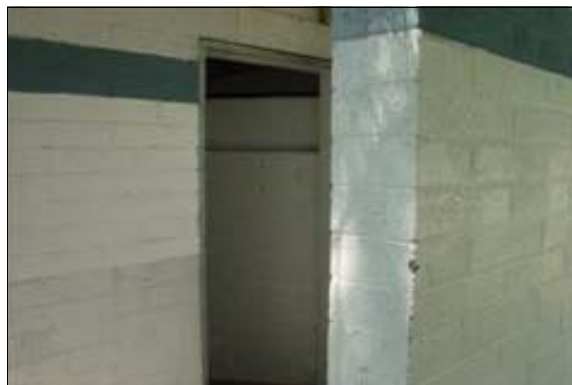
Men's Restroom

Finding: There is no signage indicating accessibility on the latch side of the entry door of the restroom. There is no Title 24 gender use signage on the entrance door.

Full Rec: The restroom is designated accessible and should be made accessible for the facility. Post signage centered 60 inches above the ground surface on the latch side of the entrance door identifying the restroom as accessible upon completion of the following items (see CBC 1115B., ADAAG 4.1.2(7) and ADAAG 4.1.6(3)(e). Signage shall include Braille and raised lettering, the gender or unisex use symbol and the ISA symbol. Post Title 24 gender use signage on the door @ 60" o.c. a.f.f.

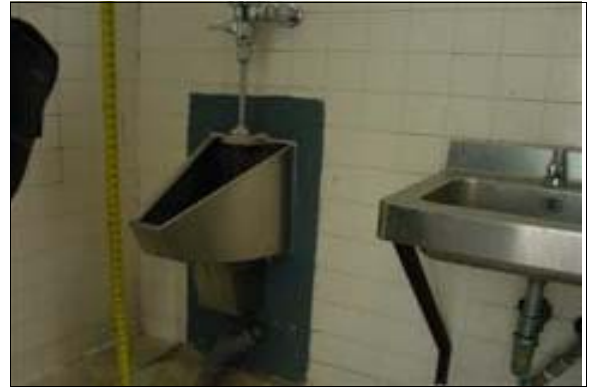
Men's Restroom

Finding: The height of the urinal rim in the restroom is greater than 17 inches above the finished floor.

Full Rec: Lower the urinal designated to be accessible in the restroom so that the rim height is not more than 17 inches above the finished floor.

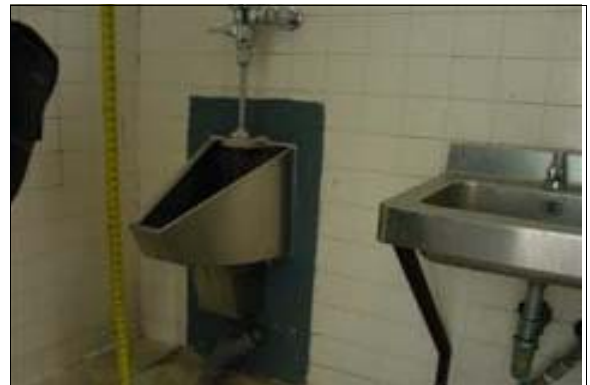
Men's Restroom

Finding: The height of the urinal flush control in the restroom is greater than 44 inches above the finished floor.

Full Rec: Lower the flush control valve on the urinal designated to be accessible in the restroom to a height not greater than 44 inches above the finished floor (see ADAAG 4.18.4).

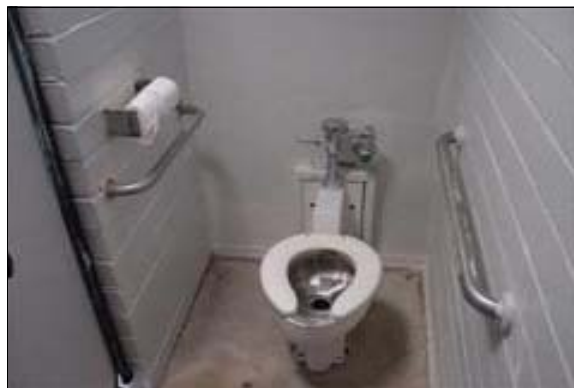
Men's Restroom

Finding: There is insufficient clear floor space in the stall designated to be accessible in the restroom. The door to the stall designated to be accessible in the restroom does not close automatically or have accessible hardware.

Full Rec: Modify or replace the stall designated to be accessible in the restroom so that it complies with ADAAG 4.17.3, CBC 1115B and CBC Figures 11B-1A and 1B. Standard accessible stalls require 60 inches in width with 56 inches depth for wall-mounted toilets or 59 inches depth for floor-mounted toilets to accommodate individuals in wheelchairs. The minimum width of a front-approach doorway shall provide at least 32 inches and a side-approach doorway shall provide at least 34 inches. The door shall swing outward, close automatically and provide accessible hardware.

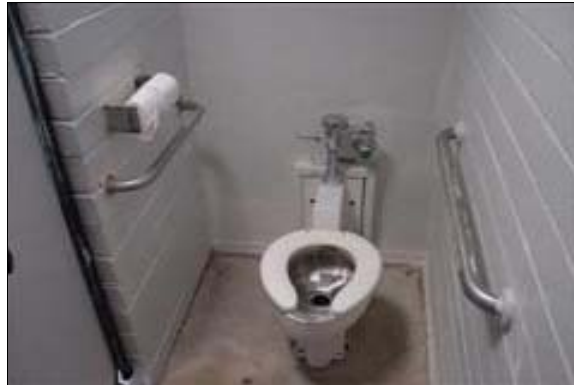
Men's Restroom

Finding: There is no back grab bar in the stall designated to be accessible in the restroom.

Full Rec: Install a 36-inch back grab bar at a height of 33 inches above the finished floor in the stall designated to be accessible of the restroom. Grab bars must be able to support a point load of at least 250 pounds and shall be less than the allowable shear stress of the grab bar material.

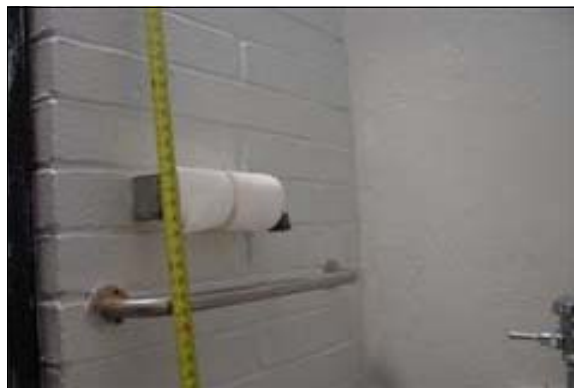
Men's Restroom

Finding: The height of the side grab bars in the stall designated to be accessible of the restroom is greater than 33 inches above the finished floor.

Full Rec: Remount the side grab bars in the stall designated to be accessible in the restroom so that the height of the gripping surface is centered at 33 inches above finished floor. Grab bars must be able to support a point load of at least 250 pounds and shall be less than the allowable shear stress of the grab bar material.

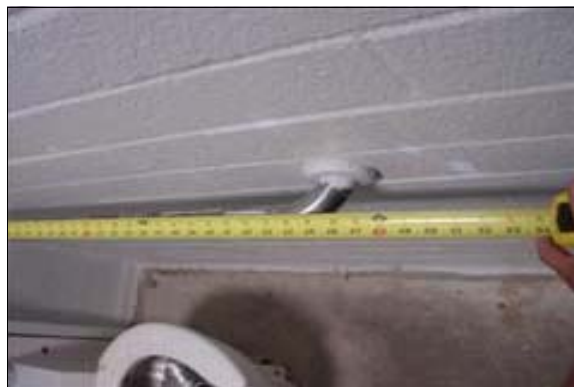
Men's Restroom

Finding: The length of the side grab bars in the stall designated to be accessible in the restroom is less than 42 inches. The side grab bars in the stall designated to be accessible in the restroom do not extend 54 inches from the back wall.

Full Rec: Replace the side grab bars in the stall designated to be accessible in the restroom with a 42-inch/ 48 -inch side grab bar complying with ADAAG 4.26 and CBC 1115B.8. The front end of the grab bar shall extend at least 54 inches from the back wall and the back end of the grab bar shall be mounted within 12 inches from the back wall. Grab bars must be able to support a point load of at least 250 pounds and shall be less than the allowable shear stress of the grab bar material.

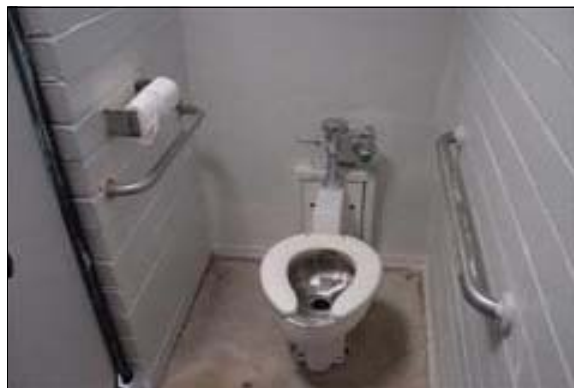
Men's Restroom

Finding: The distance from the end of the left grab bar to the back wall in the stall designated to be accessible in the restroom is greater than 12 inches.

Full Rec: Remount the side grab bar in the stall designated to be accessible in the restroom so that it is not more than 12 inches from the back wall (see ADAAG Figure 29 and CBC 1115B.8). Grab bars must be able to support a point load of at least 250 pounds and shall be less than the allowable shear stress of the grab bar material.

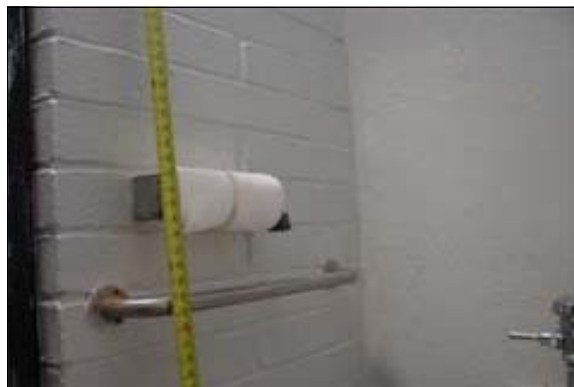
Men's Restroom

Finding: The toilet paper dispenser in the stall designated to be accessible in the restroom interferes with the use of the side grab bar.

Full Rec: Remount the toilet paper dispenser in the stall designated to be accessible in the restroom so that it does not interfere with the use of the side grab bar (see ADAAG 4.16.6 and Figure 29(b)). Toilet paper dispensers must allow continuous paper flow.

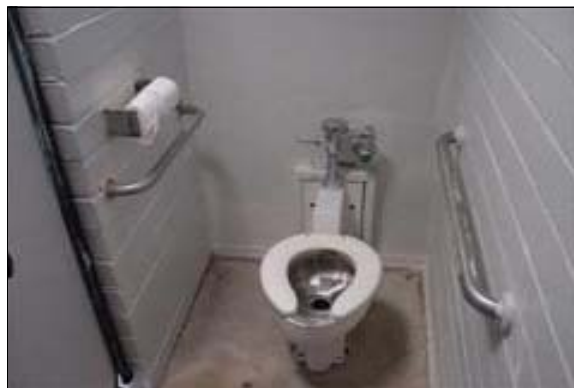
Men's Restroom

Finding: The height of the toilet seat in the stall designated to be accessible in the restroom is less than 17 inches above the finished floor.

Full Rec: Remove or modify the toilet in the stall designated to be accessible in the restroom so that the seat height is between 17 inches and 19 inches above the finished floor (see ADAAG 4.16.3).

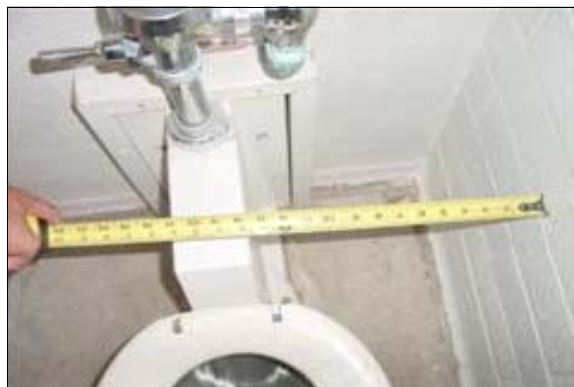
Men's Restroom

Finding: The distance from the center of the toilet to the nearest side wall in the stall designated to be accessible in the restroom is less than 18 inches.

Full Rec: Relocate the toilet or stall side wall so that the distance from the centerline of the toilet to the nearest side wall in the stall designated to be accessible in the restroom is exactly 18 inches (see ADAAG Figure 28).

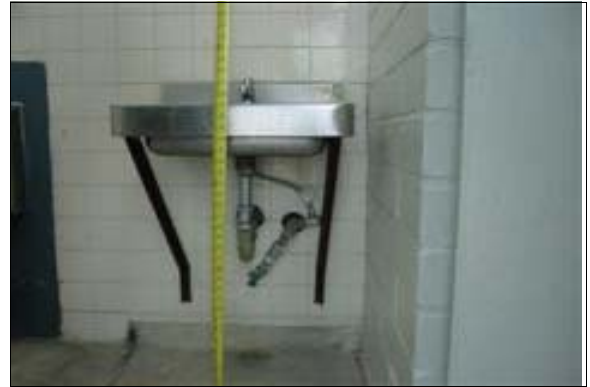
Men's Restroom

Finding: The knee clearance space under the lavatory designated to be accessible in the restroom is less than 29 inches. The knee depth space under the lavatory designated to be accessible in the restroom is less than 27 inches at 8 inches under the lavatory apron.

Full Rec: Replace the lavatory designated to be accessible in the restroom to provide at least 29 inches of clear knee space between the finished floor and bottom of the lavatory apron. Make sure to provide at least 27 inches at 8 inches under the apron (see ADAAG 4.19.2).

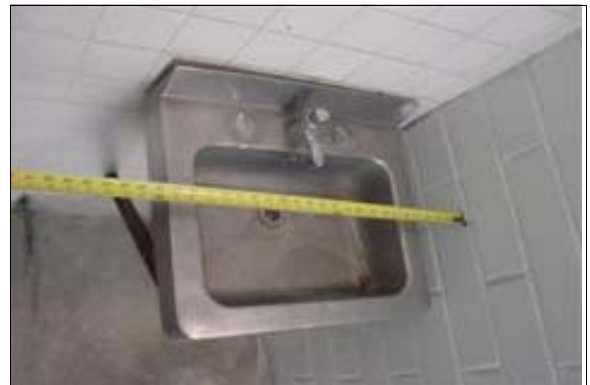
Men's Restroom

Finding: The distance from the center of the lavatory to the adjacent side wall in the restroom is less than 18 inches.

Full Rec: Relocate the lavatory to provide a centerline of at least 18 inches. Make sure to provide at least 30 inches in width and 48 inch length of clear floor space to allow an accessible forward approach (see ADAAG 4.19.3).

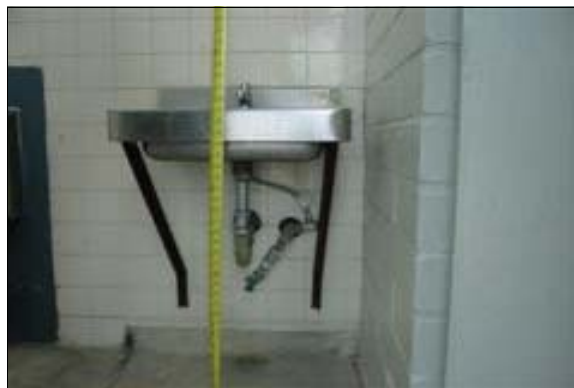
Men's Restroom

Finding: The pipes under the lavatory in the restroom do not provide protection against contact.

Full Rec: Insulate or otherwise configure pipes under the lavatory designated to be accessible in the restroom to protect against contact (see ADAAG 4.19.4). Make certain there are no sharp or abrasive surfaces under the lavatory.

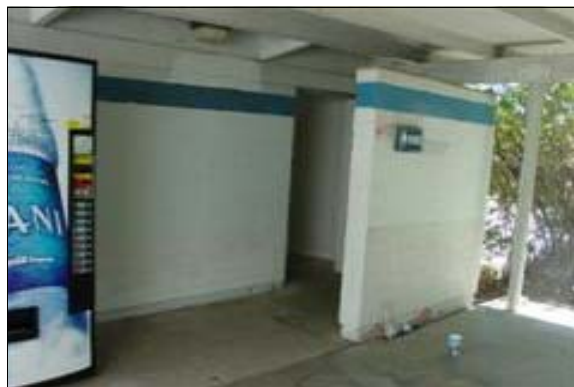
Women's Restroom

Finding: There is no signage indicating accessibility on the latch side of the entry door of the restroom. There is no Title 24 gender use signage on the entrance door.

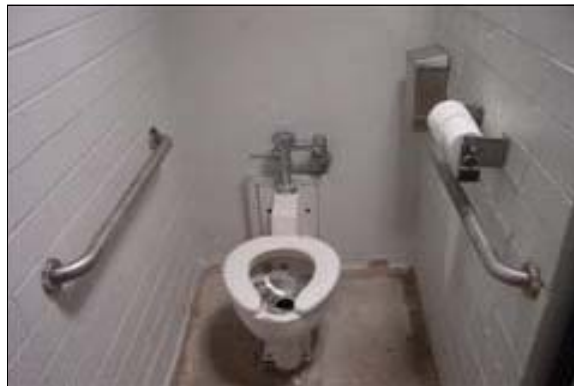
Women's Restroom

Finding: There is insufficient clear floor space in the stall designated to be accessible in the restroom. The door to the stall designated to be accessible in the restroom does not close automatically or have accessible hardware.

Full Rec: Modify or replace the stall designated to be accessible in the restroom so that it complies with ADAAG 4.17.3, CBC 1115B and CBC Figures 11B-1A and 1B. Standard accessible stalls require 60 inches in width with 56 inches depth for wall-mounted toilets or 59 inches depth for floor-mounted toilets to accommodate individuals in wheelchairs. The minimum width of a front-approach doorway shall provide at least 32 inches and a side-approach doorway shall provide at least 34 inches. The door shall swing outward, close automatically and provide accessible hardware.

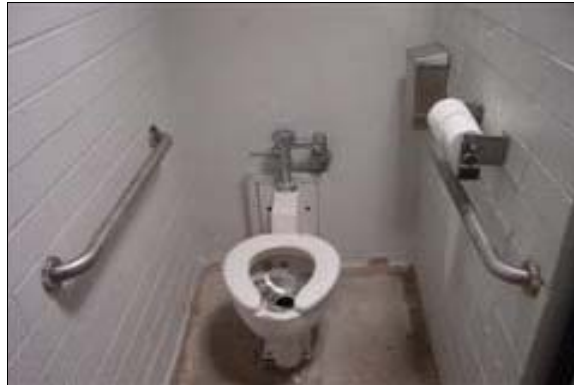
Women's Restroom

Finding: There is no back grab bar in the stall designated to be accessible in the restroom.

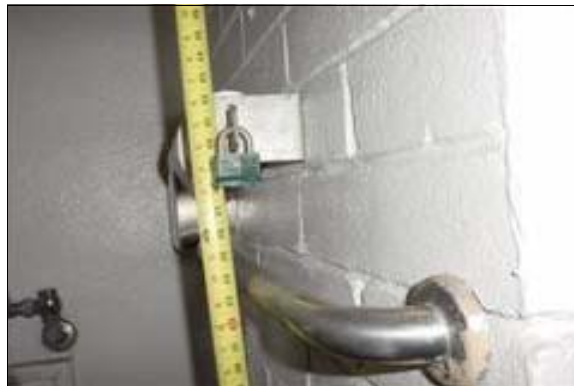
Women's Restroom

Finding: The height of the side grab bars in the stall designated to be accessible of the restroom is greater than 33 inches above the finished floor.

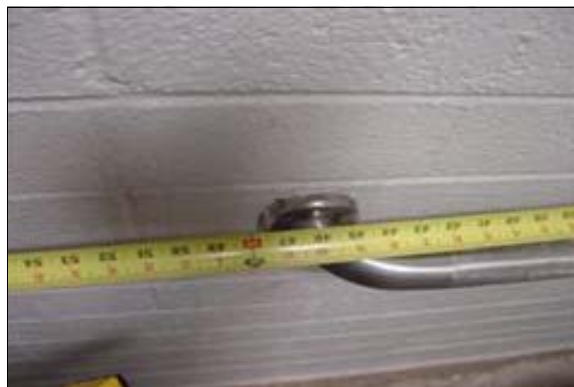
Women's Restroom

Finding: The length of the side grab bars in the stall designated to be accessible in the restroom is less than 42 inches. The side grab bars in the stall designated to be accessible in the restroom do not extend 54 inches from the back wall.

Full Rec: Replace the side grab bars in the stall designated to be accessible in the restroom with a 42-inch/ 48 -inch side grab bar complying with ADAAG 4.26 and CBC 1115B.8. The front end of the grab bar shall extend at least 54 inches from the back wall and the back end of the grab bar shall be mounted within 12 inches from the back wall. Grab bars must be able to support a point load of at least 250 pounds and shall be less than the allowable shear stress of the grab bar material.

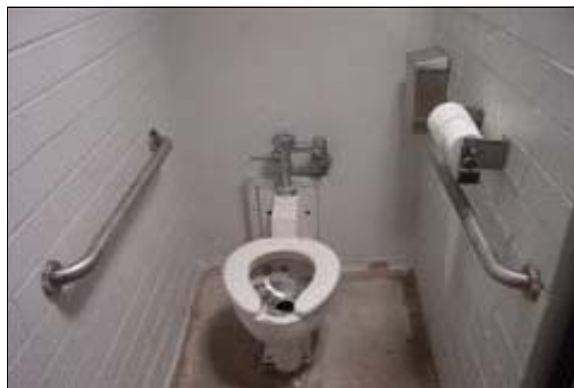
Women's Restroom

Finding: The distance from the end of the side grab bars to the back wall in the stall designated to be accessible in the restroom is greater than 12 inches.

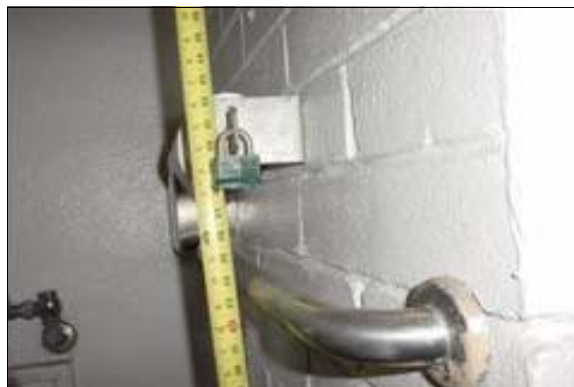
Women's Restroom

Finding: The toilet paper dispenser in the stall designated to be accessible in the restroom interferes with the use of the side grab bar.

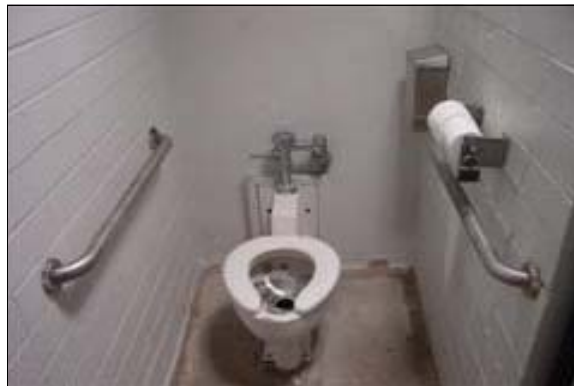
Women's Restroom

Finding: The flush control on the toilet in the stall designated to be accessible in the restroom is not on the wide (approach) side of the toilet.

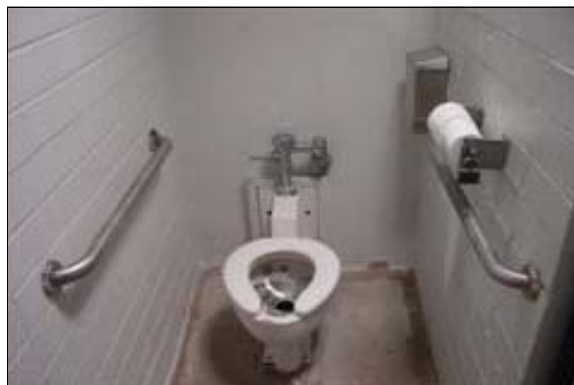
Women's Restroom

Finding: The height of the toilet seat in the stall designated to be accessible in the restroom is less than 17 inches above the finished floor.

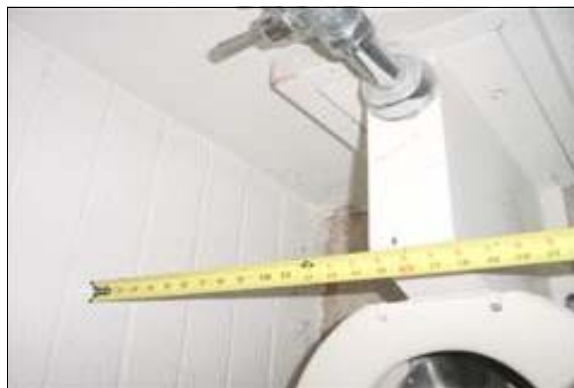
Women's Restroom

Finding: The distance from the center of the toilet to the nearest side wall in the stall designated to be accessible in the restroom is less than 18 inches.

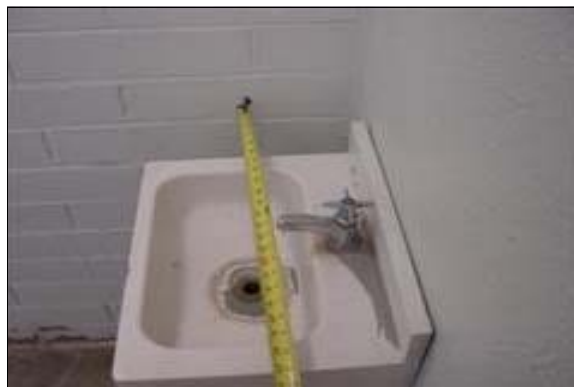
Women's Restroom

Finding: The faucet controls on the lavatory in the restroom require tight grasping, pinching, or twisting of the wrist and are not accessible.

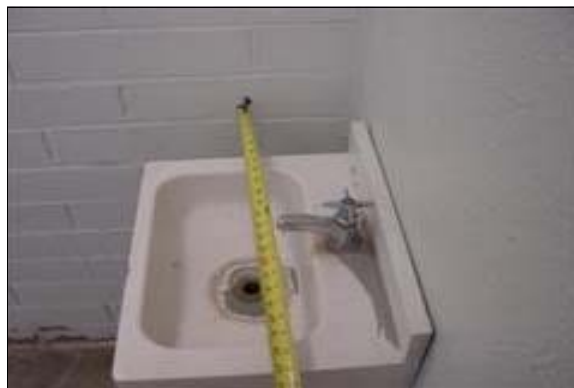
Women's Restroom

Finding: The distance from the center of the lavatory to the adjacent side wall in the restroom is less than 18 inches.

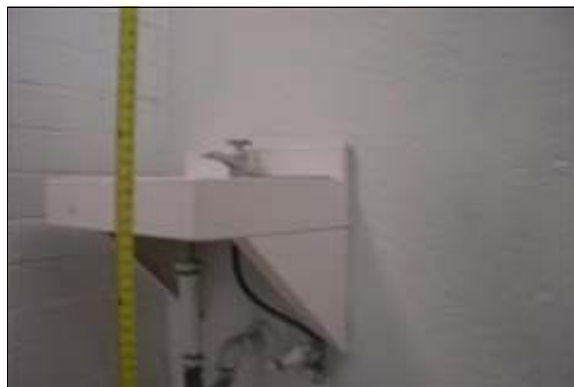
Women's Restroom

Finding: The pipes under the lavatory in the restroom do not provide protection against contact.

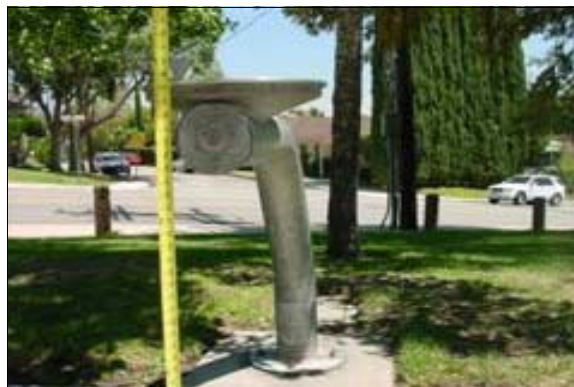
Drinking Fountain Next to the Men's Restroom

Finding: The drinking fountain is not a "high-low" design. The spout outlet height is greater than 36 inches.

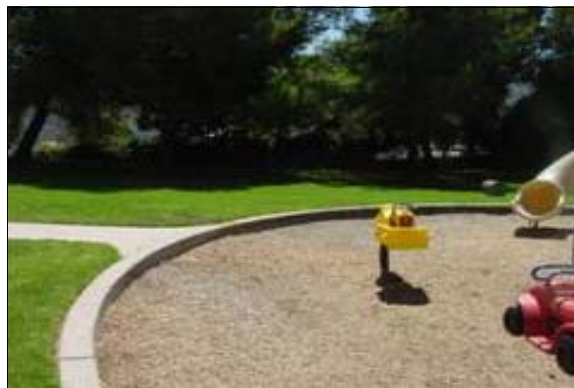
Play Equipment

Finding: The surface beneath the play equipment is wood chips, making the area nonaccessible to individuals with mobility impairments. There is a change in elevation greater than 1/2 inch at the entrance to the play equipment, due to a lack of fill.
