Photo Report
Oakmont View Park
Programs, Services, and Activities

Finding: The Oakmont View Park, located at 2140 Oakmont View Drive in Glendale California, was inspected by Disability Access Consultants, Inc., on August 13, 2007.

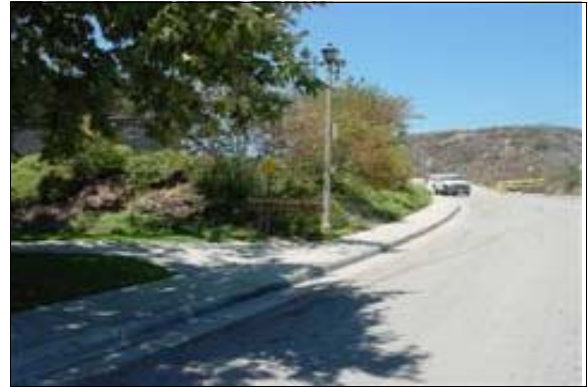
Citations: ADAAG 4.1.2; ADAAG 4.1.3; ADAAG 4.1.5; ADAAG 4.1.6
 Minimum Quantity: 1
 Maximum Quantity: 1
Minimum Estimated Cost: \$0.00
Maximum Estimated Cost: \$0.00
 Record Number: 1093
 Priority:

Full Rec: Any renovation or new construction that occurred after January 26, 1992, is subject to meet full code specifications for the California Building Code and ADAAG requirements. All recommendations in this report are based on ADAAG and CBC title 24 requirements. Consult with your design professional to determine which elements are affected by these requirements. It is recommended that Disability Access Consultants, Inc. is consulted for inspection of any new construction or renovation at the facility.

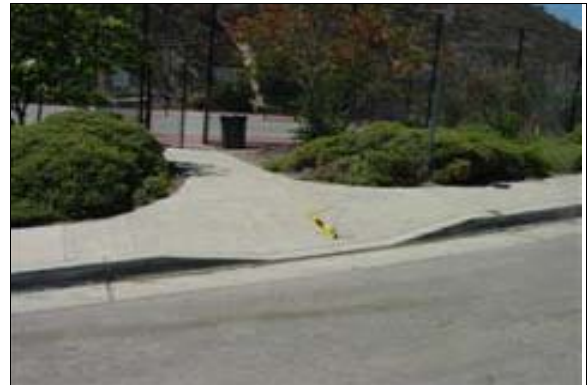
Curb Ramp to the Tennis Courts
 Citations: CBC 1127B.5.3; ADAAG 4.7.2 & 4.29
 Minimum Quantity: 1
 Maximum Quantity: 1
Minimum Estimated Cost: \$1,033.00
Maximum Estimated Cost: \$1,033.00
 Record Number: 1094
 Priority:

Finding: The slope of the curb ramp is greater than 8.33%. The cross slope is greater than 2%. The slope at the bottom landing is greater than 2%. The cross slope at the top landing is greater than 2%. The width of the curb ramp is less than 48 inches. The slope of the side flares is greater than 10%. The curb ramp does not provide a grooved border along the top and sides of the ramp at the level of the sidewalk. The concrete curb ramp does not provide a detectable warning surface which includes truncated domes.

Full Rec: Replace the curb ramp with a compliant curb ramp at least 48 inches in width that provides a slope no greater than 8.33%. Install a detectable warning surface which extends the full length and width of the concrete curb ramp and its side flares with truncated domes that contrast visually by either light on dark or dark on light which is an integral part of the concrete curb ramp. The truncated domes may be cast in place or stamped or of a prefabricated surface treatment (see CBC 1127B.5.8).

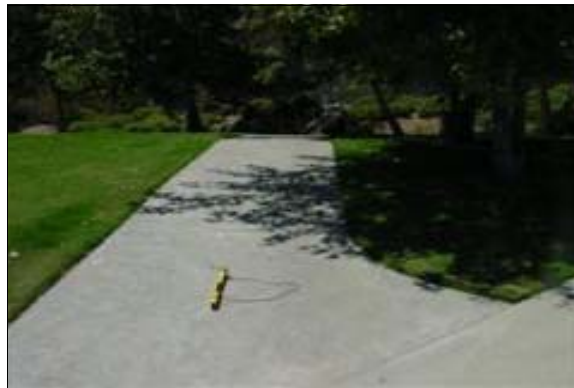
Path of Travel to the Tennis Courts

Finding: There are slopes greater than 5% on the primary path of travel from the public right of way to the tennis courts.

Citations: CBC 1133B.7.1.3; CBC 1133B.7.3; ADAAG 4.3.7

Full Rec: Resurface the path of travel to provide a level surface that does not exceed a slope greater than 5%. Cross slopes shall not exceed 2%.

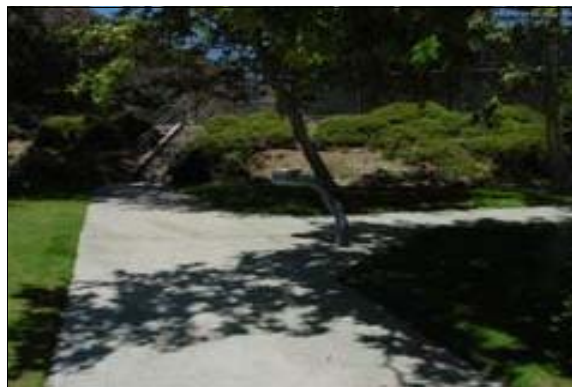
Finding: There is one drinking fountain on primary paths of travel.

Citations: CBC 1117B.1; ADAAG 4.15

Full Rec: Fifty percent of the drinking fountains on primary paths of travel shall be accessible (see CBC 1117B.1 and ADAAG 4.15). Install a "high-low" fountain design to comply with both state and federal requirement. Fountains not located in alcoves need side rails or wing walls on both sides.
