Photo Report
Pelanconi Park
Programs, Services, and Activities

Finding: Pelanconi Park, located at 1000 Grandview Avenue in Glendale California, was inspected by Disability Access Consultants, Inc., on June 8, 2007.

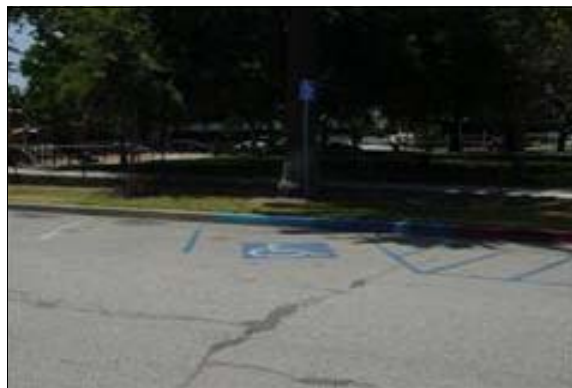
Parking on Cleveland

Finding: There is one accessible parking space out of ## parking spaces which does not meet the minimum number of accessible parking spaces for compliance. The accessible parking space measures 108 inches wide and 175 inches long. The access aisle, located on the passenger's side (right side) of the parking space, measures 96 inches wide. The access aisle does not contain "NO PARKING" in 12" high white letters.

Citations: CBC 1129B; ADAAG 4.6; ADAAG A4.6.

Full Rec: Three out of the 52 total number of parking spaces are required to be designated exclusively for accessible parking, as required by ADAAG and CBC 1129B. Restripe the existing parking space marked accessible and create two additional accessible parking spaces, each measuring at least 108 inches wide and 216 inches long. Designate one parking space as "van-accessible". The van-accessible space shall provide an access aisle measuring at least 96 inches wide (8 feet) on the passenger side (right side) of the vehicle space (see CBC 1129B). The additional parking spaces shall each provide an access aisle measuring at least 60 inches wide, that may be shared. Add the words NO PARKING in 12 inch high white letters at the entrance to the accessible parking access aisle.

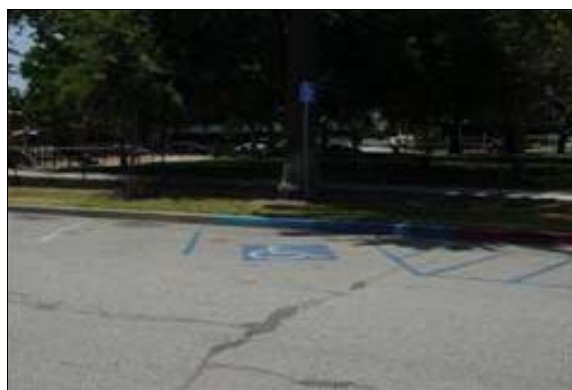
Parking on Cleveland

Finding: The surface of the accessible parking space in the parking lot has a slope greater than 2%.

Citations: CBC 1129B; ADAAG 4.6.3

Full Rec: Pave the parking lot at the accessible spaces to provide a level surface. Parking surfaces and access aisles shall be located in areas not exceeding 2% slope in all directions (see CBC 1129B and ADAAG 4.6.3).

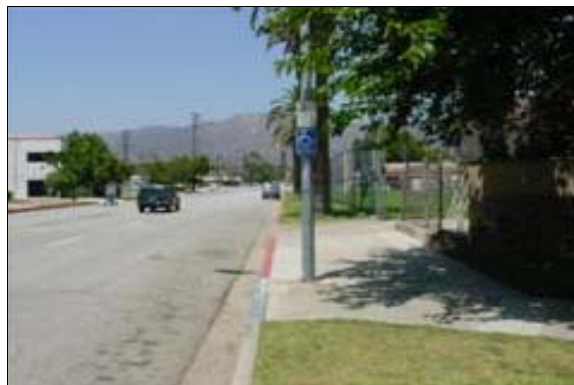
Parking on San Fernando

Finding: There is one parallel parking space designated accessible on San Fernando. There is signage designating the parallel parking space as accessible.

Citations: CBC 1129B; ADAAG 4.6.4

Full Rec: Discontinue designating parallel parking spaces as accessible. Parallel parking spaces do not meet the requirements set forth by ADAAG regarding access aisle and encroachment of other vehicles or objects and requires individuals to travel behind vehicles other than their own in some situations. If no other off-street parking is available, make certain that the facility provides an accessible passenger loading zone located on the shortest route to the primary entrance.

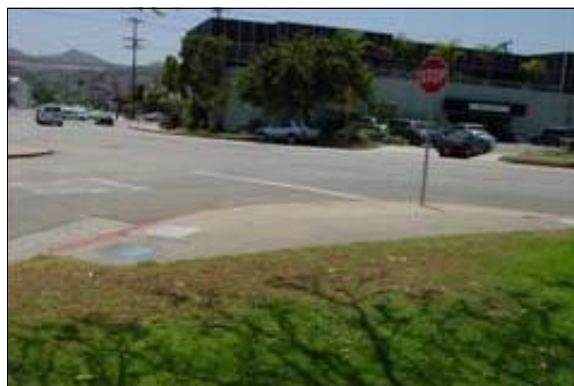
Accessible Route from the Public Right of Way

Finding: There is no crosswalk provided on the path of travel from the public right of way to the facility. The required accessible route crosses a vehicular way.

Citations: ADAAG 4.7.9 ADAAG 4.2.9

Full Rec: Stripe a crosswalk not less than 48 inches wide on the path of travel to the accessible entrance of the facility. Provide a level surface that does not exceed a slope greater than 5%. Cross slopes shall not exceed 2%. Detectable warnings should be placed at the entrance and exit of the crosswalk.

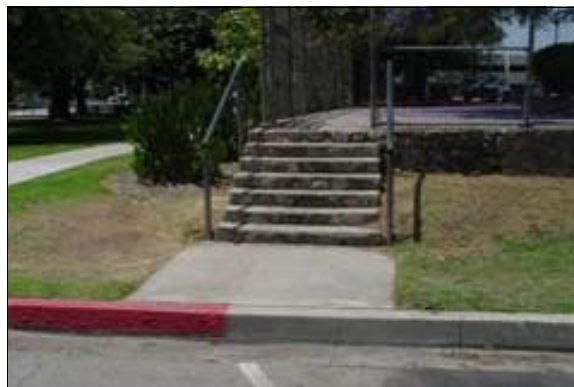
Exterior Stairs off of Cleveland

Finding: The handrails do not provide 12-inch extensions beyond the top and bottom treads.

Citations: CBC 1133B.4.2; ADAAG 4.9.4

Full Rec: Install handrails on each side of stairway that provide 12-inch top and bottom handrail extensions that extend beyond the top and bottom treads of the stairway which are parallel to the ground surface and return smoothly to the post or wall.

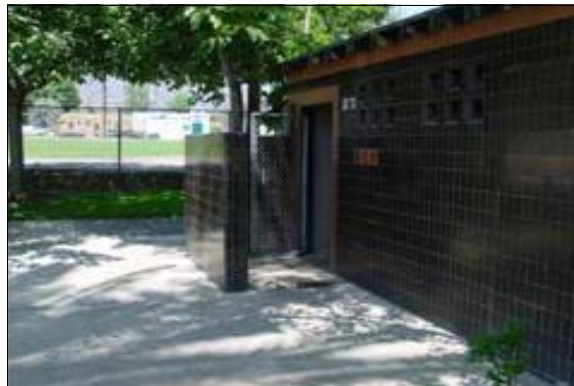
Men's Restroom

Finding: There is no signage indicating accessibility on the latch side of the entry door of the restroom. There is no Title 24 gender use signage on the entrance door.

Citations: CBC 1115B.5; ADAAG 4.1.6; ADAAG 4.1.2(7); ADAAG 4.1.6(3)(e); ADAAG 4.30

Full Rec: The restroom is designated accessible and should be made accessible for the facility. Post signage centered 60 inches above the ground surface on the latch side of the entrance door identifying the restroom as accessible upon completion of the following items (see CBC 1115B., ADAAG 4.1.2(7) and ADAAG 4.1.6(3)(e). Signage shall include Braille and raised lettering, the gender or unisex use symbol and the ISA symbol. Post Title 24 gender use signage on the door @ 60" o.c. a.f.f.

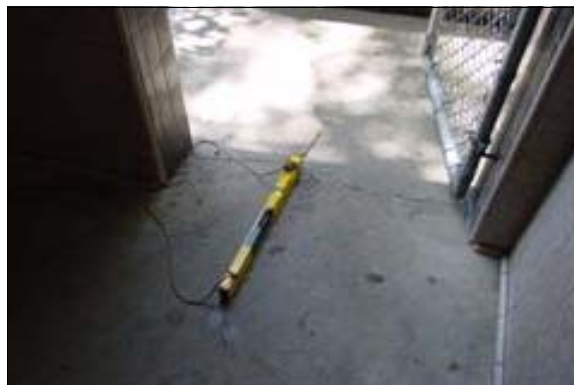
Men's Restroom

Finding: The landing at the entrance door does not provide sufficient clear floor space, due to the privacy wall. There is no level landing provided at the entrance door.

Citations: CBC 1133B.2.4.2; ADAAG 4.13.6

Full Rec: Provide a level and clear landing at least 60 inches in length in the direction of the door swing.

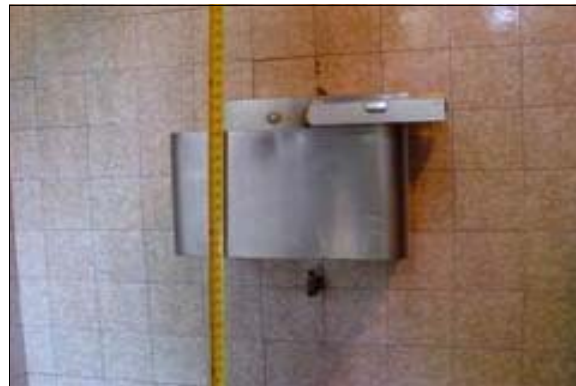
Men's Restroom

Citations: ADAAG 4.19.2

Full Rec: Replace the lavatory designated to be accessible in the restroom to provide at least 29 inches of clear knee space between the finished floor and bottom of the lavatory apron. Make sure to provide at least 27 inches at 8 inches under the apron (see ADAAG 4.19.2).

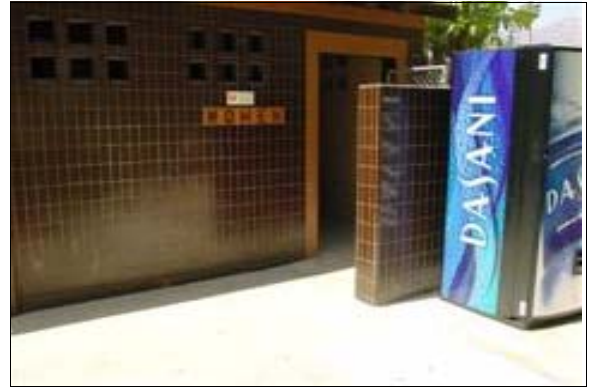
Women's Restroom

Finding: There is no signage indicating accessibility on the latch side of the entry door of the restroom. There is no Title 24 gender use signage on the entrance door.

Citations: CBC 1115B.5; ADAAG 4.1.6; ADAAG 4.1.2(7); ADAAG 4.1.6(3)(e); ADAAG 4.30

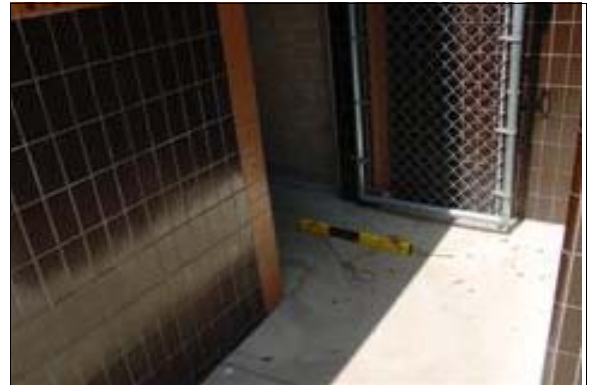
Women's Restroom

Finding: The landing at the entrance door does not provide sufficient clear floor space.

Citations: CBC 1133B.2.4.2; ADAAG 4.13.6

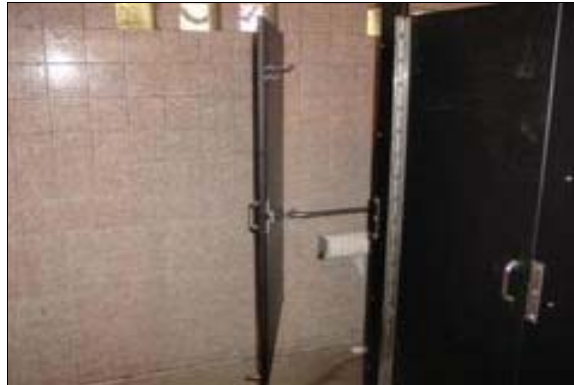
Women's Restroom

Finding: The height of the coat hook on the stall door designated to be accessible in the restroom is greater than 48 inches above the floor surface.

Citations: CBC 1115B.9.2; ADAAG A4.27

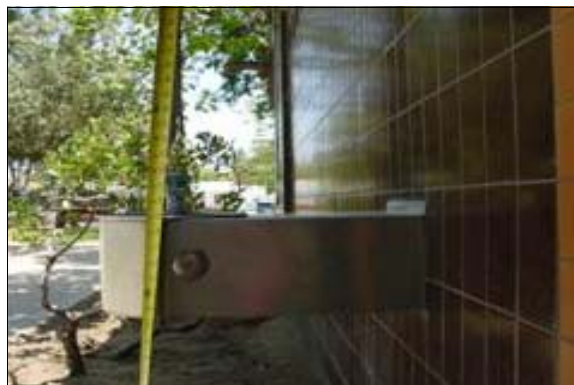
Drinking Fountain at the Restrooms

Finding: The drinking fountain is not a "high-low" design. There is less than 27 inches knee clearance height.

Citations: CBC 1117B.1; ADAAG 4.15

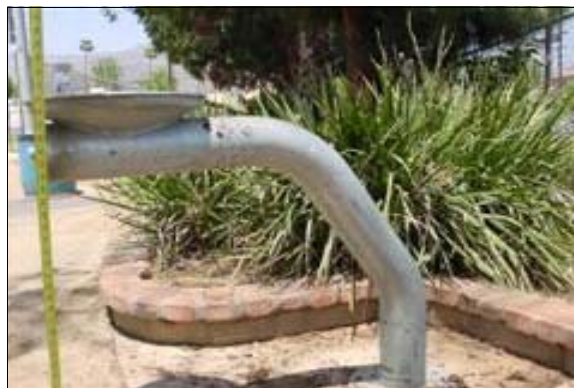
Drinking Fountain at the Softball Field

Finding: The drinking fountain is not a "high-low" design. The spout outlet height is greater than 36 inches.

Citations: CBC 1117B.1; ADAAG 4.15

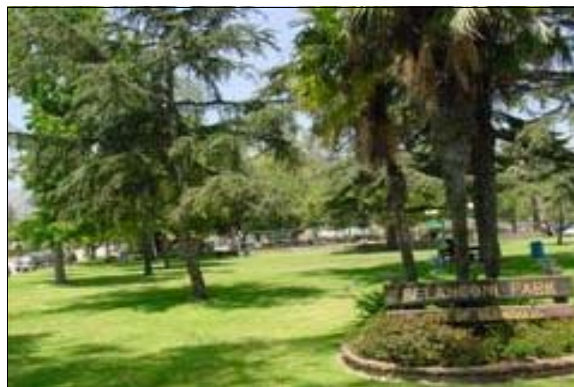
Outdoor Dining Area at the South End of the Park

Finding: There is no accessible route to the picnic tables in the outdoor dining area. The surface under and around the outdoor dining area picnic tables is grass, preventing access of individuals with mobility impairments.

Citations: ADAAG 5.8; ADAAG A4.2.5; ADAAG A4.2.6
