**Photo Report**  
**Piedmont Park**  
**Programs, Services, and Activities**

**Finding:** Piedmont Park, located at 1145 Lexington Drive in Glendale California, was inspected by Disability Access Consultants, Inc., on August 13, 2007.

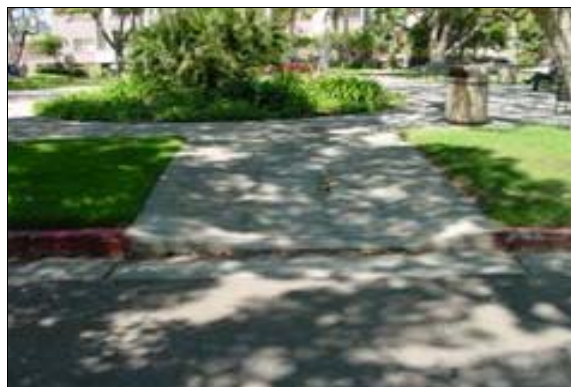
**Curb Ramp (East)**

**Finding:** The slope of the curb ramp is greater than 8.33%. The concrete curb ramp does not provide a detectable warning surface which includes truncated domes.

**Full Rec:** Replace the curb ramp with a compliant curb ramp at least 48 inches in width that provides a slope no greater than 8.33%. Install a detectable warning surface which extends the full length and width of the concrete curb ramp and its side flares with truncated domes that contrast visually by either light on dark or dark on light which is an integral part of the concrete curb ramp. The truncated domes may be cast in place or stamped or of a prefabricated surface treatment (see CBC 1127B.5.8).

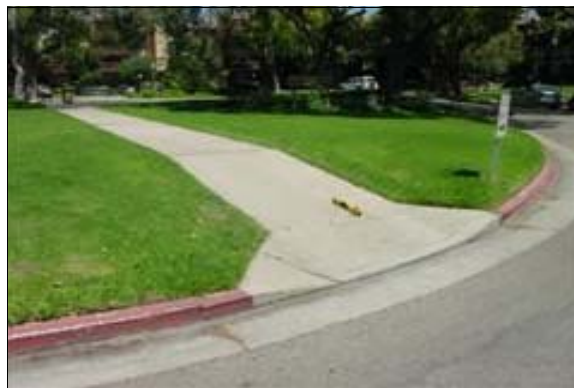
**Curb Ramp (South)**

**Finding:** The slope of the curb ramp is greater than 8.33%. The transition at the bottom landing is abrupt. The curb ramp does not provide a grooved border along the top and sides of the ramp at the level of the sidewalk. The concrete curb ramp does not provide a detectable warning surface which includes truncated domes.

**Full Rec:** Replace the curb ramp with a compliant curb ramp at least 48 inches in width that provides a slope no greater than 8.33%. Install a detectable warning surface which extends the full length and width of the concrete curb ramp and its side flares with truncated domes that contrast visually by either light on dark or dark on light which is an integral part of the concrete curb ramp. The truncated domes may be cast in place or stamped or of a prefabricated surface treatment (see CBC 1127B.5.8).

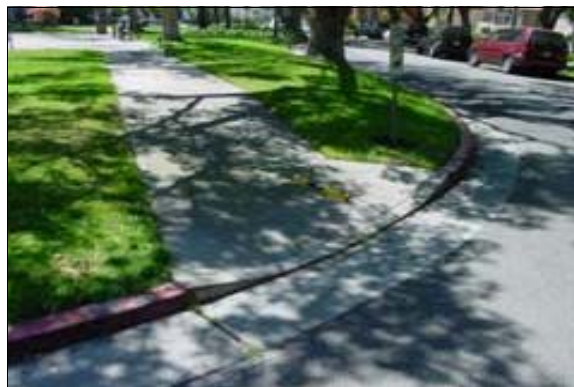
**Curb Ramp (West)**

**Finding:** The slope of the curb ramp is greater than 8.33%. The slope at the top landing is greater than 2%. The slope of the side flares is greater than 10%. The curb ramp does not provide a grooved border along the top and sides of the ramp at the level of the sidewalk. The concrete curb ramp does not provide a detectable warning surface which includes truncated domes.

**Full Rec:** Replace the curb ramp with a compliant curb ramp at least 48 inches in width that provides a slope no greater than 8.33%. Install a detectable warning surface which extends the full length and width of the concrete curb ramp and its side flares with truncated domes that contrast visually by either light on dark or dark on light which is an integral part of the concrete curb ramp. The truncated domes may be cast in place or stamped or of a prefabricated surface treatment (see CBC 1127B.5.8).

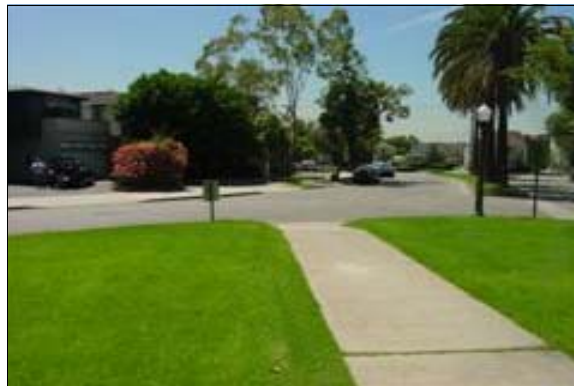
**Accessible Route from the Public Right of Way**

**Finding:** There is an accessible route from the public right of way to the accessible entrance of the facility.

**Full Rec:** Post directional signage. Make certain to post signage indicating the direction to accessible building entrances at every major junction along the accessible route. Signs shall include the International Symbol of Accessibility.

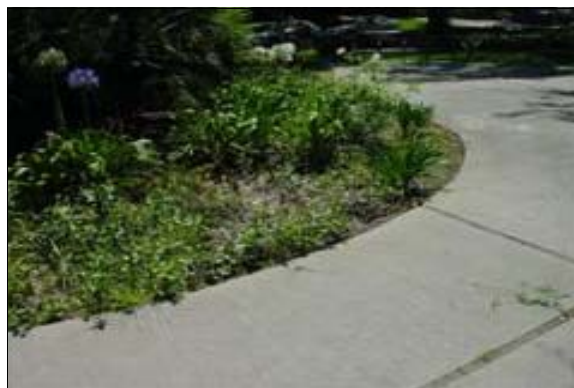
**Open Tree Well**

**Finding:** There is an open tree well along the path of travel with a change in elevation greater than 1/2 inch, creating a tripping hazard.

**Full Rec:** Install edge protection on each side of the open tree well consisting of 3-inch high guide curb above the surface of the path of travel (see CBC 1133B.7.1 and ADAAG 4.3.8).

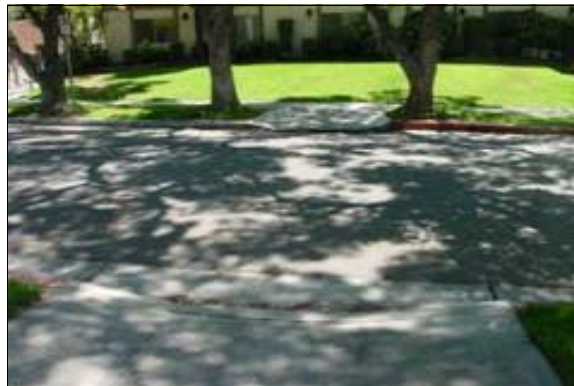
***Path of Travel to the Park***

**Finding:** There is no crosswalk provided on the path of travel to the (east) curb ramp. The required accessible route crosses a vehicular way.

**Full Rec:** Stripe a crosswalk not less than 48 inches wide on the path of travel to the accessible entrance of the park. Provide a level surface that does not exceed a slope greater than 5%. Cross slopes shall not exceed 2%. Detectable warnings should be placed at the entrance and exit of the crosswalk.

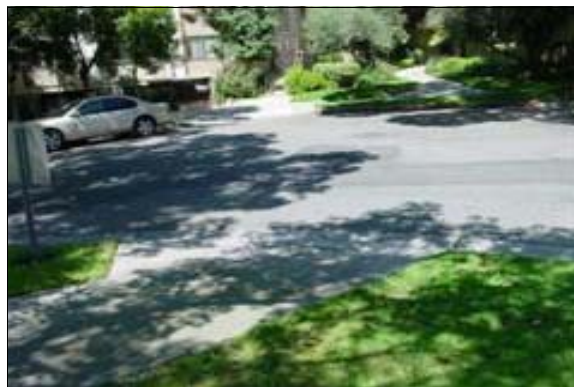
***Path of Travel to the Park***

**Finding:** There is no crosswalk provided on the path of travel to the (west) curb ramp. The required accessible route crosses a vehicular way.

**Full Rec:** Stripe a crosswalk not less than 48 inches wide on the path of travel to the accessible entrance of the facility. Provide a level surface that does not exceed a slope greater than 5%. Cross slopes shall not exceed 2%. Detectable warnings should be placed at the entrance and exit of the crosswalk.

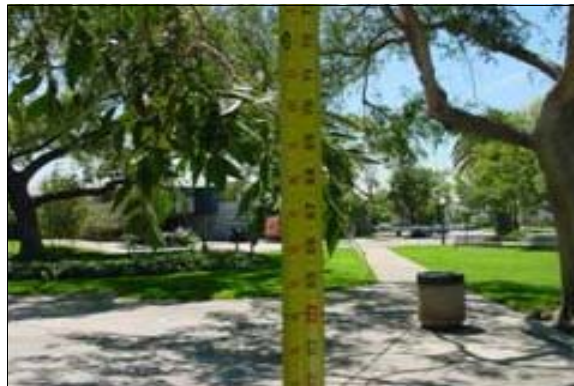
#### ***Protruding Object***

**Finding:** At the time of inspection, vegetation encroached into the primary path of travel, obstructing passage by reducing the vertical clearance to less than 80 inches along the accessible route.

**Full Rec:** Maintain grass or landscaping adjacent to primary path of travel walkways to eliminate any encroachment into the accessible route.
