Photo Report
Scholl Canyon Golf and Tennis
Programs, Services, and Activities

Finding: Scholl Canyon Golf and Tennis, located at 3800 East Glenoaks Boulevard in Glendale California, was inspected by Disability Access Consultants, Inc., on June 20, 2007.

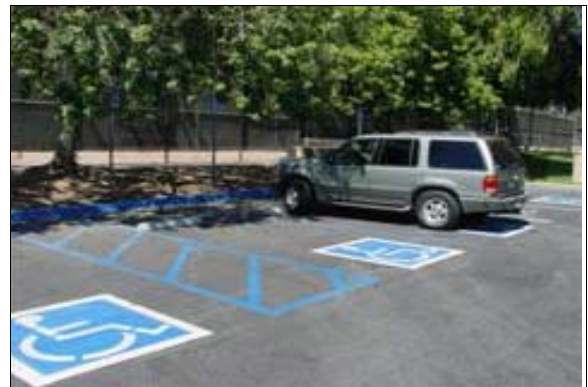
Finding: There are five accessible parking spaces out of 162 parking spaces which does not meet the minimum number of accessible parking spaces for compliance.

Full Rec: Six out of the 162 total number of parking spaces are required to be designated exclusively for accessible parking, as required by ADAAG and CBC 1129B.

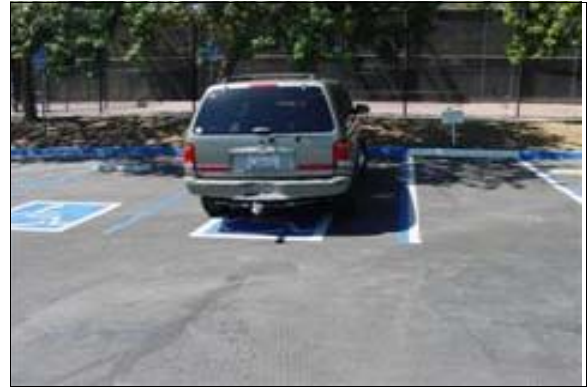
Finding: Parking Continued: Four of the designated accessible parking spaces provided in the parking lot measure at least 108 inches wide and at least 216 inches long. One of the designated accessible parking spaces measures less than 108 inches wide and at least 216 inches long. The designated "van-accessible" parking space provides an access aisle, located on the passenger side (right side) of the parking space, measuring at least 96 inches wide. Two of the standard accessible parking spaces provide an adjacent access aisle measuring 60 inches wide. One of the standard accessible parking spaces provides an adjacent access aisle measuring less than 60 inches wide. There is no access aisle provided adjacent to one of the accessible parking spaces. The access aisles do not contain "NO PARKING" in 12" high white letters.

Full Rec: Restripe the existing parking spaces marked accessible and create one additional accessible parking space, each measuring at least 108 inches wide and 216 inches long. The van-accessible space shall provide an access aisle measuring at least 96 inches wide (8 feet) on the passenger side (right side) of the vehicle space (see CBC 1129B). The additional parking spaces shall each provide an access aisle measuring at least 60 inches wide, that may be shared. Add the words NO PARKING in 12 inch high white letters at the entrance to each accessible parking access aisle.

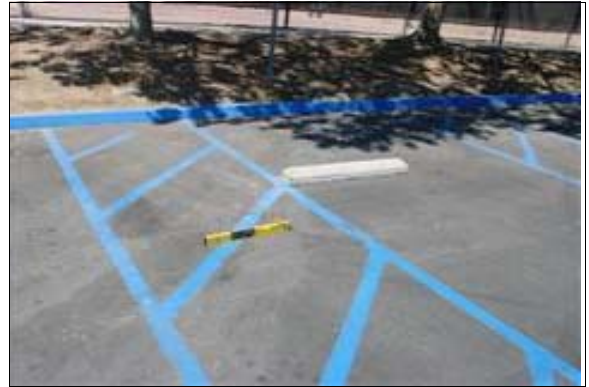
Finding: The surface of the accessible parking spaces in the parking lot has a slope greater than 2%.

Full Rec: Pave the parking lot at the accessible spaces to provide a level surface. Parking surfaces and access aisles shall be located in areas not exceeding 2% slope in all directions (see CBC 1129B and ADAAG 4.6.3).

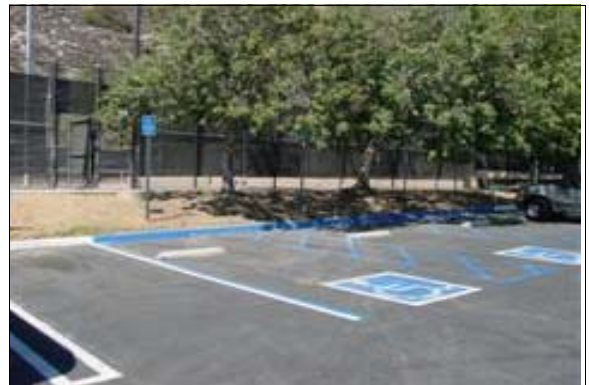
Finding: The location of the accessible parking spaces requires individuals with disabilities to travel behind parked cars other than their own. There is an access aisle provided at the head of the accessible parking spaces, however the head aisle is not striped.

Full Rec: Stripe a 48-inch access aisle at the head of the accessible parking spaces.

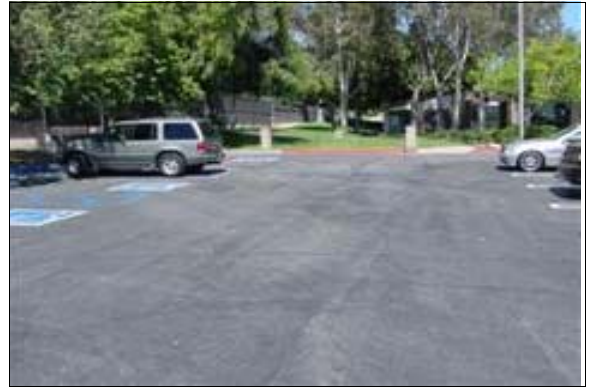
Finding: There is no crosswalk provided on the path of travel from the accessible parking spaces to the facility. The required accessible route crosses a vehicular way.

Full Rec: Stripe a crosswalk not less than 48 inches wide on the path of travel to the accessible entrance. Provide a level surface that does not exceed a slope greater than 5%. Cross slopes shall not exceed 2%. Detectable warnings should be placed at the entrance and exit of the crosswalk.

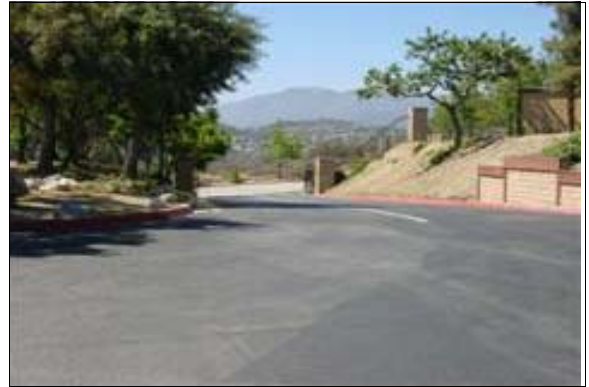
Accessible Route from the Public Right of Way

Finding: There is no crosswalk provided on the path of travel from the public right of way to the facility. The required accessible route crosses a vehicular way.

Full Rec: Stripe a crosswalk not less than 48 inches wide on the path of travel to the accessible entrance of the facility. Provide a level surface that does not exceed a slope greater than 5%. Cross slopes shall not exceed 2%. Detectable warnings should be placed at the entrance and exit of the crosswalk.

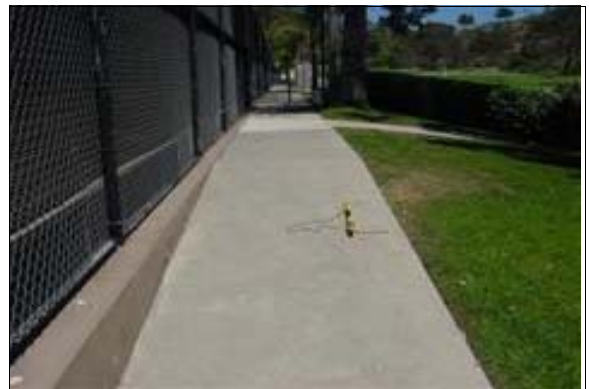
Path of Travel to Tennis Courts 7 thru 10

Finding: There are slopes greater than 5% on the primary path of travel from tennis courts 1 thru 6 to tennis courts 7 thru 10.

Full Rec: Resurface the path of travel to provide a level surface that does not exceed a slope greater than 5%. Cross slopes shall not exceed 2%.

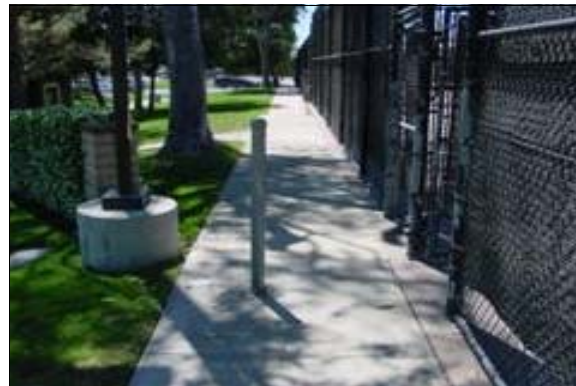
Path of Travel to Tennis Courts 8, 9, and 10

Finding: The concrete walkway serves as a primary path of travel. The width of the concrete walkway is less than 48 inches in width, due to a post in the path of travel.

Full Rec: Remove the post to provide at least 48 inches in width along the path of travel. Otherwise, modify the exterior primary path of travel by extending the width of the concrete walkway to at least 48 inches (see CBC 1118B.2 and ADAAG 4.3.3). Since the accessible route is less than 60 inches in width, provide passing spaces at least 60 inches by 60 inches at reasonable intervals every 200 feet.

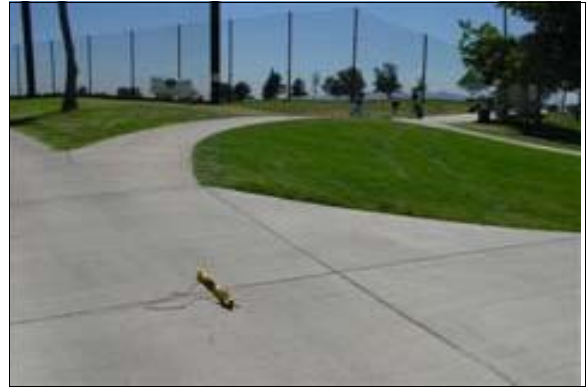
Path of Travel to the Driving Range

Finding: There are slopes greater than 5% on the primary path of travel from the Club House and Café to the driving range.

Full Rec: Resurface the path of travel to provide a level surface that does not exceed a slope greater than 5%. Cross slopes shall not exceed 2%.

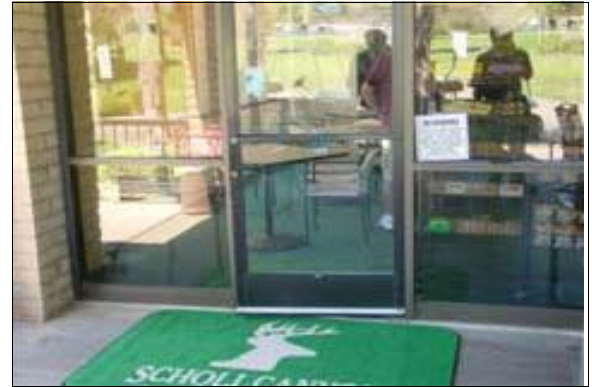
Path of Travel to the Scholl Canyon Café

Finding: The mat at the entrance does not adhere to the underlying floor surface and creates a hazardous path of travel.

Full Rec: Securely fasten the mats or replace with a mat that grips to the underlying floor surface to provide a firm, stable, continuous and relatively smooth path of travel surface (see CBC 1124B.3 and ADAAG 4.5.3). Mats along the primary path of travel shall provide beveled edges on all sides to prevent roll over.

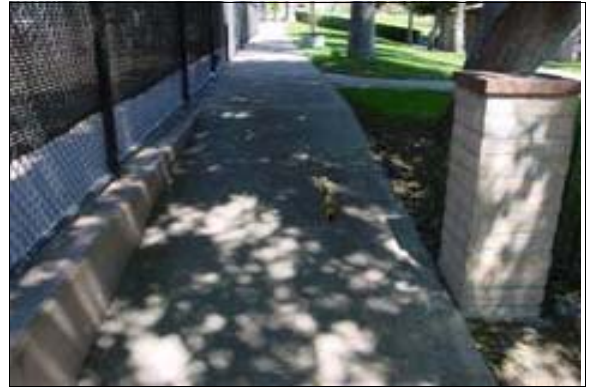
Path of Travel to the Tennis Courts 1 thru 4

Finding: There are slopes greater than 5% on the primary path of travel to tennis courts 1 thru 4.

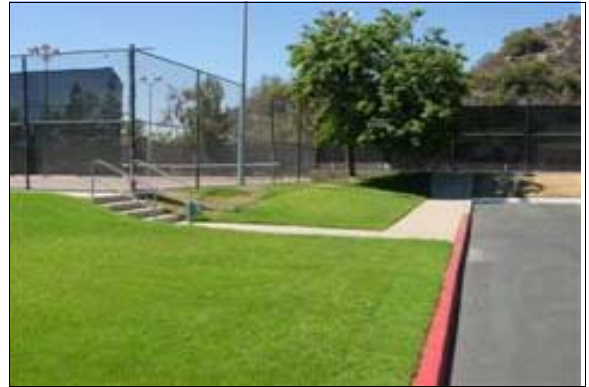
Exterior Stairs to the Tennis Courts

Finding: The handrails do not provide 12-inch extensions beyond the top and bottom treads.

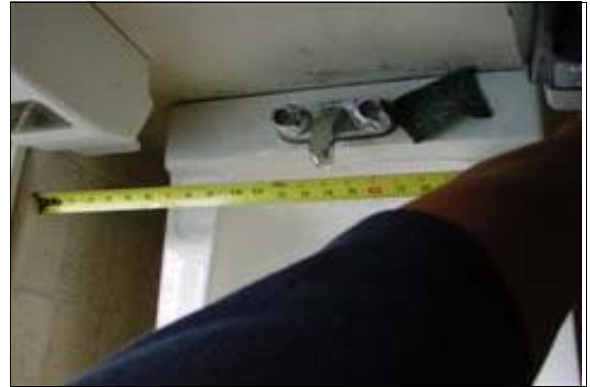
Unisex Restroom at the Maintenance Building

Finding: The distance from the center of the lavatory to the adjacent side wall in the restroom is less than 18 inches.

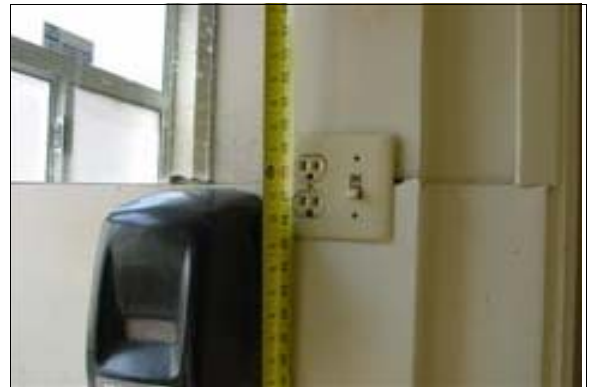
Unisex Restroom at the Maintenance Building

Finding: The bottom edge of the reflecting surface of the mirror in the restroom is greater than 40 inches above the finished floor.

Full Rec: Lower the mirror in the restroom so that the bottom edge of the reflecting surface is no higher than 40 inches above the finished floor and the topmost portion of the reflecting surface extends at least 74 inches above the finished floor (see ADAAG A4.19.6). A single, full-length mirror is recommended since it can accommodate all people. Make certain to provide a minimum clear floor space in front of the mirror of 30 inches in width and 48 inches in length.

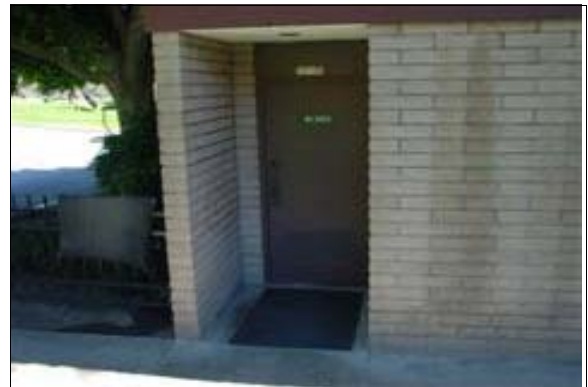
Women's Restroom at the Clubhouse

Finding: The mat at the entrance does not adhere to the underlying floor surface and creates a hazardous path of travel.

Full Rec: Securely fasten the mats or replace with a mat that grips to the underlying floor surface to provide a firm, stable, continuous and relatively smooth path of travel surface (see CBC 1124B.3 and ADAAG 4.5.3). Mats along the primary path of travel shall provide beveled edges on all sides to prevent roll over.

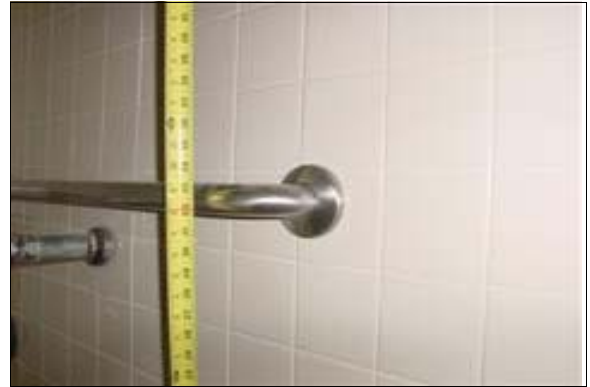
Women's Restroom at the Clubhouse

Finding: The height of the back grab bar in the stall designated to be accessible of the restroom is less than 33 inches above the finished floor.

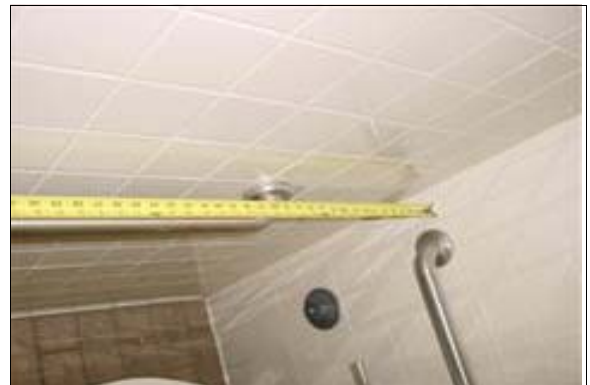
Women's Restroom at the Clubhouse

Finding: The distance from the end of the side grab bar to the back wall in the stall designated to be accessible in the restroom is greater than 12 inches.
