Photo Report
Sparr Heights Senior Center Community Building
Programs, Services, and Activities

Finding: The Sparr Heights Senior Center Community Building, located at 1613 Glencoe Way in Glendale California, consists of one single story structure built in July 2004. The facility was inspected by Disability Access Consultants, Inc., on June 7, 2007.

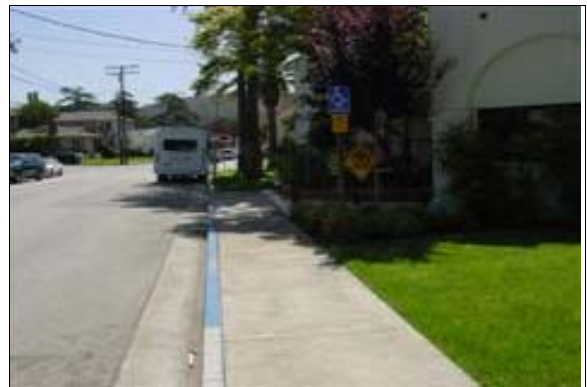
Finding: There is one parallel parking space designated accessible on Paloma Avenue. There is signage designating the parallel parking spaces as accessible.

Full Rec: Discontinue designating parallel parking spaces as accessible. Parallel parking spaces do not meet the requirements set forth by ADAAG regarding access aisle and encroachment of other vehicles or objects and requires individuals to travel behind vehicles other than their own in some situations. If no other off-street parking is available, make certain that the facility provides an accessible passenger loading zone located on the shortest route to the primary entrance.

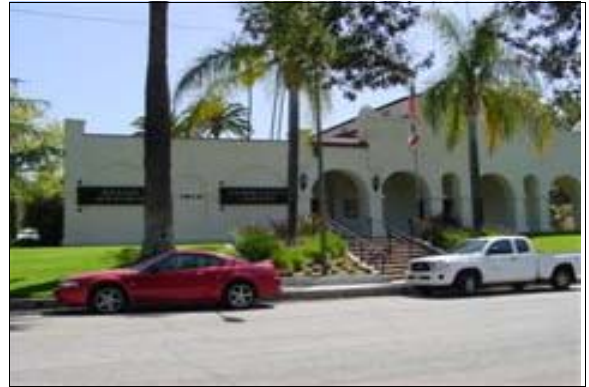
Accessible Route from the Public Right of Way

Finding: There is no accessible route from the public right of way to the accessible entrance of the facility.

Alternative Rec: Post directional signage.

Full Rec: Provide at least one accessible route from the public right of way to the accessible entrance of the facility. Make certain to post signage indicating the direction to accessible building entrances at every major junction along the accessible route. Signs shall include the International Symbol of Accessibility.

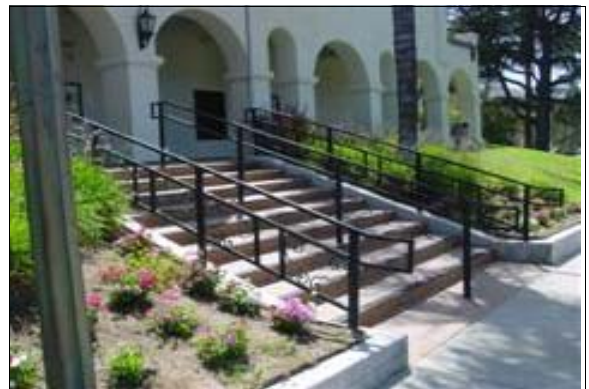
Path of Travel to the Main Entrance

Finding: There are only stairs on the path of travel to the primary entrance, preventing access to individuals with mobility impairments. There is no signage posted directing individuals with disabilities to the accessible entrance.

Alternative Rec: Post signage at the nonaccessible primary entrance directing individuals to the accessible entrance (see CBC 1103.2.4.2, ADAAG 4.1.2(7), ADAAG 4.1.3(8)(d), ADAAG 4.1.3(16) and ADAAG 4.30).

Full Rec: At least one accessible entrance shall serve as primary entrance to the facility and shall be located on the ground level (CBC 1114B.1.2, ADAAG 4.1.2(7), ADAAG 4.1.3(8)(d), ADAAG 4.1.3(16) and ADAAG 4.30). Install a ramp or other means of vertical access at the LOCATION, if technically feasible. Post signage or directional signage complying with CBC and ADAAG guidelines.

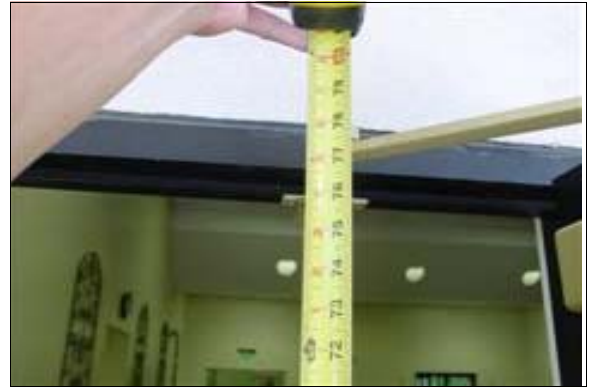
Protruding Object

Finding: The door closing device limits the vertical headroom clearance to less than 80 inches in height and protrudes into the primary path of travel.

Full Rec: Replace the door closing device with a device that fits above the door casing and does not protrude into the primary path of travel.

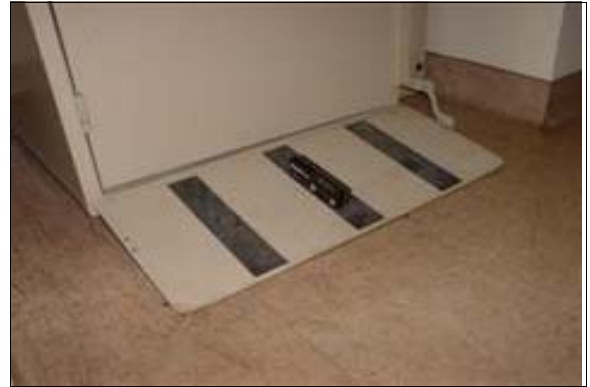
Platform Lift to the Stage in the Verdugo Room

Finding: There is no level landing provided at the entrance to the platform lift.

Full Rec: Provide a level and clear landing at least 60 inches in length in the direction of the door swing.

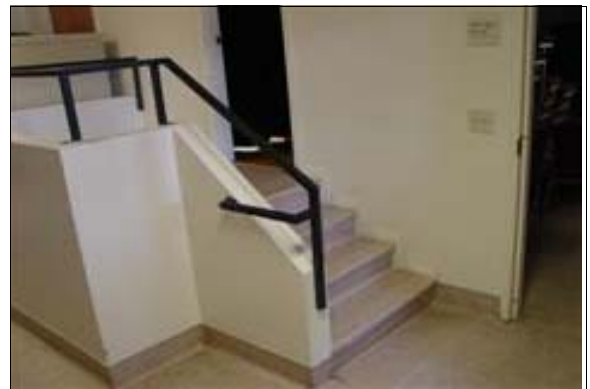
Interior Stairs to the Stage in the Verdugo Room

Finding: There is no detectable striping on the top and bottom treads of the interior stairway.

Full Rec: Affix detectable contrasting striping to the top and bottom treads of the stairway that clearly contrasts in color from the tread and is at least 2 inches in width placed no more than 1 inch from the tread nose or landing.

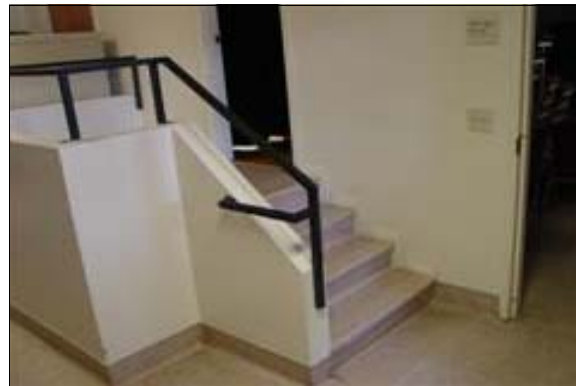
Interior Stairs to the Stage in the Verdugo Room

Finding: There is only one handrail on the stairway. The handrail does not provide 12-inch extensions beyond the top and bottom treads.

Full Rec: Install handrails on each side of stairway that provide a gripping surface between 1 1/4 to 1 7/8 inches with 12-inch top and bottom handrail extensions that extend beyond the top and bottom treads of the stairway which are parallel to the ground surface and return smoothly to the post or wall. Handrails shall be mounted at a height between 34 and 38 inches at a distance no less than 1 1/2 inches from the adjacent wall.

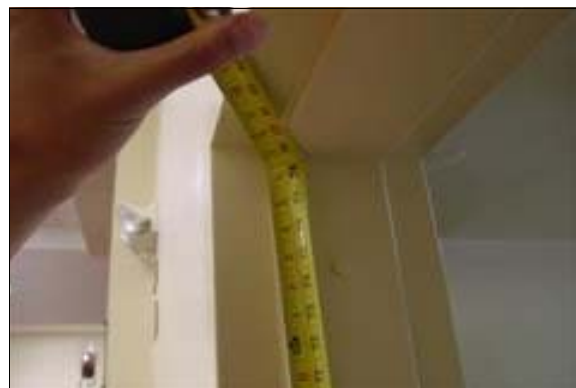
Interior Door to the Stage in the Verdugo Room

Finding: The vertical clearance height of the entrance door provides less than 80 inches.

Full Rec: Consult a design professional to determine the feasibility of extending the height of the doorway to provide at least 80 inches clearance height (see CBC 1133B.2.3.1 and ADAAG 4.4.2).

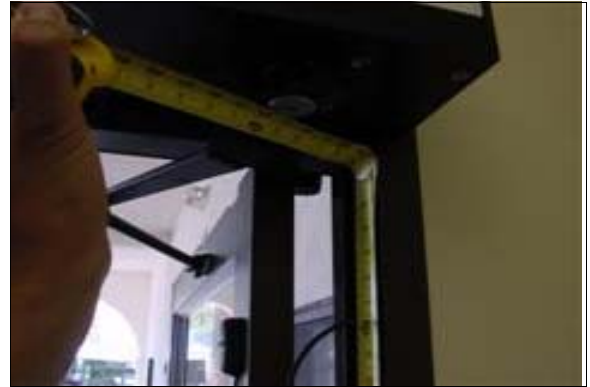
Main Entrance

Finding: The vertical clearance height of the entrance door provides less than 80 inches.

Full Rec: Consult a design professional to determine the feasibility of extending the height of the doorway to provide at least 80 inches clearance height (see CBC 1133B.2.3.1 and ADAAG 4.4.2).

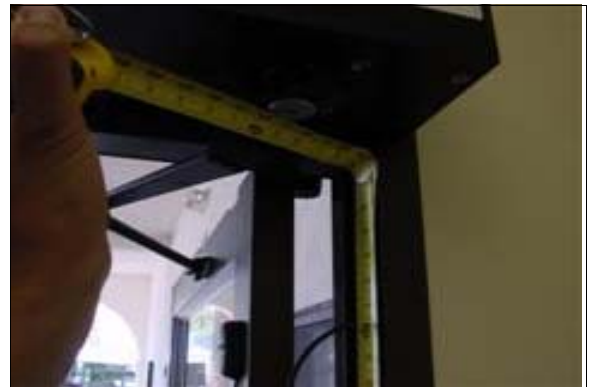
Rear Entrance

Finding: The vertical clearance height of the entrance door provides less than 80 inches.

Full Rec: Consult a design professional to determine the feasibility of extending the height of the doorway to provide at least 80 inches clearance height (see CBC 1133B.2.3.1 and ADAAG 4.4.2).

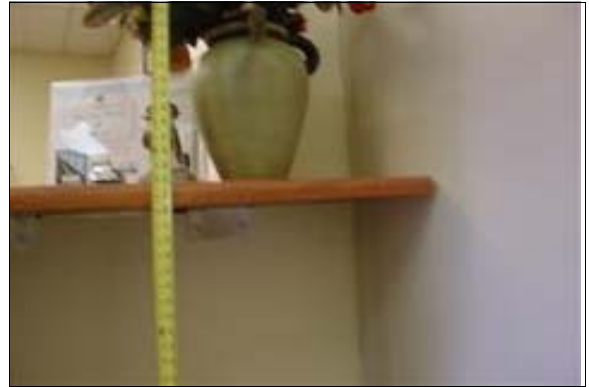
Finding: The height of the main office reception counter is greater than 34 inches.

Full Rec: Lower at least a 36 inch wide portion of the reception counter to a maximum height between 28 and 34 inches (see CBC 1122B.4).

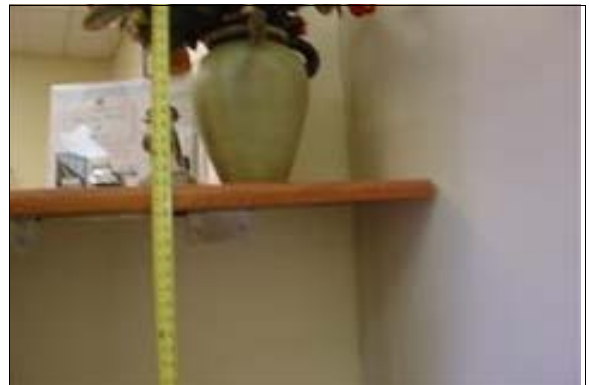
Finding: The facility does not provide accessible signage at the reception counter that indicates there is assistance provided upon request.

Full Rec: Provide signage at the reception counter that states: "Assistance Is Available, Please Contact an Employee." The sign should contain the International Symbol of Accessibility.

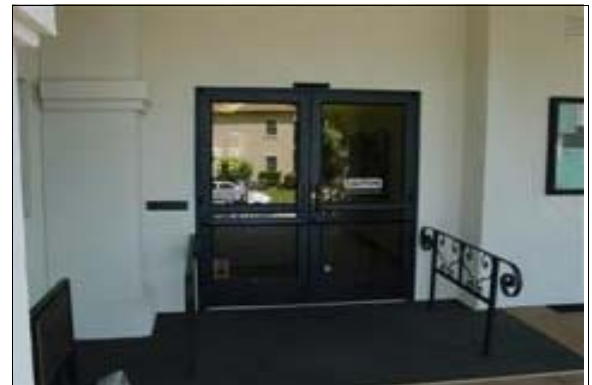
Main Entrance

Finding: The main entrance does not have accessible signage mounted on the wall adjacent to the latch side of the door.

Full Rec: Install signage centered at 60 inches above the finished floor on the wall adjacent to the latch side of the entry doorway stating ENTRANCE from the outside and EXIT from the inside, with raised UPPERCASE letters between 5/8 inch and 2 inches in height and Grade 2 Braille characters. The sign shall comply with the finish and contrast requirements set forth in CBC 1117B.5 and ADAAG 4.30.5. Signage should be located where a person may approach within three inches of the sign without encountering protruding objects or standing within the swing of the door.

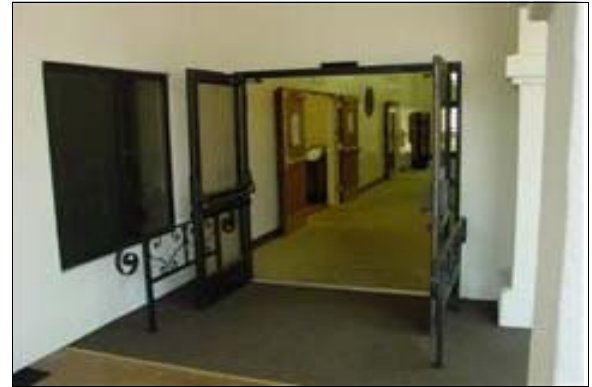
Rear Entrance

Finding: There is no signage with the International Symbol of Accessibility on the entrance door to the facility designating it as accessible.

Full Rec: The International Symbol of Accessibility shall be the standard used to identify facilities that are accessible to and usable by physically disabled persons (see CBC 1117B.5.1). All building entrances that are accessible to and usable by persons with disabilities shall be identified with an ISA symbol (see CBC 1117B.5.7).

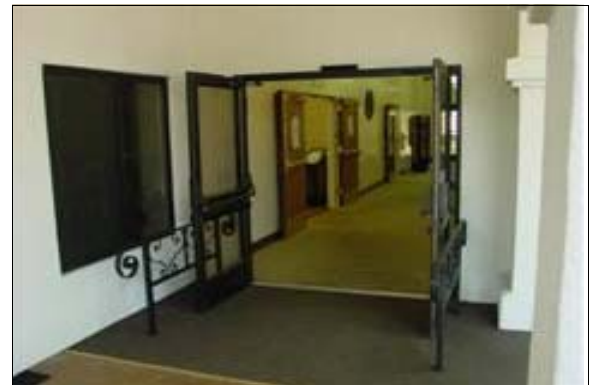
Rear Entrance

Finding: The entrance door does not have accessible signage mounted on the wall adjacent to the latch side of the door.

Full Rec: Install signage centered at 60 inches above the finished floor on the wall adjacent to the latch side of the entry doorway stating ENTRANCE from the outside and EXIT from the inside, with raised UPPERCASE letters between 5/8 inch and 2 inches in height and Grade 2 Braille characters. The sign shall comply with the finish and contrast requirements set forth in CBC 1117B.5 and ADAAG 4.30.5. Signage should be located where a person may approach within three inches of the sign without encountering protruding objects or standing within the swing of the door.

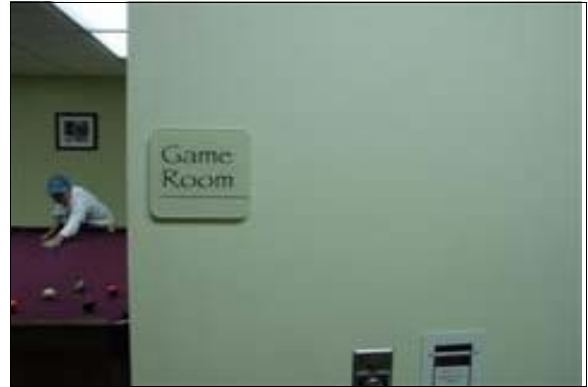
Room Signage

Finding: Rooms have signage attached to the wall adjacent to the latch side of the doors, though the signage does not include Braille characters, raised lettering, and is not centered at 60 inches above the floor surface.

Full Rec: Install accessible signage identifying each room on the wall adjacent to the latch side of the doorway centered at 60 inches above the finished floor. Signage should be located where a person may approach within three inches of the sign without encountering protruding objects or standing within the swing of the door. Signs shall include raised UPPERCASE letters/numbers between 5/8 inch and 2 inches in height and Grade 2 Braille characters. Color and finish shall comply with CBC 1117B.5 and ADAAG 4.30.

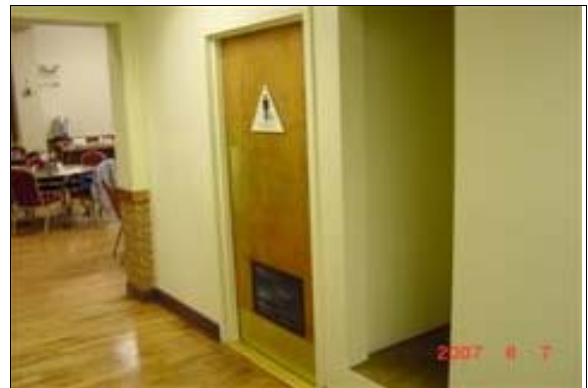
Men's Restroom

Finding: There is no signage indicating accessibility on the latch side of the entry door of the restroom. The gender use signage on the entrance door does not comply with Title 24.

Full Rec: The restroom is designated accessible and should be made accessible for the facility. Post signage centered 60 inches above the ground surface on the latch side of the entrance door identifying the restroom as accessible upon completion of the following items (see CBC 1115B., ADAAG 4.1.2(7) and ADAAG 4.1.6(3)(e). Signage shall include Braille and raised lettering, the gender or unisex use symbol and the ISA symbol. Post Title 24 gender use signage on the door @ 60" o.c. a.f.f.

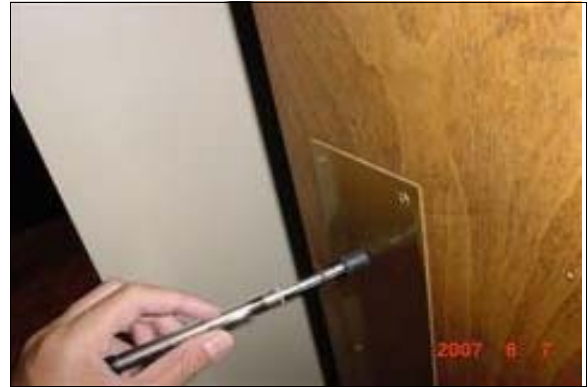
Men's Restroom

Finding: The door opening force for the interior door is greater than 5 pounds of force.

Full Rec: Adjust the closers on all interior doors to a maximum door opening force of 5 pounds of force (see ADAAG 4.13.11 & CBC 1133B.2.5).

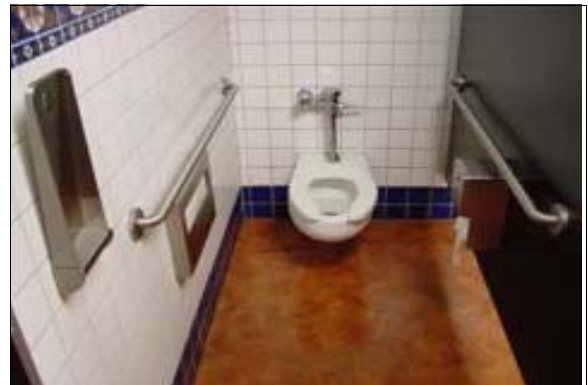
Men's Restroom

Finding: There is insufficient clear floor space in the stall designated to be accessible in the restroom. The door to the stall designated to be accessible in the restroom does not close automatically.

Full Rec: Modify or replace the stall designated to be accessible in the restroom so that it complies with ADAAG 4.17.3, CBC 1115B and CBC Figures 11B-1A and 1B. Standard accessible stalls require 60 inches in width with 56 inches depth for wall-mounted toilets or 59 inches depth for floor-mounted toilets to accommodate individuals in wheelchairs. The minimum width of a front-approach doorway shall provide at least 32 inches and a side-approach doorway shall provide at least 34 inches. The door shall swing outward, close automatically and provide accessible hardware.

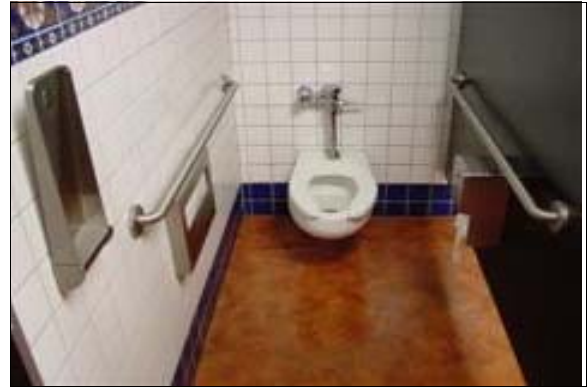
Men's Restroom

Finding: There is no back grab bar in the stall designated to be accessible in the restroom.

Full Rec: Install a 36-inch back grab bar at a height of 33 inches above the finished floor in the stall designated to be accessible of the restroom. Grab bars must be able to support a point load of at least 250 pounds and shall be less than the allowable shear stress of the grab bar material.

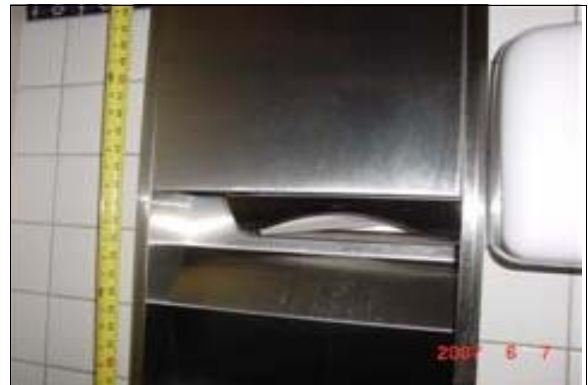
Men's Restroom

Finding: The height of the controls and operating mechanisms for the paper towel dispenser in the restroom is greater than 40 inches.

Full Rec: Relocate the paper towel dispenser in the restroom to a maximum height of 40 inches for all the controls and operating mechanisms (see CBC 1115B.9.2).

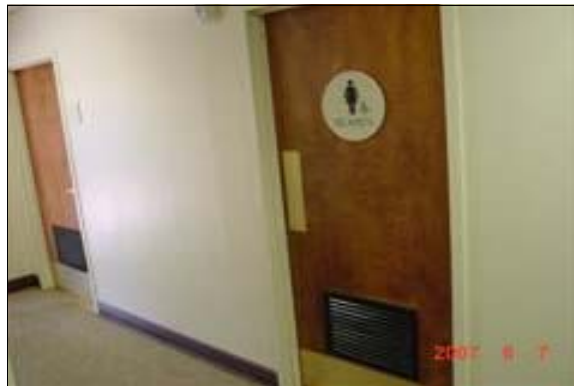
Women's Restroom

Finding: There is no signage indicating accessibility on the latch side of the entry door of the restroom. The gender use signage on the entrance door does not comply with Title 24.

Full Rec: The restroom is designated accessible and should be made accessible for the facility. Post signage centered 60 inches above the ground surface on the latch side of the entrance door identifying the restroom as accessible upon completion of the following items (see CBC 1115B., ADAAG 4.1.2(7) and ADAAG 4.1.6(3)(e). Signage shall include Braille and raised lettering, the gender or unisex use symbol and the ISA symbol. Post Title 24 gender use signage on the door @ 60" o.c. a.f.f.

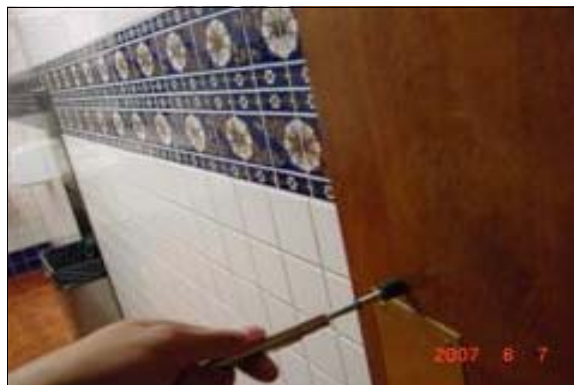
Women's Restroom

Finding: The door opening force for the interior door is greater than 5 pounds of force.

Full Rec: Adjust the closers on all interior doors to a maximum door opening force of 5 pounds of force (see ADAAG 4.13.11 & CBC 1133B.2.5).

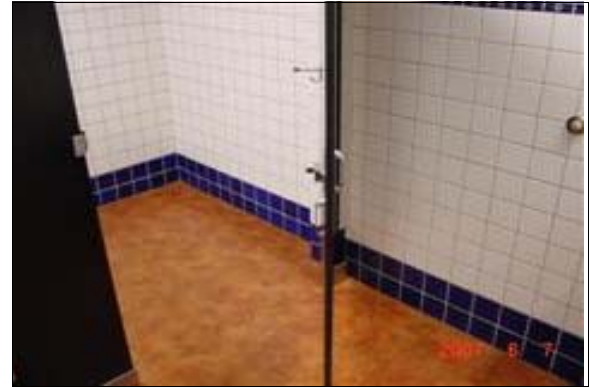
Women's Restroom

Finding: The distance from the center of the toilet to the nearest side wall in the stall designated to be accessible in the restroom is greater than 18 inches.

Full Rec: Relocate the toilet or stall side wall so that the distance from the centerline of the toilet to the nearest side wall in the stall designated to be accessible in the restroom is exactly 18 inches (see ADAAG Figure 28).

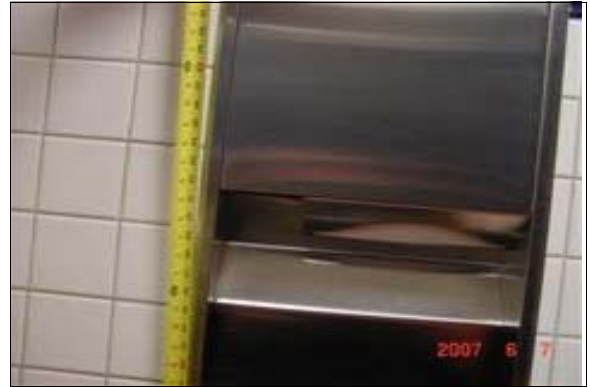
Women's Restroom

Finding: The height of the controls and operating mechanisms for the paper towel dispenser in the restroom is greater than 40 inches.

Full Rec: Relocate the paper towel dispenser in the restroom to a maximum height of 40 inches for all the controls and operating mechanisms (see CBC 1115B.9.2).

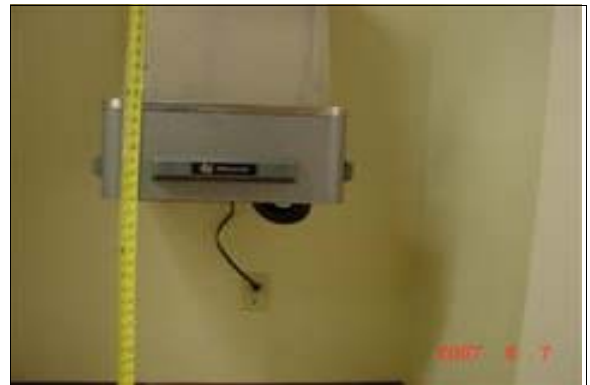
Finding: There are two drinking fountains on primary paths of travel.

Full Rec: Fifty percent of the drinking fountains on primary paths of travel shall be accessible (see CBC 1117B.1 and ADAAG 4.15). Install a "high-low" fountain design to comply with both state and federal requirement. Fountains not located in alcoves need side rails or wing walls on both sides.

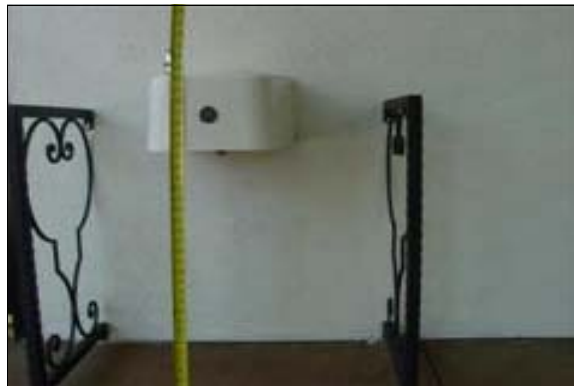
Drinking Fountain at the Rear Entrance

Finding: The drinking fountain is not a "high-low" design. The spout outlet height is greater than 36 inches.

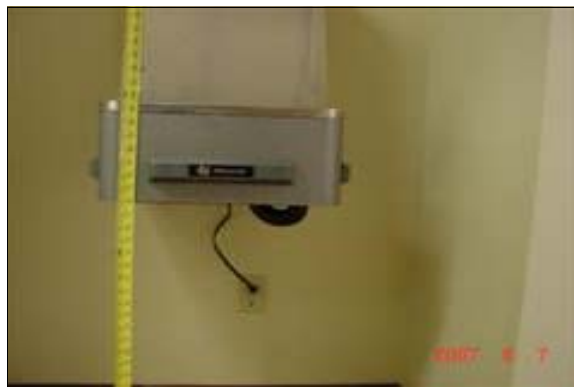
Drinking Fountain Next to the Restrooms

Finding: The drinking fountain is not a "high-low" design. The spout outlet height is greater than 36 inches.

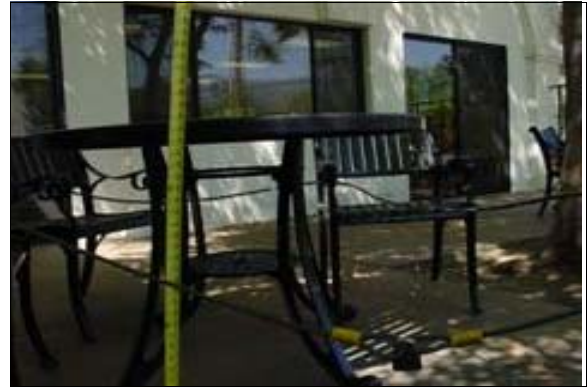
Outdoor Dining Area

Finding: The knee space at the tables in the outdoor dining area is less than 19 inches deep.

Full Rec: Modify or replace one of the tables in the outdoor dining area to provide knee clearance of at least 27 inches in height, 30 inches in width and 19 inches in depth (see CBC 1122B.3, ADAAG 4.32.2 and ADAAG Figure 45). The table top height shall not exceed 34 inches above the finished floor.
