Photo Report
Sports Complex
Programs, Services, and Activities

Finding: The Sports Complex, located at 2200 Fern Lane in Glendale California, was inspected by Disability Access Consultants, Inc., on June 7, 2007. Facilities include the Sports Complex Operations Office and the Maintenance Building.

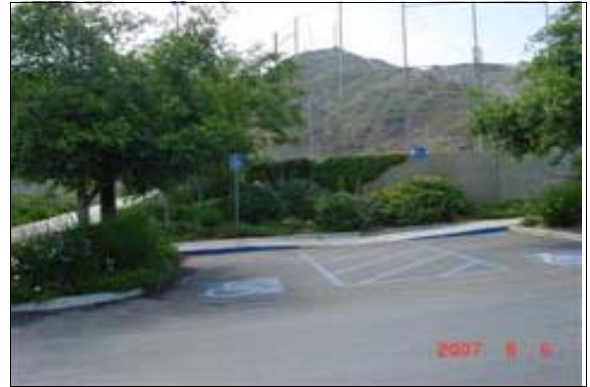
Finding: Two of the designated accessible parking spaces provided in the parking lot measure 108 inches wide and 216 inches long. Three of the designated accessible parking spaces measure less than 108 inches wide and at least 216 inches long. Three of the designated accessible parking spaces measure less than 108 inches wide and less than 216 inches long. The van-accessible parking spaces provide an access aisle, located on the passenger side (right side) of the parking space, measuring at least 96 inches wide. Three of the standard accessible parking spaces provide an adjacent access aisle measuring at least 60 inches wide. Two of the standard accessible parking spaces provide an adjacent access aisle measuring less than 60 inches wide. The access aisles do not contain "NO PARKING" in 12" high white letters.

Full Rec: Restripe the designated accessible parking spaces to create one van-accessible and seven standard accessible parking spaces, each measuring at least 108 inches wide and 216 inches long. Designate one parking space as "van-accessible". The van-accessible space shall provide an access aisle measuring at least 96 inches wide (8 feet) on the passenger side (right side) of the vehicle space (see CBC 1129B). The additional parking spaces shall each provide an access aisle measuring at least 60 inches wide, that may be shared. Add the words NO PARKING in 12 inch high white letters at the entrance to each accessible parking access aisle.

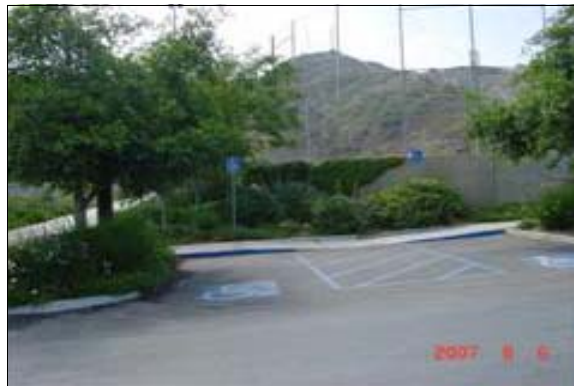
Finding: There is no vertically-mounted signage at two of the designated accessible parking spaces in the parking lot showing the International Symbol of Accessibility. There is no additional signage marked "van-accessible" at the van-accessible parking spaces. There is signage designating one of the standard accessible parking spaces as "van-accessible".

Full Rec: Install a permanently posted reflectorized sign measuring 70 square inches that includes an ISA symbol adjacent to and visible from the accessible parking space (see CBC 1129B.5). The bottom edge of the sign must be mounted 80 inches from the ground surface so that it cannot be obscured by a parked vehicle (see CBC 1129B.5). The "van-accessible" parking space shall provide an additional sign marked "van-accessible" mounted below the sign (see CBC 1129B.5 and ADAAG 4.6.4).

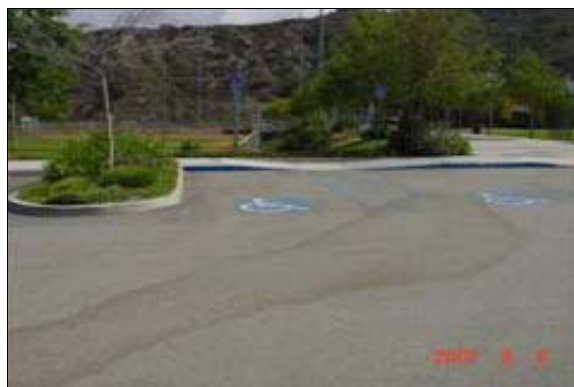
Finding: Five of the designated accessible parking spaces in the parking lot are not outlined on both sides.

Full Rec: Each designated accessible parking space shall be identified with a pavement marking consisting of outlining the accessible space in blue and outlining an ISA symbol in white; or outlining a 36 inch by 36 inch white on blue ISA symbol positioned where it can be viewed when a vehicle is parked in the space.

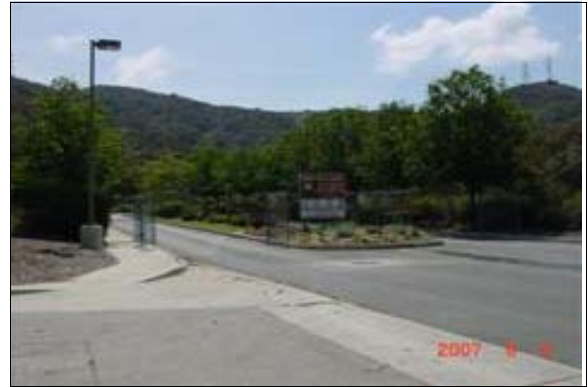
Finding: There is no warning signage posted at the entrance to the parking lot regarding unauthorized use of accessible parking spaces in the parking lot.

Full Rec: Post a sign in a conspicuous place to the entrance of the parking lot, or immediately adjacent to and visible from each accessible parking space. The warning sign shall measure at least 17 inches by 22 inches in size and consist of lettering at least 1 inch in height that clearly and conspicuously states the following; "Unauthorized vehicles parked in designated accessible spaces not displaying distinguishing placards or license plates issued for persons with disabilities may be towed away at owner's expense. Towed vehicles may be reclaimed at ____ or by telephoning ____ ." Fill in the blank spaces with appropriate information as a permanent part of the sign and maintain the currency of the information (see CBC 1129B.5). Be sure to add the CVC 22511.8(a)(d) to the sign.

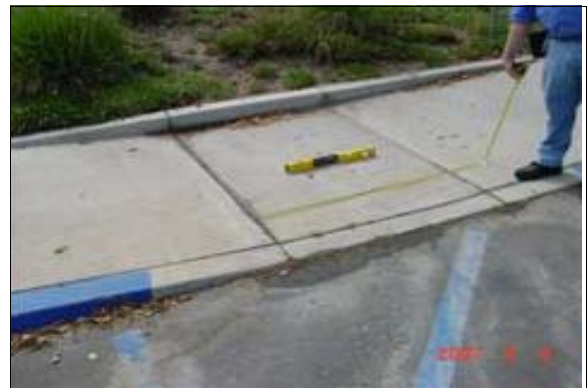
Curb Ramp at the Accessible Parking Spaces Next to the Baseball Field (Left)

Finding: The cross slope of the right side of the concrete sidewalk curb ramp is greater than 2%. The slope at the right top landing is greater than 2%. The concrete curb ramp does not provide a detectable warning surface which includes truncated domes.

Full Rec: Replace the curb ramp with a compliant curb ramp at least 48 inches in width that provides a slope no greater than 8.33%. Install a detectable warning surface which extends the full length and width of the concrete curb ramp and its side flares with truncated domes that contrast visually by either light on dark or dark on light which is an integral part of the concrete curb ramp. The truncated domes may be cast in place or stamped or of a prefabricated surface treatment (see CBC 1127B.5.8).

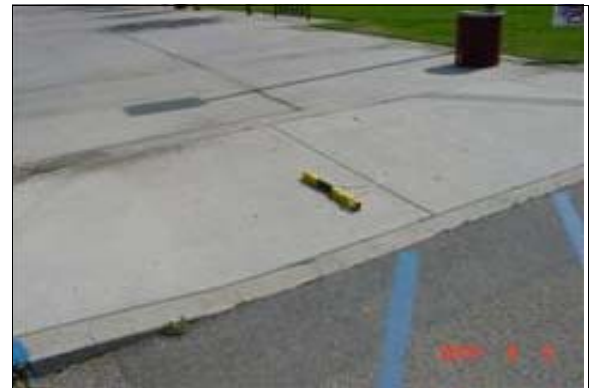
Curb Ramp at the Accessible Parking Spaces Outside of the Office (Right)

Finding: The slope of the curb ramp is greater than 8.33%. The slope at the bottom landing is greater than 2%. The slope of the side flares is greater than 10%. The concrete curb ramp does not provide a detectable warning surface which includes truncated domes.

Full Rec: Replace the curb ramp with a compliant curb ramp at least 48 inches in width that provides a slope no greater than 8.33%. Install a detectable warning surface which extends the full length and width of the concrete curb ramp and its side flares with truncated domes that contrast visually by either light on dark or dark on light which is an integral part of the concrete curb ramp. The truncated domes may be cast in place or stamped or of a prefabricated surface treatment (see CBC 1127B.5.8).

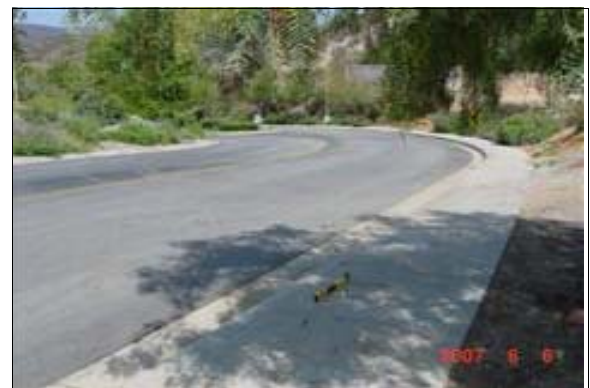
Accessible Route from the Public Right of Way

Finding: There is no accessible route from the public right of way to the accessible entrance of the facility. There are slopes greater than 5% along the path of travel.

Alternative Post directional signage.
Rec:
(Where Available)

Full Rec: Provide at least one accessible route from the public right of way to the accessible entrance of the facility. Make certain to post signage indicating the direction to accessible building entrances at every major junction along the accessible route. Signs shall include the International Symbol of Accessibility.

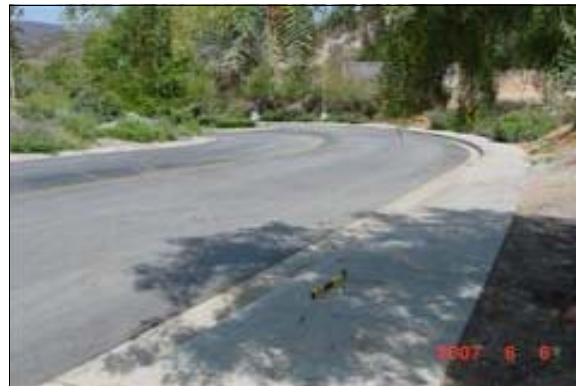
Accessible Route from the Public Right of Way

Finding: There are slopes greater than 5% on the primary path of travel from the public right of way to the Sports Complex.

Full Rec: Resurface the path of travel to provide a level surface that does not exceed a slope greater than 5%. Cross slopes shall not exceed 2%.

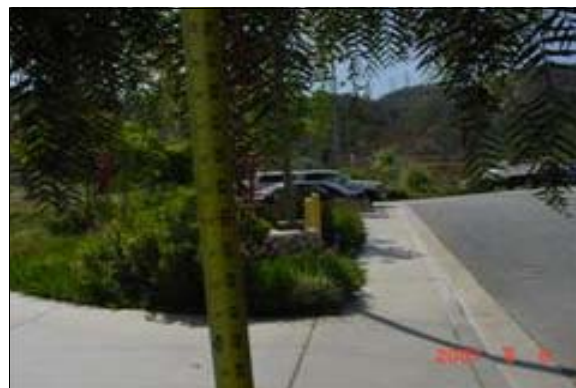
Accessible Route from the Public Right of Way

Finding: At the time of inspection, vegetation encroached into the primary path of travel, obstructing passage by reducing the vertical clearance height to less than 80 inches along the accessible route.

Full Rec: Maintain grass or landscaping adjacent to primary path of travel walkways to eliminate any encroachment into the accessible route.

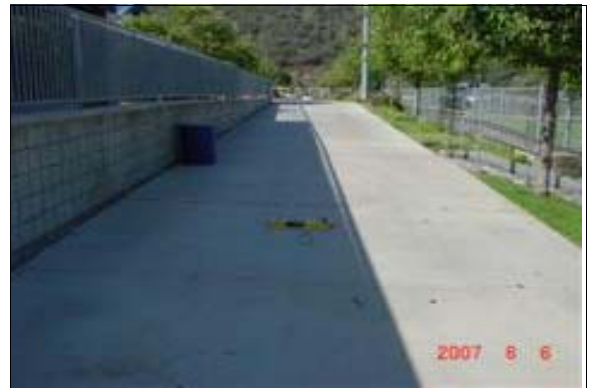
Path of Travel Next to the Outdoor Dining Area

Finding: There are cross slopes greater than 2% on the primary path of travel next to the outdoor dining area.

Full Rec: Resurface the path of travel to provide a level surface that does not exceed a slope greater than 5%. Cross slopes shall not exceed 2%.

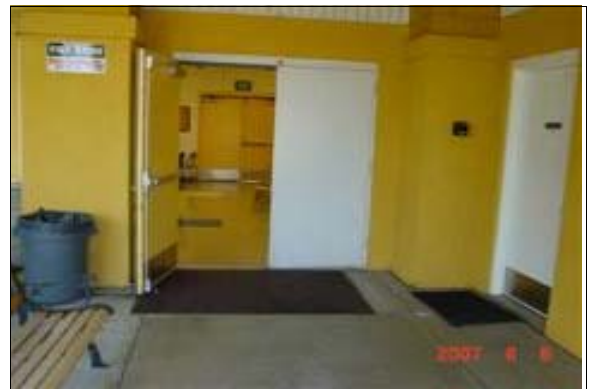
Path of Travel to the Conference Room

Finding: The mat at the entrance does not adhere to the underlying floor surface and creates a hazardous path of travel.

Full Rec: Securely fasten the mats or replace with a mat that grips to the underlying floor surface to provide a firm, stable, continuous and relatively smooth path of travel surface (see CBC 1124B.3 and ADAAG 4.5.3). Mats along the primary path of travel shall provide beveled edges on all sides to prevent roll over.

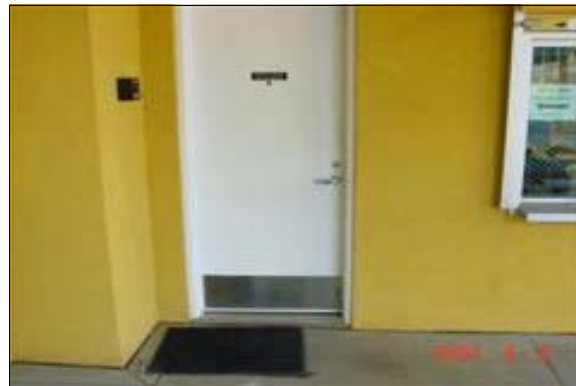
Path of Travel to the Main Entrance

Finding: The mat at the main entrance does not adhere to the underlying floor surface and creates a hazardous path of travel.

Full Rec: Securely fasten the mats or replace with a mat that grips to the underlying floor surface to provide a firm, stable, continuous and relatively smooth path of travel surface (see CBC 1124B.3 and ADAAG 4.5.3). Mats along the primary path of travel shall provide beveled edges on all sides to prevent roll over.

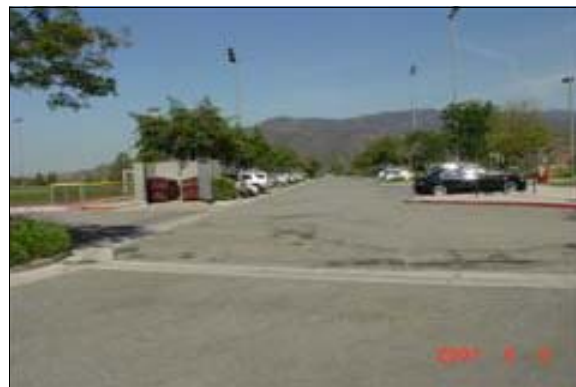
Path of Travel to the Soccer Field

Finding: There is no crosswalk provided on the path of travel from the accessible parking spaces to the soccer field. The required accessible route crosses a vehicular way.

Full Rec: Stripe a crosswalk not less than 48 inches wide on the path of travel to the accessible entrance of the facility. Provide a level surface that does not exceed a slope greater than 5%. Cross slopes shall not exceed 2%. Detectable warnings should be placed at the entrance and exit of the crosswalk.

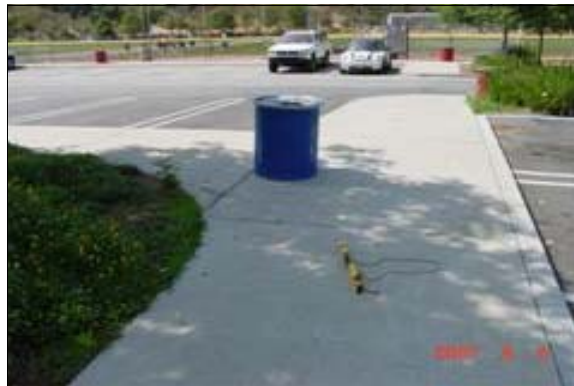
Path of Travel to the Sports Complex Operations Office

Finding: There are slopes greater than 5% on the primary path of travel from the public right of way to the Sports Complex Operations Office.

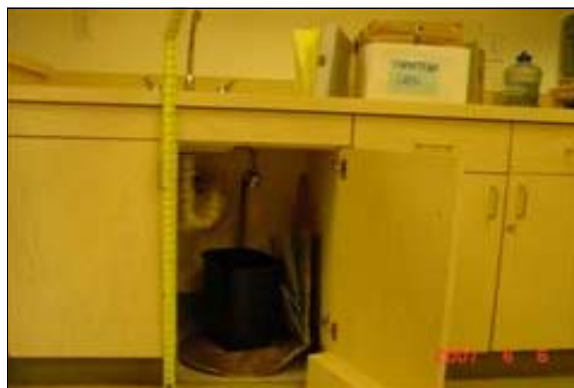
Sink in the Conference Room

Finding: The height of the counter surface of the sink designated to be accessible in the Multi-Purpose Room is greater than 34 inches above the finished floor.

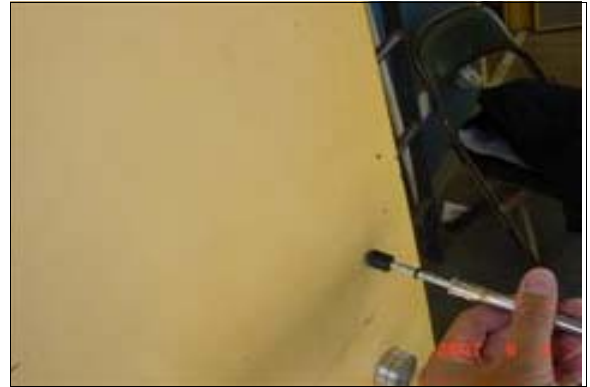
Maintenance Building

Finding: The bottom 10 inches of the doors do not provide a smooth, uninterrupted surface, or panel to allow the door to be opened by a wheelchair footrest without creating a trap or hazardous condition, due to the doorstop.

Full Rec: Install a panel or replace the door to provide a smooth, uninterrupted surface for the bottom 10 inches of the door.

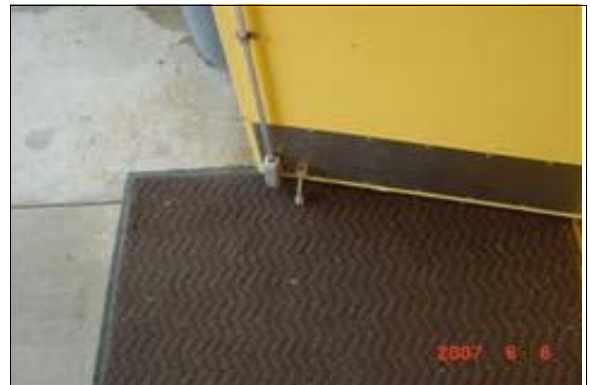
Sports Complex Operations Office

Finding: The door opening force for the exterior door is greater than 5 pounds of force.

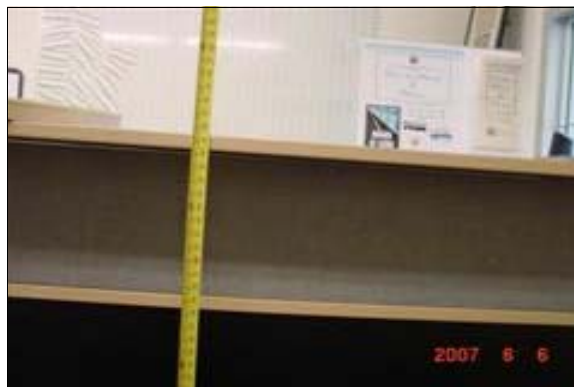
Finding: The facility does not provide accessible signage at the reception counter that indicates there is assistance provided upon request.

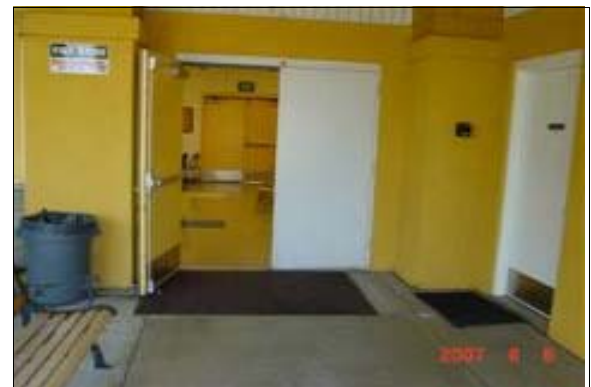
Conference Room

Finding: The main entrance does not have accessible signage mounted on the wall adjacent to the latch side of the door.

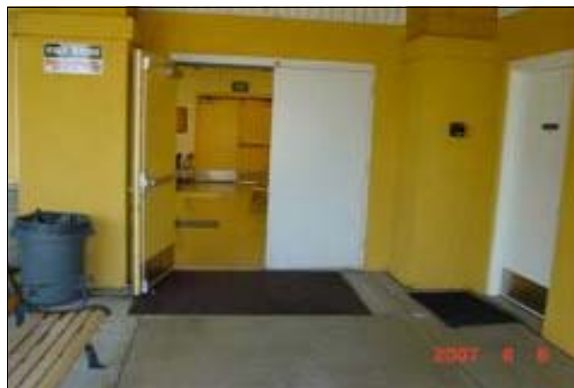
Directional Signage

Finding: There is no directional signage to the accessible entrance from the public right of way or other common use areas.

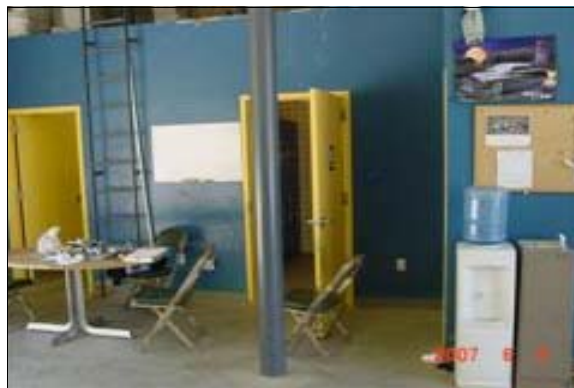
Unisex Restroom in the Maintenance Building

Finding: The door opening force for the interior door is greater than 5 pounds of force.

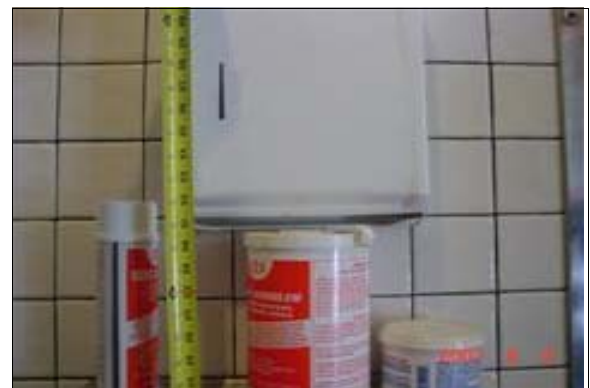
Unisex Restroom in the Maintenance Building

Finding: The height of the controls and operating mechanisms for the hand dryer in the restroom is greater than 40 inches.

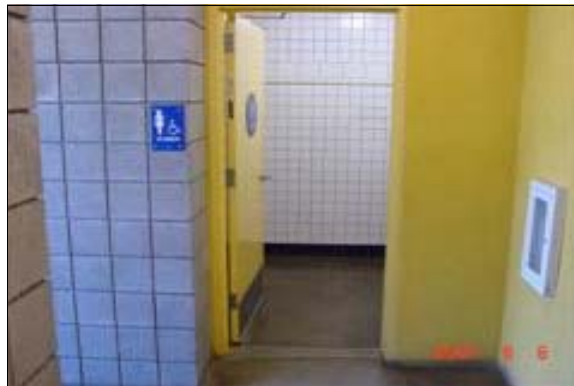
Women's Restroom at the Sports Complex Operations Office

Finding: The door to the stall designated to be accessible in the restroom does not close automatically or have accessible hardware.

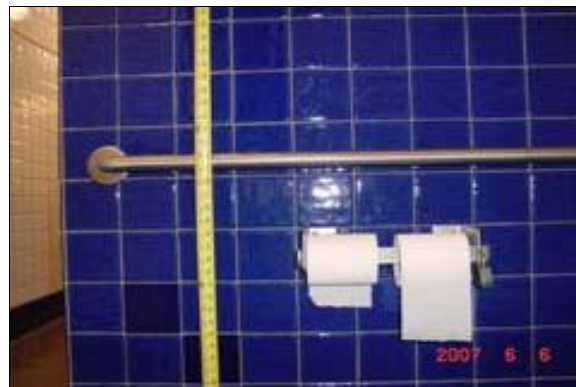
Women's Restroom at the Sports Complex Operations Office

Finding: The flush control on the toilet in the stall designated to be accessible in the restroom is not on the wide (approach) side of the toilet.
