**Photo Report**  
**Verdugo Adobe Park**  
**Programs, Services, and Activities**

**Finding:** The Verdugo Adobe Park, located at 2211 Bonita Drive in Glendale California, was inspected by Disability Access Consultants, Inc., on June 12 an 14, 2007.

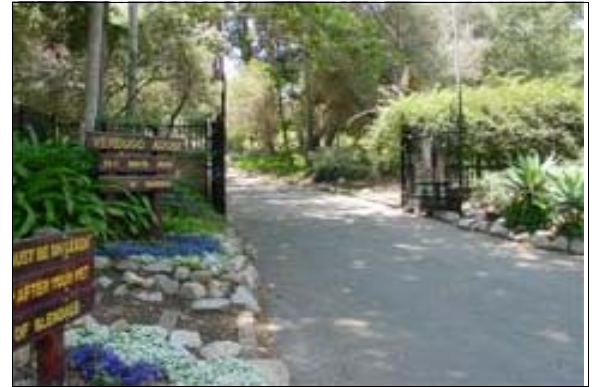
**Accessible Route from the Public Right of Way**

**Finding:** There is no accessible route from the public right of way to the accessible entrance of the facility. The accessible route crosses vehicular traffic.

**Alternative Rec:** Post directional signage.  
**(Where Available)**

**Full Rec:** Provide at least one accessible route from the public right of way to the accessible entrance of the facility. Make certain to post signage indicating the direction to accessible building entrances at every major junction along the accessible route. Signs shall include the International Symbol of Accessibility.

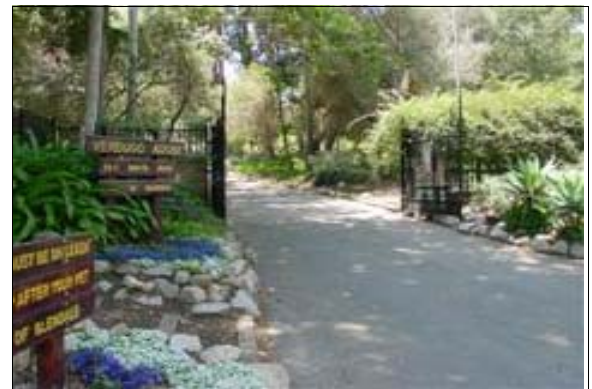
**Accessible Route from the Public Right of Way**

**Finding:** There is no crosswalk provided on the path of travel from the public right of way to the facility. The required accessible route crosses a vehicular way.

**Full Rec:** Stripe a crosswalk not less than 48 inches wide on the path of travel to the accessible entrance of the facility. Provide a level surface that does not exceed a slope greater than 5%. Cross slopes shall not exceed 2%. Detectable warnings should be placed at the entrance and exit of the crosswalk.

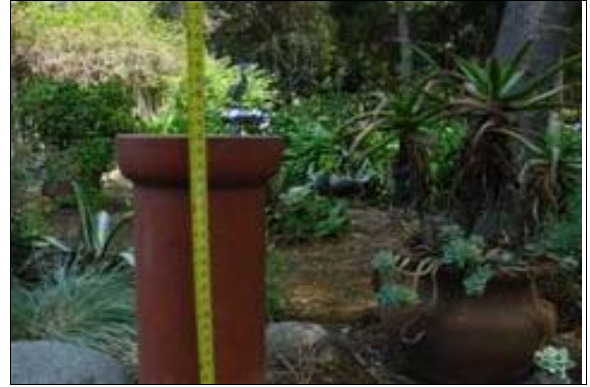
***Path of Travel to the Drinking Fountain***

**Finding:** The path of travel to the drinking fountain is dirt, preventing access to individuals with mobility impairments.

**Full Rec:** Install an accessible route to where programs, services and activities are provided (see CBC 1114B.1.2 and ADAAG 4.3.2). The minimum width of the path of travel shall be 48 inches with a firm, stable and slip-resistant surface. No protruding objects are permitted on the accessible path of travel and slopes shall not exceed 5% in the direction of travel.

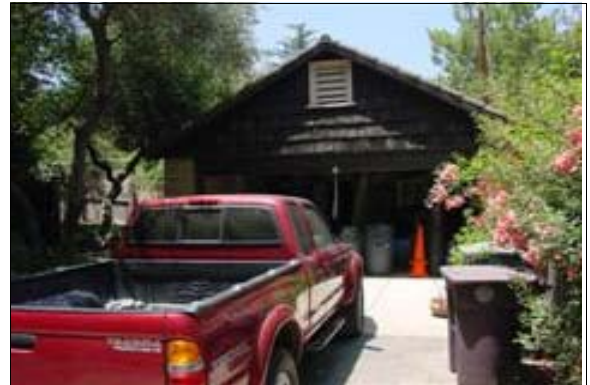
***Path of Travel to the Maintenance Garage***

**Finding:** There is no crosswalk provided on the path of travel to the Maintenance Garage. The required accessible route crosses a vehicular way.

**Full Rec:** Stripe a crosswalk not less than 48 inches wide on the path of travel to the accessible entrance of the facility. Provide a level surface that does not exceed a slope greater than 5%. Cross slopes shall not exceed 2%. Detectable warnings should be placed at the entrance and exit of the crosswalk.

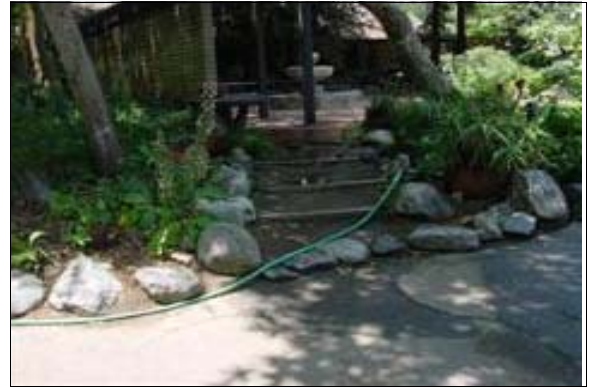
***Path of Travel to the Museum***

**Finding:** There are only stairs to the primary functions provided, preventing access to individuals with mobility impairments.

**Full Rec:** Since programs, services and activities to staff and the public are provided in this location, those programs, services and activities are required to be made accessible. It is recommended that a ramp be installed or other means of vertical access.

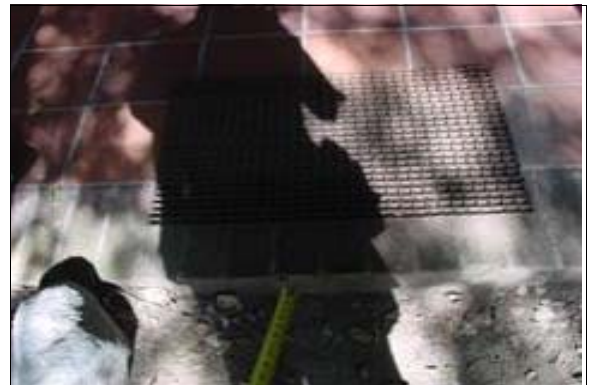
***Path of Travel to the Museum***

**Finding:** The mats at the porch do not adhere to the underlying floor surface and create a hazardous path of travel.

**Full Rec:** Securely fasten the mats or replace with a mat that grips to the underlying floor surface to provide a firm, stable, continuous and relatively smooth path of travel surface (see CBC 1124B.3 and ADAAG 4.5.3). Mats along the primary path of travel shall provide beveled edges on all sides to prevent roll over.

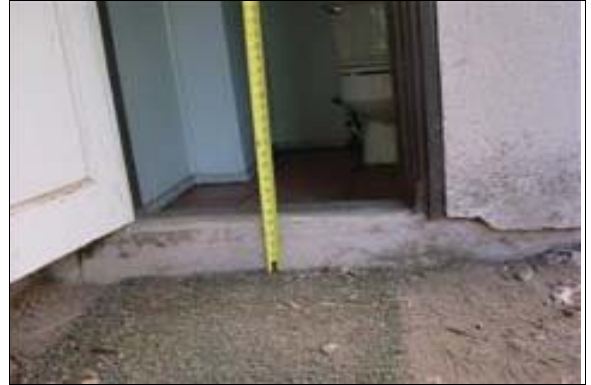
***Path of Travel to the Restroom at the Rear of the Museum***

**Finding:** There is a step on the primary path of travel to the unisex restroom at the rear of the Museum, preventing access to individuals with mobility impairments.

**Full Rec:** Since programs, services and activities to staff and the public are provided in this location, those programs, services and activities are required to be made accessible. It is recommended that a ramp be installed or other means of vertical access.

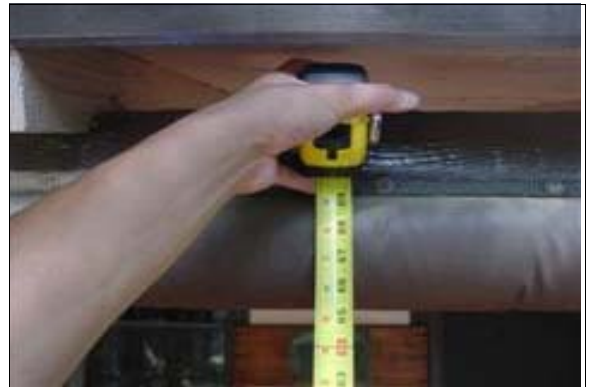
***Protruding Object***

**Finding:** The vertical headroom clearance outside of the Museum is less than 80 inches in height.

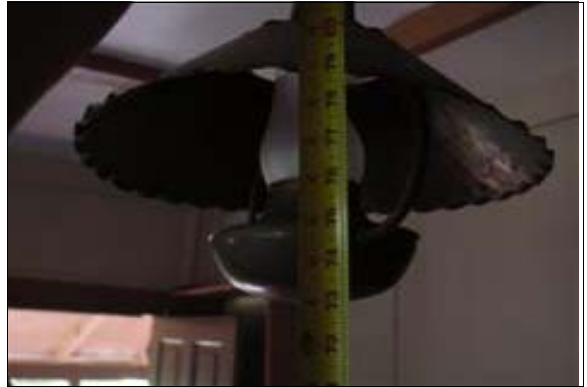
**Protruding Object**

**Finding:** The leading edge of the light in the lobby at the Museum is more than 4 inches from the wall and less than 80 inches above the floor and protrudes into the primary path of travel.

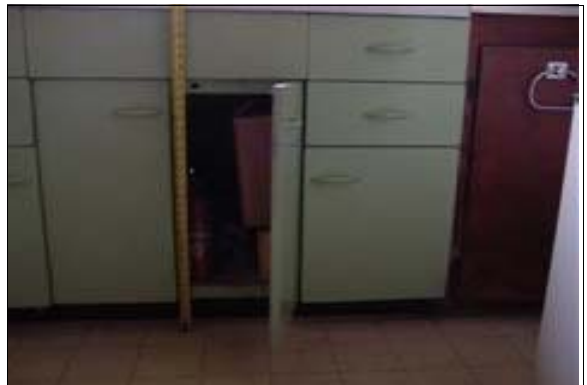
**Sink in the Museum**

**Finding:** The sink in the Museum is in an enclosed cabinet, thereby preventing an accessible forward approach. The height of the counter surface of the sink is greater than 34 inches above the finished floor.

**Full Rec:** Sinks in rooms must provide clear floor space in front of the sink for an accessible forward approach and shall provide at least 27 inches clear knee space and a minimum of nine inches clear toe space (see ADAAG 4.19.2). If neither clear floor space and knee and toe clearance can be provided, remove the sink cabinet and replace with an accessible wall-mounted sink unit.

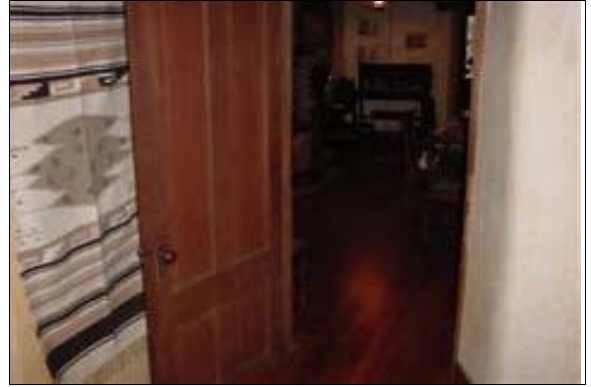
**Interior Doors in the Museum**

**Finding:** Interior passage doors have round doorknobs, which require twisting of the wrist to operate.

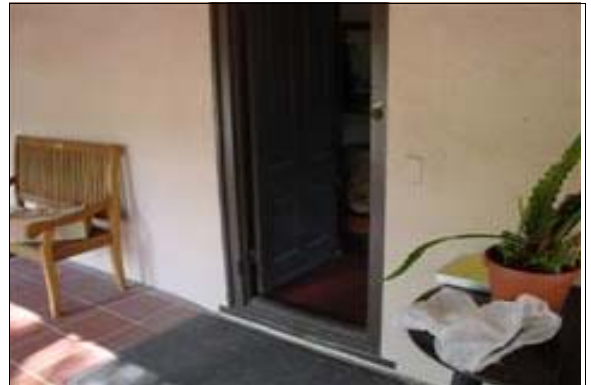
**Museum**

**Finding:** The clear opening width of the door is less than 32 inches.

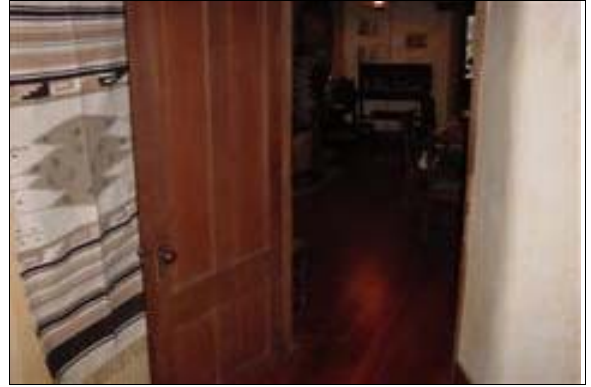
**Room Signage**

**Finding:** Rooms in the Museum do not have accessible signage mounted on the wall adjacent to the latch side of the doors.

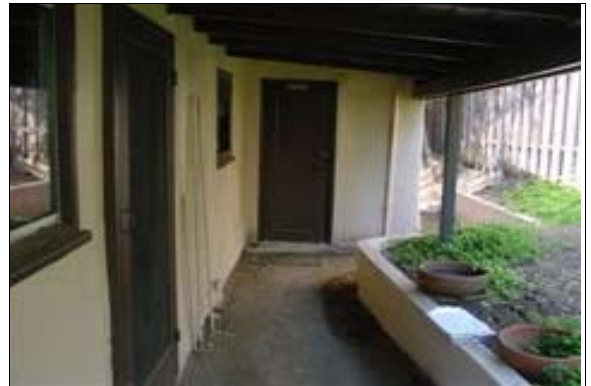
**Unisex Restroom at the Rear of the Museum**

**Finding:** There is no signage indicating accessibility on the latch side of the entry door of the restroom. There is no Title 24 gender use signage on the entrance door.

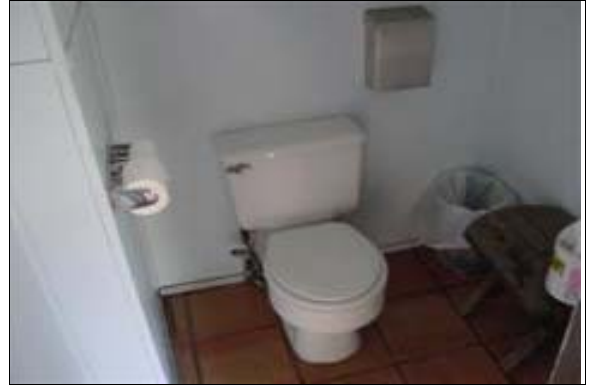
***Unisex Restroom at the Rear of the Museum***

**Finding:** The flush control on the toilet in the restroom is not on the wide (approach) side of the toilet.

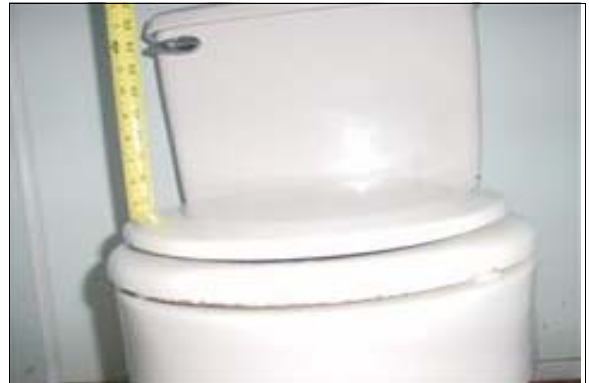
***Unisex Restroom at the Rear of the Museum***

**Finding:** The height of the toilet seat in the restroom is less than 17 inches above the finished floor.

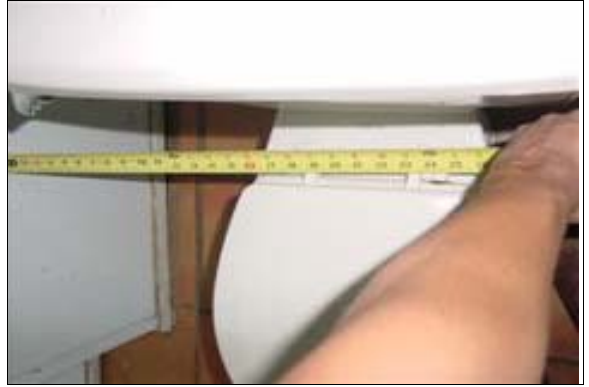
**Unisex Restroom at the Rear of the Museum**

**Finding:** The distance from the center of the toilet to the nearest side wall in the restroom is greater than 18 inches.

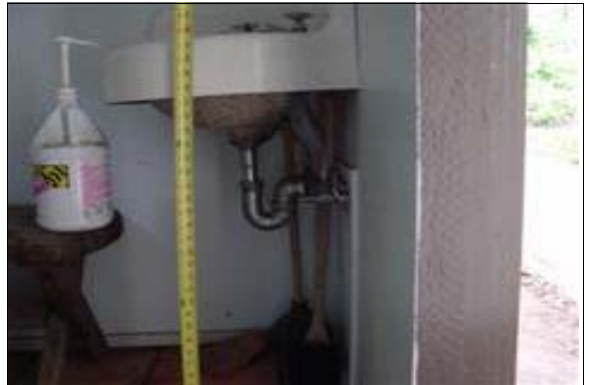
**Unisex Restroom at the Rear of the Museum**

**Finding:** The faucet controls on the lavatory in the restroom require tight grasping, pinching, or twisting of the wrist and are not accessible.

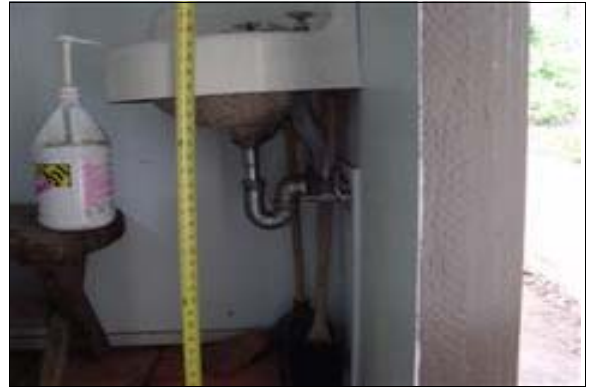
**Unisex Restroom at the Rear of the Museum**

**Finding:** The distance from the center of the lavatory to the adjacent side wall in the restroom is less than 18 inches.
