**Photo Report**

**Verdugo Park**

**Finding:** The Verdugo Park, located 1621 Canada Boulevard in Glendale California, was inspected by Disability Access Consultants, Inc., on June 5, 2007. Facilities include the Verdugo Park Skate Park Operations Office, Caretaker's House, Food Service Building, Maintenance Building, North and South restrooms, Stengel Field, and the Stengel Field Stadium.

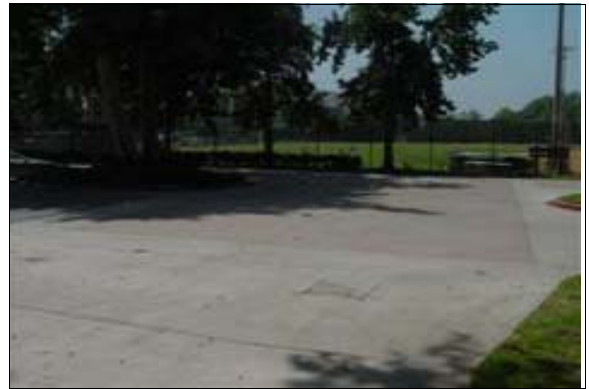
**Parking Lot Next to the Skate Park Operations Office**

**Finding:** There is no crosswalk provided on the path of travel from the accessible parking space to the facility. The required accessible route crosses a vehicular way.

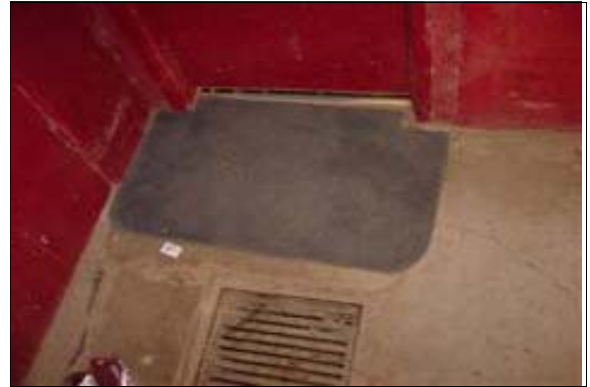
***Path of Travel to the Locker Rooms at Stengel Field***

**Finding:** The mat at the entrance does not adhere to the underlying floor surface and creates a hazardous path of travel.

**Full Rec:** Securely fasten the mats or replace with a mat that grips to the underlying floor surface to provide a firm, stable, continuous and relatively smooth path of travel surface (see CBC 1124B.3 and ADAAG 4.5.3). Mats along the primary path of travel shall provide beveled edges on all sides to prevent roll over.

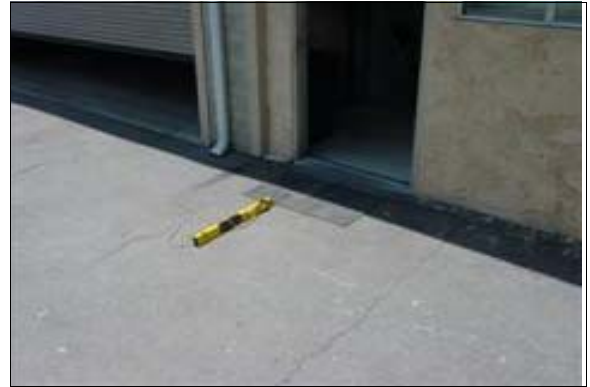
***Path of Travel to the Maintenance Building***

**Finding:** The mat at the entrance does not adhere to the underlying floor surface and creates a hazardous path of travel.

**Full Rec:** Securely fasten the mats or replace with a mat that grips to the underlying floor surface to provide a firm, stable, continuous and relatively smooth path of travel surface (see CBC 1124B.3 and ADAAG 4.5.3). Mats along the primary path of travel shall provide beveled edges on all sides to prevent roll over.

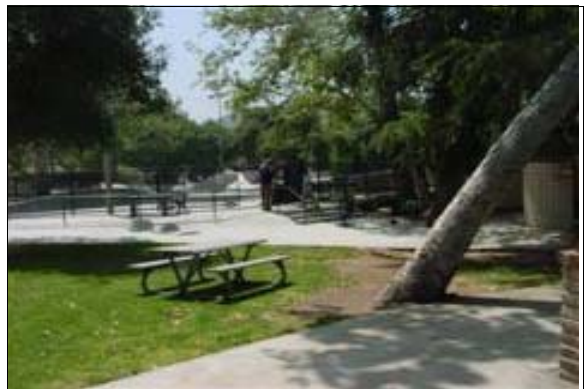
***Path of Travel to the Skate Park***

**Finding:** There are only stairs to the primary functions provided, preventing access to individuals with mobility impairments.

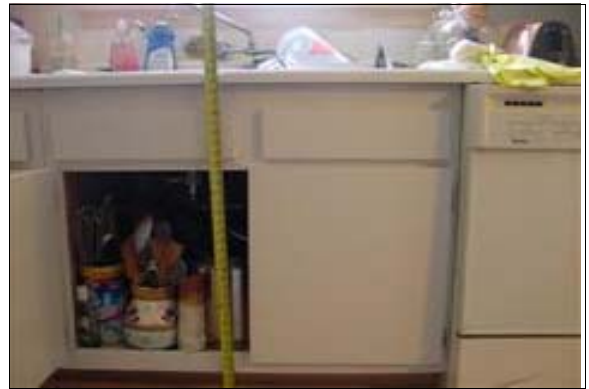
***Sink in the Caretaker's House***

**Finding:** The sink in the kitchen is in an enclosed cabinet, thereby preventing an accessible forward approach. The height of the counter surface of the sink is greater than 34 inches above the finished floor.

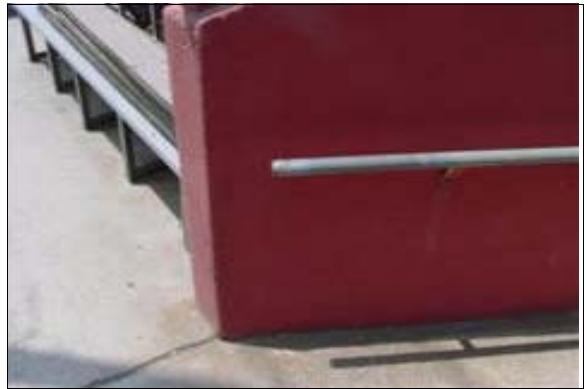
**Exterior Ramp to the Stengel Field Stadium  
(Right)**

**Finding:** The ends of the handrails end abruptly.

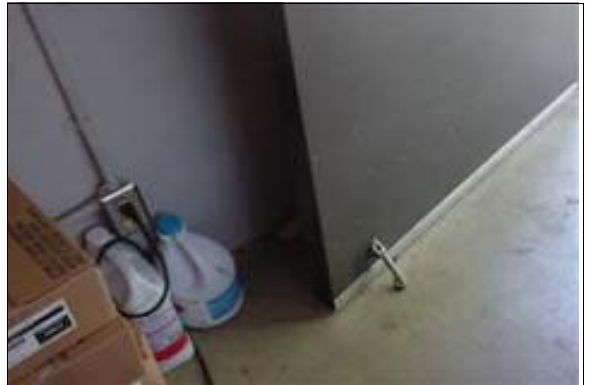
#### **Skate Park Operations Office**

**Finding:** The bottom 10 inches of the door does not provide a smooth, uninterrupted surface, or panel to allow the door to be opened by a wheelchair footrest without creating a trap or hazardous condition, due to the doorstop.

**Full Rec:** Install a panel or replace the door to provide a smooth, uninterrupted surface for the bottom 10 inches of the door.

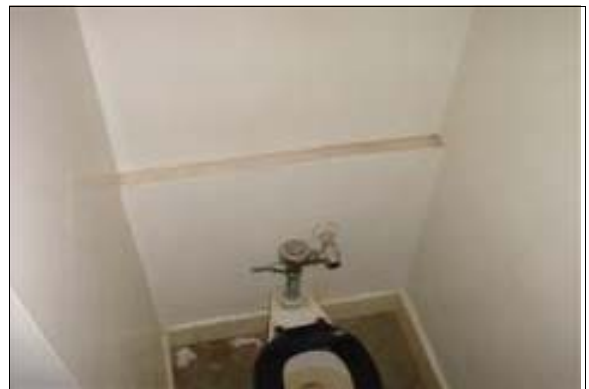
**Men's Restroom in the High School Locker Room at Stengel Field**

**Finding:** There is insufficient clear floor space in the stall designated to be accessible in the restroom. The stall door to the stall designated to be accessible in the restroom swings inward limiting the clear floor space in the stall designated to be accessible. The door to the stall designated to be accessible in the restroom does not close automatically or have accessible hardware.

**Full Rec:** Modify or replace the stall designated to be accessible in the restroom so that it complies with ADAAG 4.17.3, CBC 1115B and CBC Figures 11B-1A and 1B. Standard accessible stalls require 60 inches in width with 56 inches depth for wall-mounted toilets or 59 inches depth for floor-mounted toilets to accommodate individuals in wheelchairs. The minimum width of a front-approach doorway shall provide at least 32 inches and a side-approach doorway shall provide at least 34 inches. The door shall swing outward, close automatically and provide accessible hardware.

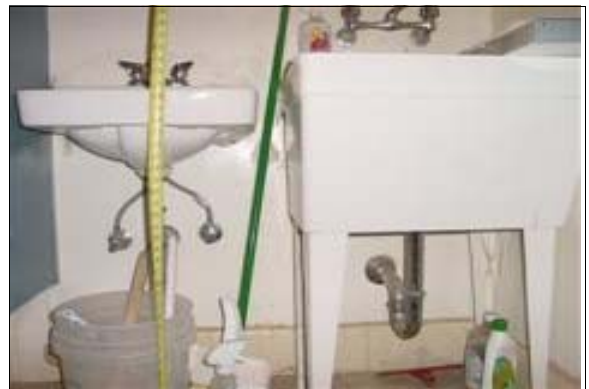
**Men's Restroom in the High School Locker Room at Stengel Field**

**Finding:** The faucet controls on the lavatory in the restroom require tight grasping, pinching, or twisting of the wrist and are not accessible.
