Photo Report
Wilson Mini Park
Programs, Services, and Activities

Finding: The Wilson Mini Park, located at 1101 Wilson Avenue in Glendale California, was inspected by Disability Access Consultants, Inc., on August 13, 2007.

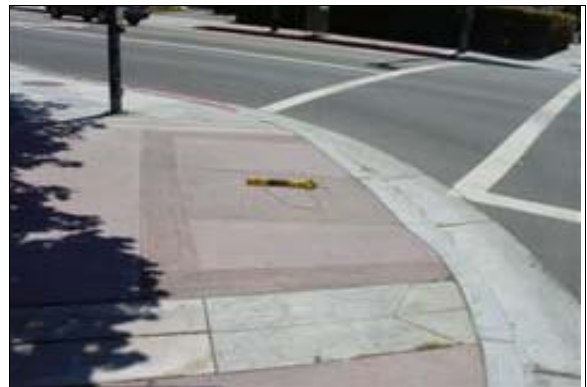
Curb Ramp at the Corner of Wilson and Adams

Finding: The slope of the curb ramp is greater than 8.33%. The slope at the bottom landing is greater than 2%. The slope at the top landing is greater than 2%. The slope of the side flares is greater than 10%. The concrete curb ramp does not provide a detectable warning surface which includes truncated domes.

Full Rec: Replace the curb ramp with a compliant curb ramp at least 48 inches in width that provides a slope no greater than 8.33%. Install a detectable warning surface which extends the full length and width of the concrete curb ramp and its side flares with truncated domes that contrast visually by either light on dark or dark on light which is an integral part of the concrete curb ramp. The truncated domes may be cast in place or stamped or of a prefabricated surface treatment (see CBC 1127B.5.8).

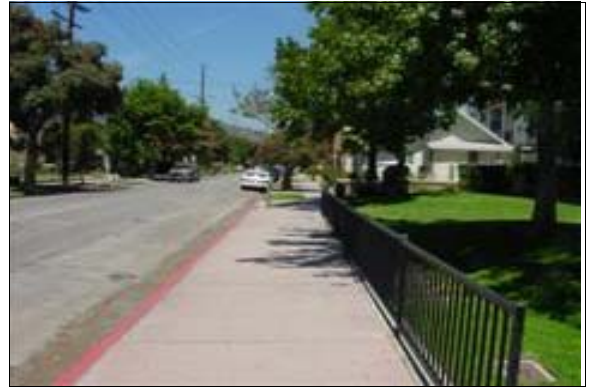
Accessible Route from the Public Right of Way

Finding: There is an accessible route from the public right of way to the accessible entrance of the facility.

Full Rec: Post directional signage. Make certain to post signage indicating the direction to accessible building entrances at every major junction along the accessible route. Signs shall include the International Symbol of Accessibility.

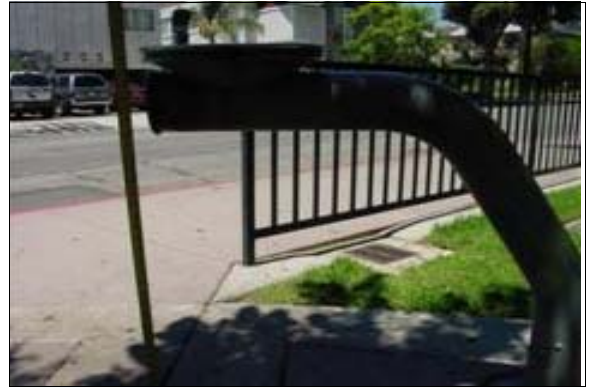
Finding: There is one drinking fountain on primary paths of travel.

Full Rec: Fifty percent of the drinking fountains on primary paths of travel shall be accessible (see CBC 1117B.1 and ADAAG 4.15). Install a "high-low" fountain design to comply with both state and federal requirement. Fountains not located in alcoves need side rails or wing walls on both sides.

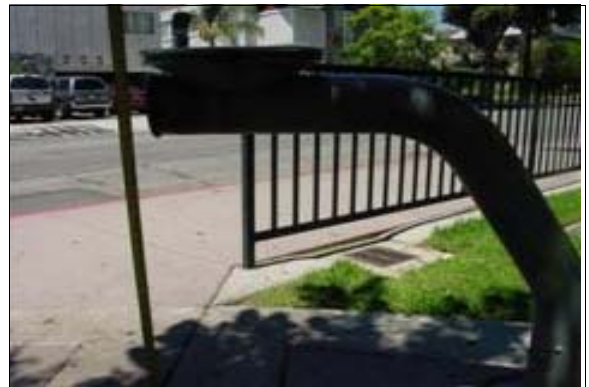
Drinking Fountain Next to the Play Equipment

Finding: The drinking fountain is not a "high-low" design.

Full Rec: Fifty percent of the drinking fountains on primary paths of travel shall be accessible (see CBC 1117B.1 and ADAAG 4.15). Install a "high-low" fountain design to comply with both state and federal requirements and install a side rail or wing wall next to each side of the fountain.

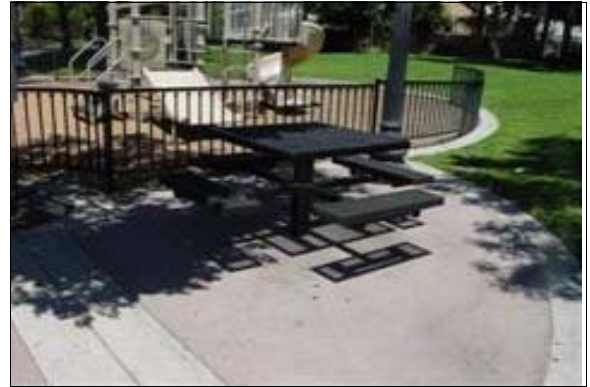
Outdoor Dining Area

Finding: The tables in the outdoor dining area are nonaccessible by design.

Full Rec: Modify or replace one of the tables in the outdoor dining area to provide knee clearance of at least 27 inches in height, 30 inches in width and 19 inches in depth (see CBC 1122B.3, ADAAG 4.32.2 and ADAAG Figure 45). The table top height shall not exceed 34 inches above the finished floor.

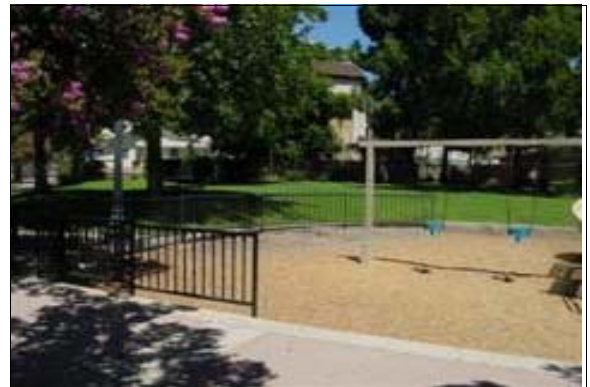
Play Equipment

Finding: The surface beneath the play equipment is wood chips, making the area nonaccessible to individuals with mobility impairments. There is a change in elevation greater than 1/2 inch at the entrance to the play equipment, due to the a lack of fill.

Full Rec: The play area should be made an accessible play area for the facility. Provide a maneuvering space with an accessible resilient surface beneath the play components and adjacent to the play components where technically feasible. An adequate maneuvering space has an accessible surface and is not less than 60 inches by 60 inches where an individual with a mobility impairment can be a part of the activities provided at the play components.
