**Photo Report**  
**Windsor Mini Park**  
**Programs, Services, and Activities**

## Windsor Mini Park

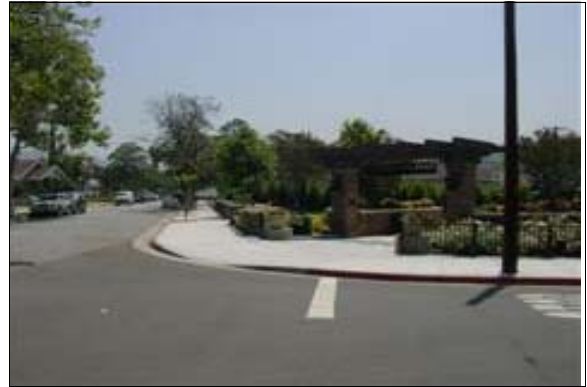
**Finding:** The Windsor Mini Park, located at 1300 East Windsor in Glendale California, was inspected by Disability Access Consultants, Inc., on June 12, 2007.

**Full Rec:** Any renovation or new construction that occurred after January 26, 1992, is subject to meet full code specifications for the California Building Code and ADAAG requirements. All recommendations in this report are based on ADAAG and CBC title 24 requirements. Consult with your design professional to determine which elements are affected by these requirements. It is recommended that Disability Access Consultants, Inc. is consulted for inspection of any new construction or renovation at the facility.

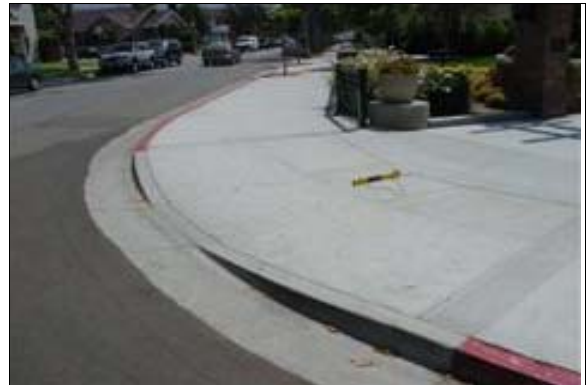
**Curb Ramp at the Entrance to the Park**  
 Citations: CBC 1127B.5.3; ADAAG 4.7.2 & 4.29  
 Minimum Quantity: 1  
 Maximum Quantity: 1  
**Minimum Estimated Cost:** \$1,033.00  
**Maximum Estimated Cost:** \$1,033.00  
 Record Number: 1752  
 Priority:

**Finding:** The width of the curb-cut ramp is less than 48 inches. The slope at the bottom landing is greater than 2%. The concrete curb ramp does not provide a detectable warning surface which includes truncated domes.

**Full Rec:** Replace the curb ramp with a compliant curb ramp at least 48 inches in width that provides a slope no greater than 8.33%. Install a detectable warning surface which extends the full length and width of the concrete curb ramp and its side flares with truncated domes that contrast visually by either light on dark or dark on light which is an integral part of the concrete curb ramp. The truncated domes may be cast in place or stamped or of a prefabricated surface treatment (see CBC 1127B.5.8).

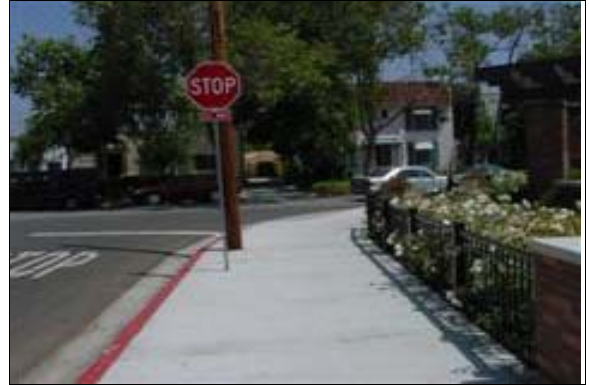
**Accessible Route from the Public Right of Way**

**Finding:** There is an accessible route from the public right of way to the accessible entrance of the facility.

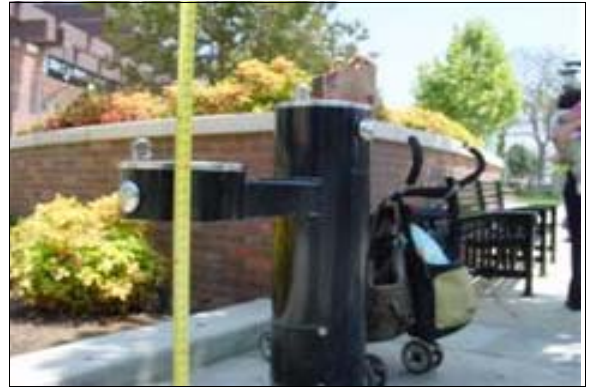
**Finding:** There is one drinking fountain on primary paths of travel.

**Full Rec:** Fifty percent of the drinking fountains on primary paths of travel shall be accessible (see CBC 1117B.1 and ADAAG 4.15). Install a "high-low" fountain design to comply with both state and federal requirement. Fountains not located in alcoves need side rails or wing walls on both sides.

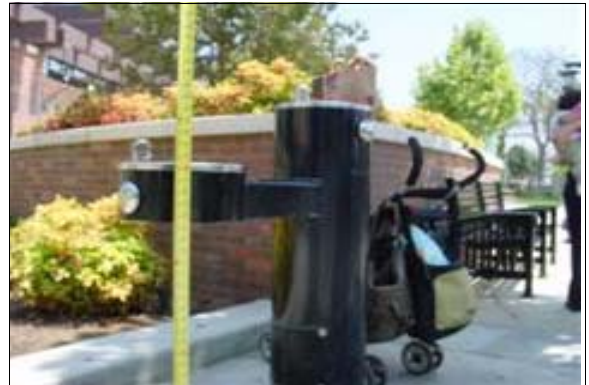
***Drinking Fountain at the Outdoor Dining Area***

**Finding:** The leading edge of the drinking fountain is more than 4 inches from the wall and greater than 27 inches from the floor and protrudes into the primary path of travel.

**Full Rec:** Fifty percent of the drinking fountains on primary paths of travel shall be accessible (see CBC 1117B.1 and ADAAG 4.15). Install a side rail or wing wall next to each side of the fountain.

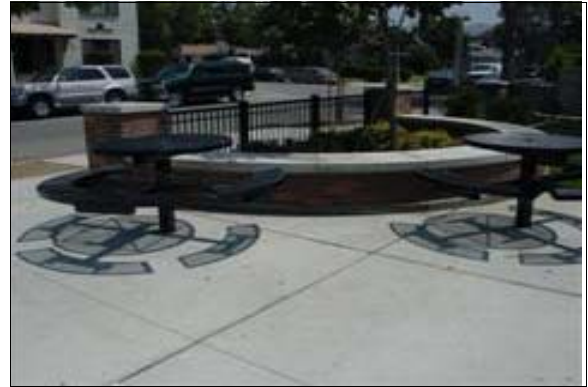
**Outdoor Dining Area**

**Finding:** The tables at the outdoor dining area are nonaccessible by design.

**Full Rec:** Modify or replace one of the tables in the outdoor dining area to provide knee clearance of at least 27 inches in height, 30 inches in width and 19 inches in depth (see CBC 1122B.3, ADAAG 4.32.2 and ADAAG Figure 45). The table top height shall not exceed 34 inches above the finished floor.

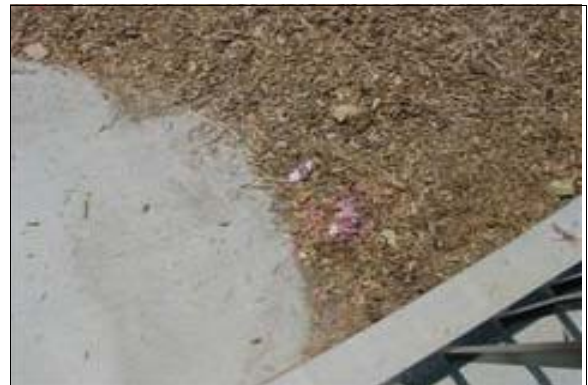
**Play Equipment**

**Finding:** There are slopes greater than 6.33% along the path of travel to the play equipment. The surface beneath the play area is wood chips, making the area nonaccessible to individuals with mobility impairments.

**Full Rec:** Provide an accessible route to the play area (CBC 1104B.1.2 and ADAAG 4.3.2). The minimum width of the path of travel is 48 inches with 60 inch by 60 inch passing spaces provided every 200 feet and shall not exceed a slope greater than 6.33%. Provide a maneuvering space with an accessible resilient surface beneath the play components and adjacent to the play components where technically feasible. An adequate maneuvering space has an accessible surface and is not less than 60 inches by 60 inches where an individual with a mobility impairment can be a part of the activities provided at the play components.
