Photo Report
Youth and Family Services Office
Programs, Services, and Activities

Finding: The Youth and Family Services Office, located at 815 East Harvard in Glendale California, consists of one single story structure. The facility was inspected by Disability Access Consultants, Inc., on June 5, 2007.

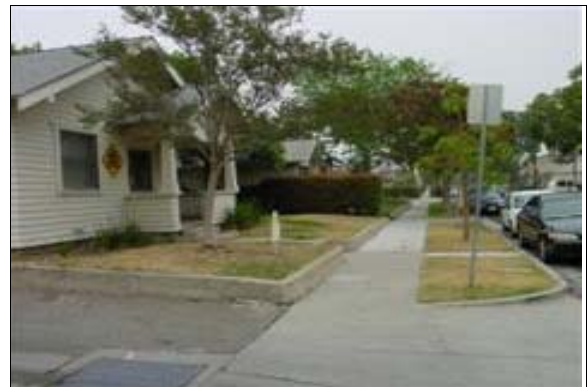
Accessible Route from the Public Right of Way

Finding: There is no accessible route from the public right of way to the accessible entrance of the facility. There are only stairs on the primary path of travel.

Alternative Post directional signage.
Rec:
(Where Available)

Full Rec: Provide at least one accessible route from the public right of way to the accessible entrance of the facility. Make certain to post signage indicating the direction to accessible building entrances at every major junction along the accessible route. Signs shall include the International Symbol of Accessibility.

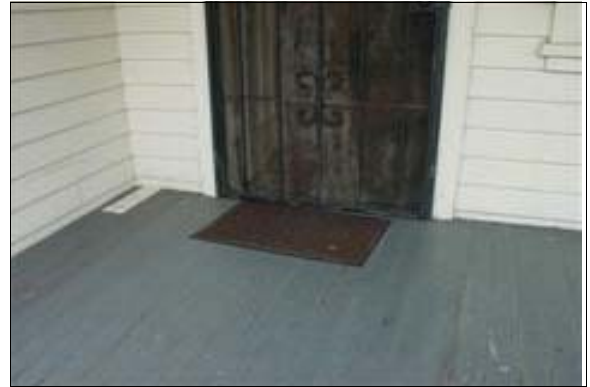
Path of Travel to the Main Entrance

Finding: The mat at the main entrance does not adhere to the underlying floor surface and creates a hazardous path of travel.

Full Rec: Securely fasten the mats or replace with a mat that grips to the underlying floor surface to provide a firm, stable, continuous and relatively smooth path of travel surface (see CBC 1124B.3 and ADAAG 4.5.3). Mats along the primary path of travel shall provide beveled edges on all sides to prevent roll over.

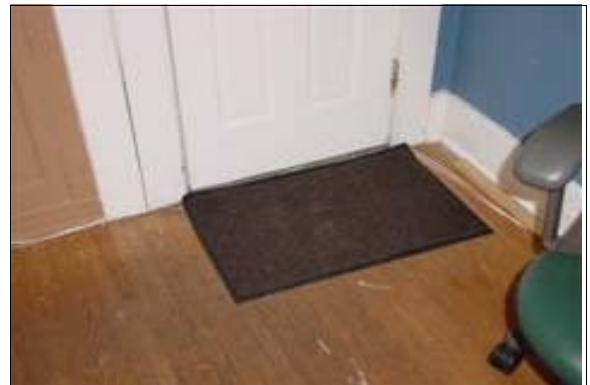
Path of Travel to the Rear Entrance

Finding: The mat does not adhere to the underlying floor surface and creates a hazardous path of travel.

Full Rec: Securely fasten the mats or replace with a mat that grips to the underlying floor surface to provide a firm, stable, continuous and relatively smooth path of travel surface (see CBC 1124B.3 and ADAAG 4.5.3). Mats along the primary path of travel shall provide beveled edges on all sides to prevent roll over.

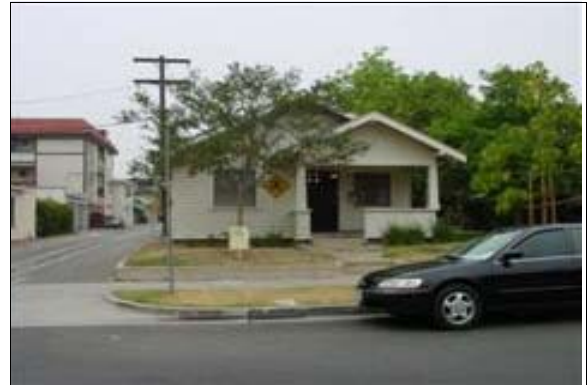
Path of Travel to the Youth and Family Services Office

Finding: There are only stairs to the primary functions provided, preventing access to individuals with mobility impairments.

Full Rec: Since programs, services and activities to staff and the public (volunteers, etc.) are provided in this location, those programs, services and activities are required to be made accessible. It is recommended that a ramp be installed or other means of vertical access.

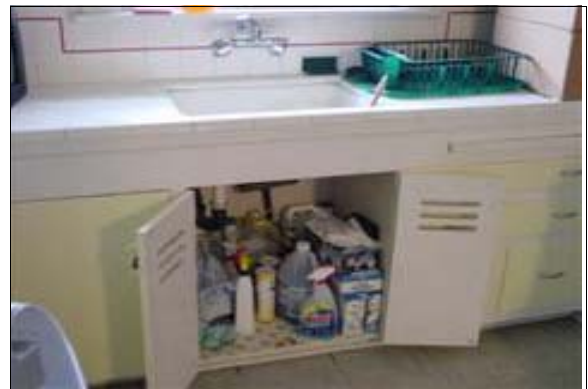
Sink in the Kitchen

Finding: The sink in the Kitchen is in an enclosed cabinet, thereby preventing an accessible forward approach. The height of the counter surface of the sink is greater than 34 inches above the finished floor.

Full Rec: Sinks in rooms must provide clear floor space in front of the sink for an accessible forward approach and shall provide at least 27 inches clear knee space and a minimum of nine inches clear toe space (see ADAAG 4.19.2). If neither clear floor space and knee and toe clearance can be provided, remove the sink cabinet and replace with an accessible wall-mounted sink unit.

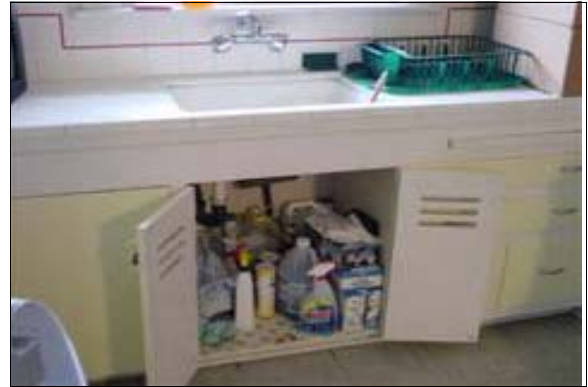
Sink in the Kitchen

Finding: The pipes under the sink in the Kitchen do not provide protection against contact.

Full Rec: Insulate or otherwise configure pipes under the sink designated to be accessible in the room to protect against contact (see ADAAG 4.19.4). Make certain there are no sharp or abrasive surfaces under the sink.

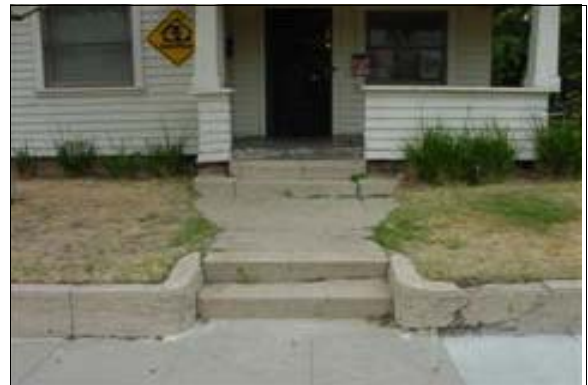
Exterior Stairs to the Main Entrance

Finding: There is no detectable striping on each tread of the exterior stairway.

Full Rec: Affix detectable contrasting striping to each tread of the stairway that clearly contrasts in color from the tread and is at least 2 inches in width placed no more than 1 inch from the tread nose or landing.

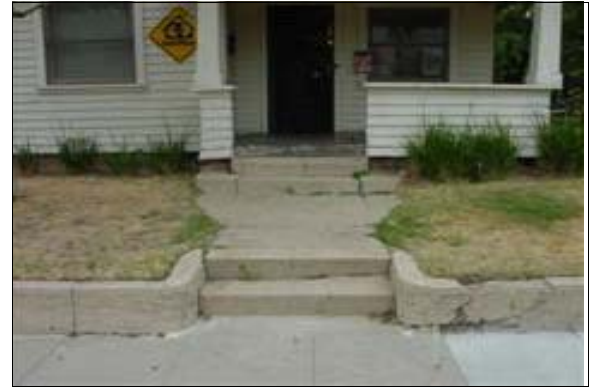
Exterior Stairs to the Main Entrance

Finding: There are no handrails provided on the stairway.

Full Rec: Install pipe rail handrails on each side of stairway that provide a gripping surface between 1 1/4 to 1 7/8 inches with 12-inch top and bottom handrail extensions that extend beyond the top and bottom treads of the stairway which are parallel to the floor surface. Handrails shall be mounted at a height between 34 and 38 inches at a distance no less than 1 1/2 inches from the adjacent wall.

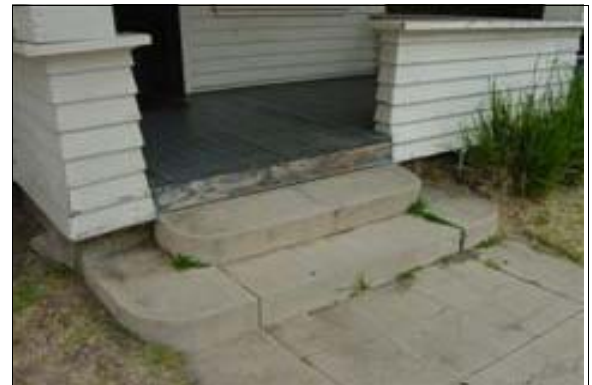
Exterior Stairs to the Main Entrance

Finding: The riser height is not uniform.

Full Rec: Modify or replace the stairs to provide a uniform riser height between 4 and 7 inches (see CBC 1006.3).

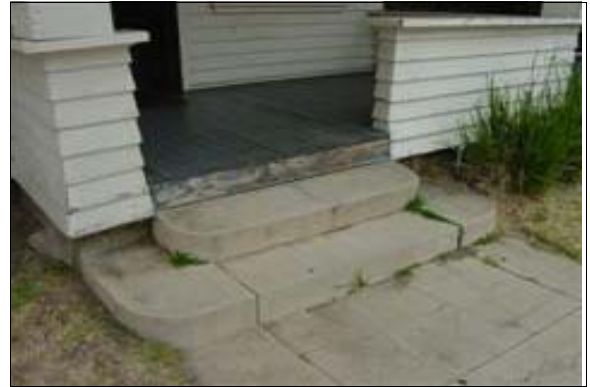
Exterior Stairs to the Main Entrance

Finding: The tread depth (width) is not uniform.

Full Rec: Modify or replace the stairs so that the tread depth (width) is at least 11 inches, measured from riser to riser, and uniform (see CBC 1006.3.4.9.2 and ADAAG 4.9.2).

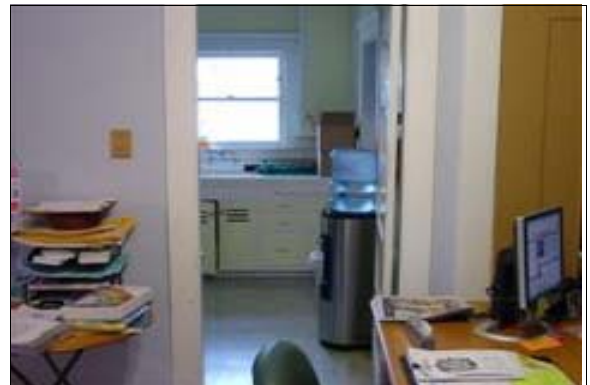
Interior Door to the Kitchen

Finding: The clear opening width of the door is less than 32 inches.

Full Rec: Widen the door opening and install a door that provides at least 32 inches of clear width with the door open 90 degrees (see CBC 1133B.2.3.1 and ADAAG 4.13.5).

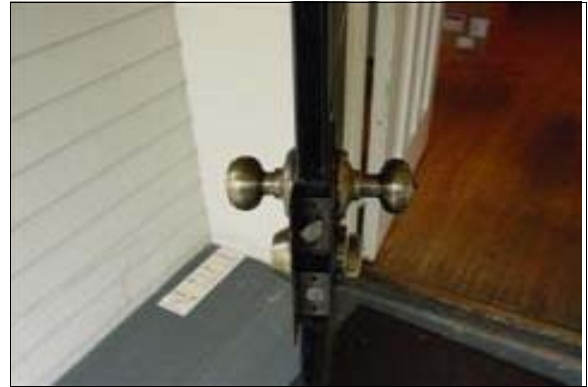
Main Entrance

Finding: The exterior passage door has a round doorknob, which requires twisting of the wrist to operate.

Full Rec: Replace the existing door hardware with accessible hardware (see ADAAG 4.13.9).

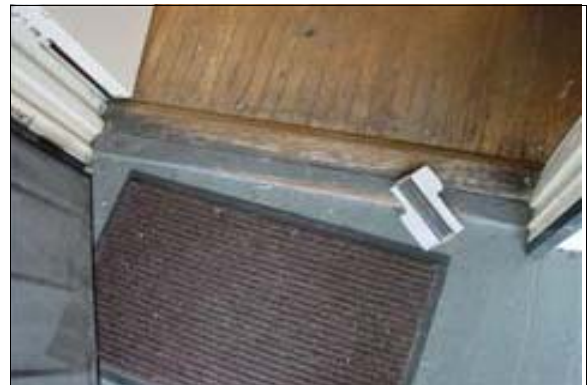
Main Entrance

Finding: The height of the threshold at the entrance door is greater than 1/2 inch.

Full Rec: Modify or replace the threshold to provide a smooth transition. The threshold should not exceed a beveled 1/2 inch. Provide a 60 inch level landing in the direction of the door swing.

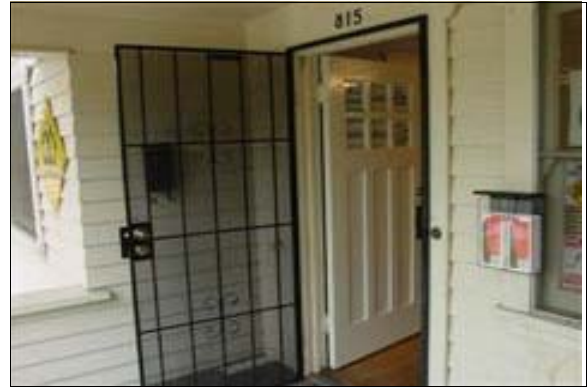
Main Entrance

Finding: The vertical clearance height of the entrance door provides less than 80 inches.

Full Rec: Consult a design professional to determine the feasibility of extending the height of the doorway to provide at least 80 inches clearance height (see CBC 1133B.2.3.1 and ADAAG 4.4.2).

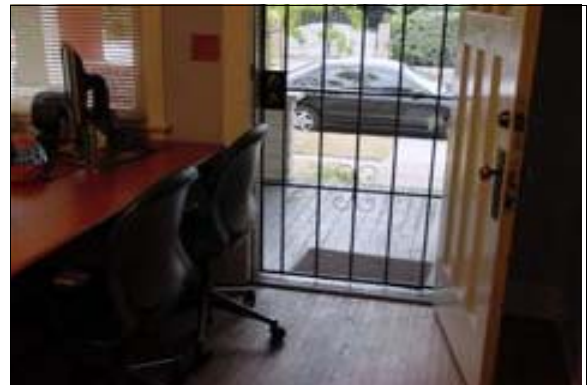
Main Entrance

Finding: There is less than 24 inches of clearance on the latch side of the exterior entrance door, due to the placement of the desk.

Full Rec: Relocate the desk to provide at least 24 inches of latch side clearance at the entrance door. Otherwise, install an automatic door opening device to the primary entrance complying with ADAAG 4.13.12 and ANSI/BHMA A156.10, 1985, standards.

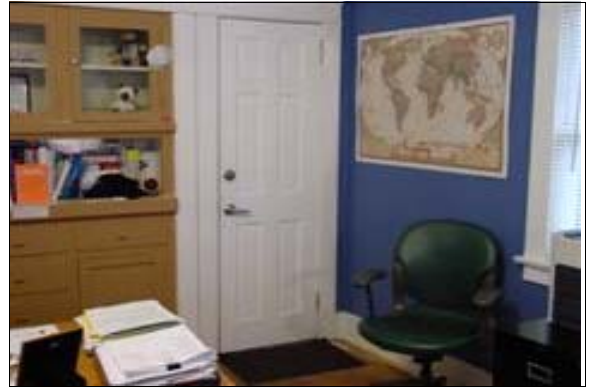
Rear Entrance

Finding: The clear opening width of the door is less than 32 inches.

Full Rec: Widen the door opening and install a door that provides at least 32 inches of clear width with the door open 90 degrees (see CBC 1133B.2.3.1 and ADAAG 4.13.5).

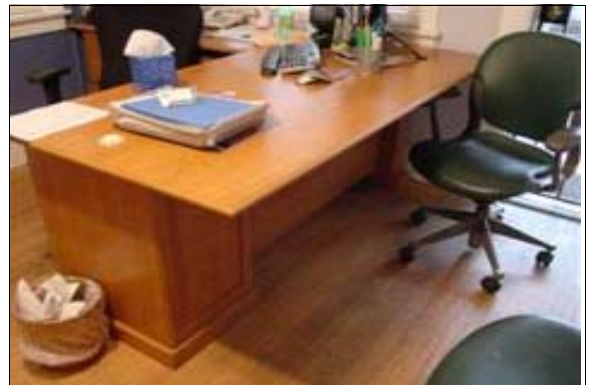
Finding: The facility does not provide accessible signage at the reception counters that indicates there is assistance provided upon request.

Full Rec: Provide signage at the reception counters that states: "Assistance Is Available, Please Contact an Employee." The sign should contain the International Symbol of Accessibility.

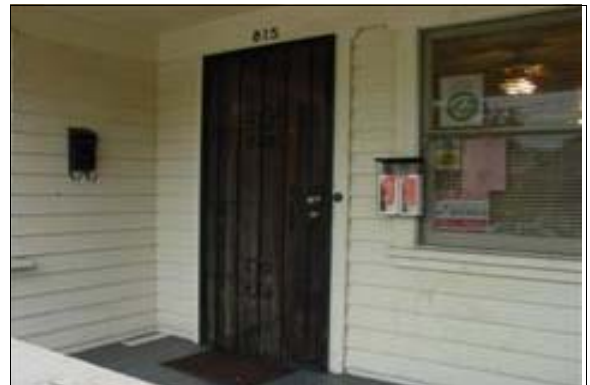
Main Entrance

Finding: There is no signage with the International Symbol of Accessibility on the entrance door to the facility designating it as accessible.

Full Rec: The International Symbol of Accessibility shall be the standard used to identify facilities that are accessible to and usable by physically disabled persons (see CBC 1117B.5.1). All building entrances that are accessible to and usable by persons with disabilities shall be identified with an ISA symbol (see CBC 1117B.5.7).

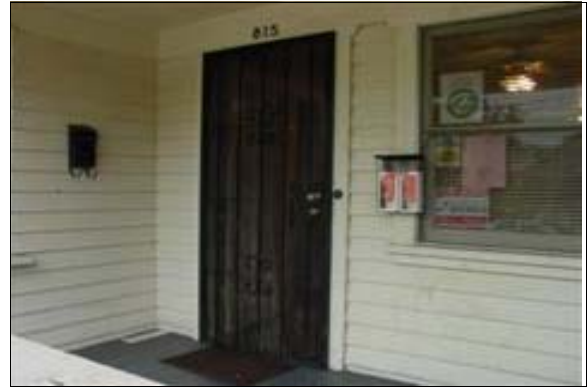
Main Entrance

Finding: The main entrance does not have accessible signage mounted on the wall adjacent to the latch side of the door.

Full Rec: Install signage centered at 60 inches above the finished floor on the wall adjacent to the latch side of the entry doorway stating ENTRANCE from the outside and EXIT from the inside, with raised UPPERCASE letters between 5/8 inch and 2 inches in height and Grade 2 Braille characters. The sign shall comply with the finish and contrast requirements set forth in CBC 1117B.5 and ADAAG 4.30.5. Signage should be located where a person may approach within three inches of the sign without encountering protruding objects or standing within the swing of the door.

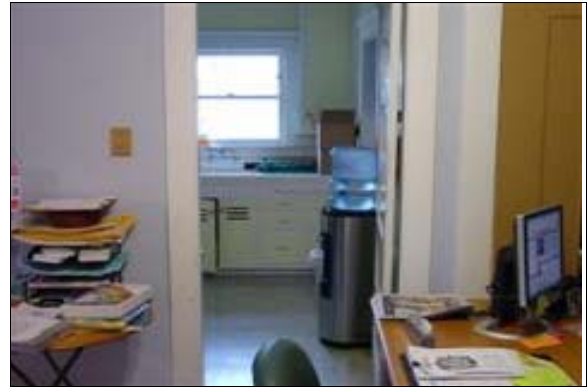
Room Signage

Finding: Rooms do not have accessible signage mounted on the wall adjacent to the latch side of the doors.

Full Rec: Install accessible signage identifying each room on the wall adjacent to the latch side of the doorway centered at 60 inches above the finished floor. Signage should be located where a person may approach within three inches of the sign without encountering protruding objects or standing within the swing of the door. Signs shall include raised UPPERCASE letters/numbers between 5/8 inch and 2 inches in height and Grade 2 Braille characters. Color and finish shall comply with CBC 1117B.5 and ADAAG 4.30.

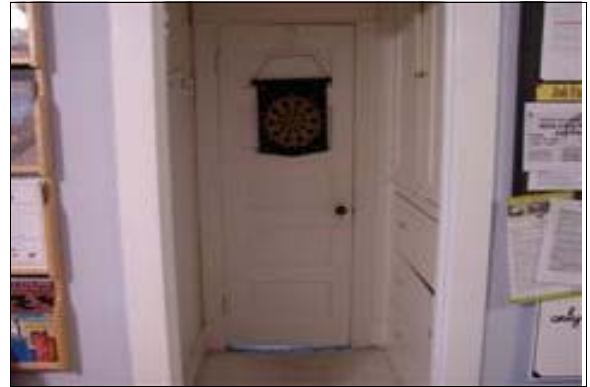
Unisex Restroom

Finding: There is no signage indicating accessibility on the latch side of the entry door of the restroom. There is no Title 24 gender use signage on the entrance door.

Full Rec: The restroom is designated accessible and should be made accessible for the facility. Post signage centered 60 inches above the ground surface on the latch side of the entrance door identifying the restroom as accessible upon completion of the following items (see CBC 1115B., ADAAG 4.1.2(7) and ADAAG 4.1.6(3)(e). Signage shall include Braille and raised lettering, the gender or unisex use symbol and the ISA symbol. Post Title 24 gender use signage on the door @ 60" o.c. a.f.f.

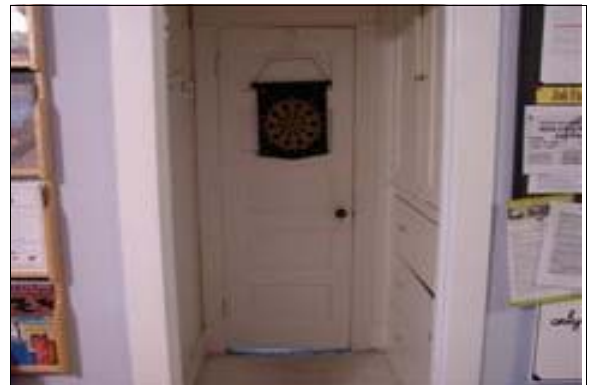
Unisex Restroom

Finding: The clear opening width of the entrance doorway to the restroom is less than 32 inches.

Full Rec: Widen the entrance doorway to the restroom to provide a clear opening width of at least 32 inches when the door is open 90 degrees (see ADAAG 4.13.5).

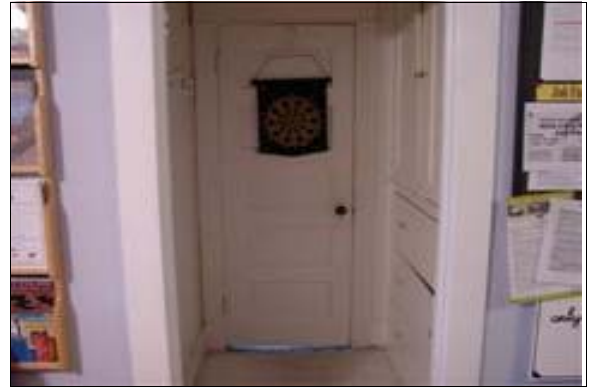
Unisex Restroom

Finding: The entrance door to the restroom has a round doorknob that requires tight grasping or twisting of the wrist to operate.

Full Rec: Replace the door hardware mounted on the restroom complying with ADAAG 4.13.9. Make certain accessible door hardware is mounted no higher than 48 inches above the finished floor.

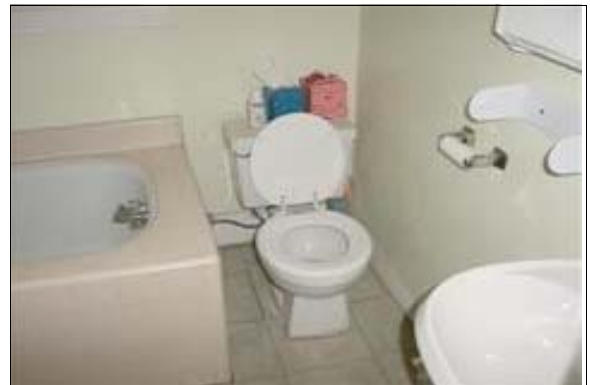
Unisex Restroom

Finding: This restroom is not accessible and cannot be easily altered. There is not sufficient clear floor space in the restroom to accommodate an individual in a wheelchair.

Full Rec: Consult a design professional to modify the restroom. One or more walls may need to be moved to provide sufficient clear floor space to inscribe a 60-inch diameter turning radius in the restroom to accommodate an individual in a wheelchair.

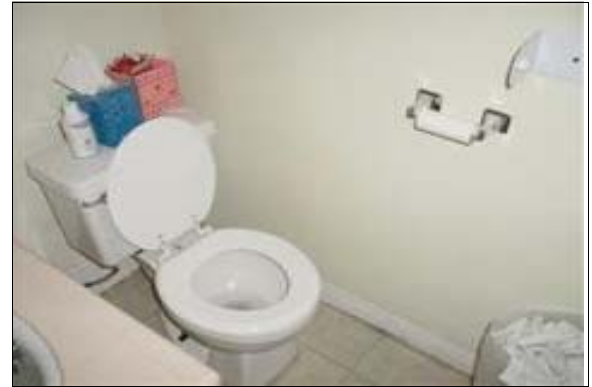
Unisex Restroom

Finding: There are no grab bars in the restroom.

Full Rec: Install one 36-inch back grab bar and one 42/48-inch side grab bar in the restroom. Grab bars shall be mounted at a height of 33 inches above the finished floor. Grab bars must be able to support a point load of at least 250 pounds and shall be less than the allowable shear stress of the grab bar material.

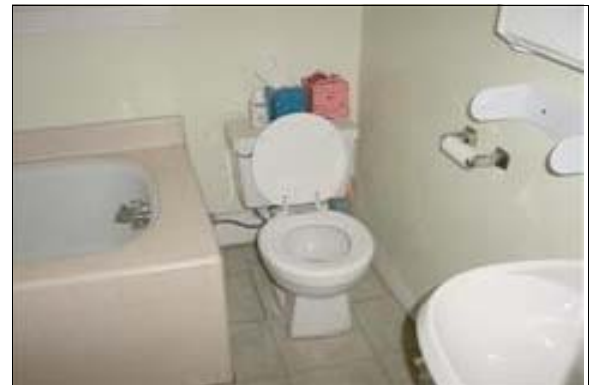
Unisex Restroom

Finding: The height of the toilet seat in the restroom is less than 17 inches above the finished floor.

Full Rec: Remove or modify the toilet in the restroom so that the seat height is between 17 inches and 19 inches above the finished floor (see ADAAG 4.16.3).

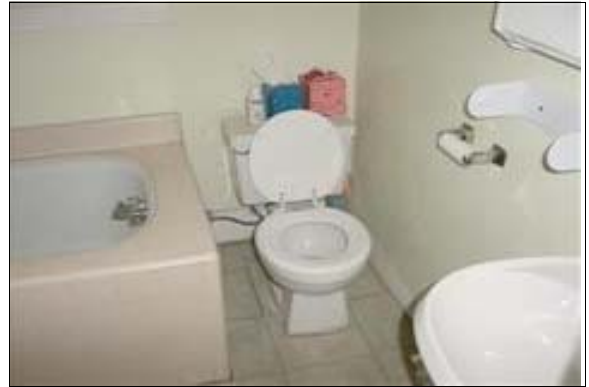
Unisex Restroom

Finding: The distance from the center of the toilet to the nearest side wall in the restroom is less than 18 inches.

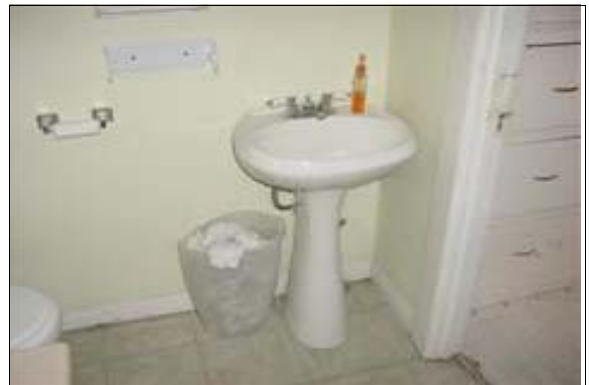
Unisex Restroom

Finding: The knee clearance space under the lavatory designated to be accessible in the restroom is less than 29 inches. The knee depth space under the lavatory designated to be accessible in the restroom is less than 27 inches at 8 inches under the lavatory apron.

Full Rec: Replace the lavatory designated to be accessible in the restroom to provide at least 29 inches of clear knee space between the finished floor and bottom of the lavatory apron. Make sure to provide at least 27 inches at 8 inches under the apron (see ADAAG 4.19.2).

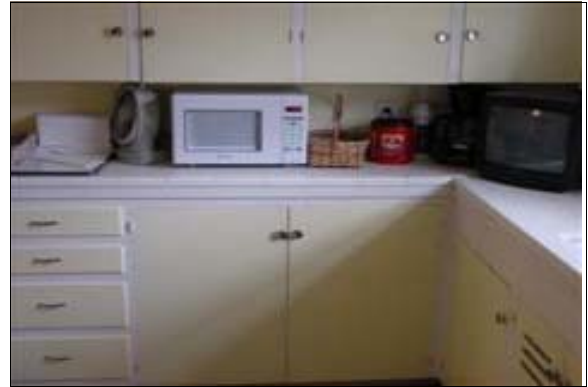
Kitchen

Finding: The height of the food service counter is greater than 34 inches.

Full Rec: Lower the food service counter to a height between 28 inches and 34 inches from the finished floor (see CBC 1122B.4 and ADAAG 4.32.4).
