Accessibility Survey

Americans with Disabilities Act And Title 24 of the California Building Code

Montrose Parking Lot #3

Inspected January 2008

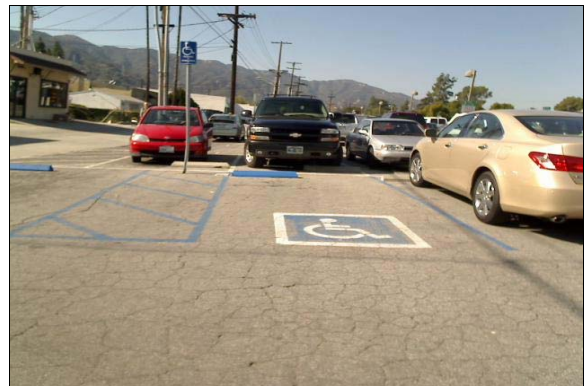
Accessible Parking

Finding: There are 8 accessible parking spaces out of 324 parking spaces which meets the minimum number for compliance. The accessible parking spaces do not measure at least 108 inches wide and 216 inches long. There is no "van-accessible" parking space and the access aisles does not contain "NO PARKING" in 12" high white letters.

Full Rec: Restripe the existing accessible spaces so each measures at least 108 inches wide and 216 inches long. Designate one parking space as "van-accessible". The van-accessible space shall provide a 96 inch wide passenger side access aisle. Add the words NO PARKING in 12 inch high white letters at the entrance to each accessible parking access aisle.

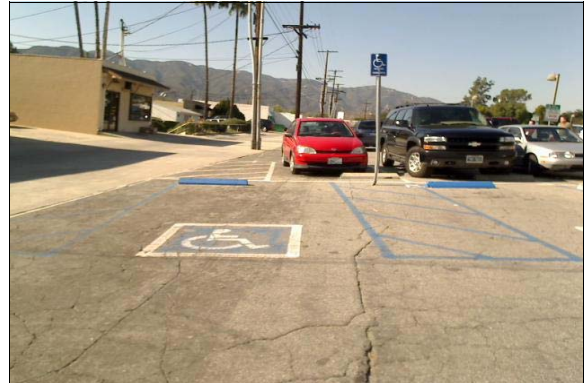
Accessible Parking

Finding: There is no accessible route between the accessible parking spaces and the public right of way. The accessible spaces require travel behind vehicles other than the wheelchair users space.

Full Rec: Install a compliant path of travel from the sidewalk (public right of way) to the accessible parking space. Wheelchair users must not be forced to go behind parked cars other than their own.

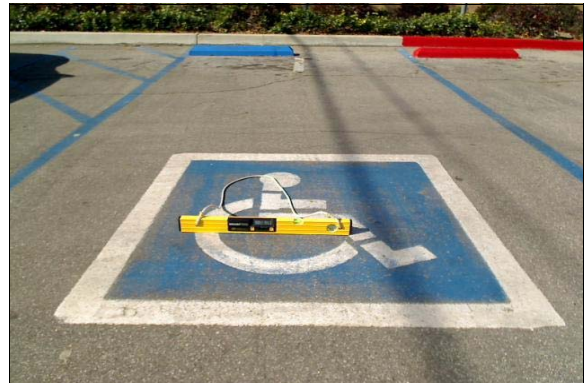
Accessible Parking

Finding: The surface of the accessible parking spaces has slopes greater than 2%.

Full Rec: Pave the parking lot at the accessible spaces to provide a level surface. Parking surfaces and access aisles shall be located in areas not exceeding a 2% slope in all directions (see CBC 1129B and ADAAG 4.6.3).

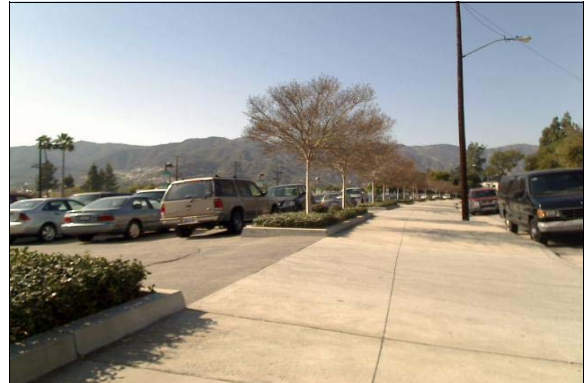
Accessible Parking

Finding: There is no warning signage posted at the entrances from Florencita Avenue regarding unauthorized use of accessible parking spaces in the parking lot.

Full Rec: Post a sign in a conspicuous place at the entrance of the parking lot, or immediately adjacent to and visible from each accessible space. The warning sign shall measure at least 17 inches by 22 inches in size and consist of lettering at least 1 inch in height that states the following; "Unauthorized vehicles parked in designated accessible spaces not displaying distinguishing placards or license plates issued for persons with disabilities may be towed away at owner's expense. Towed vehicles may be reclaimed at _____ or by telephoning ____ ." Fill in the blank spaces with appropriate information as a permanent part of the sign and be sure to add the CVC 22511.8(a)(d) to the sign.

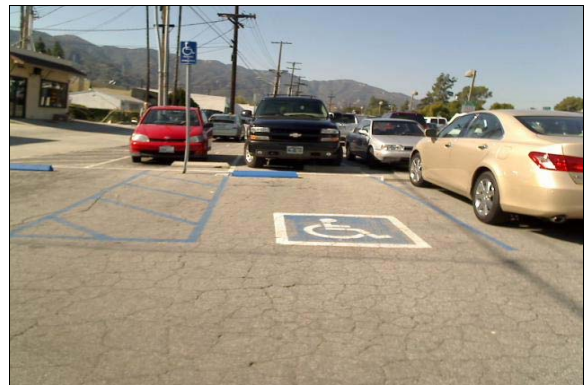
Accessible Parking

Finding: There is vertically-mounted signage at the accessible parking spaces, however, the signs use the word "Handicapped". Several spaces do not have a sign at the head of the space.

Full Rec: Install a permanently posted reflectorized sign measuring 70 square inches that includes an ISA symbol adjacent to and visible from the accessible parking space (see CBC 1129B.5). The bottom edge of the sign must be mounted 80 inches from the ground surface so that it cannot be obscured by a parked vehicle (see CBC 1129B.5). The "van-accessible" parking space shall provide an additional sign marked "van-accessible" mounted below the sign (see CBC 1129B.5 and ADAAG 4.6.4). Do not use the word "Handicapped" on signage.

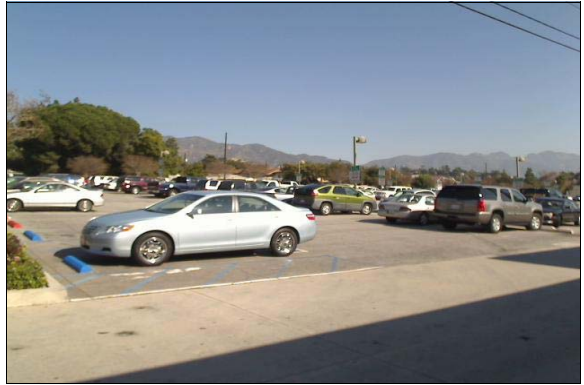
Accessible Route from the Public Right of Way

Finding: There is no accessible route from the public right of way to the parking lot or to the accessible parking space.

Full Rec: Provide at least one accessible route from the public right of way to the parking lot and to the accessible parking spaces. Make certain to post signage indicating the direction of the accessible route to the public right of way. Signs shall include the International Symbol of Accessibility.
