Accessibility Survey

City of Glendale

College Parking Lot #33

Inspected January 2008

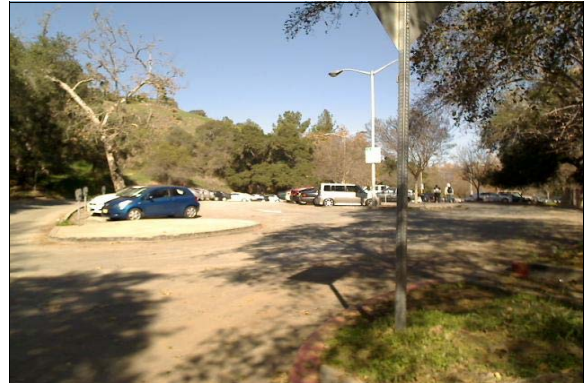
Finding: Parking Lot #33 is located at 1623 Canada Boulevard in Glendale, California. The parking lot was inspected by Disability Access Consultants, Inc., on January 16, 2008.

Full Rec: Any renovation or new construction that occurred after January 26, 1992, is subject to meet full code specifications for the California Building Code and ADAAG requirements. All recommendations in this report are based on ADAAG and CBC Title 24 requirements. Consult with your design professional to determine which elements are affected by these requirements. It is recommended that Disability Access Consultants, Inc. is consulted for inspection of any new construction or renovation at the facility.

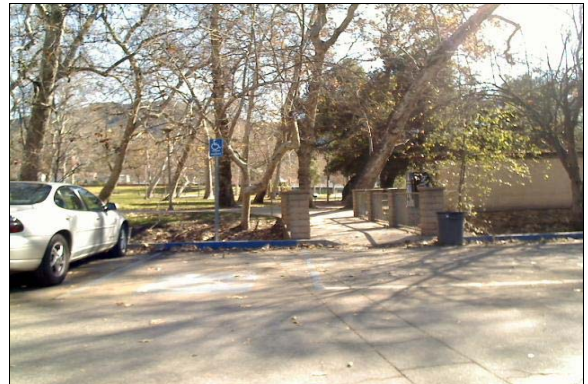
Accessible Parking

Finding: There are 2 accessible parking spaces out of 165 parking spaces which does not meet the minimum number for compliance. The accessible parking spaces do not measure at least 108 inches wide and 216 inches long. There is no "van-accessible" parking space, the access aisle is not striped and does not contain "NO PARKING" in 12" high white letters.

Full Rec: Six out of the 165 total number of marked parking spaces are required to be designated exclusively for accessible parking. Restripe the existing accessible spaces and create 4 more that will measure at least 108 inches wide and 216 inches long. Designate one parking space as "van-accessible". The van-accessible space shall provide a 96 inch wide passenger side access aisle. Add the words NO PARKING in 12 inch high white letters at the entrance to each accessible parking access aisle.

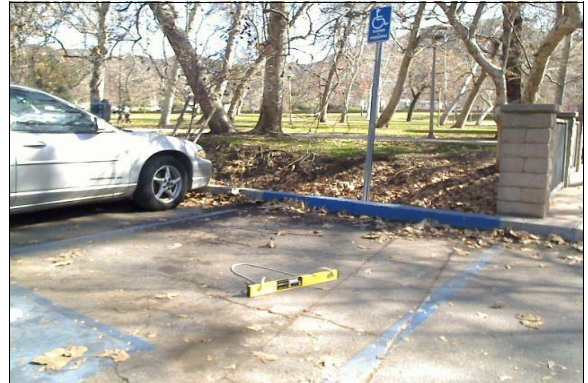
Accessible Parking

Finding: The surface of the accessible parking space on the left slopes greater than 2%.

Full Rec: Pave the parking lot at the accessible space to provide a level surface. Parking surfaces and access aisles shall be located in areas not exceeding 2% slope in all directions (see CBC 1129B and ADAAG 4.6.3).

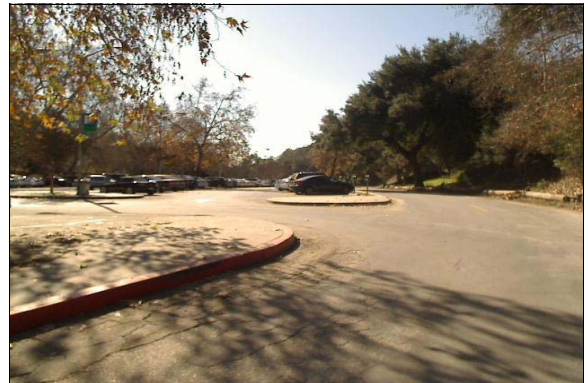
Accessible Parking

Finding: There is no warning signage posted at the entrance from Canada Boulevard regarding unauthorized use of accessible parking spaces in the parking lot.

Full Rec: Post a sign in a conspicuous place at the entrance of the parking lot, or immediately adjacent to and visible from each accessible space. The warning sign shall measure at least 17 inches by 22 inches in size and consist of lettering at least 1 inch in height that states the following; "Unauthorized vehicles parked in designated accessible spaces not displaying distinguishing placards or license plates issued for persons with disabilities may be towed away at owner's expense. Towed vehicles may be reclaimed at _____ or by telephoning ____ ." Fill in the blank spaces with appropriate information as a permanent part of the sign and be sure to add the CVC 22511.8(a)(d) to the sign.

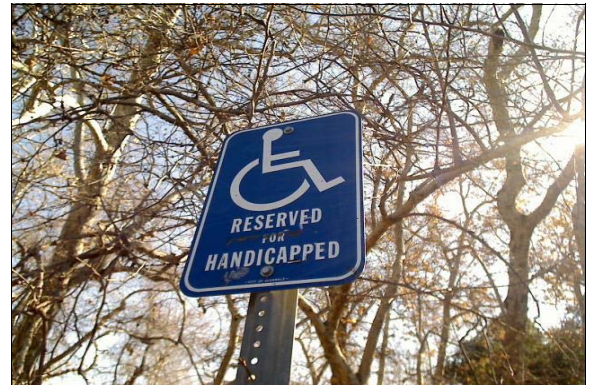
Accessible Parking

Finding: There is vertically-mounted signage at the accessible parking spaces, however, the signs use the word "Handicapped".

Full Rec: Install a permanently posted reflectorized sign measuring 70 square inches that includes an ISA symbol adjacent to and visible from the accessible parking space (see CBC 1129B.5). The bottom edge of the sign must be mounted 80 inches from the ground surface so that it cannot be obscured by a parked vehicle (see CBC 1129B.5). The "van-accessible" parking space shall provide an additional sign marked "van-accessible" mounted below the sign (see CBC 1129B.5 and ADAAG 4.6.4). Do not use the word "Handicapped" on signage.

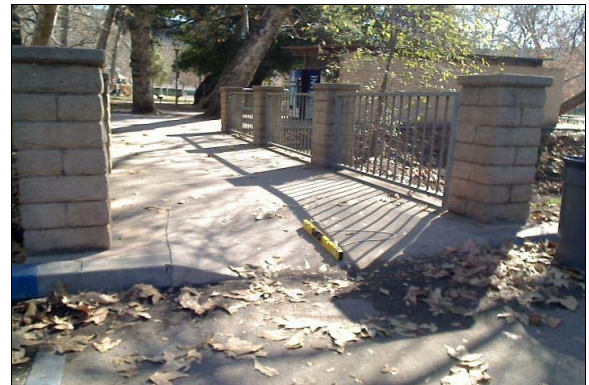
Curb Ramp at the Accessible Parking Access Aisle

Finding: The width of the curb-cut ramp is less than 48 inches. The transition at the bottom landing is abrupt and the side flares slope greater than 10%.

Full Rec: Replace the curb ramp with a compliant curb ramp at least 48 inches in width that provides a slope no greater than 8.33% and a cross slope no greater than 2%. The slope of the top landing shall not exceed 2% and shall provide at least 48 inches in length of maneuvering clearance. The bottom landing shall provide a smooth transition. The side flares shall be no greater in slope than 10%.

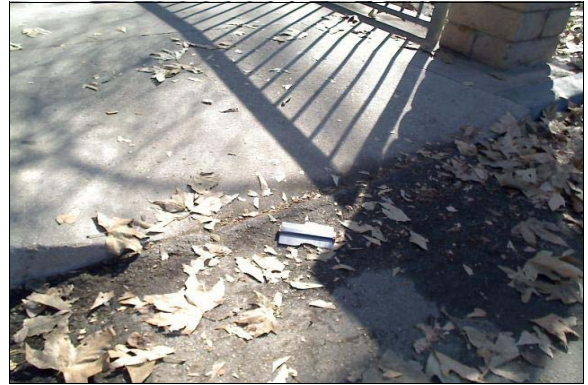
Curb Ramp at the Accessible Parking Access Aisle

Finding: The curb ramp does not provide a 12 inch grooved border along the top and side flares and does not have a detectable warning surface of truncated domes.

Full Rec: Provide a grooved border at least 12 inches wide along the top and sides of the curb ramp at the level surface of the sidewalk (see CBC 1127B.5.7). Install a compliant detectable warning surface which extends the full length and width of the concrete curb ramp and its side flares with truncated domes that contrast visually by either light on dark or dark on light which is an integral part of the concrete curb ramp.

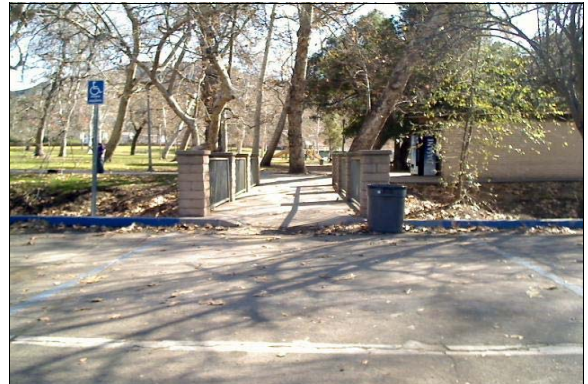
Accessible Route from the Public Right of Way

Finding: There is accessible route from the parking lot to the public right of way. There is no directional signage.

Alternative Provide directional signage to the public right of way.
Rec:
(Where Available)

Full Rec: Provide at least one accessible route from the public right of way to the parking lot and to the accessible parking spaces. Make certain to post signage indicating the direction of the accessible route to the public right of way. Signs shall include the International Symbol of Accessibility.
