Accessibility Survey

Americans with Disabilities Act And Title 24 of the California Building Code

City of Glendale

Montrose Parking Lot #1

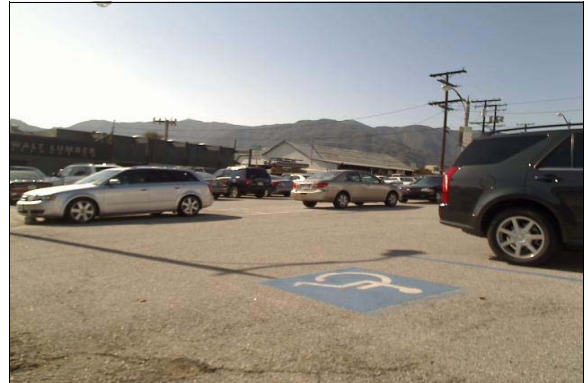
Finding: Parking Lot #1 is located at the intersection of Honolulu Avenue and Verdugo Road in Glendale, California. The parking lot was inspected by Disability Access Consultants, Inc., on January 17, 2008.

Full Rec: Any renovation or new construction that occurred after January 26, 1992, is subject to meet full code specifications for the California Building Code and ADAAG requirements. All recommendations in this report are based on ADAAG and CBC Title 24 requirements. Consult with your design professional to determine which elements are affected by these requirements. It is recommended that Disability Access Consultants, Inc. is consulted for inspection of any new construction or renovation at the facility.

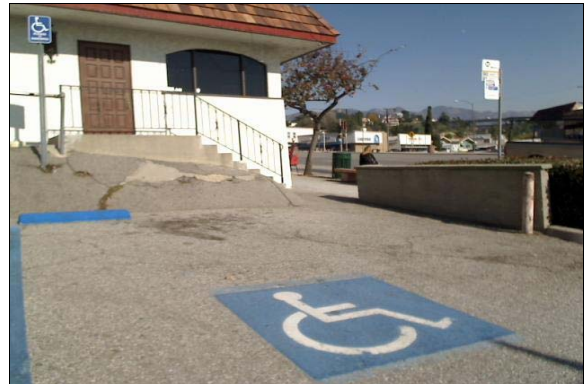
Accessible Parking

Finding: There is one (1) accessible parking space out of 36 parking spaces which is one less space than the minimum number for compliance. The accessible parking space does not measure at least 216 inches long and is not outlined on the right side. There is no "van-accessible" space and no access aisle.

Full Rec: Restripe the existing accessible space and create a van-accessible space each measuring at least 108 inches wide and 216 inches long. The van-accessible space shall provide a 96 inch wide passenger side access aisle. Add the words NO PARKING in 12 inch high white letters at the entrance to the access aisle.

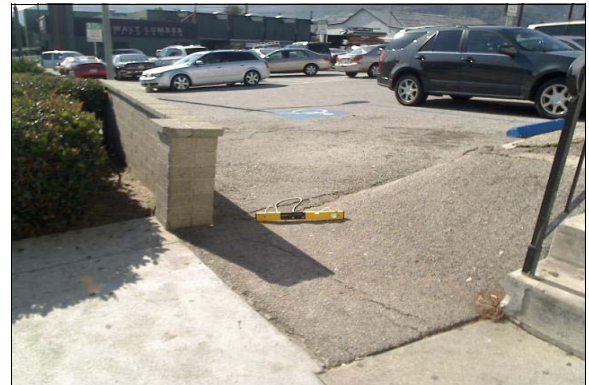
Accessible Parking

Finding: There is an accessible route between the accessible parking space and the public right of way. The route is less than 48 inches wide and slopes greater than 5%.

Full Rec: Install a compliant path of travel from the sidewalk (public right of way) to the accessible parking space. The route should be at least 48 inches wide, have running slopes less than 5% and cross slopes less than 2%. The surface should be firm, stable, and slip resistant.

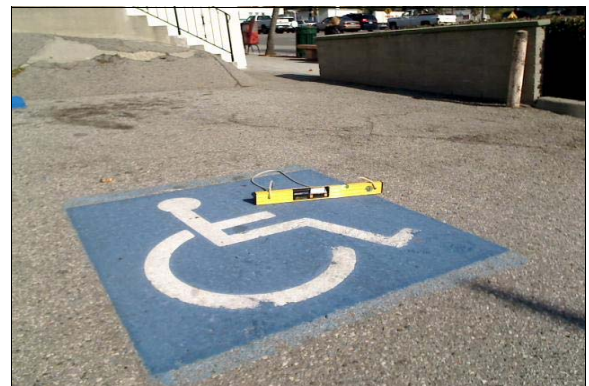
Accessible Parking

Finding: The surface of the accessible parking space has slopes greater than 2%.

Full Rec: Pave the parking lot at the accessible space to provide a level surface. Parking surfaces and access aisles shall be located in areas not exceeding a 2% slope in all directions (see CBC 1129B and ADAAG 4.6.3).

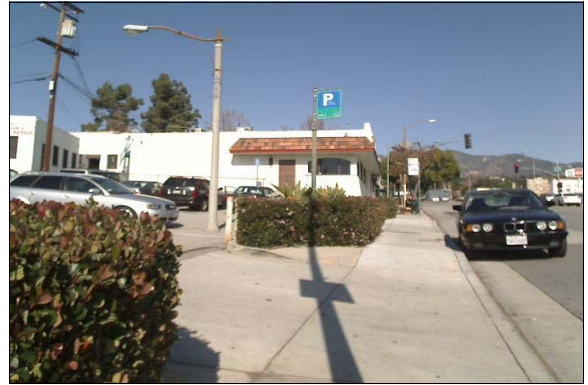
Accessible Parking

Finding: There is no warning signage posted at the entrance from Verdugo Road regarding unauthorized use of accessible parking spaces in the parking lot.

Full Rec: Post a sign in a conspicuous place at the entrance of the parking lot, or immediately adjacent to and visible from each accessible space. The warning sign shall measure at least 17 inches by 22 inches in size and consist of lettering at least 1 inch in height that states the following; "Unauthorized vehicles parked in designated accessible spaces not displaying distinguishing placards or license plates issued for persons with disabilities may be towed away at owner's expense. Towed vehicles may be reclaimed at _____ or by telephoning ____ ." Fill in the blank spaces with appropriate information as a permanent part of the sign and be sure to add the CVC 22511.8(a)(d) to the sign.

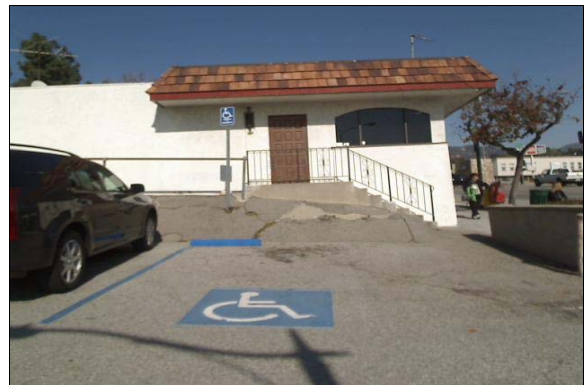
Accessible Parking

Finding: There is vertically-mounted signage at the accessible parking space, however, the signs use the word "Handicapped".

Full Rec: Install a permanently posted reflectorized sign measuring 70 square inches that includes an ISA symbol adjacent to and visible from the accessible parking space (see CBC 1129B.5). The bottom edge of the sign must be mounted 80 inches from the ground surface so that it cannot be obscured by a parked vehicle (see CBC 1129B.5). The "van-accessible" parking space shall provide an additional sign marked "van-accessible" mounted below the sign (see CBC 1129B.5 and ADAAG 4.6.4). Do not use the word "Handicapped" on signage.

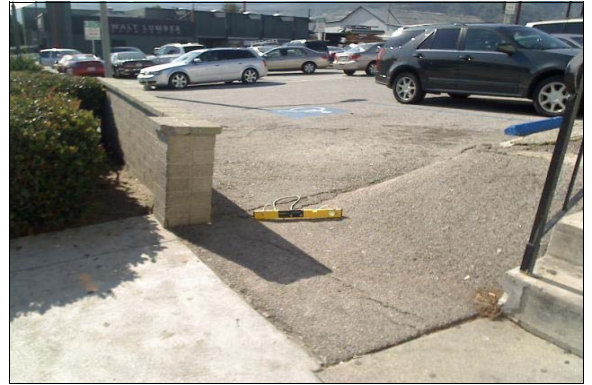
Accessible Route from the Public Right of Way

Finding: There is no directional signage to the accessible entrance from the public right of way.

Full Rec: Install directional signage at the entrance from the public right of way.
