601 and 603 Bohlig Rd. Arborist Report

Prepared for Camille Neagu
601 Bohlig Road
Glendale, CA 91207

Prepared by James Komen
BCMA WE-9909B
RCA #555

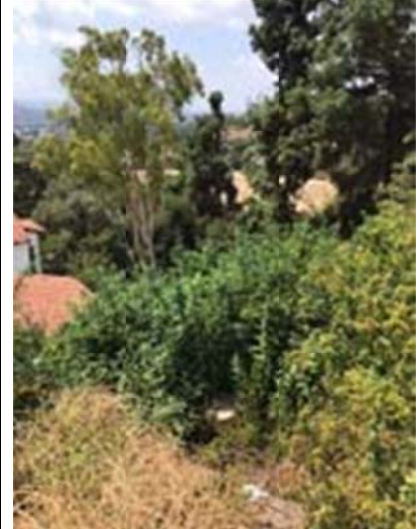
<p>Tree 1 <i>Schinus molle</i> – California Pepper Tree</p> <p>This tree was removed prior to my site visit. It was not protected by ordinance.</p>

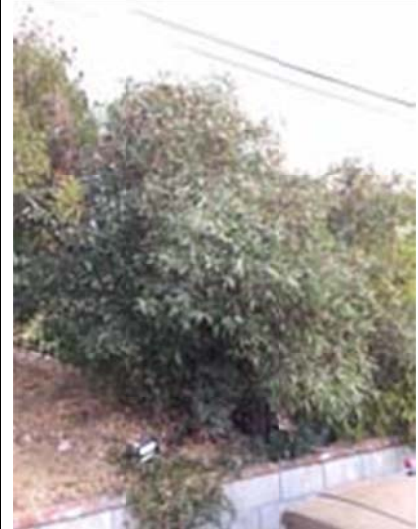
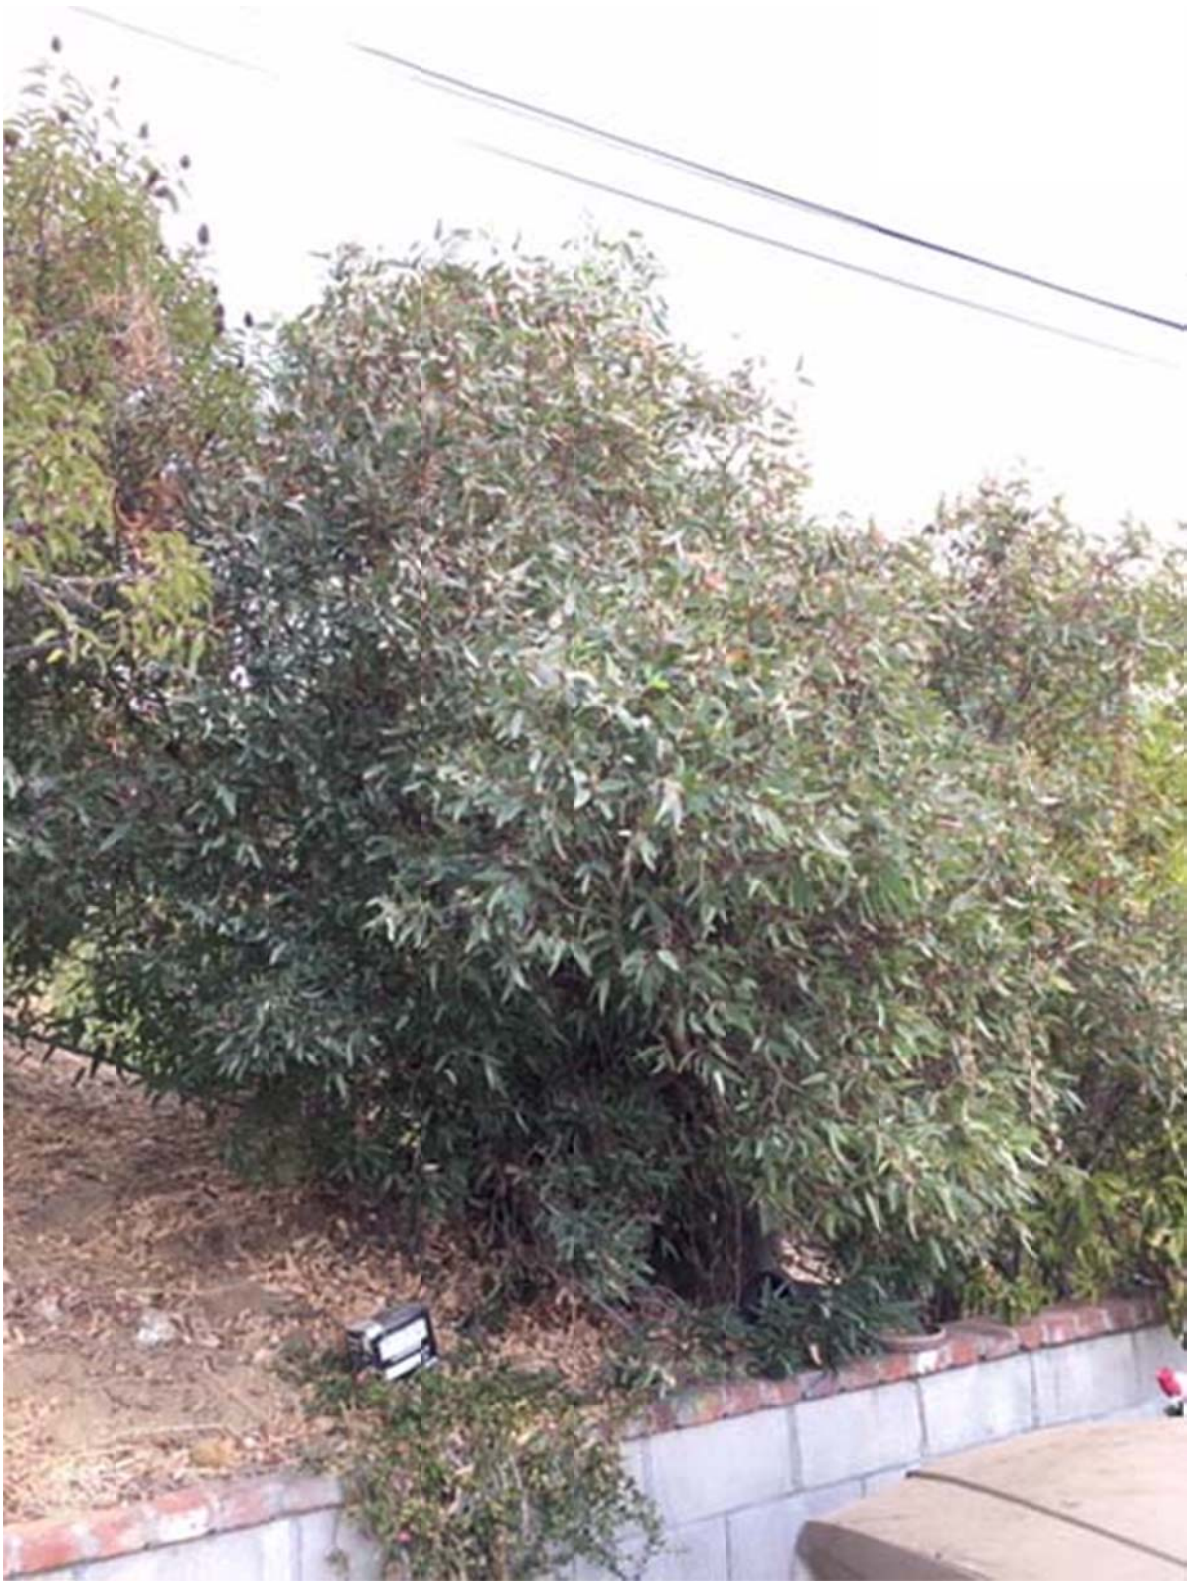
Figure 3: Tree OP2

<p>Tree OP2 <i>Eucalyptus globulus</i> – Blue Gum Eucalyptus</p> <p>This tree is not protected by the City of Glendale Indigenous Tree Protection Ordinance. What remains are stump sprouts from the trunk of a former mature Eucalyptus tree that was removed several years ago. It is growing on the neighboring property to the northeast.</p>

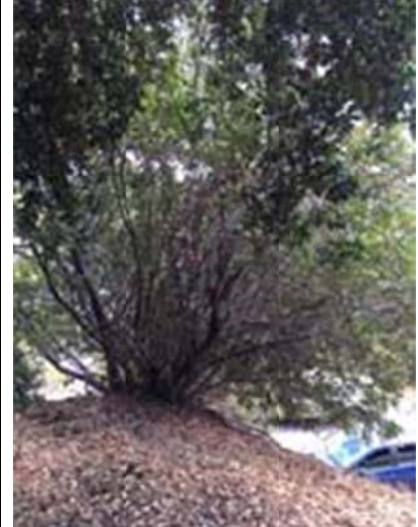
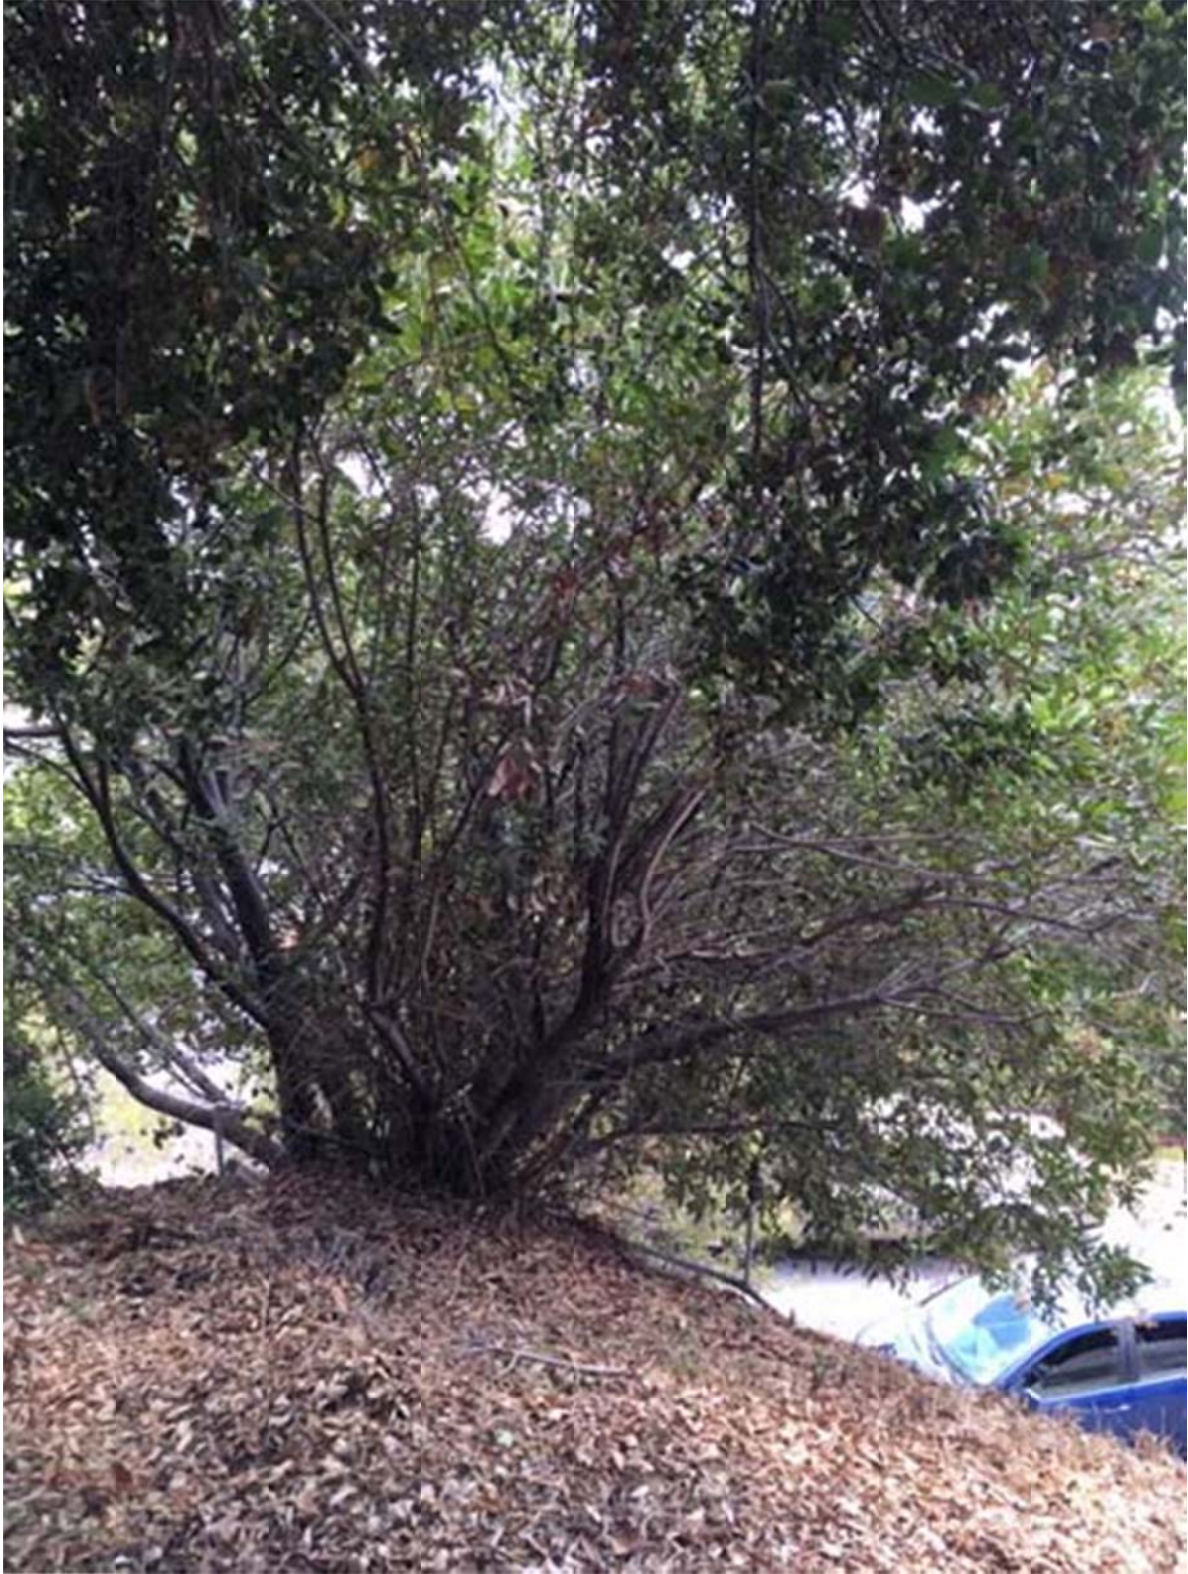
Figure 4: Tree OP3

<p>Tree OP3 <i>Heteromeles arbutifolia</i> – Toyon</p> <p>This tree is not protected by the City of Glendale Indigenous Tree Protection Ordinance. It is unlikely to be impacted by the proposed construction. It is growing on the neighboring property to the northeast.</p>

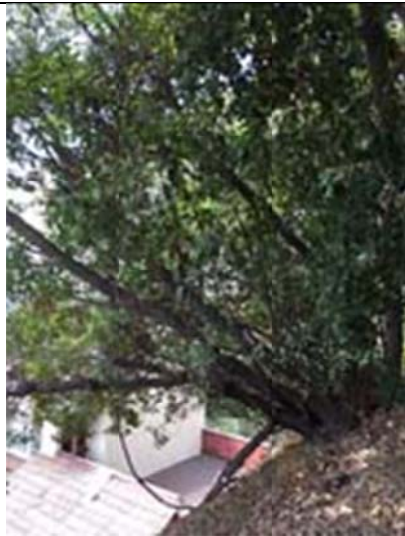
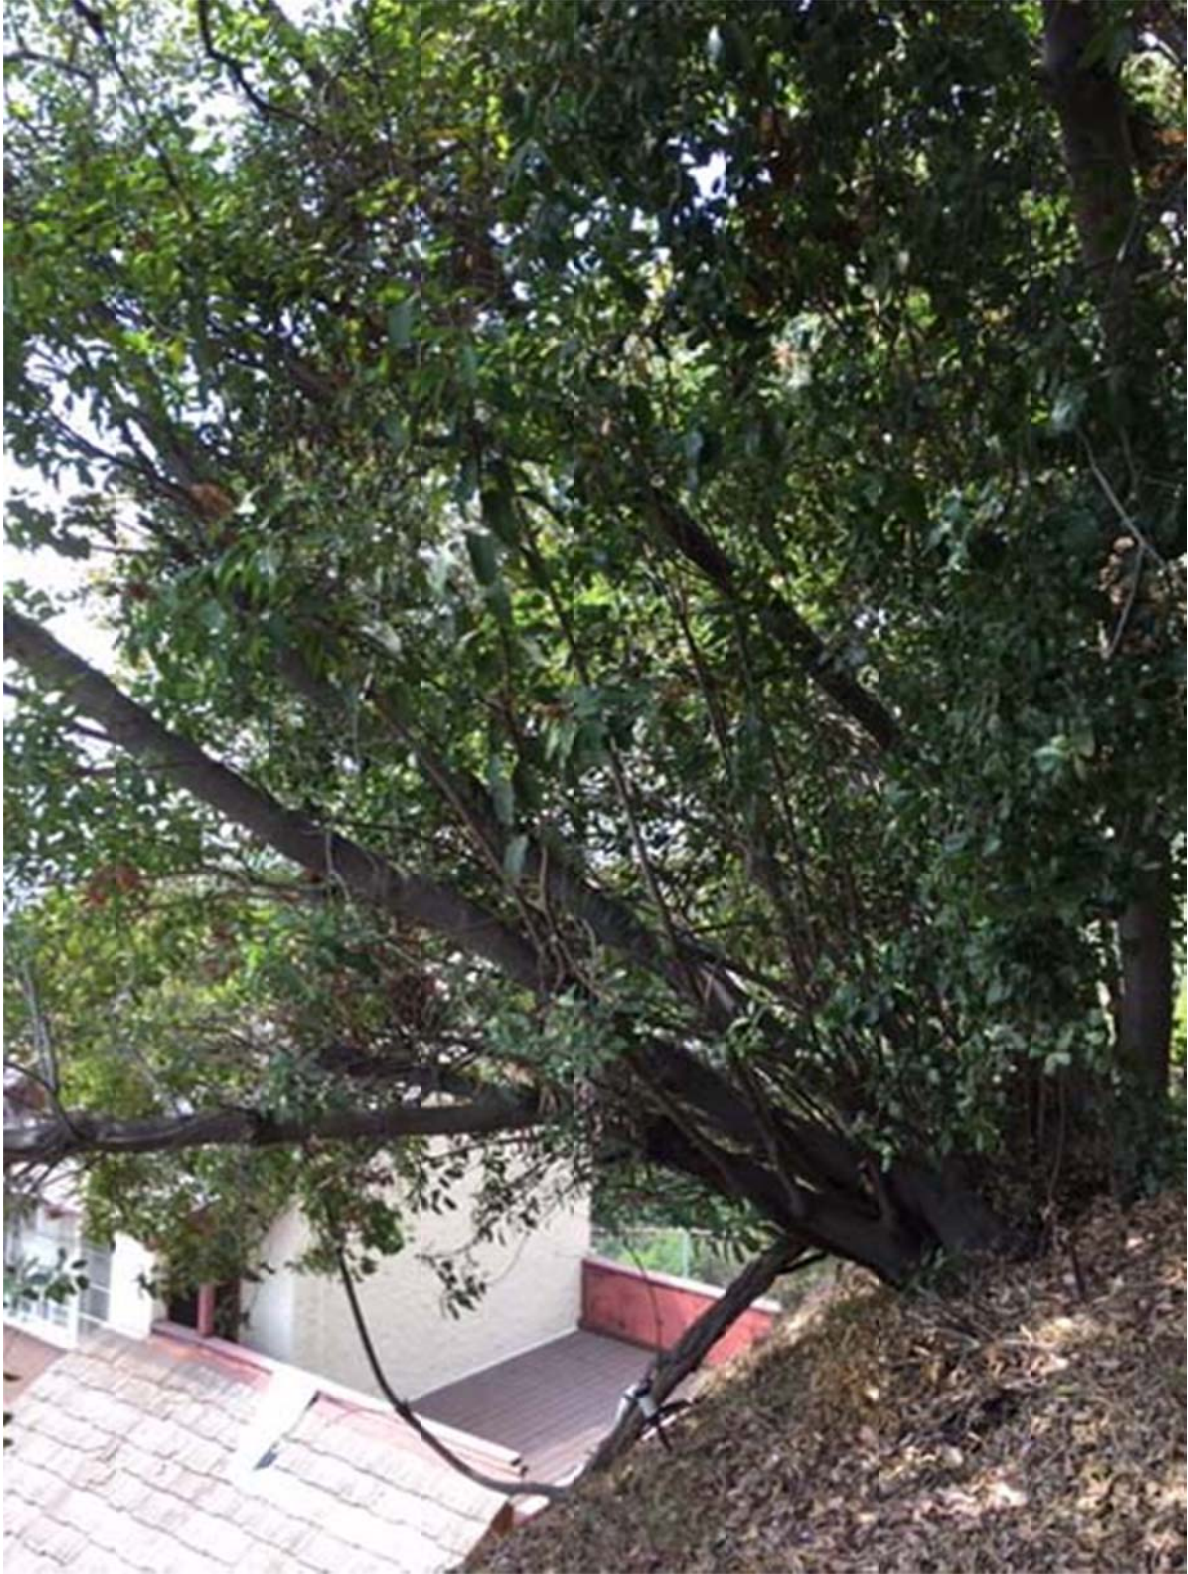
Figure 6: Tree 5

Tree 5

This tree is not protected by the City of Glendale Indigenous Tree Protection Ordinance. It will not likely be impacted by the proposed construction.

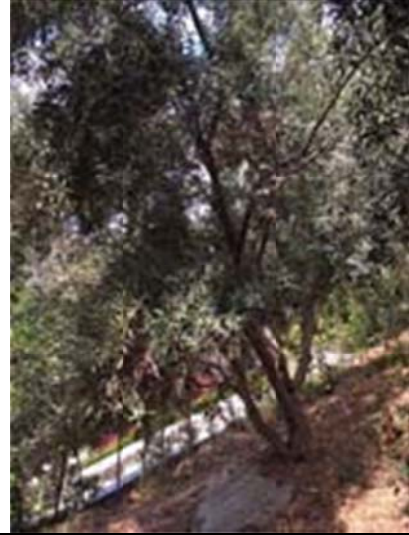
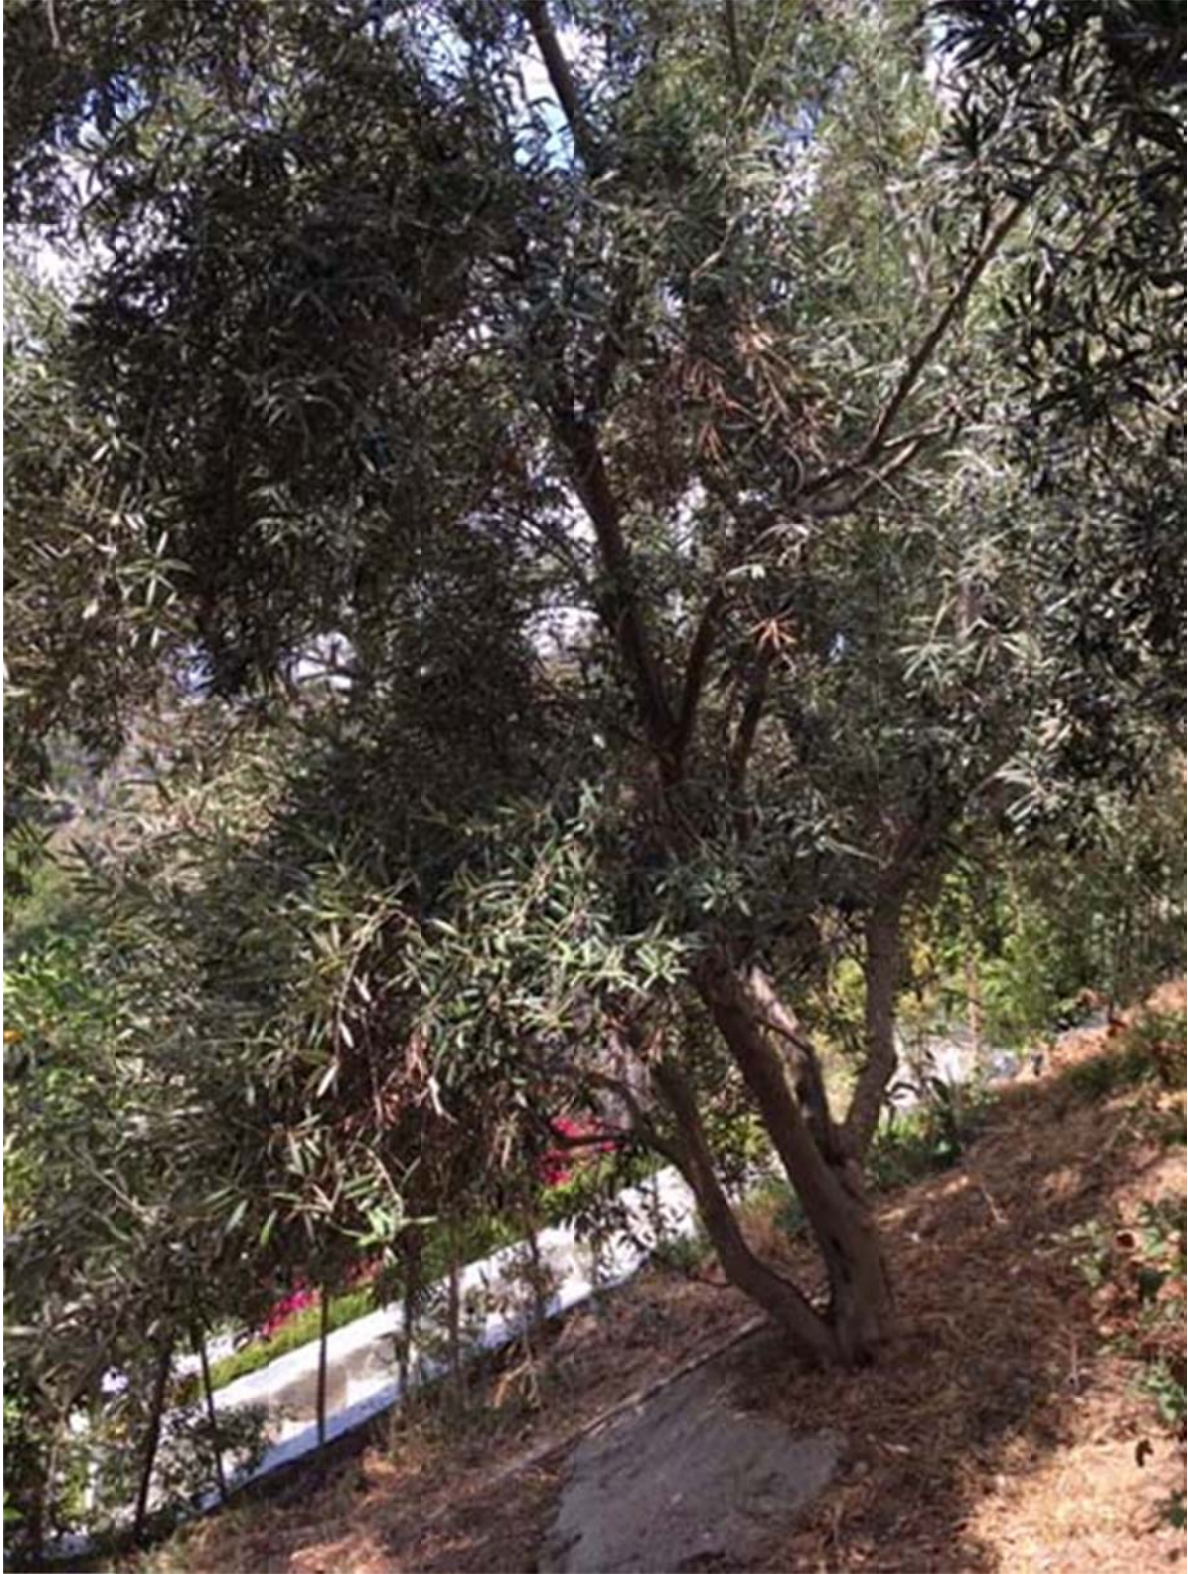
Figure 7: Tree OP6

Tree OP6

This tree is not protected by the City of Glendale Indigenous Tree Protection Ordinance. It will not likely be impacted by the proposed construction. It is growing along the property line with the neighboring property to the northeast.

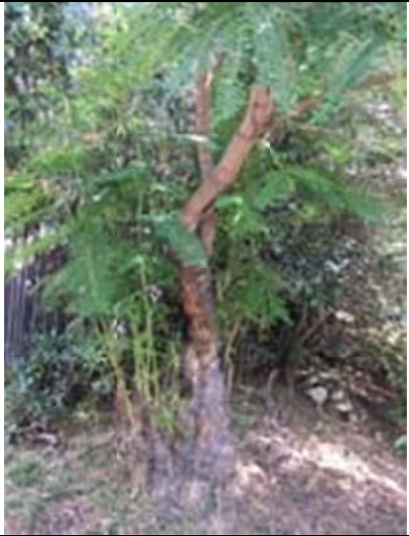
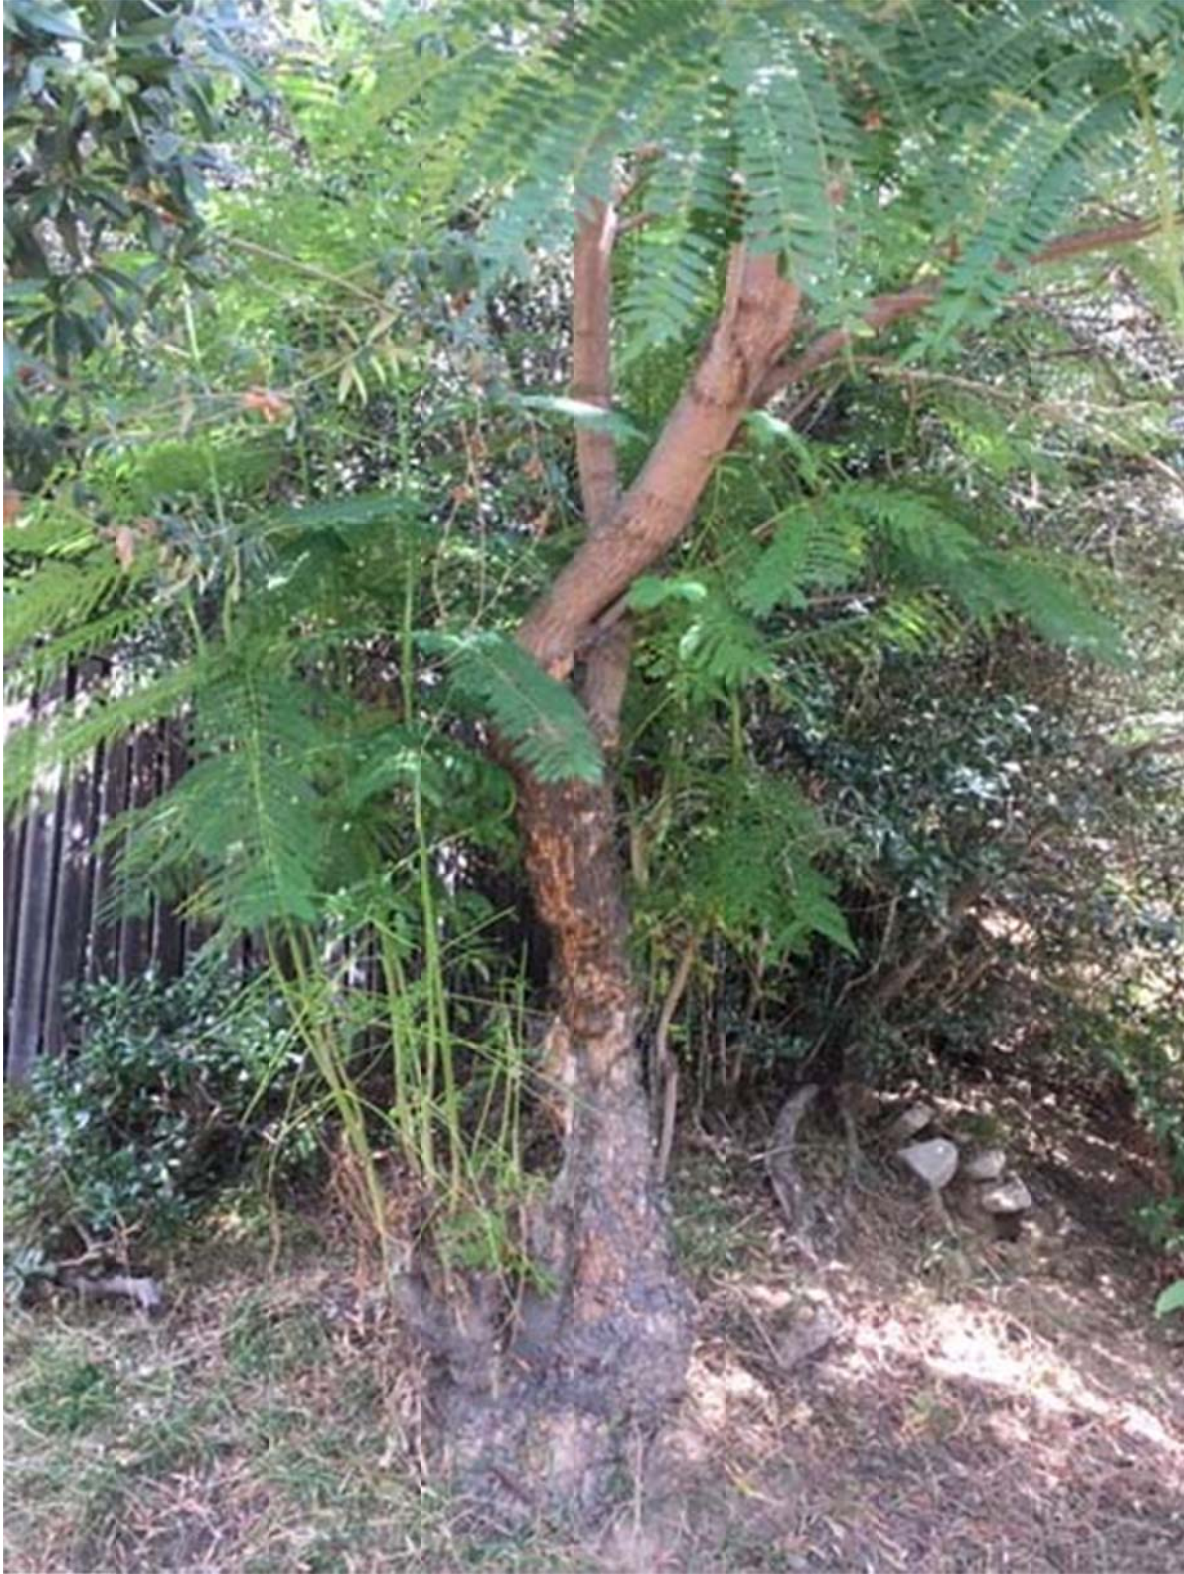
Figure 9: Tree 8

<p>Tree 8 <i>Jacaranda mimosifolia</i> – Mimosa Tree</p> <p>This tree is not protected by the City of Glendale Indigenous Tree Protection Ordinance. It will not likely be impacted by the proposed construction.</p> <p>In the past, it was pruned very heavily on the western trunk, but it has since responded well and is growing vigorously. No action is necessary at this time. It can be allowed to grow on site.</p>

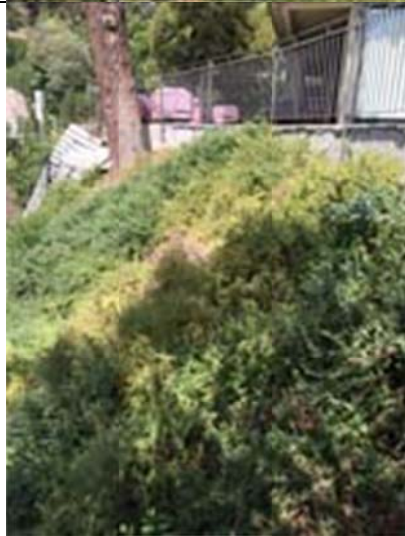
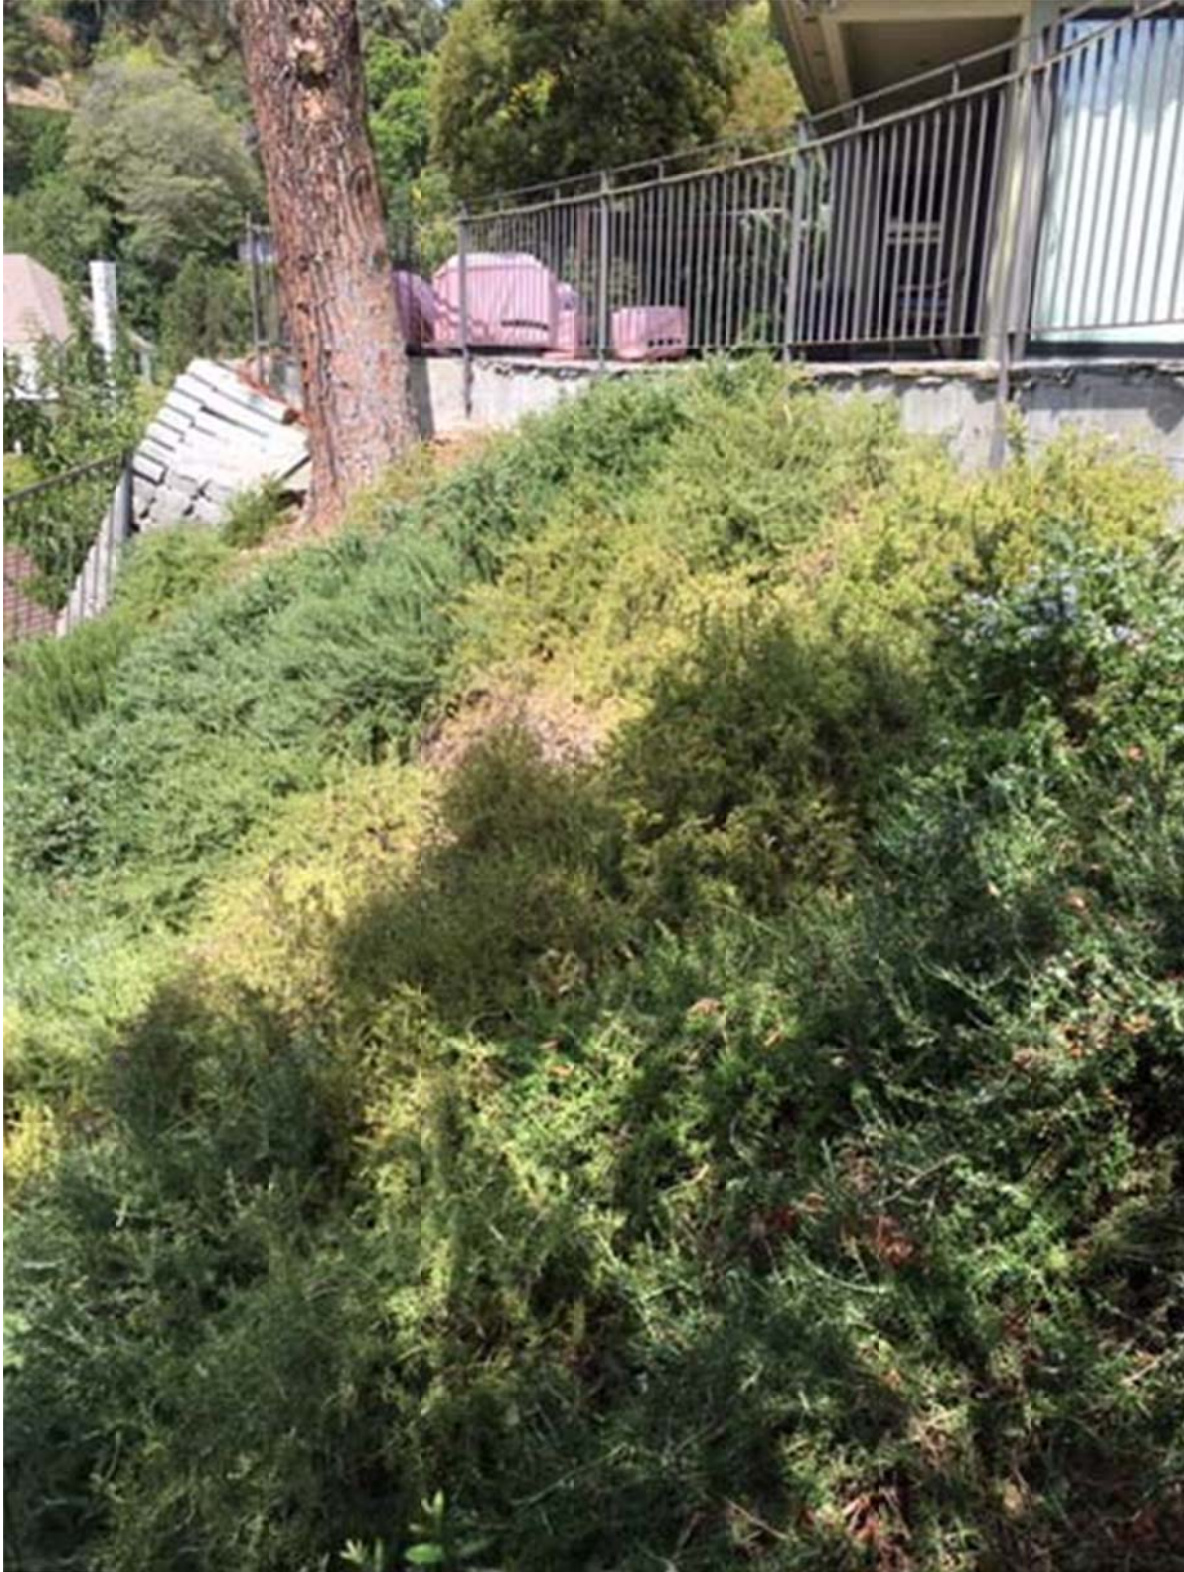
Tree OP11

This tree was removed prior to my September 10, 2019 site visit. It was not protected by the City of Glendale Indigenous Tree Protection Ordinance.

Figure 12: Tree OP11 was removed prior to my September 10, 2019 site visit.

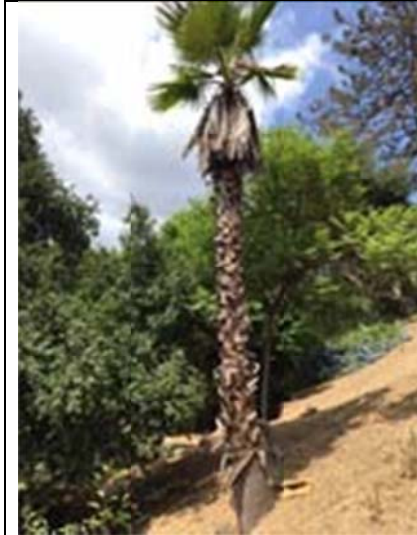
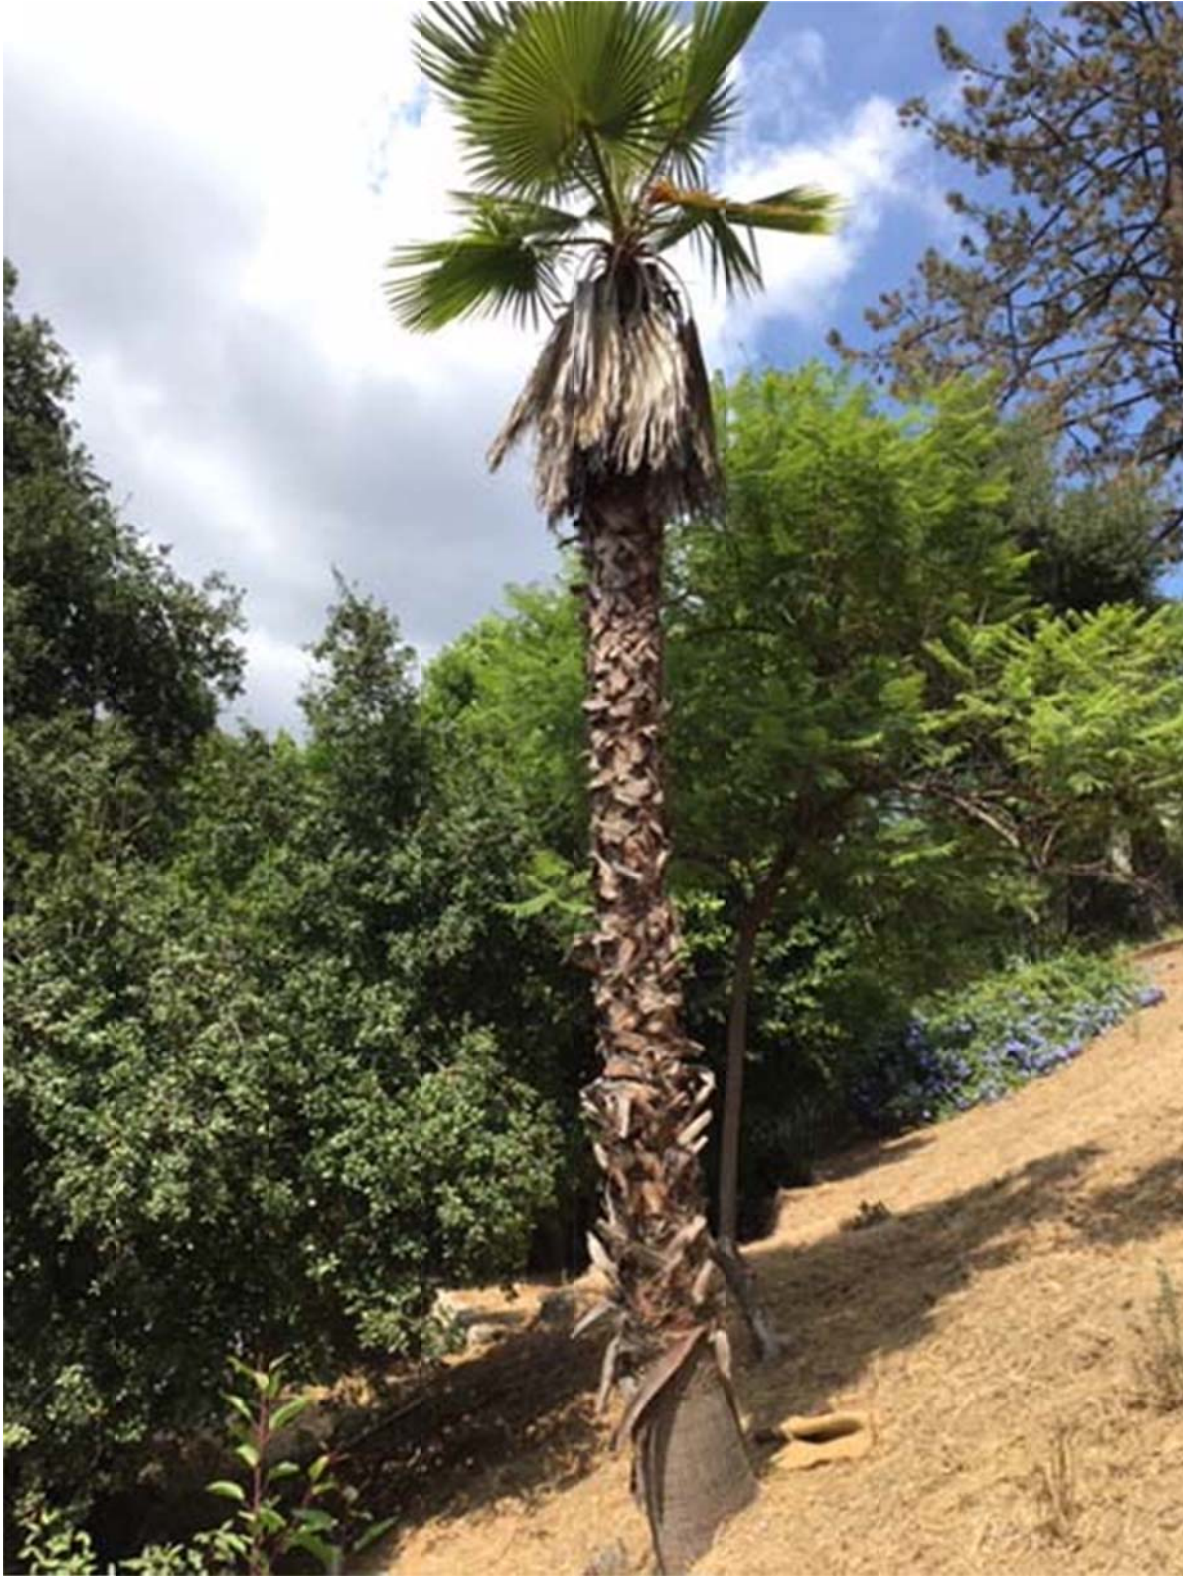
Figure 18: Tree 17

Tree 17

This tree is not protected by the City of Glendale Indigenous Tree Protection Ordinance. It will be removed because it is growing within the footprint of the grading activity necessary to construct the proposed retaining wall to the east.

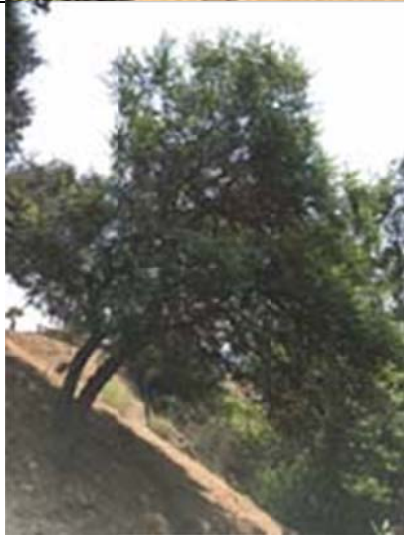
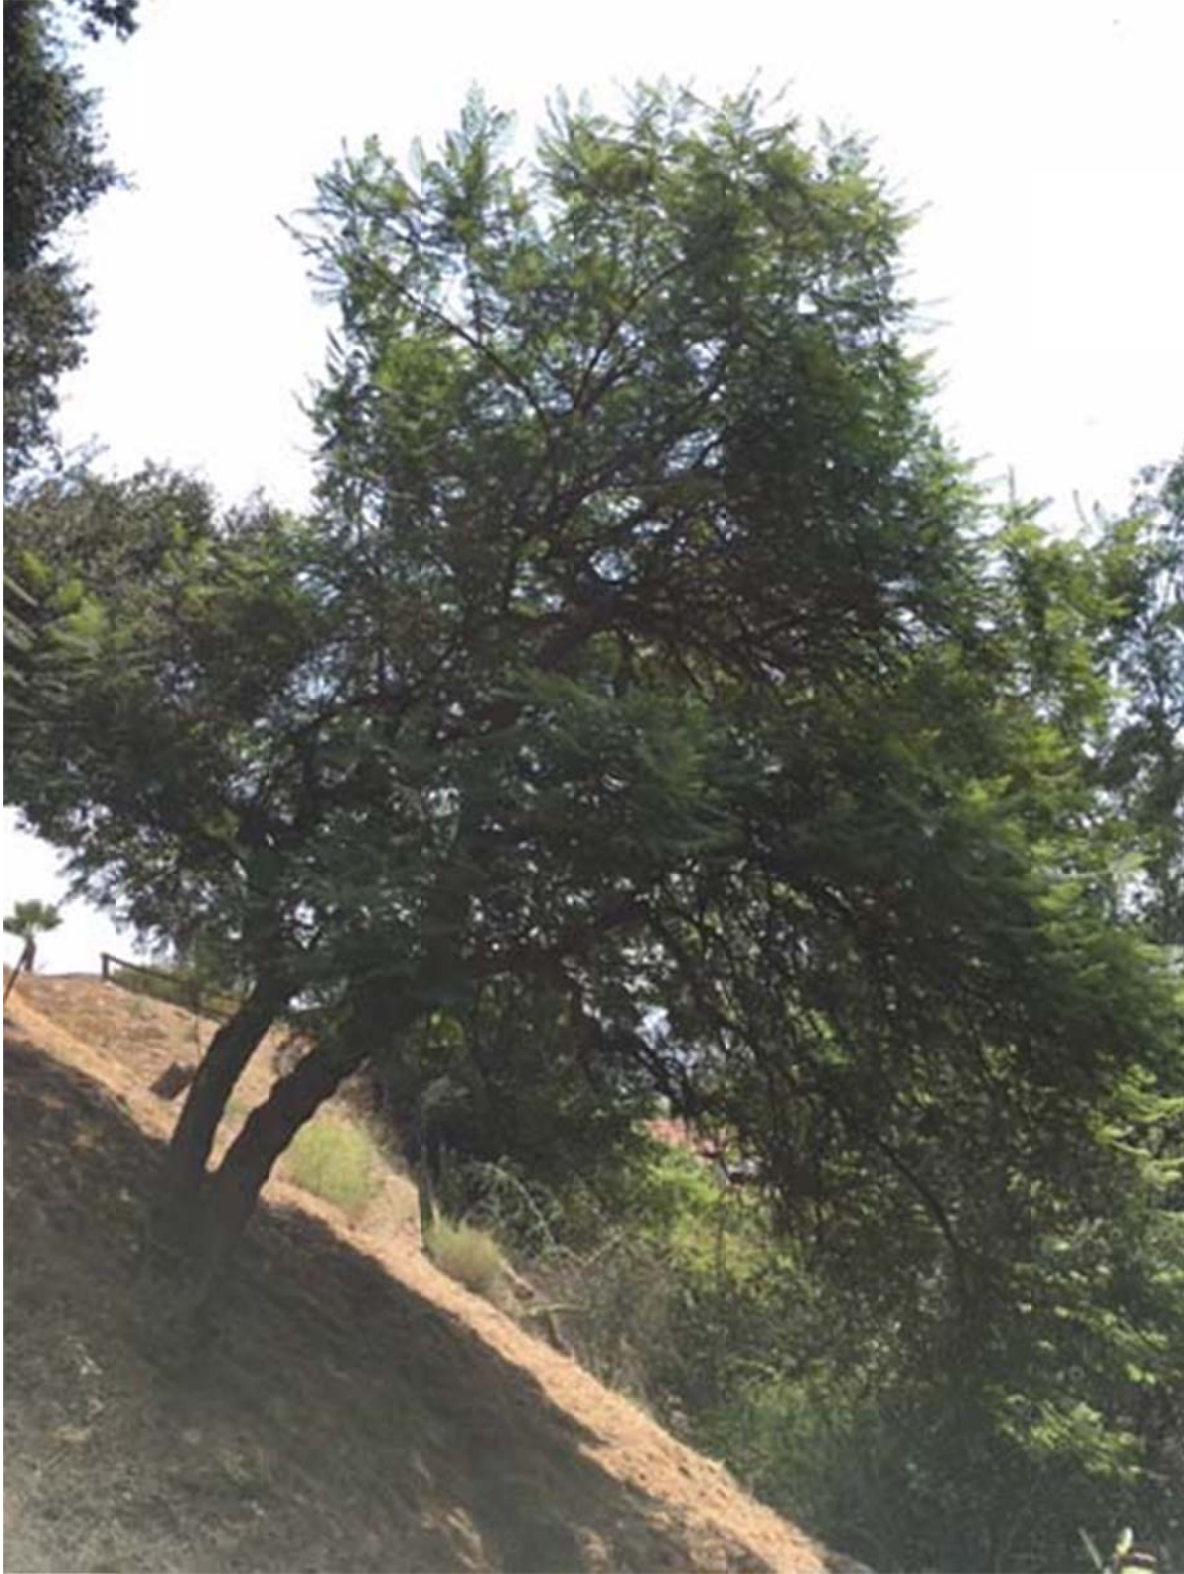
Figure 19: Tree 18

Tree 18

This tree is not protected by the City of Glendale Indigenous Tree Protection Ordinance. It will be removed because it is growing within the footprint of the grading activity necessary to construct the proposed retaining wall to the east.

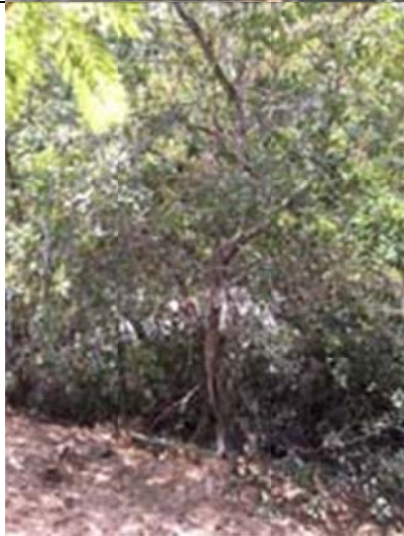
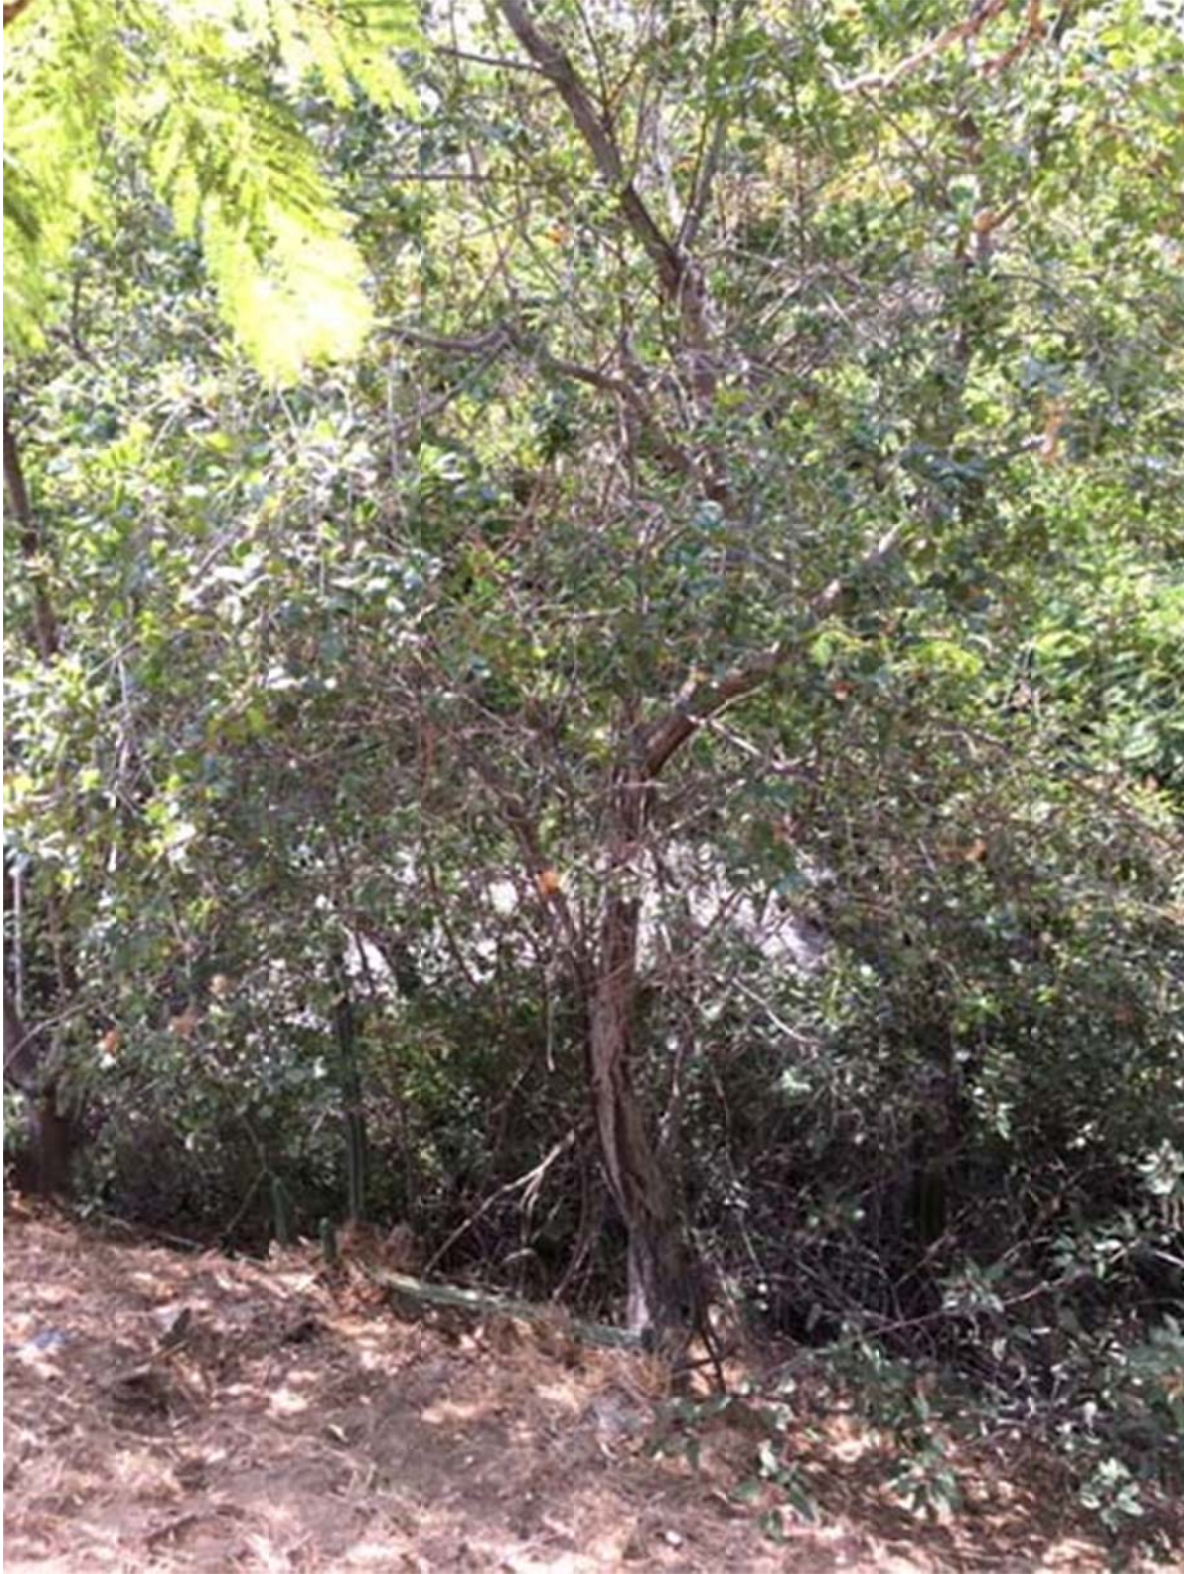
Figure 20: Tree 19

Tree 19

This tree is not protected by the City of Glendale Indigenous Tree Protection Ordinance because it is smaller than the minimum protected size of 6" DBH. This tree is proposed for removal because it is within a proposed area of grading for Lot 2.

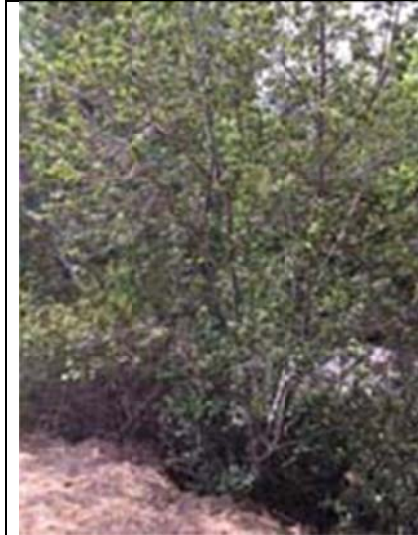
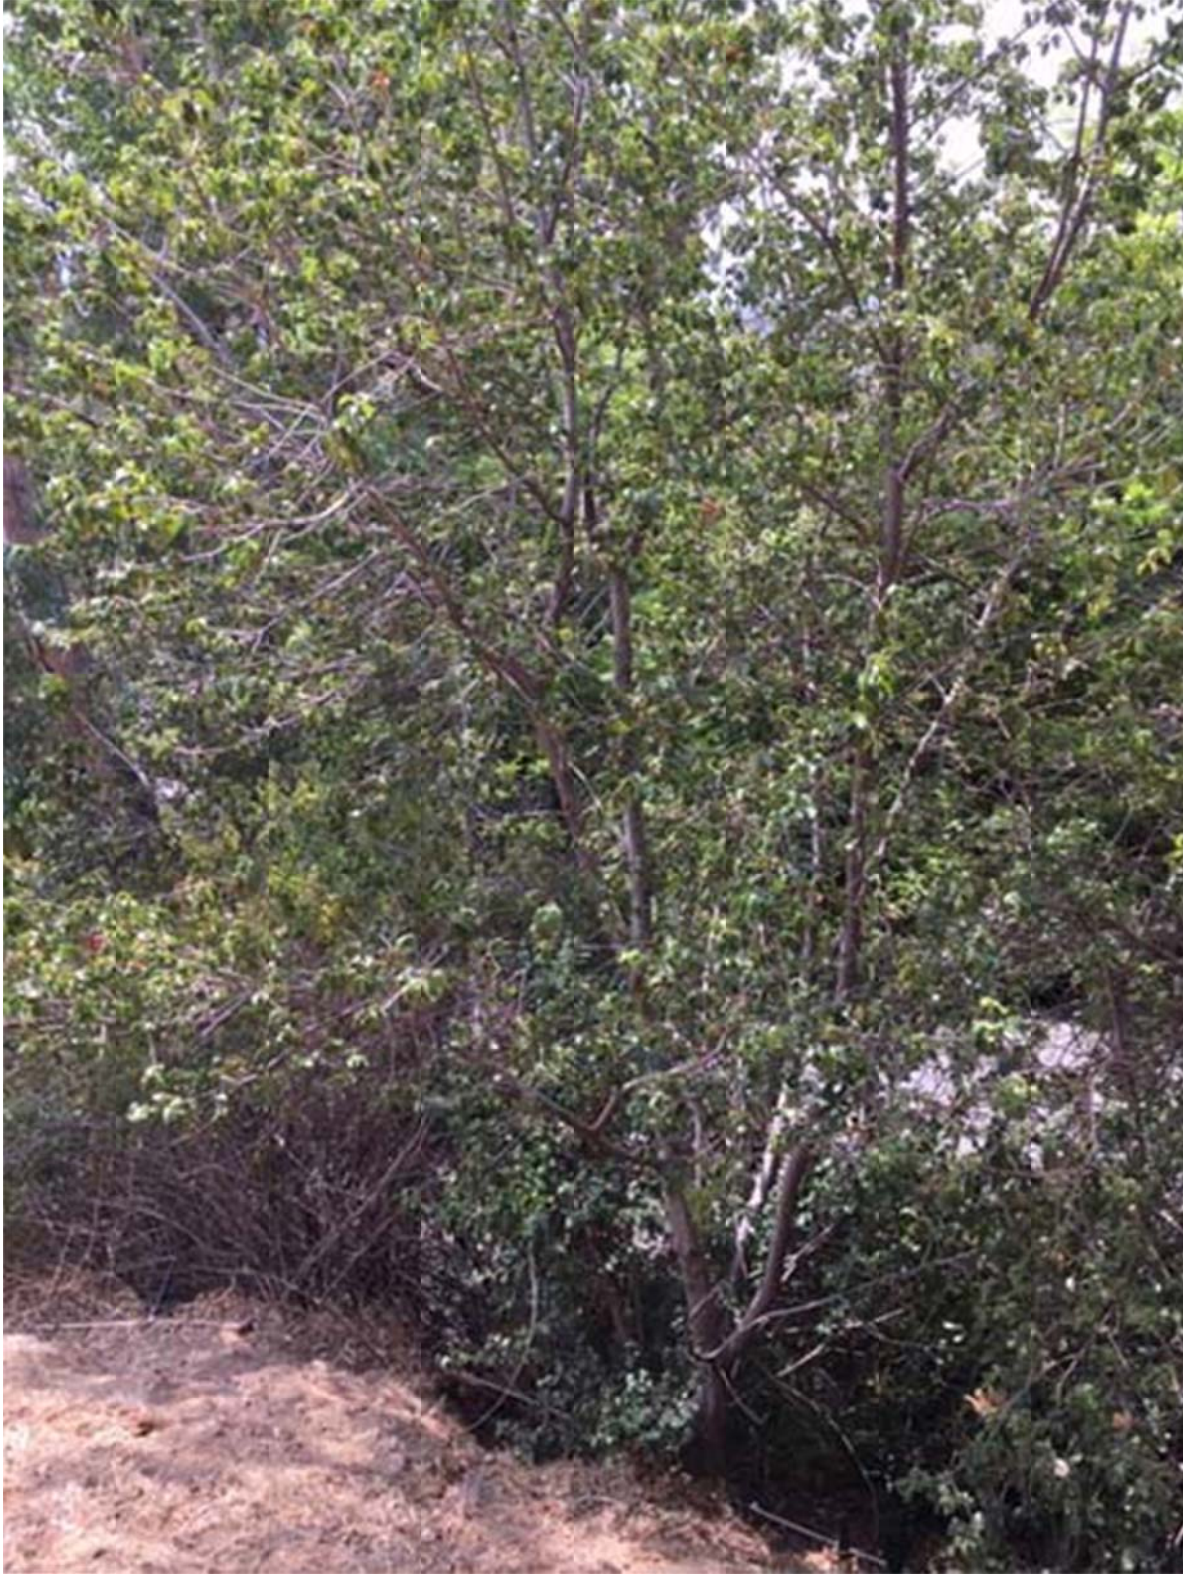
This species has many visual characteristics of the protected Coast Live Oak, but it is not the protected species. Its leaves do not have fine hairs underneath, it produces small inedible cherries, and it has slightly different-looking bark. This species is often confused with the protected Coast Live Oak.

This tree will be removed because it is within a proposed area of grading for Lot 2.

Figure 21: Tree 20 is not an oak, despite its look-alike foliage.
