601 and 603 Bohlig Rd. Arborist Report

Prepared for Camille Neagu
601 Bohlig Road
Glendale, CA 91207

Prepared by James Komen
BCMA WE-9909B
RCA #555

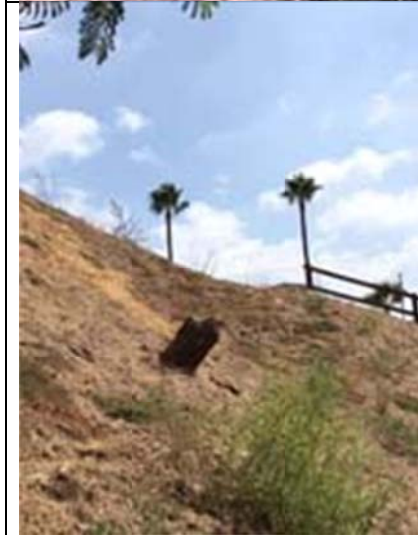
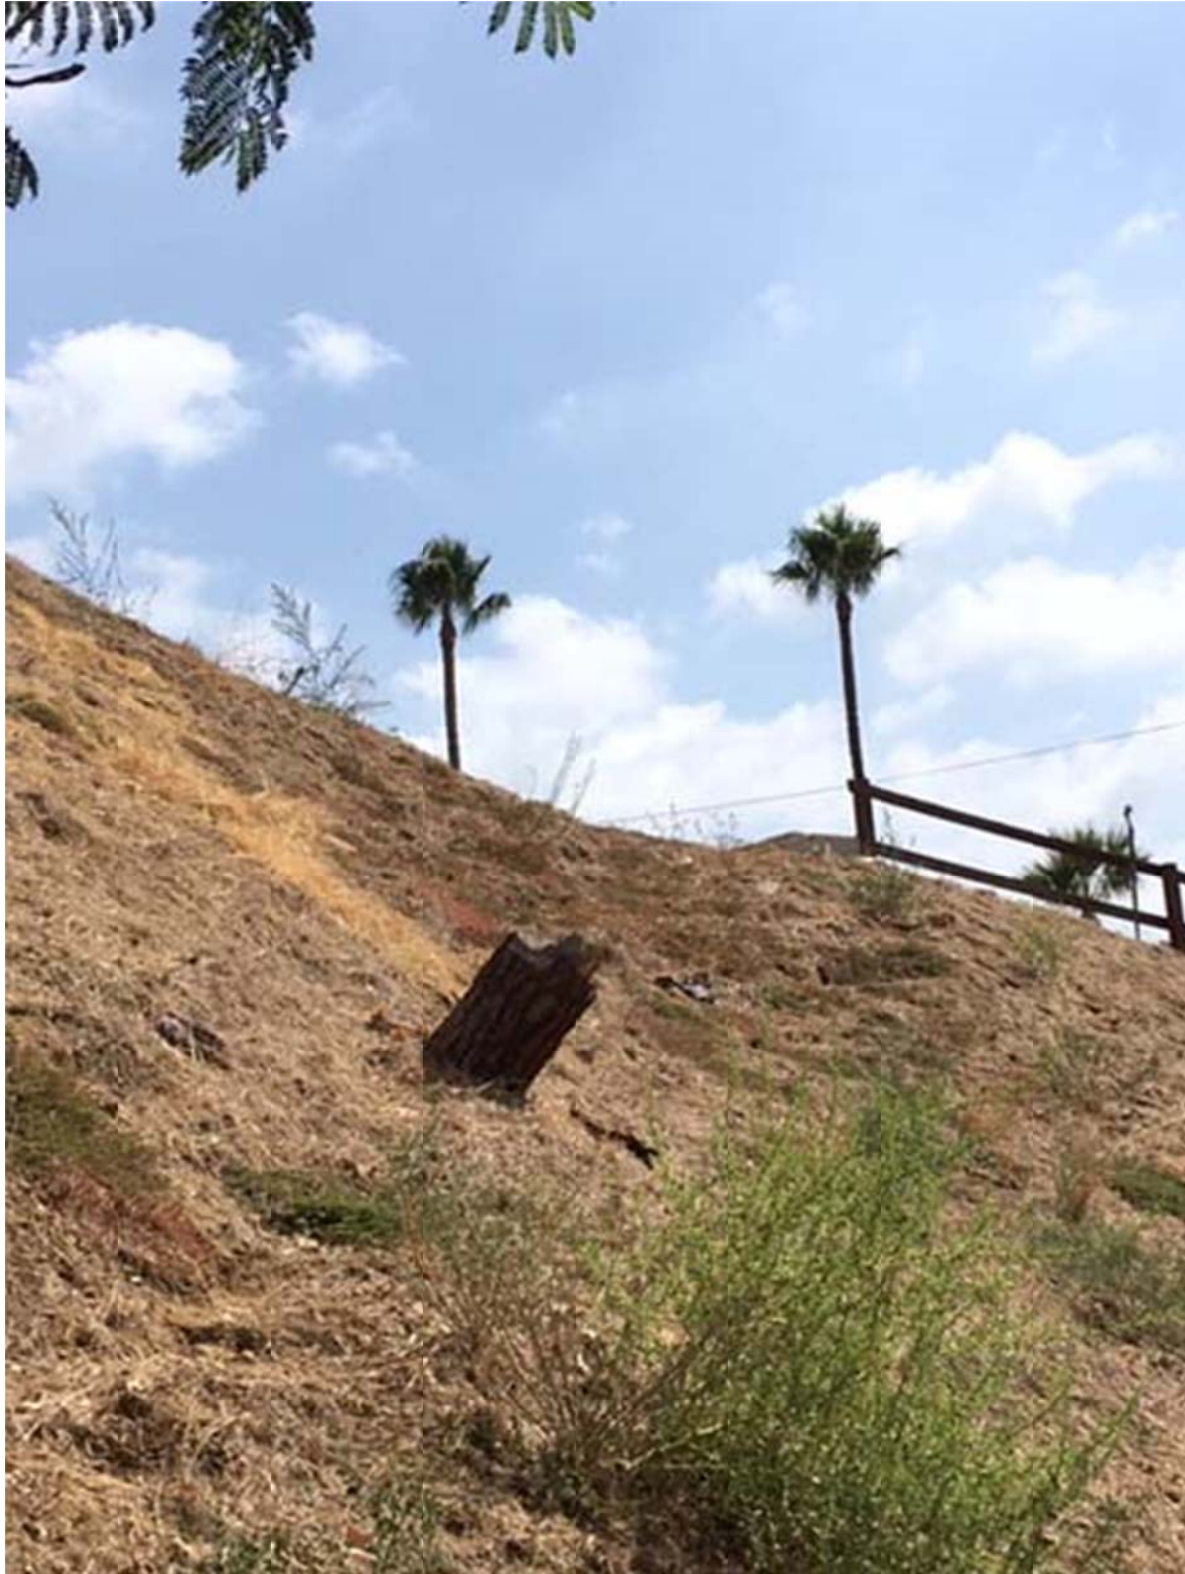
Figure 22: Tree 21 was removed prior to my September 10, 2019 site visit.

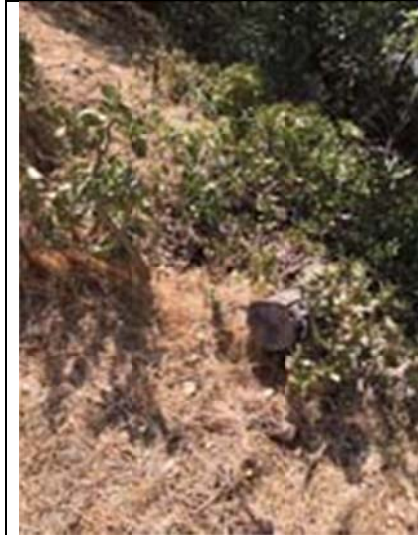
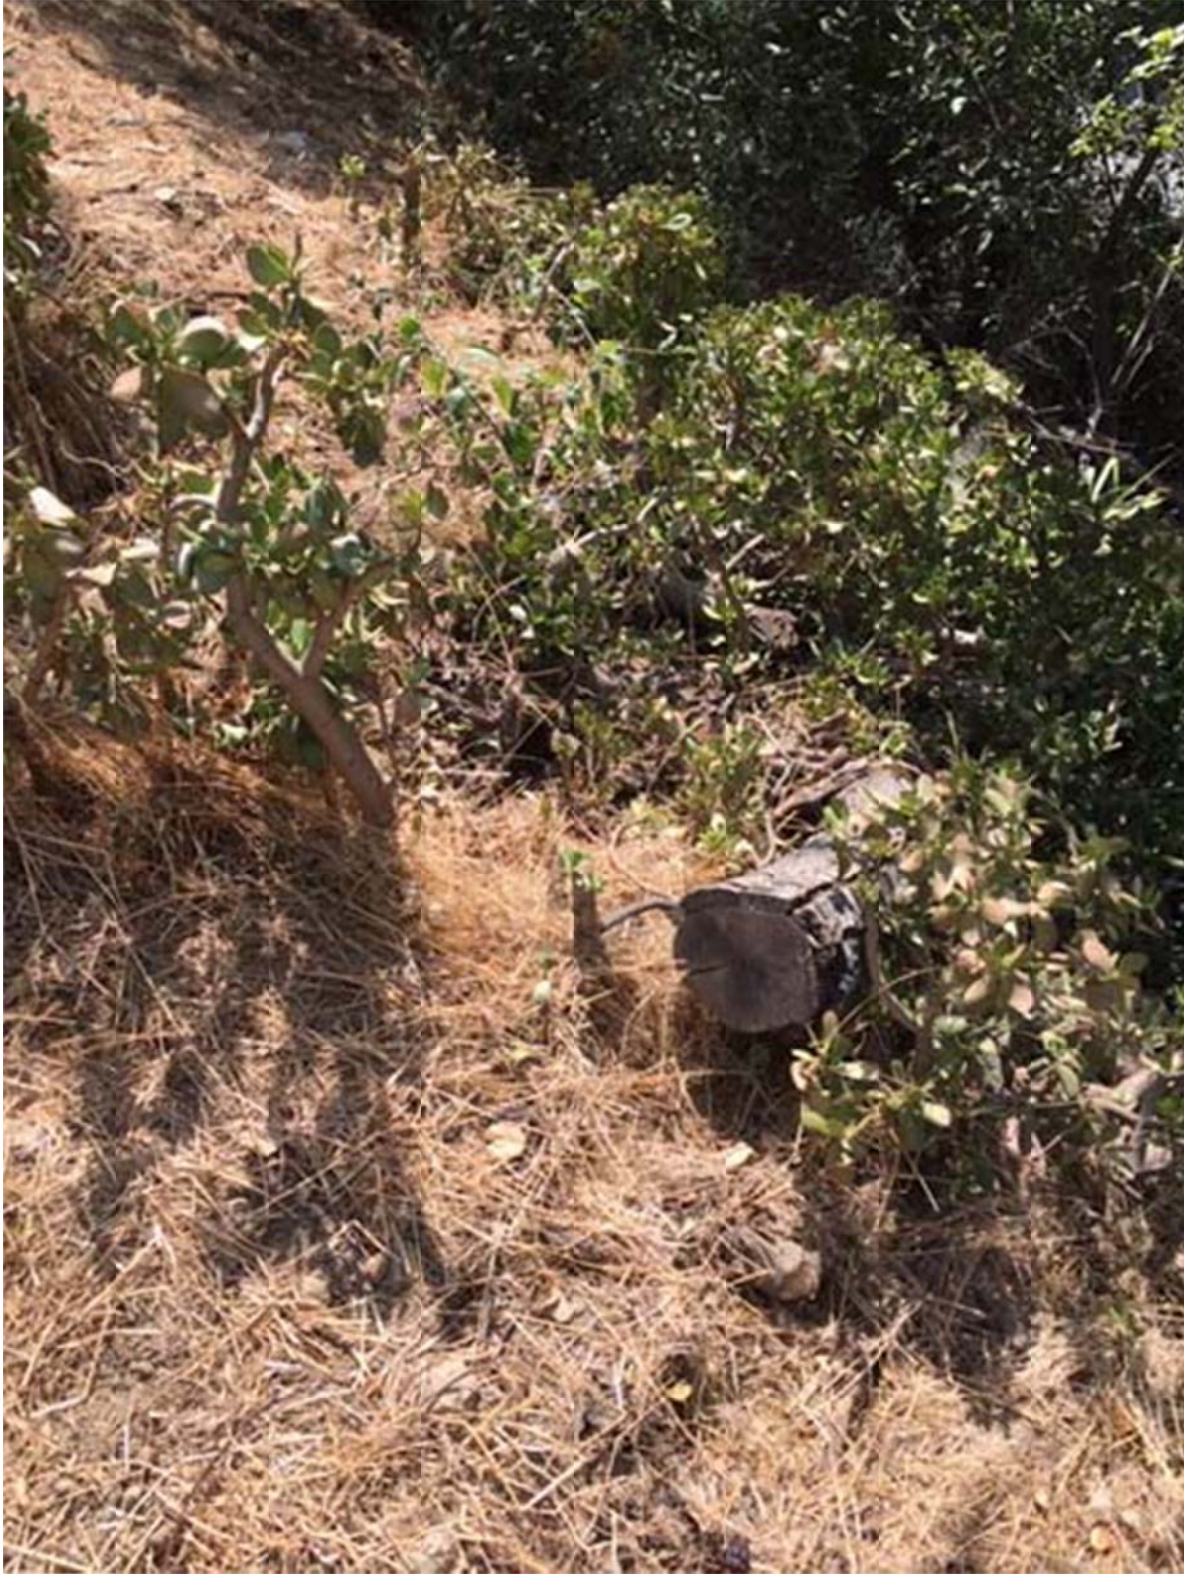
This was removed prior to my September 10, 2019 site visit. As shown in my 2017 report, it was dead in 2017 and was recommended for removal. Prior to its removal, it was larger than 6 inches in diameter, so it was protected by the City of Glendale Indigenous Tree Protection Ordinance.

Figure 24: Tree 23 was removed prior to my September 10, 2019 site visit.

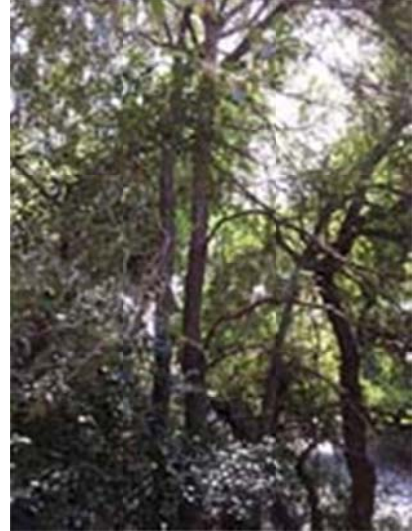
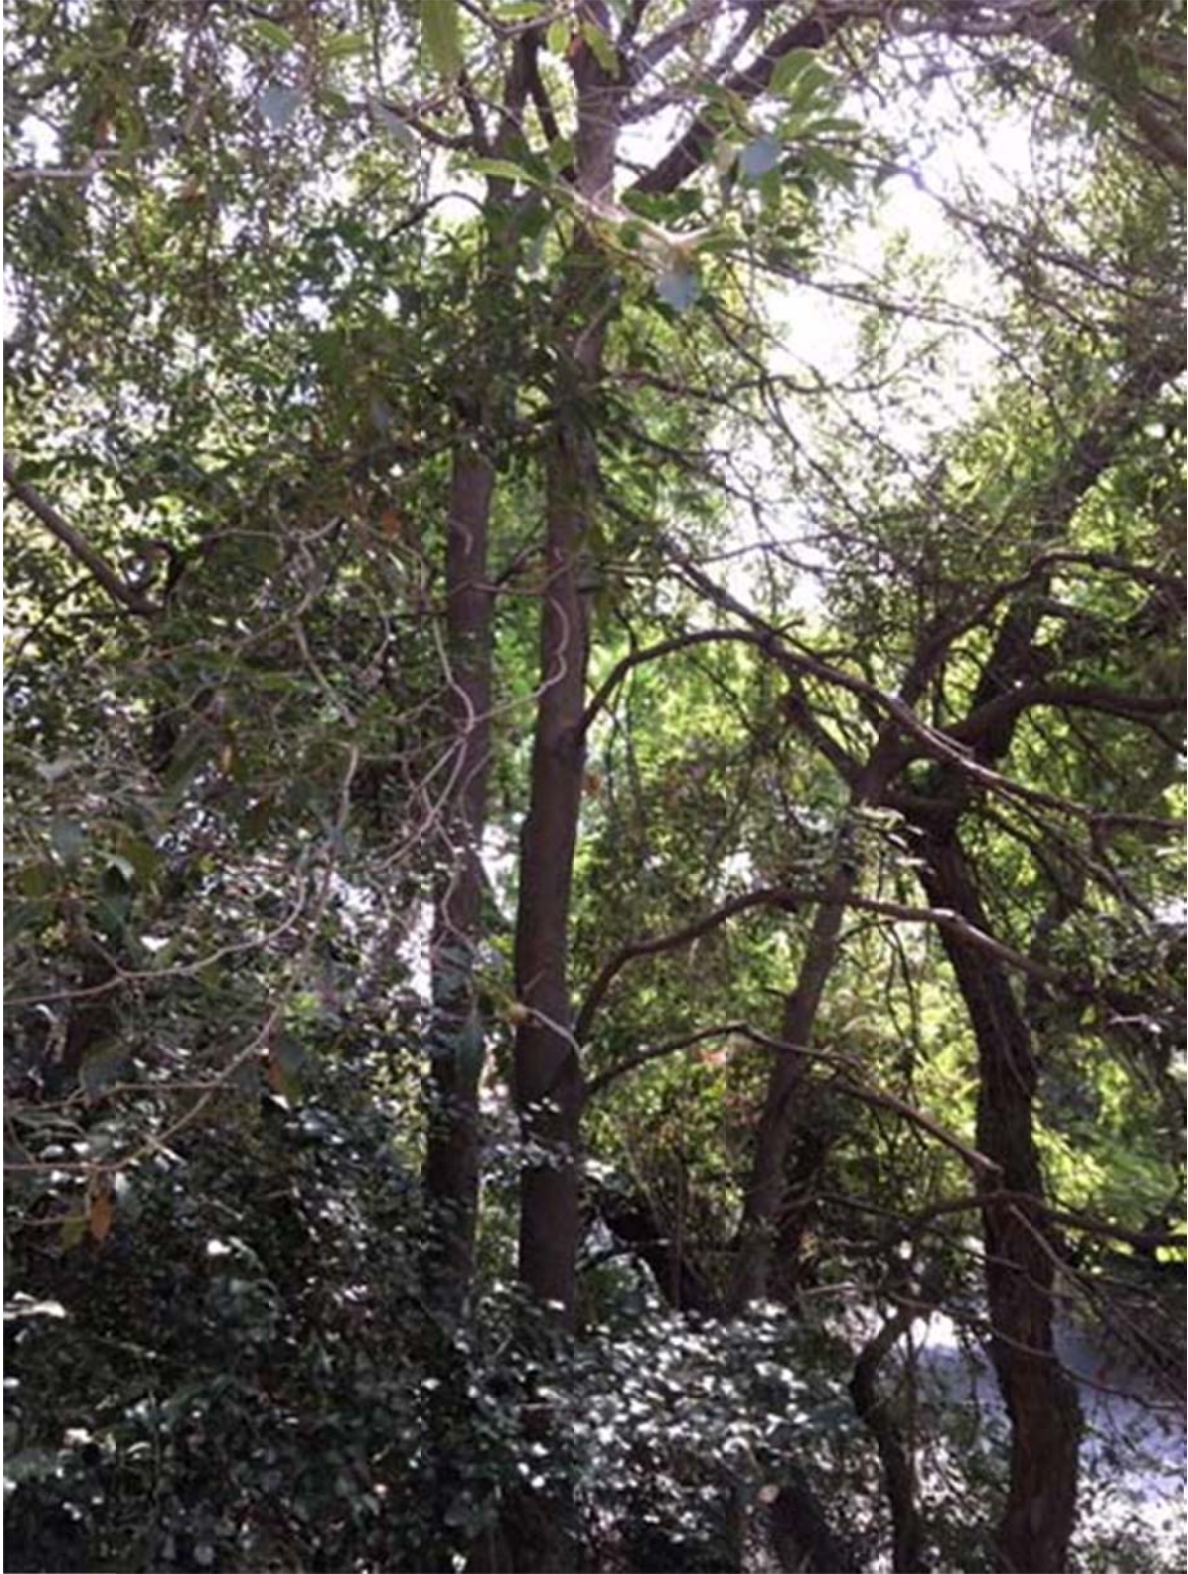
Figure 27: Tree 26

<p>Tree 26 <i>Pittosporum undulatum</i> – Victorian Box</p> <p>This tree is not protected by the City of Glendale Indigenous Tree Protection Ordinance. This tree will be removed because it is growing within the footprint of the proposed grading activity on Lot 2.</p>

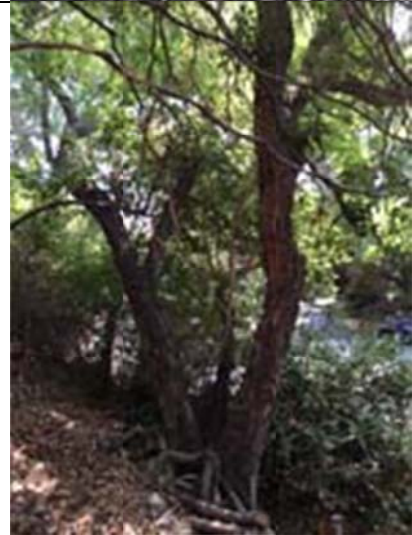
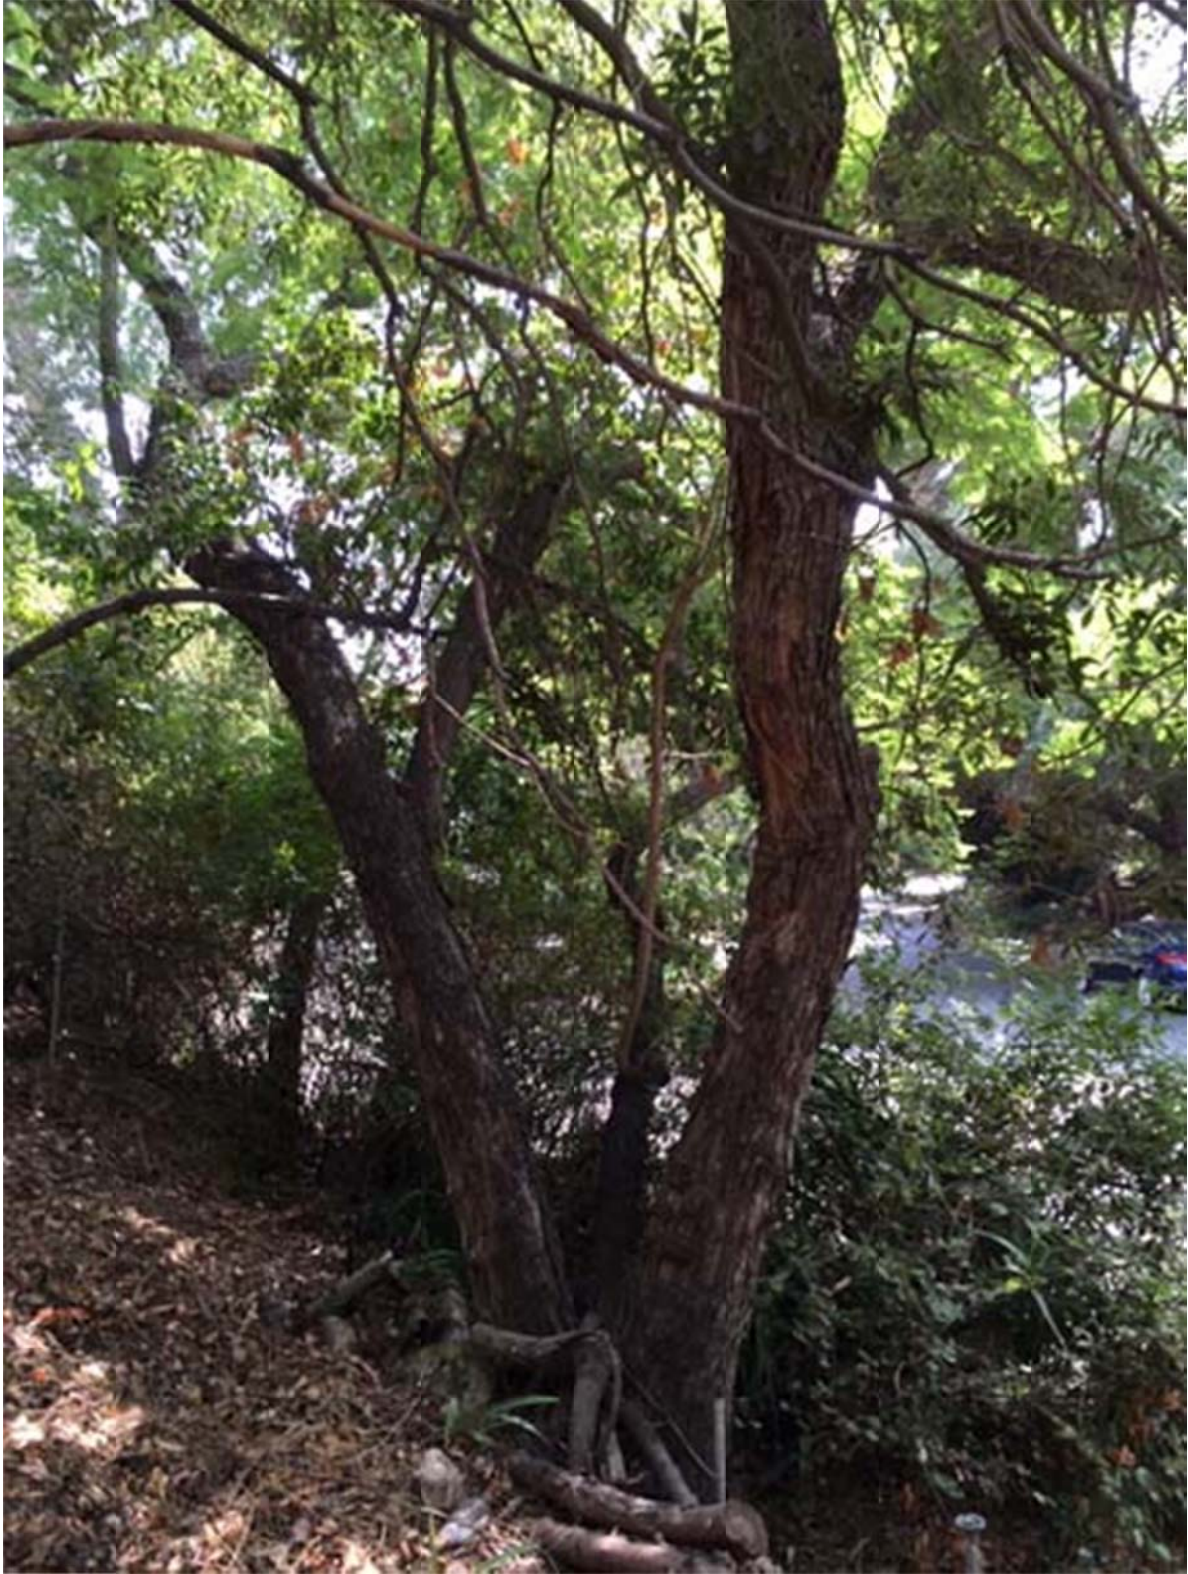
Figure 28: Tree 27

<p>Tree 27 <i>Jacaranda mimosifolia</i> – Mimosa Tree</p> <p>This tree is not protected by the City of Glendale Indigenous Tree Protection Ordinance. This tree will be removed because it is growing within the footprint of the proposed access staircase for the residence on Lot 2.</p>

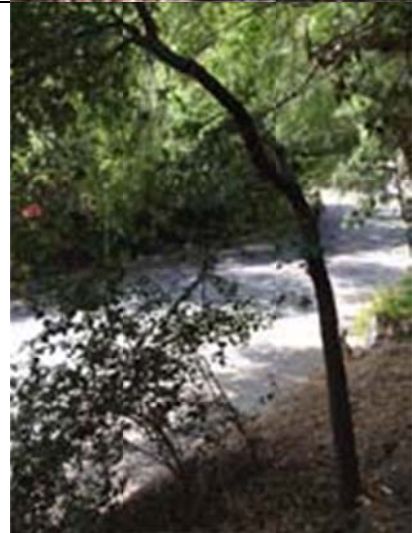
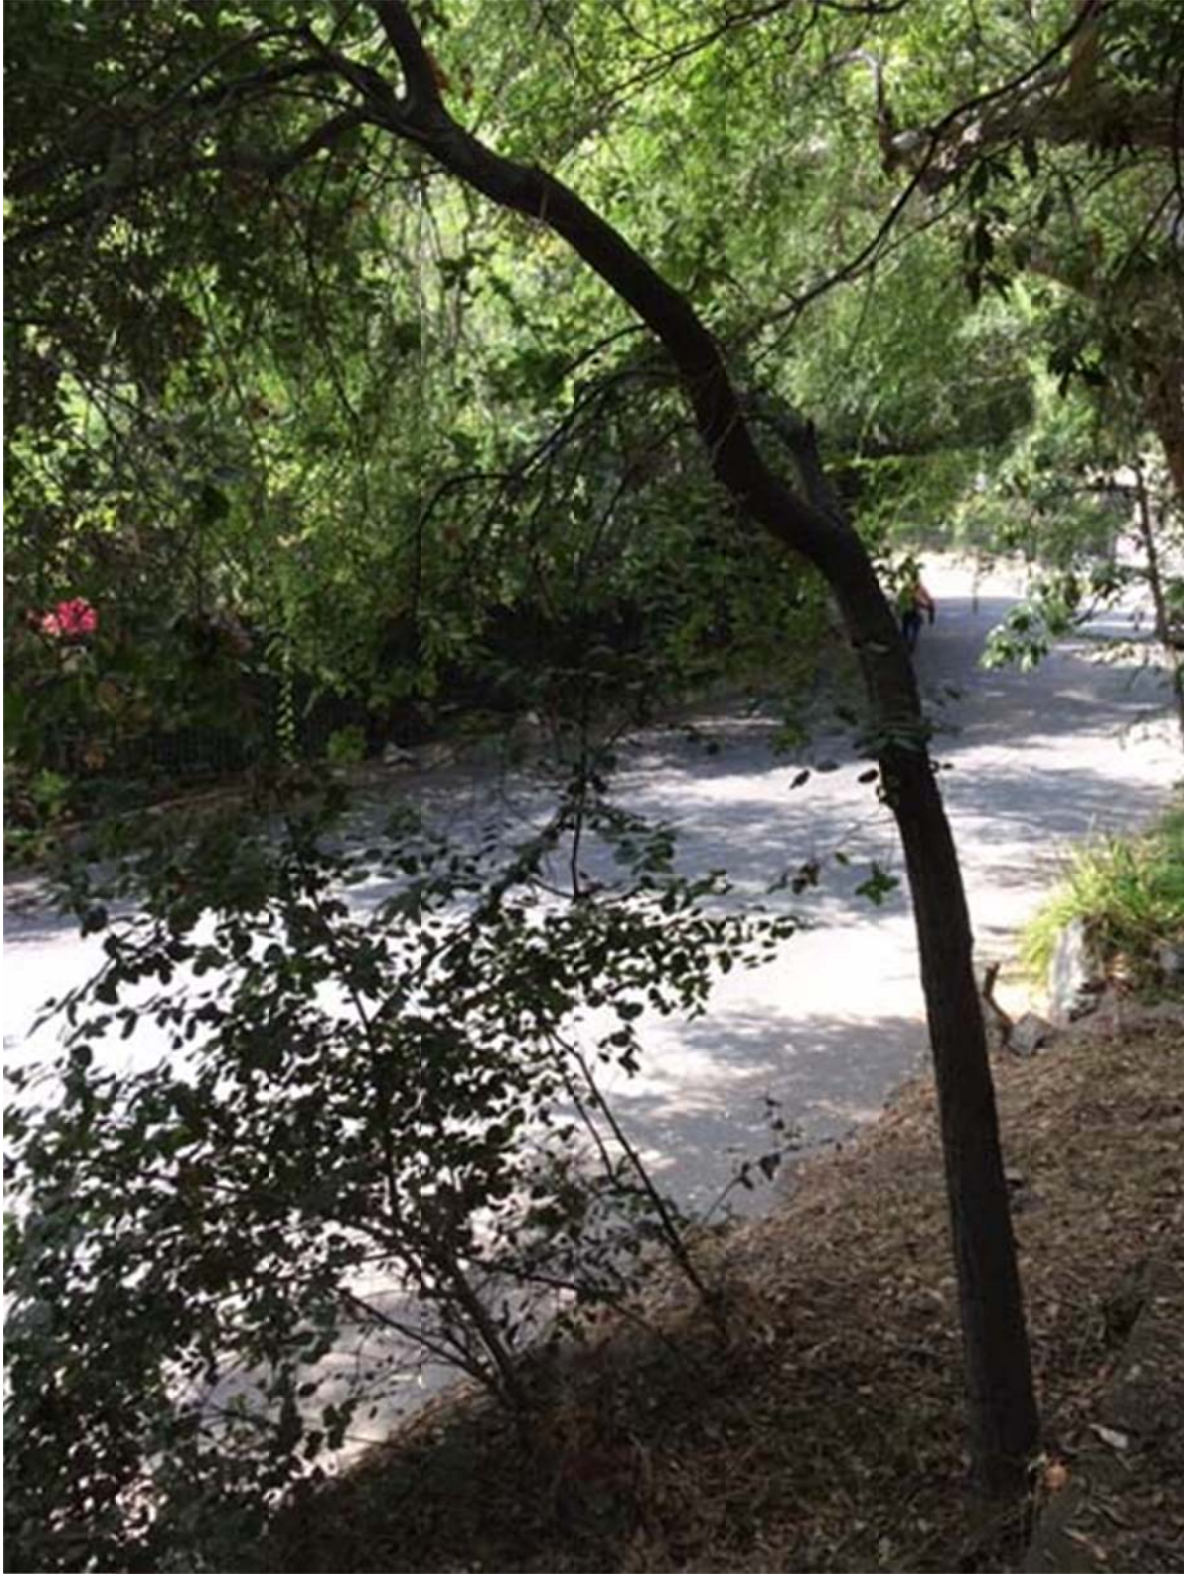
<p>Tree 28 <i>Quercus agrifolia</i> – Coast Live Oak</p> <p>This tree is not protected by the City of Glendale Indigenous Tree Protection Ordinance because it is smaller than the minimum of 6” DBH.</p> <p>This tree will be removed because it is growing within the footprint of the proposed grading activity on Lot 2.</p>

Figure 29: Tree 28 is not large enough to be protected. It will be removed.

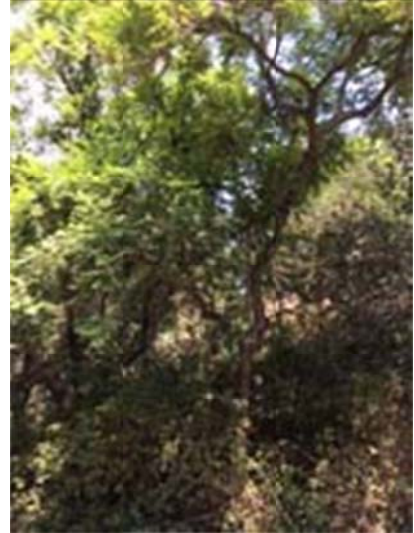
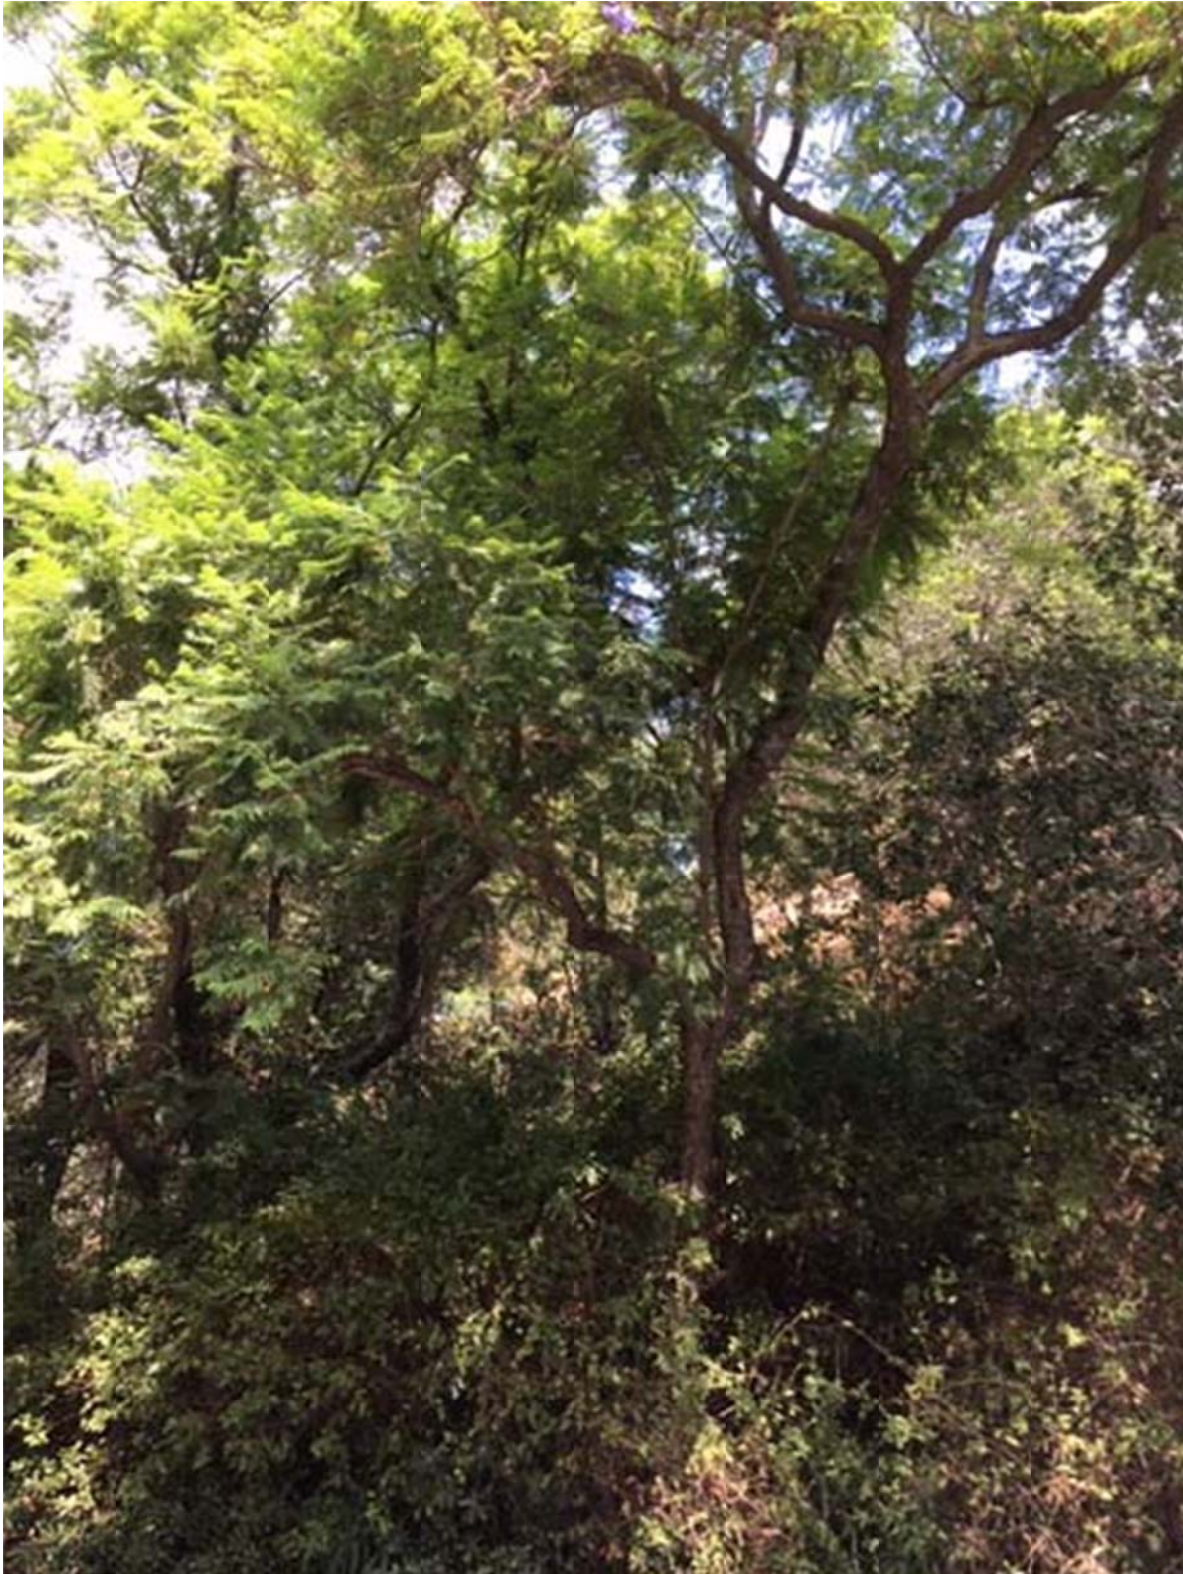
Figure 30: Tree OP29

<p>Tree OP29 <i>Jacaranda mimosifolia</i> – Mimosa Tree</p> <p>This tree is growing on the property of the neighbor to the southwest. It is not protected by the City of Glendale Indigenous Tree Protection Ordinance.</p> <p>It will not likely be impacted by construction activity if the proposed tree protection fencing is not crossed.</p>

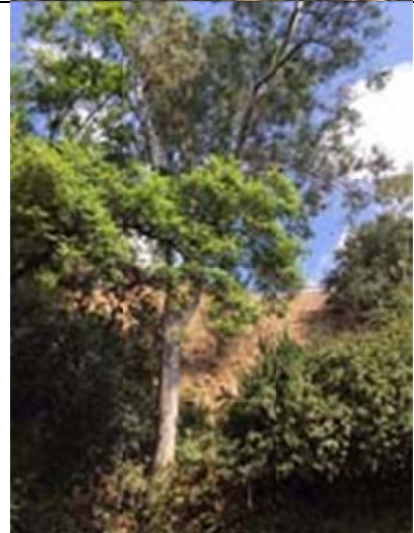
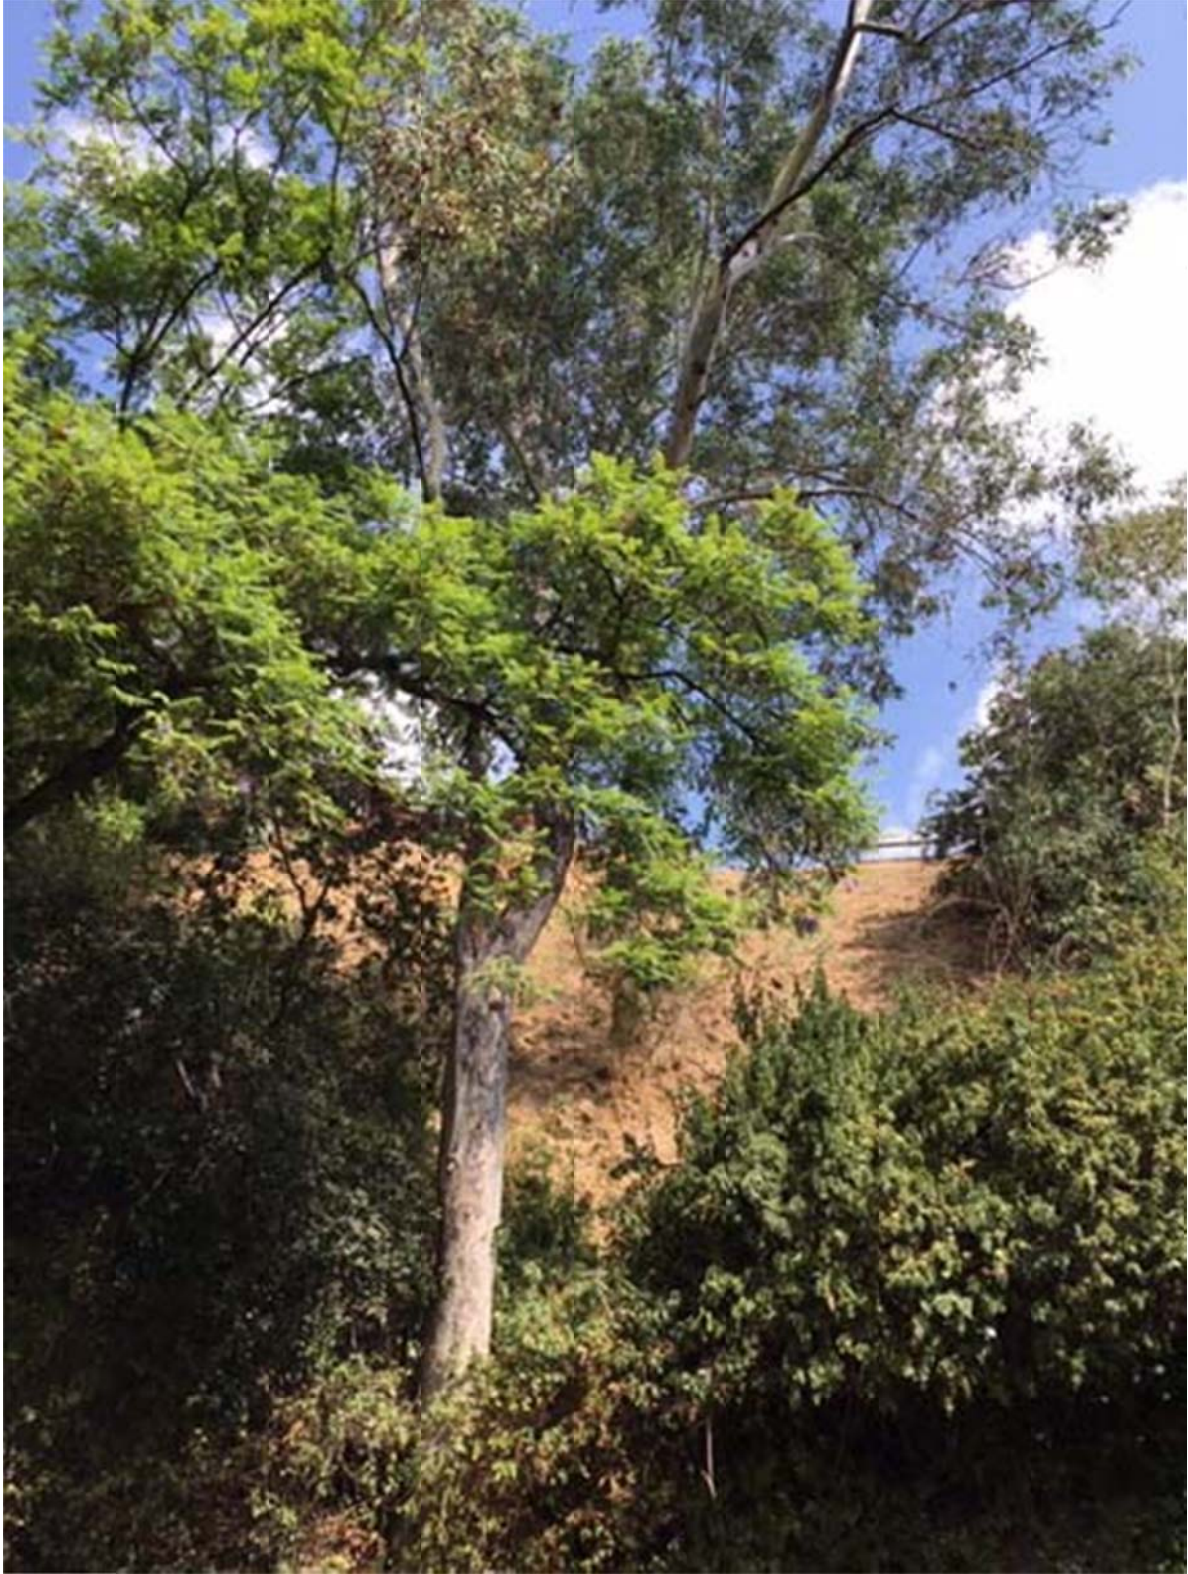
Figure 31: Tree OP30

<p>Tree OP30 <i>Eucalyptus globulus</i> – Blue Gum Eucalyptus</p> <p>This tree is growing on the property of the neighbor to the southwest. It is not protected by the City of Glendale Indigenous Tree Protection Ordinance.</p> <p>It will not likely be impacted by construction activity if the proposed tree protection fencing is not crossed.</p>

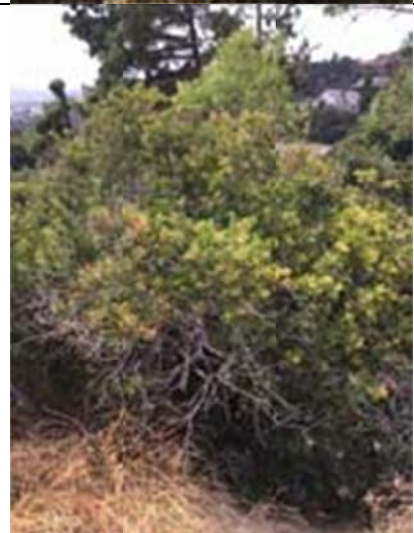
<p>Tree 31 <i>Heteromeles arbutifolia</i> – Toyon</p> <p>This tree is not protected by the City of Glendale Indigenous Tree Protection Ordinance. It will be removed because it is growing within the footprint of the proposed driveway.</p>

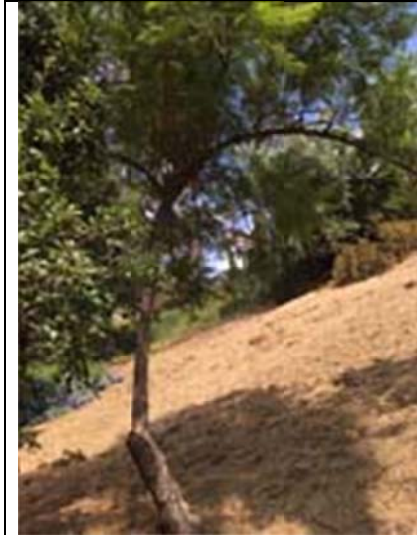
Tree 32

This tree is not protected by the City of Glendale Indigenous Tree Protection Ordinance. It will be removed because it is growing within the area proposed for re-grading.

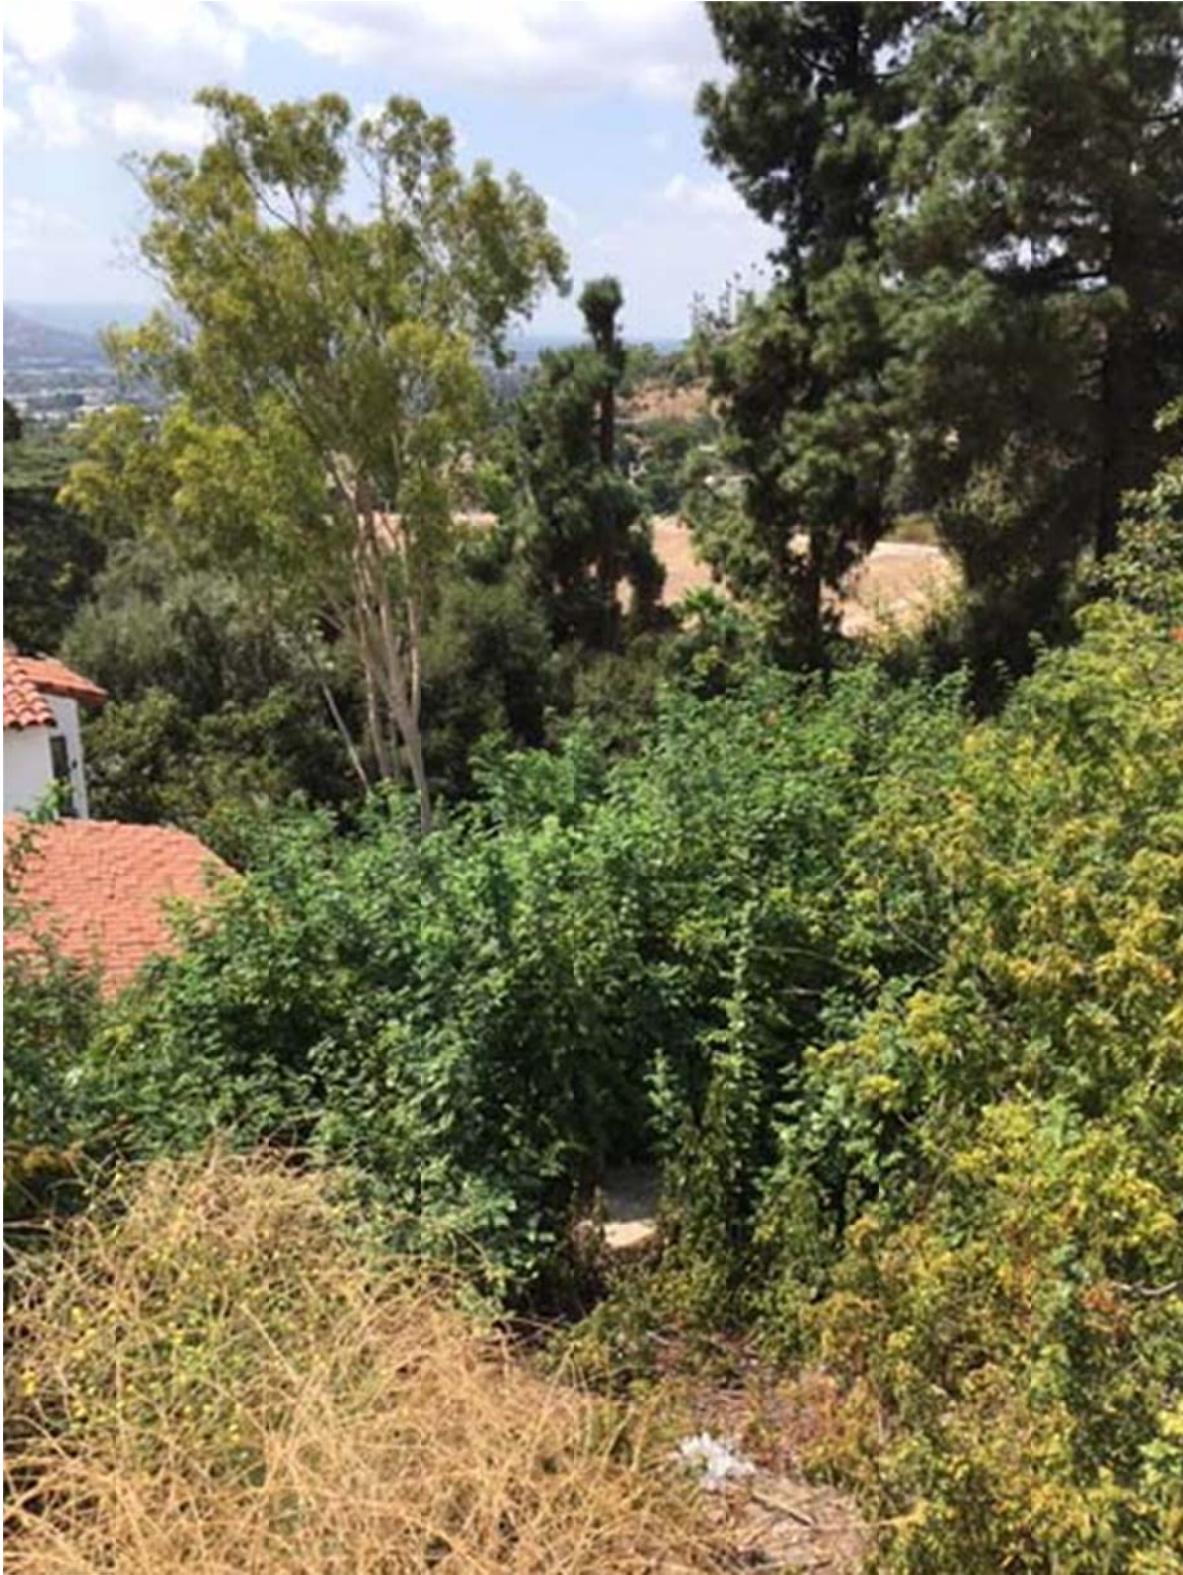
Figure 2: Tree 1 was removed prior to my September 10, 2019 site visit.

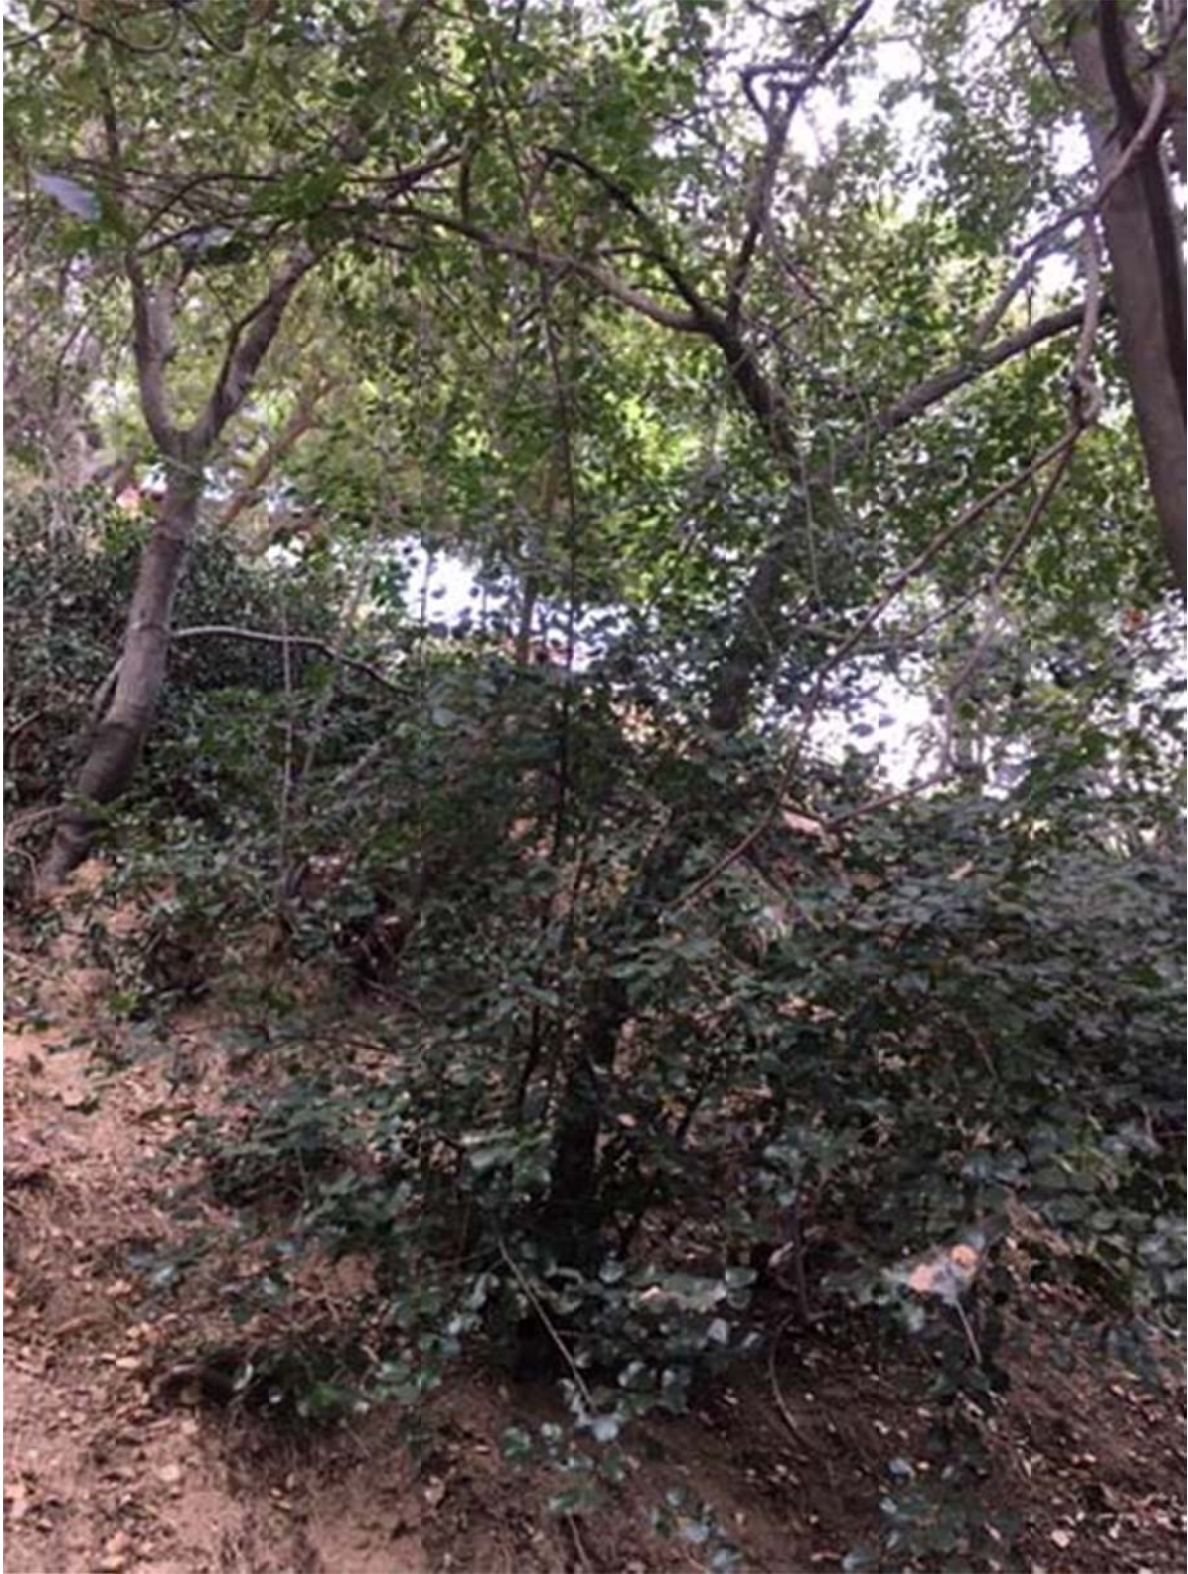
Figure 34: Tree 33 is not an oak, despite its look-alike foliage.
