Photo Report
Fremont
Programs, Services, and Activities

Finding: The Fremont Park, located at 600 West Hahn Avenue in Glendale California, was inspected by Disability Access Consultants, Inc., on June 7, 2007.

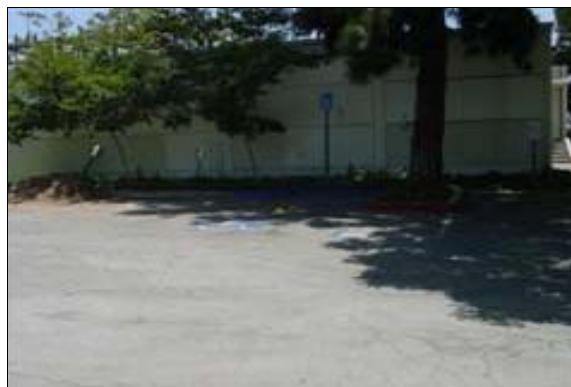
Finding: There are two parking lots provided at the facility. The paved parking lots are located outside of the Maintenance Building and next to the tennis courts.

Full Rec: Accessible paved parking spaces shall be located on the shortest accessible route of travel to the facility and shall coincide with the primary route and primary entrances used by the general public (see CBC 1129B.4, ADAAG 4.3.2(1) and ADAAG 4.14.1).

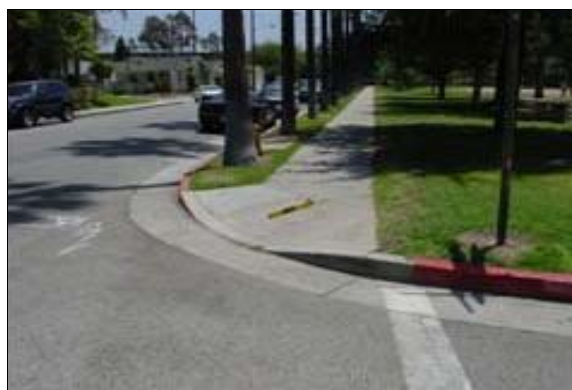
Curb Ramp at the Corner of Hahn Ave and Kenilworth Ave

Finding: The slope of the curb ramp is greater than 8.33%. The slope at the bottom landing is greater than 2%. The slope of the side flares is greater than 2%. The curb ramp does not provide a grooved border along the top and sides of the ramp at the level of the sidewalk. The concrete curb ramp does not provide a detectable warning surface which includes truncated domes.

Full Rec: Replace the curb ramp with a compliant curb ramp at least 48 inches in width that provides a slope no greater than 8.33%. Install a detectable warning surface which extends the full length and width of the concrete curb ramp and its side flares with truncated domes that contrast visually by either light on dark or dark on light which is an integral part of the concrete curb ramp. The truncated domes may be cast in place or stamped or of a prefabricated surface treatment (see CBC 1127B.5.8).

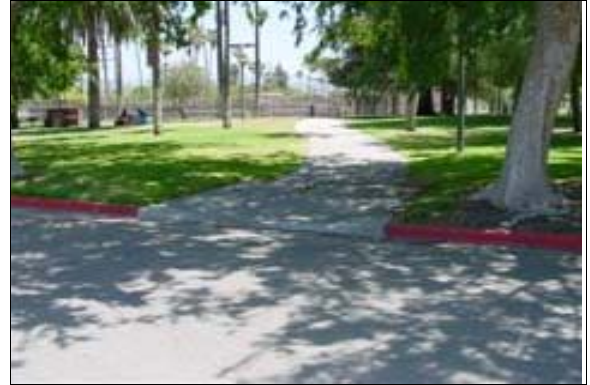
Curb Ramp off of Patterson

Finding: The slope of the curb ramp is greater than 8.33%. The slope at the top landing is greater than 2%. The slope at the bottom landing is greater than 2%. The slope of the side flares is greater than 10%. The curb ramp does not provide a grooved border along the top and sides of the ramp at the level of the sidewalk. The concrete curb ramp does not provide a detectable warning surface which includes truncated domes.

Full Rec: Replace the curb ramp with a compliant curb ramp at least 48 inches in width that provides a slope no greater than 8.33%. Install a detectable warning surface which extends the full length and width of the concrete curb ramp and its side flares with truncated domes that contrast visually by either light on dark or dark on light which is an integral part of the concrete curb ramp. The truncated domes may be cast in place or stamped or of a prefabricated surface treatment (see CBC 1127B.5.8).

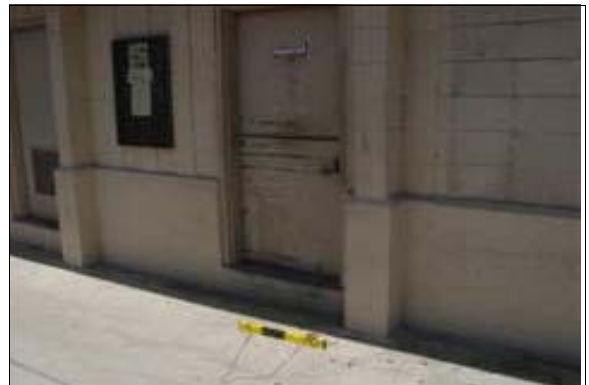
Tennis Office

Finding: There is no level landing provided at the entrance door.

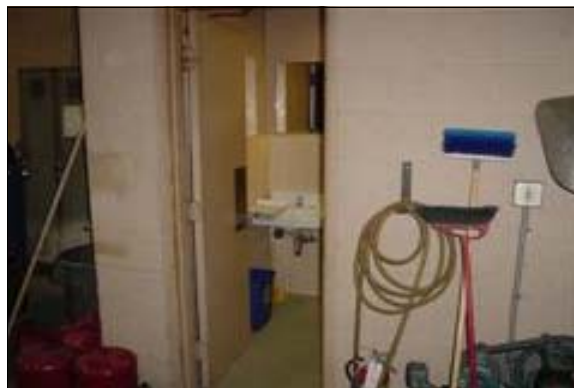
Unisex Restroom at the Maintenance Building

Finding: The clear opening width of the entrance doorway to the restroom is less than 32 inches.

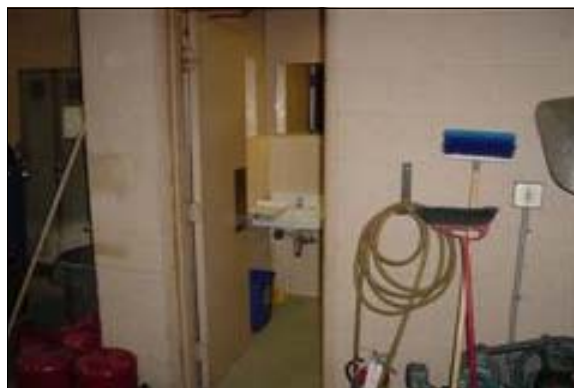
Unisex Restroom at the Maintenance Building

Finding: This restroom is not accessible and cannot be easily altered. There is not sufficient clear floor space in the restroom to accommodate an individual in a wheelchair.

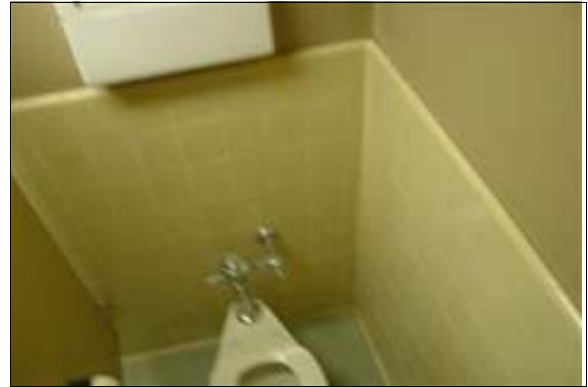
Unisex Restroom at the Maintenance Building

Finding: The height of the toilet seat in the stall designated to be accessible in the restroom is less than 17 inches above the finished floor.

Full Rec: Remove or modify the toilet in the stall designated to be accessible in the restroom so that the seat height is between 17 inches and 19 inches above the finished floor (see ADAAG 4.16.3).

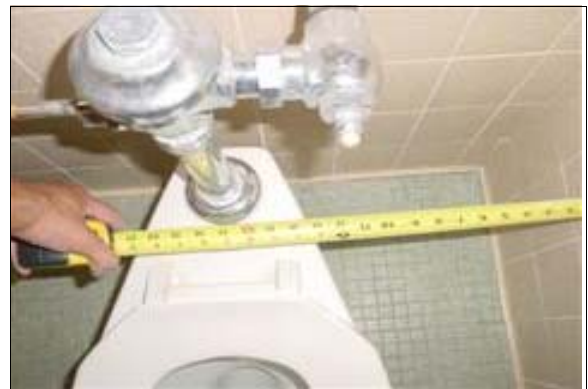
Unisex Restroom at the Maintenance Building

Finding: The distance from the center of the toilet to the nearest side wall in the stall designated to be accessible in the restroom is less than 18 inches.

Full Rec: Relocate the toilet or stall side wall so that the distance from the centerline of the toilet to the nearest side wall in the stall designated to be accessible in the restroom is exactly 18 inches (see ADAAG Figure 28).

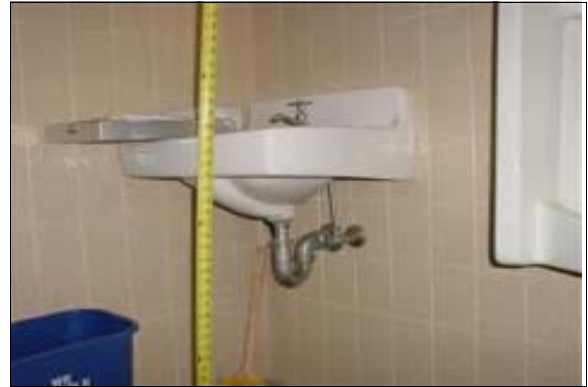
Unisex Restroom at the Maintenance Building

Finding: The knee clearance space under the lavatory designated to be accessible in the restroom is less than 29 inches. The knee depth space under the lavatory designated to be accessible in the restroom is less than 27 inches at 8 inches under the lavatory apron.

Full Rec: Replace the lavatory designated to be accessible in the restroom to provide at least 29 inches of clear knee space between the finished floor and bottom of the lavatory apron. Make sure to provide at least 27 inches at 8 inches under the apron (see ADAAG 4.19.2).

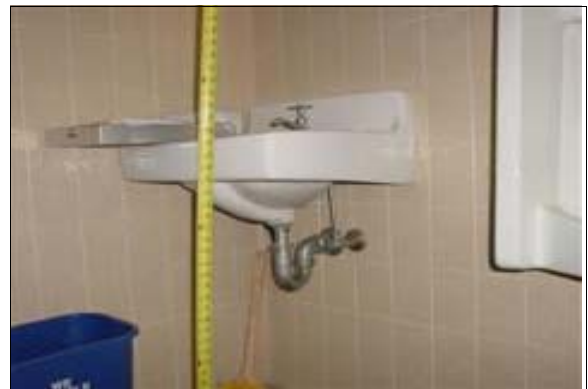
Unisex Restroom at the Maintenance Building

Finding: The pipes under the lavatory in the restroom do not provide protection against contact.

Full Rec: Insulate or otherwise configure pipes under the lavatory designated to be accessible in the restroom to protect against contact (see ADAAG 4.19.4). Make certain there are no sharp or abrasive surfaces under the lavatory.

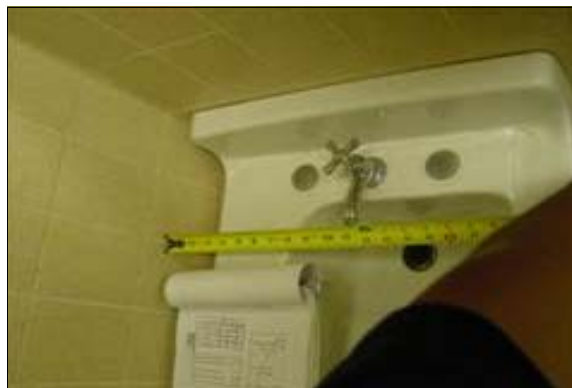
Unisex Restroom at the Maintenance Building

Finding: The distance from the center of the lavatory to the adjacent side wall in the restroom is less than 18 inches.

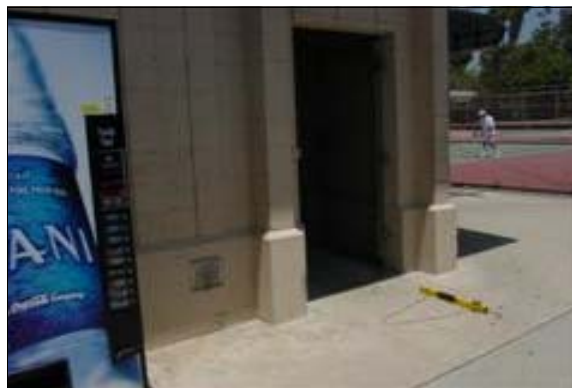
Women's Restroom at the Tennis Courts

Finding: There is no level landing provided at the entrance door.

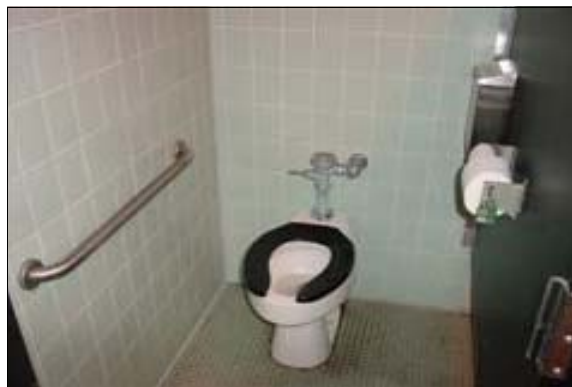
Women's Restroom at the Tennis Courts

Finding: There is insufficient clear floor space in the stall designated to be accessible in the restroom. The door to the stall designated to be accessible in the restroom does not have accessible hardware.

Full Rec: Modify or replace the stall designated to be accessible in the restroom so that it complies with ADAAG 4.17.3, CBC 1115B and CBC Figures 11B-1A and 1B. Standard accessible stalls require 60 inches in width with 56 inches depth for wall-mounted toilets or 59 inches depth for floor-mounted toilets to accommodate individuals in wheelchairs. The minimum width of a front-approach doorway shall provide at least 32 inches and a side-approach doorway shall provide at least 34 inches. The door shall swing outward, close automatically and provide accessible hardware.

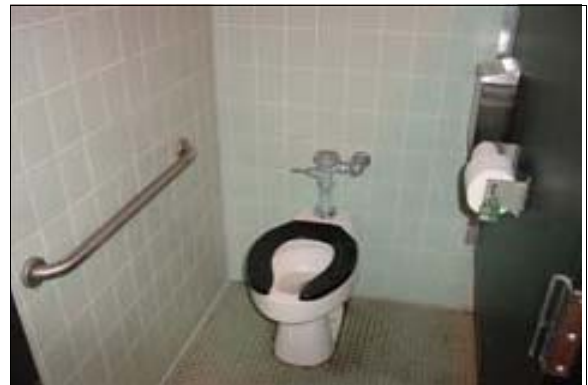
Women's Restroom at the Tennis Courts

Finding: There is no back grab bar in the stall designated to be accessible in the restroom.

Full Rec: Install a 36-inch back grab bar at a height of 33 inches above the finished floor in the stall designated to be accessible of the restroom. Grab bars must be able to support a point load of at least 250 pounds and shall be less than the allowable shear stress of the grab bar material.

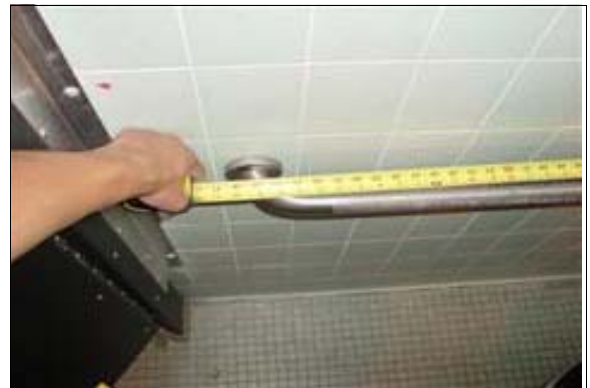
Women's Restroom at the Tennis Courts

Finding: The side grab bar in the stall designated to be accessible in the restroom does not extend 54 inches from the back wall.

Full Rec: The front end of the grab bar shall extend at least 54 inches from the back wall and the back end of the grab bar shall be mounted within 12 inches from the back wall. Grab bars must be able to support a point load of at least 250 pounds and shall be less than the allowable shear stress of the grab bar material.

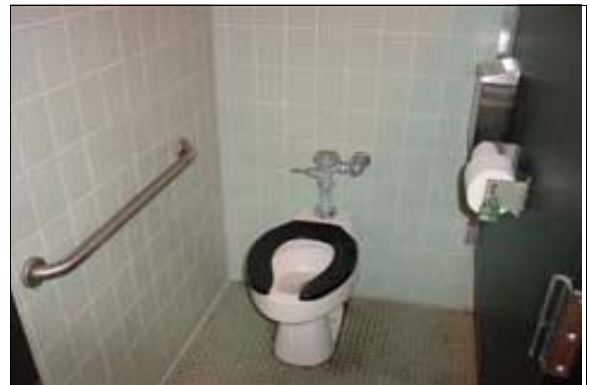
Women's Restroom at the Tennis Courts

Finding: The distance from the end of the side grab bar to the back wall in the stall designated to be accessible in the restroom is greater than 12 inches.

Full Rec: Remount the side grab bar in the stall designated to be accessible in the restroom so that it is not more than 12 inches from the back wall (see ADAAG Figure 29 and CBC 1115B.8). Grab bars must be able to support a point load of at least 250 pounds and shall be less than the allowable shear stress of the grab bar material.

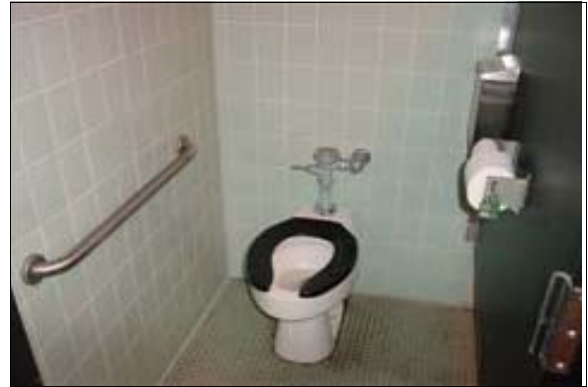
Women's Restroom at the Tennis Courts

Finding: The flush control on the toilet in the stall designated to be accessible in the restroom is not on the wide (approach) side of the toilet.

Full Rec: Relocate the flush control on the toilet in the stall designated to be accessible in the restroom so that it is on the wide (approach) side of the toilet area (see ADAAG 4.16.5). Flush controls shall be hand-operated or automatic mechanisms.

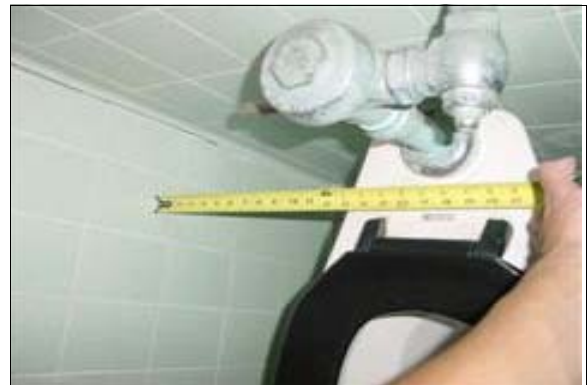
Women's Restroom at the Tennis Courts

Finding: The distance from the center of the toilet to the nearest side wall in the stall designated to be accessible in the restroom is less than 18 inches.

Full Rec: Relocate the toilet or stall side wall so that the distance from the centerline of the toilet to the nearest side wall in the stall designated to be accessible in the restroom is exactly 18 inches (see ADAAG Figure 28).

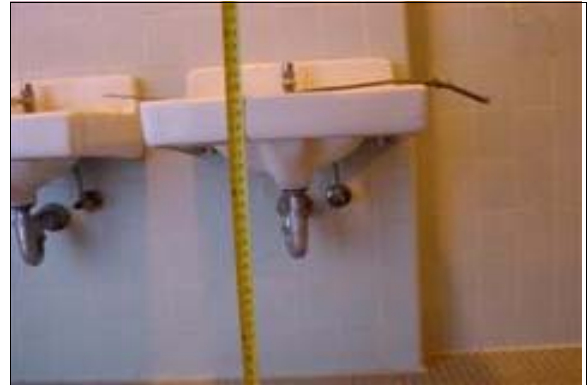
Women's Restroom at the Tennis Courts

Finding: The knee clearance space under the lavatory designated to be accessible in the restroom is less than 29 inches. The knee depth space under the lavatory designated to be accessible in the restroom is less than 27 inches at 8 inches under the lavatory apron.

Full Rec: Replace the lavatory designated to be accessible in the restroom to provide at least 29 inches of clear knee space between the finished floor and bottom of the lavatory apron. Make sure to provide at least 27 inches at 8 inches under the apron (see ADAAG 4.19.2).

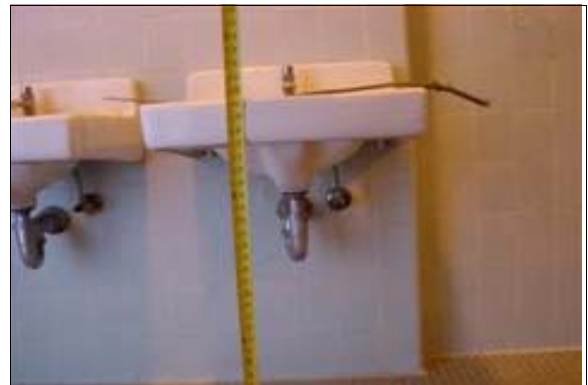
Women's Restroom at the Tennis Courts

Finding: The pipes under the lavatory in the restroom do not provide protection against contact.

Full Rec: Insulate or otherwise configure pipes under the lavatory designated to be accessible in the restroom to protect against contact (see ADAAG 4.19.4). Make certain there are no sharp or abrasive surfaces under the lavatory.

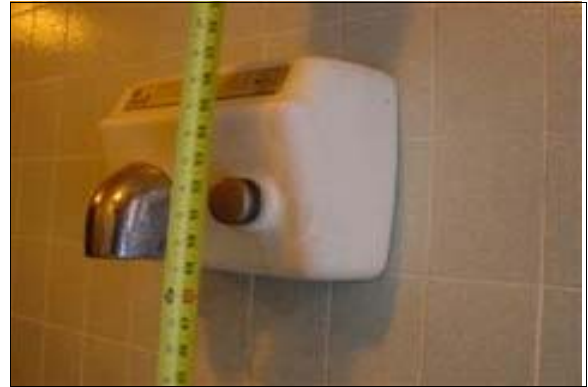
Women's Restroom at the Tennis Courts

Finding: The height of the controls and operating mechanisms for the hand dryer in the restroom is greater than 40 inches.

Full Rec: Relocate the hand dryer in the restroom to a maximum height of 40 inches for all the controls and operating mechanisms (see CBC 1115B.9.2).

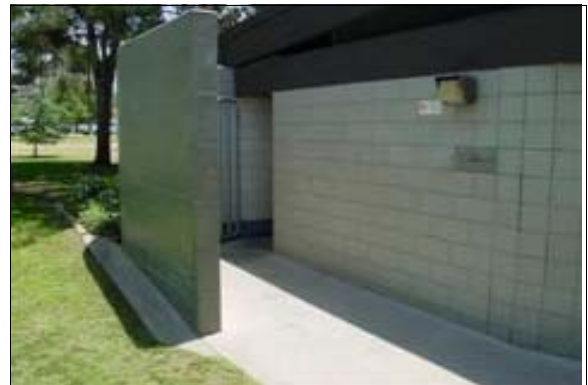
Women's Restroom Next to the Play Equipment

Finding: There is no signage indicating accessibility on the latch side of the entry door of the restroom. There is no Title 24 gender use signage on the entrance door.

Full Rec: The restroom is designated accessible and should be made accessible for the facility. Post signage centered 60 inches above the ground surface on the latch side of the entrance door identifying the restroom as accessible upon completion of the following items (see CBC 1115B., ADAAG 4.1.2(7) and ADAAG 4.1.6(3)(e). Signage shall include Braille and raised lettering, the gender or unisex use symbol and the ISA symbol. Post Title 24 gender use signage on the door @ 60" o.c. a.f.f.

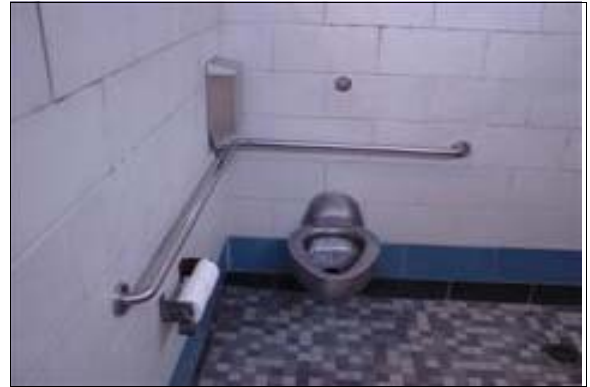
Women's Restroom Next to the Play Equipment

Finding: There is no door on the stall designated to be accessible in the restroom.

Full Rec: Install a door with appropriate accessible door hardware on the stall designated to be accessible in the restroom (see CBC 1115B.7.1.3 and ADAAG 4.13.9).

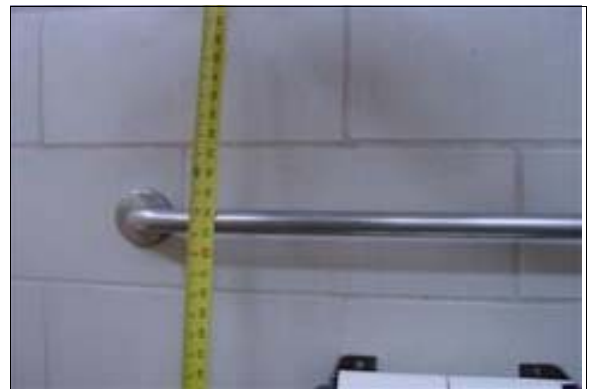
Women's Restroom Next to the Play Equipment

Finding: The height of the side grab bar in the stall designated to be accessible of the restroom is greater than 33 inches above the finished floor.

Full Rec: Remount the side grab bar in the stall designated to be accessible in the restroom so that the height of the gripping surface is centered at 33 inches above finished floor. Grab bars must be able to support a point load of at least 250 pounds and shall be less than the allowable shear stress of the grab bar material.

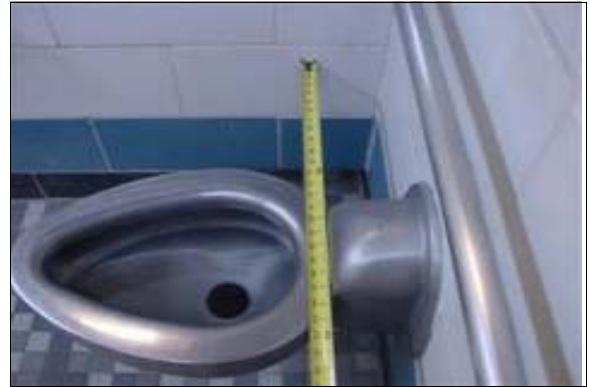
Women's Restroom Next to the Play Equipment

Finding: The distance from the center of the toilet to the nearest side wall in the stall designated to be accessible in the restroom is greater than 18 inches.

Full Rec: Relocate the toilet or stall side wall so that the distance from the centerline of the toilet to the nearest side wall in the stall designated to be accessible in the restroom is exactly 18 inches (see ADAAG Figure 28).

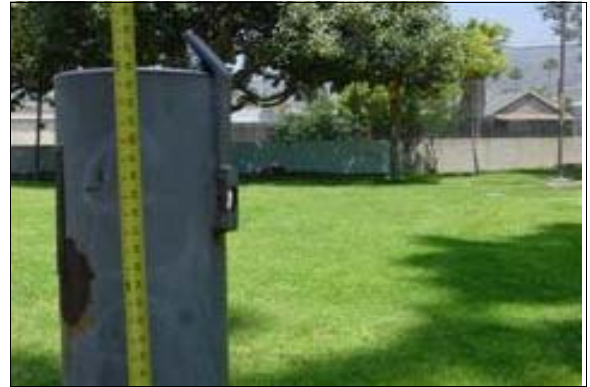
Finding: There are seven drinking fountains on primary paths of travel.

Full Rec: Fifty percent of the drinking fountains on primary paths of travel shall be accessible (see CBC 1117B.1 and ADAAG 4.15). Install a "high-low" fountain design to comply with both state and federal requirement. Fountains not located in alcoves need side rails or wing walls on both sides.

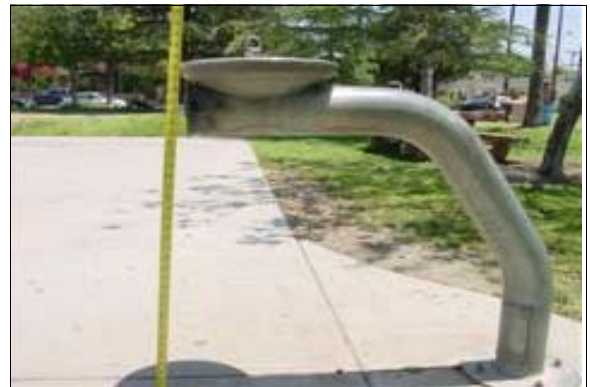
Drinking Fountain at the Basketball Courts

Finding: The drinking fountain is not a "high-low" design.

Full Rec: Fifty percent of the drinking fountains on primary paths of travel shall be accessible (see CBC 1117B.1 and ADAAG 4.15). Install a "high-low" fountain design to comply with both state and federal requirements and install a side rail or wing wall next to each side of the fountain.

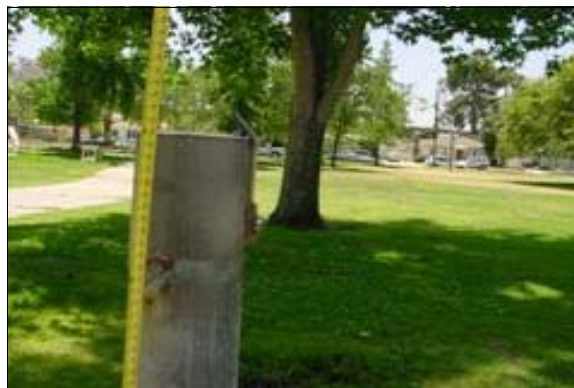
Drinking Fountain Between the Play Equipment and Tennis Courts

Finding: The drinking fountain is not a "high-low" design. The spout outlet height is greater than 36 inches. There is less than 27 inches knee clearance height.

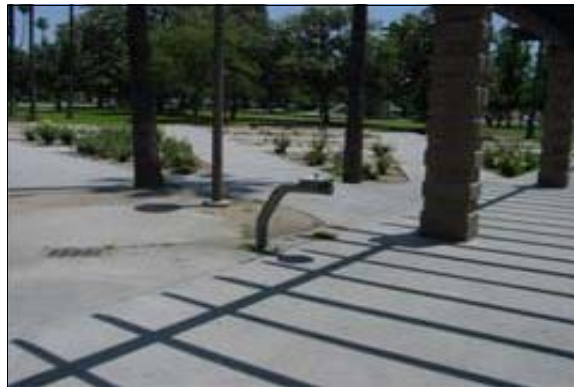
Drinking Fountain Between the Tennis Courts

Finding: The drinking fountain is not a "high-low" design.

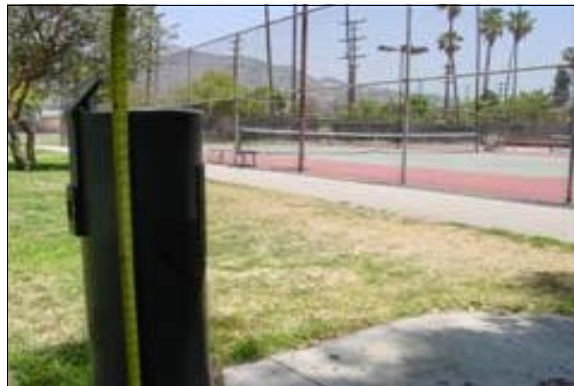
Drinking Fountain Next to the Tennis Courts

Finding: The drinking fountain is not a "high-low" design. The spout outlet height is greater than 36 inches. There is less than 27 inches knee clearance height.

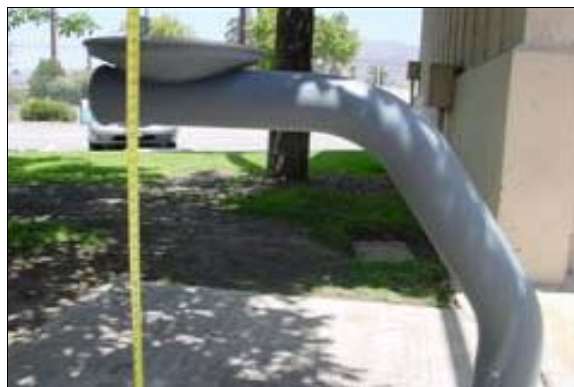
Drinking Fountain Outside of the Tennis Office

Finding: The drinking fountain is not a "high-low" design.

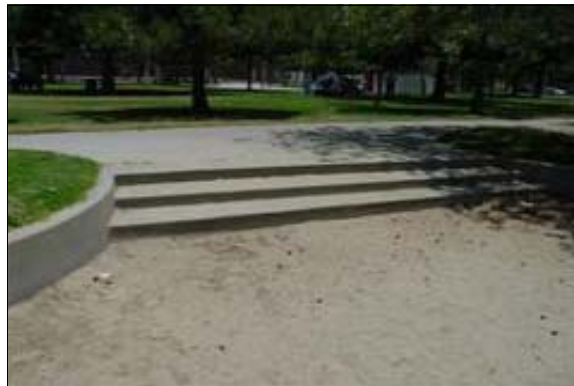
Play Equipment at the South End of the Park

Finding: There are only stairs on the path of travel to the play area, preventing access to individuals with mobility impairments.

Full Rec: Since programs, services and activities to staff and the public are provided in this location, those programs, services and activities are required to be made accessible. It is recommended that a ramp be installed or other means of vertical access.

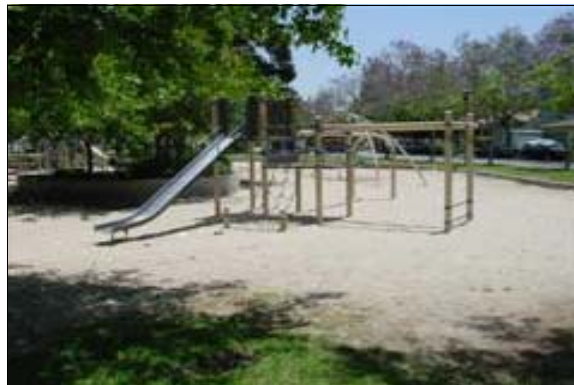
Play Equipment at the South End of the Park

Finding: The surface beneath the play equipment is sand, making the area nonaccessible to individuals with mobility impairments.

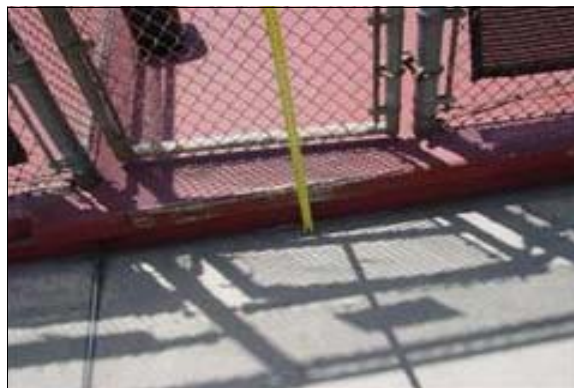
Tennis Courts

Finding: There is a step on the primary path of travel to tennis courts, preventing access to individuals with mobility impairments.

Full Rec: Since programs, services and activities to staff and the public (volunteers, etc.) are provided in this location, those programs, services and activities are required to be made accessible. It is recommended that a ramp be installed or other means of vertical access.

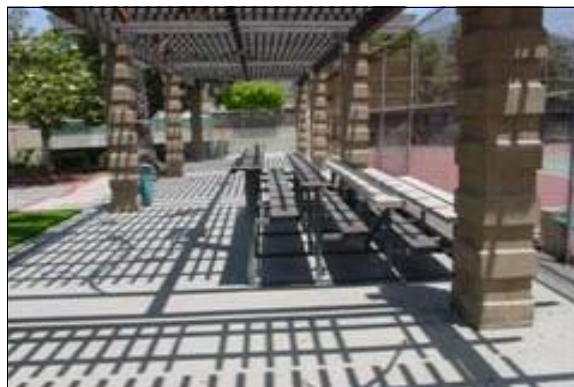
Tennis Courts

Finding: The surface under the bleachers is concrete. No wheelchair seating is provided next to the bleachers.
