Photo Report
Glorietta Park
Programs, Services, and Activities

Finding: Glorietta Park, located at 2801 North Verdugo in Glendale California, was inspected by Disability Access Consultants, Inc., on June 7, 2007.

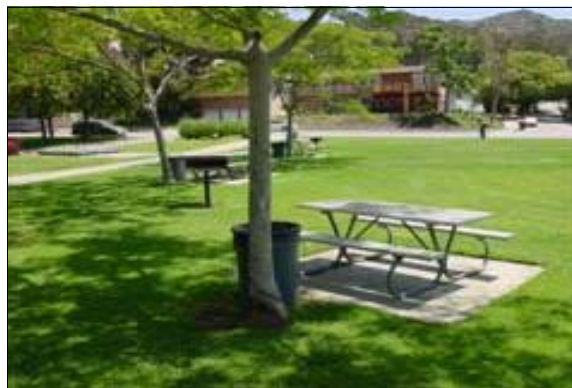
Outdoor Dining Area Next to the Baseball Field

Finding: There is no accessible route to the picnic tables in the outdoor dining area next to the baseball field. The surface around the outdoor dining area picnic tables is grass, preventing access of individuals with mobility impairments.

Full Rec: Install a 48-inch wide path to the picnic tables in the outdoor dining area that provides a smooth, stable, firm and slip resistant surface. Provide a maneuvering space sufficient to provide a 60-inch diameter turning radius adjacent to at least one of the picnic tables in the outdoor dining area.

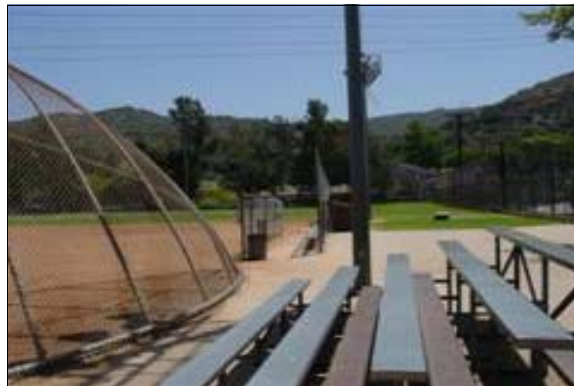
Baseball Field

Finding: The path of travel at the dugouts is dirt, preventing access to individuals with mobility impairments.

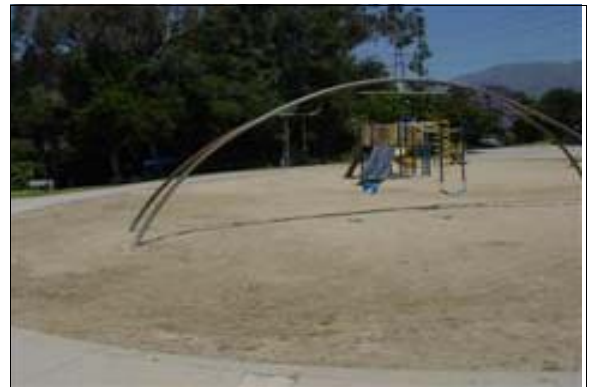
Finding: The surface beneath the play equipment is sand, making the area nonaccessible to individuals with mobility impairments.

Full Rec: The play area should be made an accessible play area for the facility. Provide a maneuvering space with an accessible resilient surface beneath the play components and adjacent to the play components where technically feasible. An adequate maneuvering space has an accessible surface and is not less than 60 inches by 60 inches where an individual with a mobility impairment can be a part of the activities provided at the play components.
