Photo Report
Lower Scholl Canyon Park
Programs, Services, and Activities

17-Jul-07

Finding: The Lower Scholl Canyon Park, located at 2849 East Glenoaks in Glendale California, was inspected by Disability Access Consultants, Inc., on June 12, 2007.

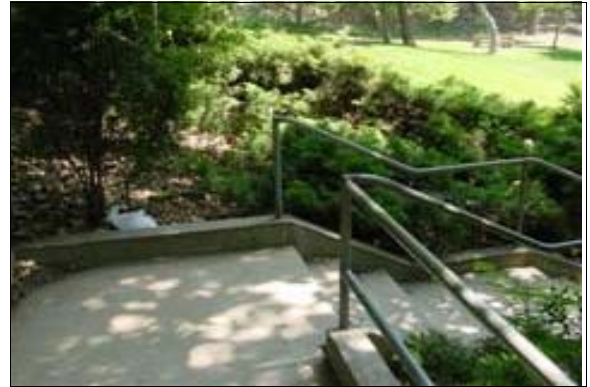
Exterior Stairs to the Lower Outdoor Dining Area (North)

Finding: There are no top handrail extensions provided on the stairway.

Full Rec: Install 12-inch handrail extensions to the top of the handrail that extends beyond the top riser and is parallel to the floor surface at the top landing.

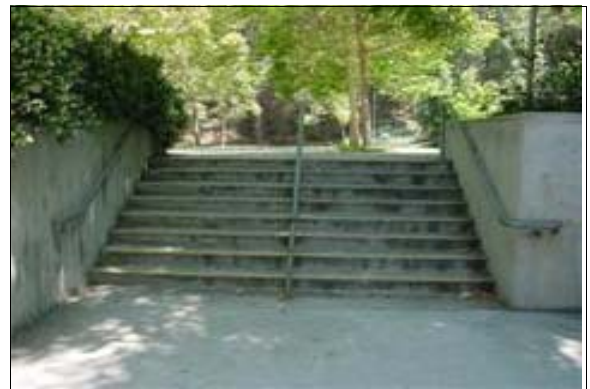
Exterior Stairs to the Lower Outdoor Dining Area (South)

Finding: The handrails do not provide 12-inch extensions beyond the center treads. The handrails are mounted at a height less than 34 inches.

Full Rec: Install handrails on each side of stairway that provide 12-inch top and bottom handrail extensions that extend beyond the top and bottom treads of the stairway which are parallel to the ground surface and return smoothly to the post or wall. Handrails shall be mounted at a height between 34 and 38 inches at a distance no less than 1 1/2 inches from the adjacent wall. To accommodate children's heights, it is recommended to install a second set of handrails at the height of 25 inches above the stairway treads.

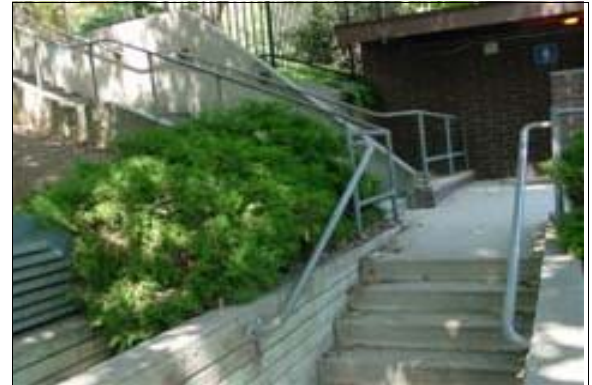
Exterior Stairs to the Play Equipment (Left)

Finding: There is no detectable striping on each tread of the exterior stairway.

Full Rec: Affix detectable contrasting striping to each tread of the stairway that clearly contrasts in color from the tread and is at least 2 inches in width placed no more than 1 inch from the tread nose or landing.

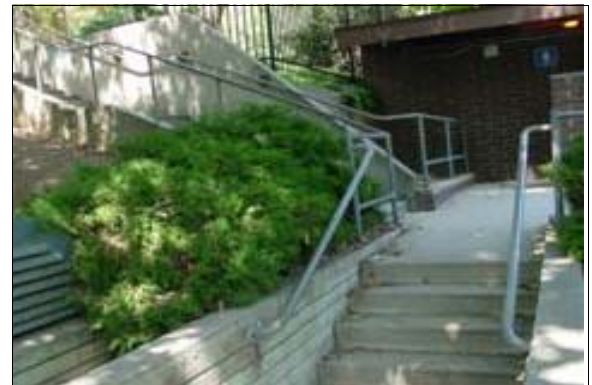
Exterior Stairs to the Play Equipment (Left)

Finding: The handrails do not provide 12-inch extensions beyond the top and bottom treads.

Full Rec: Install handrails on each side of stairway that provide 12-inch top and bottom handrail extensions that extend beyond the top and bottom treads of the stairway which are parallel to the ground surface and return smoothly to the post or wall.

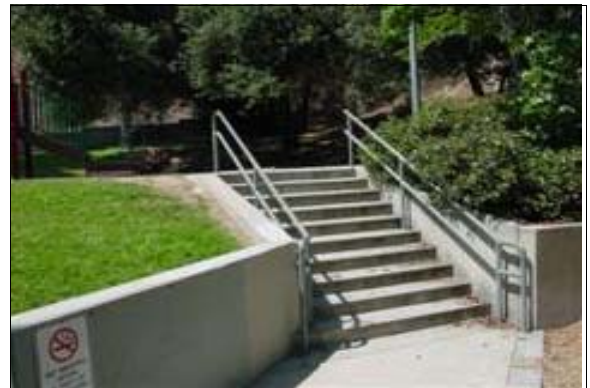
Exterior Stairs to the Play Equipment (Right)

Finding: There is no detectable striping on each tread of the exterior stairway.

Full Rec: Affix detectable contrasting striping to each tread of the stairway that clearly contrasts in color from the tread and is at least 2 inches in width placed no more than 1 inch from the tread nose or landing.

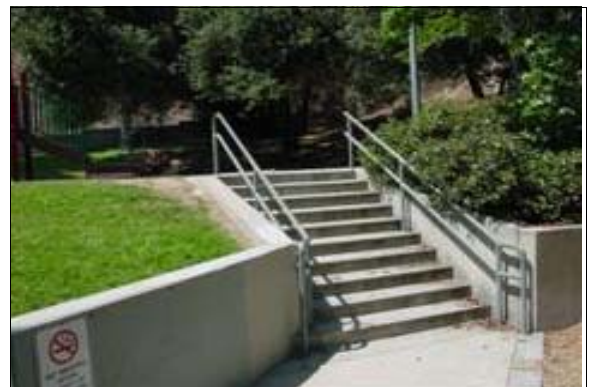
Exterior Stairs to the Play Equipment (Right)

Finding: There are no top handrail extensions provided on the stairway.

Full Rec: Install 12-inch handrail extensions to the top of the handrail that extends beyond the top riser and is parallel to the floor surface at the top landing.

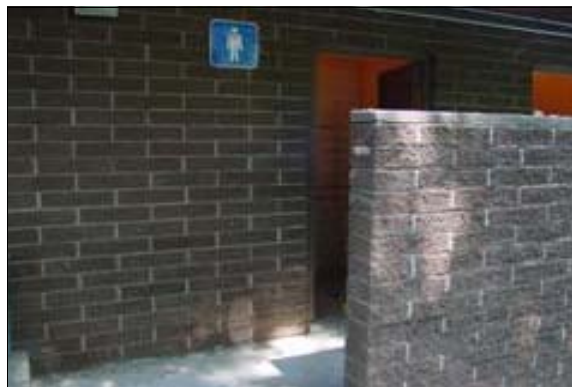
Men's Restroom

Finding: There is no signage indicating accessibility on the latch side of the entry door of the restroom. There is no Title 24 gender use signage on the entrance door.

Full Rec: The restroom is designated accessible and should be made accessible for the facility. Post signage centered 60 inches above the ground surface on the latch side of the entrance door identifying the restroom as accessible upon completion of the following items (see CBC 1115B., ADAAG 4.1.2(7) and ADAAG 4.1.6(3)(e). Signage shall include Braille and raised lettering, the gender or unisex use symbol and the ISA symbol. Post Title 24 gender use signage on the door @ 60" o.c. a.f.f.

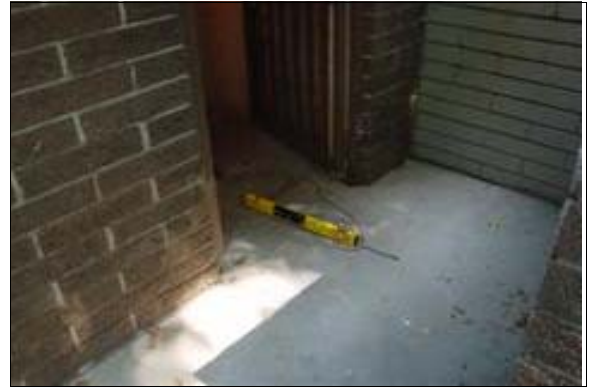
Men's Restroom

Finding: There is no level landing provided at the entrance door.

Full Rec: Provide a level and clear landing at least 60 inches in length in the direction of the door swing.

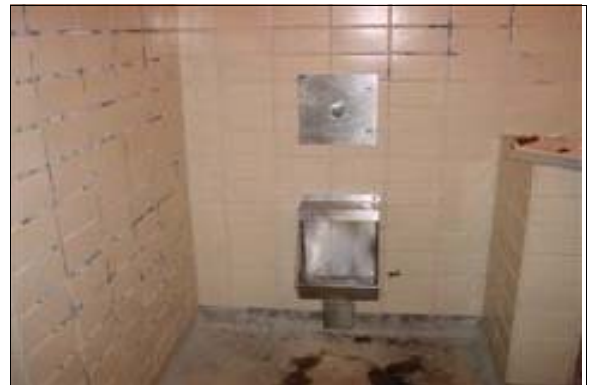
Men's Restroom

Finding: The height of the urinal rim in the restroom is greater than 17 inches above the finished floor. The height of the urinal flush control in the restroom is greater than 44 inches above the finished floor.

Full Rec: Lower the urinal designated to be accessible in the restroom so that the rim height is not more than 17 inches above the finished floor. Lower the flush control valve on the urinal designated to be accessible in the restroom to a height not greater than 44 inches above the finished floor (see ADAAG 4.18.4).

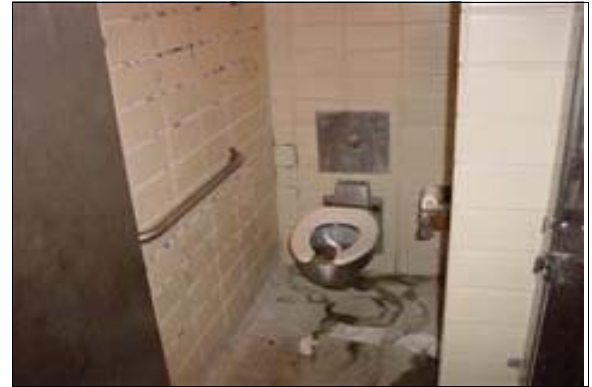
Men's Restroom

Finding: There is insufficient clear floor space in the stall designated to be accessible in the restroom. The door to the stall designated to be accessible in the restroom does not close automatically or have accessible hardware.

Full Rec: Modify or replace the stall designated to be accessible in the restroom so that it complies with ADAAG 4.17.3, CBC 1115B and CBC Figures 11B-1A and 1B. Standard accessible stalls require 60 inches in width with 56 inches depth for wall-mounted toilets or 59 inches depth for floor-mounted toilets to accommodate individuals in wheelchairs. The minimum width of a front-approach doorway shall provide at least 32 inches and a side-approach doorway shall provide at least 34 inches. The door shall swing outward, close automatically and provide accessible hardware.

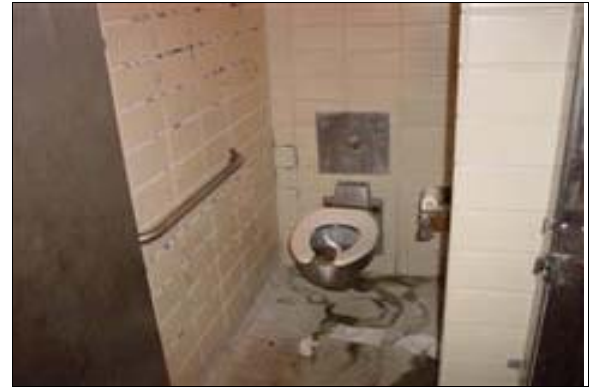
Men's Restroom

Finding: There is no back grab bar in the stall designated to be accessible in the restroom.

Full Rec: Install a 36-inch back grab bar at a height of 33 inches above the finished floor in the stall designated to be accessible of the restroom. Grab bars must be able to support a point load of at least 250 pounds and shall be less than the allowable shear stress of the grab bar material.

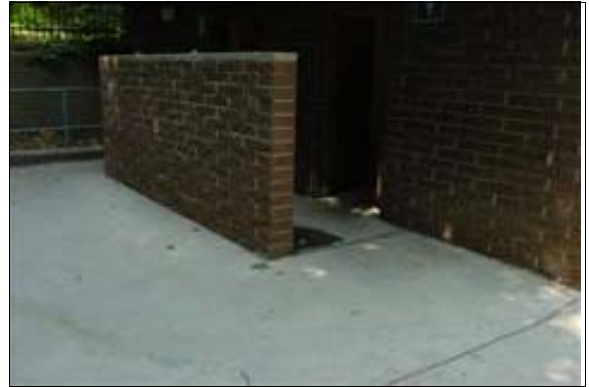
Women's Restroom

Finding: There is no signage indicating accessibility on the latch side of the entry door of the restroom. There is no Title 24 gender use signage on the entrance door.

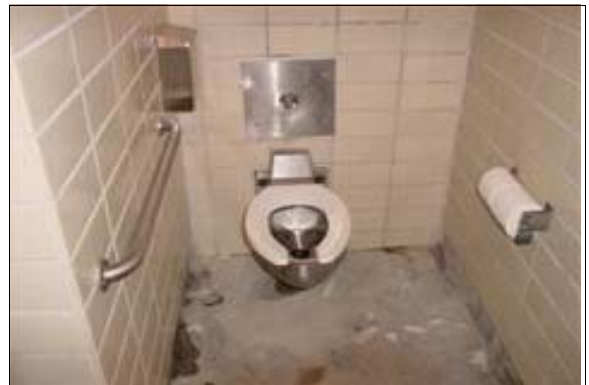
Women's Restroom

Finding: There is insufficient clear floor space in the stall designated to be accessible in the restroom. The door to the stall designated to be accessible in the restroom does not close automatically or have accessible hardware.

Full Rec: Modify or replace the stall designated to be accessible in the restroom so that it complies with ADAAG 4.17.3, CBC 1115B and CBC Figures 11B-1A and 1B. Standard accessible stalls require 60 inches in width with 56 inches depth for wall-mounted toilets or 59 inches depth for floor-mounted toilets to accommodate individuals in wheelchairs. The minimum width of a front-approach doorway shall provide at least 32 inches and a side-approach doorway shall provide at least 34 inches. The door shall swing outward, close automatically and provide accessible hardware.

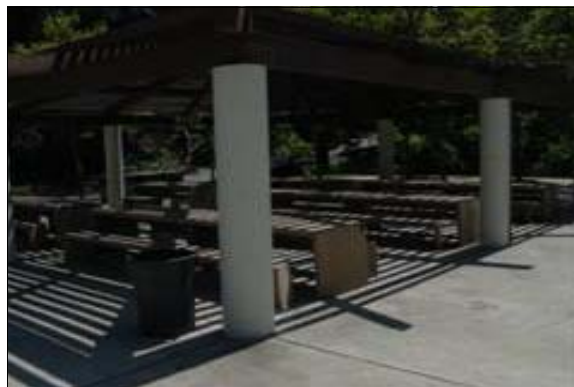
Outdoor Dining Area

Finding: The tables at the outdoor dining area next to the parking lot are nonaccessible by design.

Full Rec: Modify or replace one of the tables in the outdoor dining area to provide knee clearance of at least 27 inches in height, 30 inches in width and 19 inches in depth (see CBC 1122B.3, ADAAG 4.32.2 and ADAAG Figure 45). The table top height shall not exceed 34 inches above the finished floor.

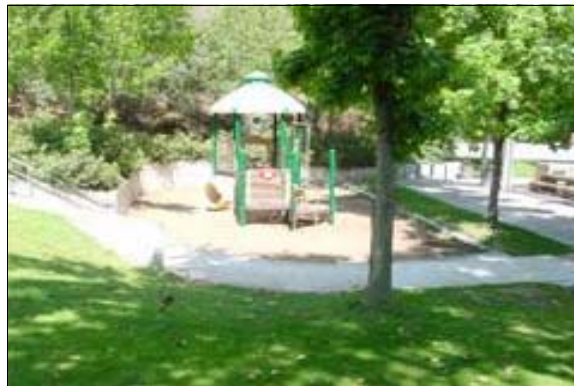
Lower Play Equipment

Finding: The surface beneath the play equipment is wood chips, making the area nonaccessible to individuals with mobility impairments.

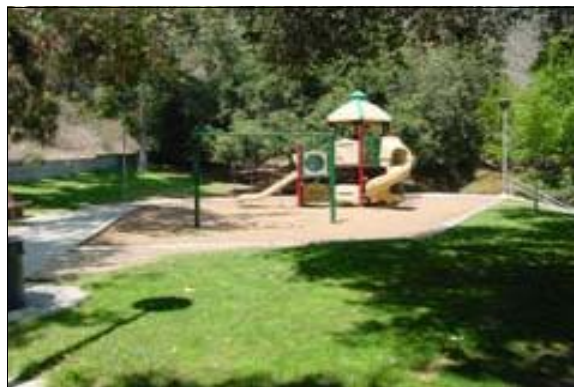
Upper Play Equipment

Finding: There are only stairs on the path of travel to the play area, preventing access to individuals with mobility impairments.

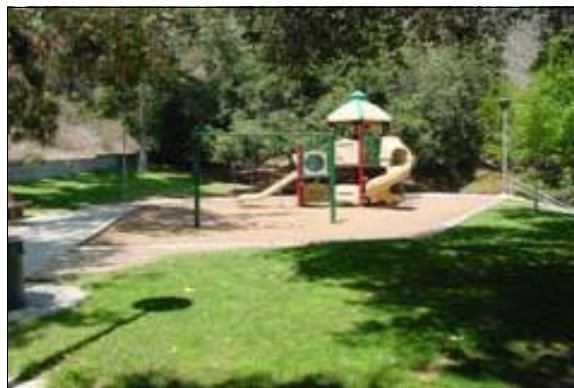
Upper Play Equipment

Finding: The surface beneath the play equipment is wood chips, making the area nonaccessible to individuals with mobility impairments.
