Photo Report
Pelanconi Park
Programs, Services, and Activities

Finding: Pelanconi Park, located at 1000 Grandview Avenue in Glendale California, was inspected by Disability Access Consultants, Inc., on June 8, 2007.

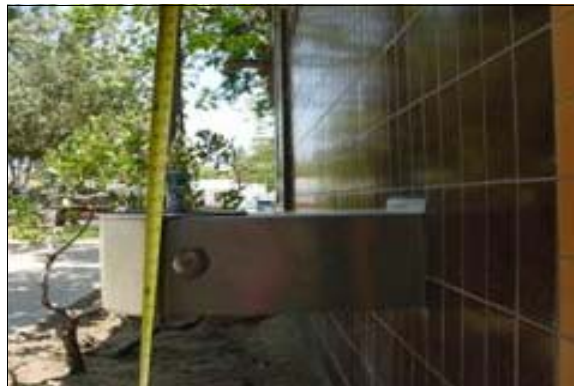
**Pelanconi Park
Drinking Fountains**

Finding: There are two drinking fountains on primary paths of travel.
