Photo Report
Scholl Canyon Golf and Tennis
Programs, Services, and Activities

Finding: Scholl Canyon Golf and Tennis, located at 3800 East Glenoaks Boulevard in Glendale California, was inspected by Disability Access Consultants, Inc., on June 20, 2007.

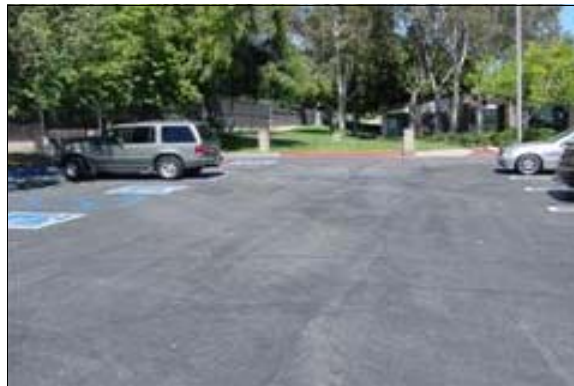
Curb Ramp Next to the Accessible Parking Spaces

Finding: The slope of the curb ramp is greater than 8.33%. The slope at the top landing is greater than 2%. The slope of the side flares is greater than 10%. The curb ramp does not provide a grooved border along the top and sides of the ramp at the level of the sidewalk. The concrete curb ramp does not provide a detectable warning surface which includes truncated domes.

Full Rec: Replace the curb ramp with a compliant curb ramp at least 48 inches in width that provides a slope no greater than 8.33%. Install a detectable warning surface which extends the full length and width of the concrete curb ramp and its side flares with truncated domes that contrast visually by either light on dark or dark on light which is an integral part of the concrete curb ramp. The truncated domes may be cast in place or stamped or of a prefabricated surface treatment (see CBC 1127B.5.8).

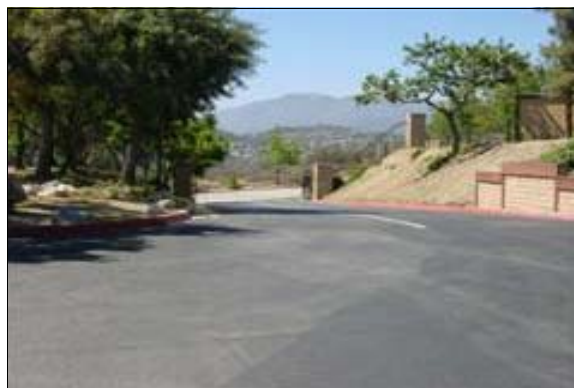
Accessible Route from the Public Right of Way

Finding: There is no accessible route from the public right of way to the accessible entrance of the facility. The accessible route crosses vehicular traffic.

Alternative Post directional signage.
Rec:
(Where Available)

Full Rec: Provide at least one accessible route from the public right of way to the accessible entrance of the facility. Make certain to post signage indicating the direction to accessible building entrances at every major junction along the accessible route. Signs shall include the International Symbol of Accessibility.

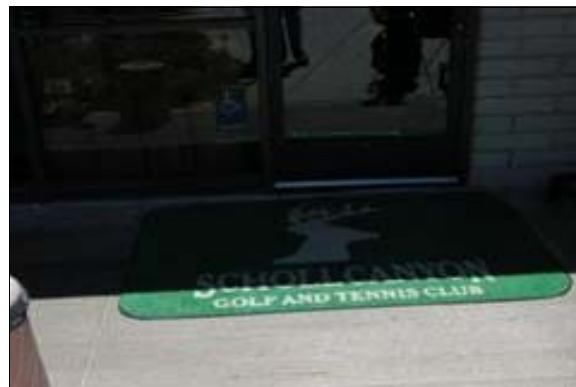
Path of Travel to the Club House

Finding: The mat at the entrance does not adhere to the underlying floor surface and creates a hazardous path of travel.

Full Rec: Securely fasten the mats or replace with a mat that grips to the underlying floor surface to provide a firm, stable, continuous and relatively smooth path of travel surface (see CBC 1124B.3 and ADAAG 4.5.3). Mats along the primary path of travel shall provide beveled edges on all sides to prevent roll over.

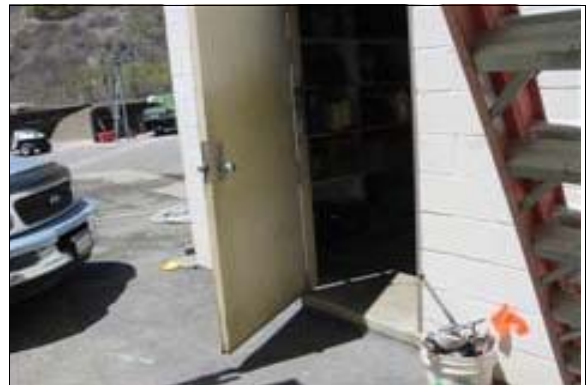
Path of Travel to the Maintenance Building

Finding: There is a step on the primary path of travel to the Maintenance Building, preventing access to individuals with mobility impairments.

Full Rec: Since programs, services and activities to staff and the public (volunteers, etc.) are provided in this location, those programs, services and activities are required to be made accessible. It is recommended that a ramp be installed or other means of vertical access.

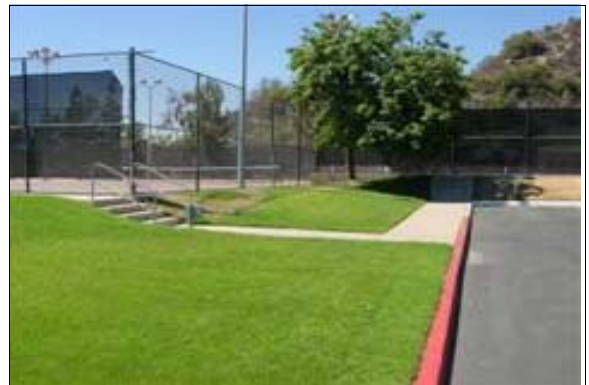
Exterior Stairs to the Tennis Courts

Finding: There is no detectable striping on each tread of the exterior stairway.

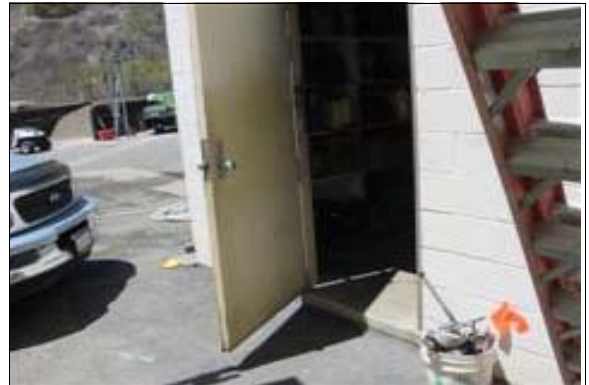
Maintenance Building

Finding: The exterior passage door has a round doorknob, which requires twisting of the wrist to operate.

Full Rec: Replace the existing door hardware with accessible hardware (see ADAAG 4.13.9).

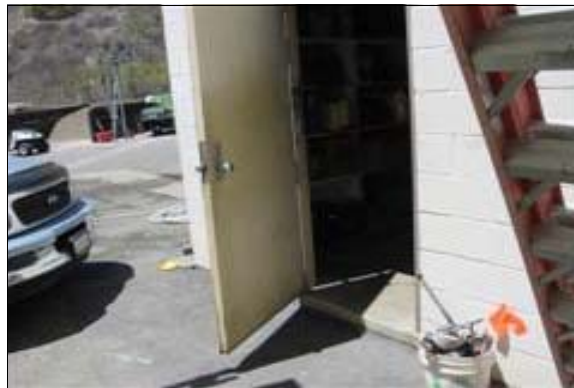
Maintenance Building

Finding: The main entrance does not have accessible signage mounted on the wall adjacent to the latch side of the door.

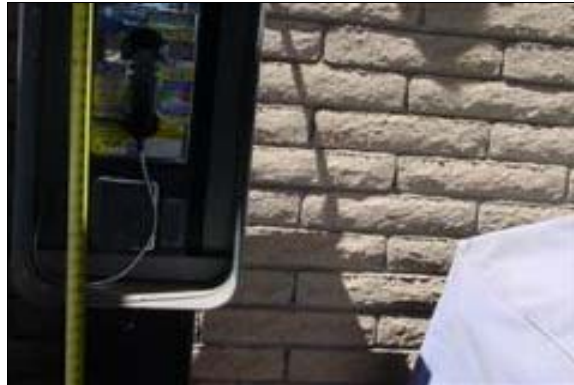
Pay Telephone

Finding: There are two pay telephones at the facility, located outside of the Café and outside of the restrooms.

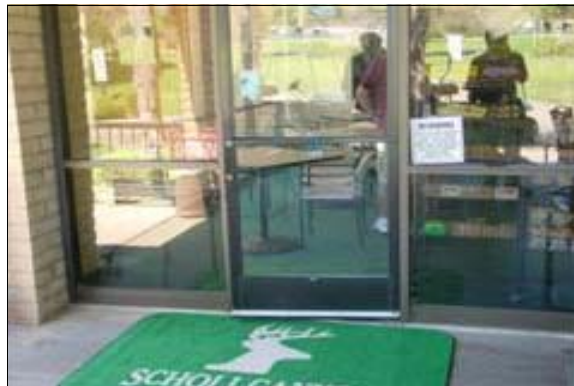
Scholl Canyon Café

Finding: There is no signage with the International Symbol of Accessibility on the entrance door to the facility designating it as accessible.

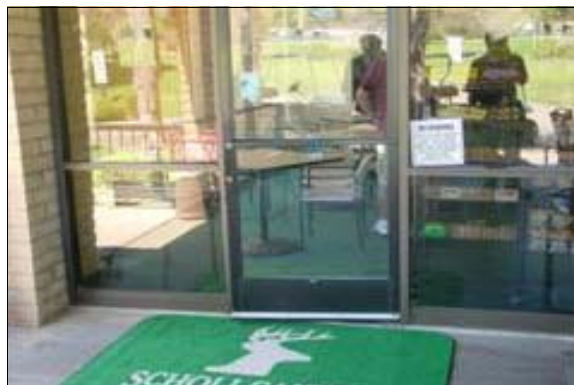
Scholl Canyon Café

Finding: The main entrance does not have accessible signage mounted on the wall adjacent to the latch side of the door.

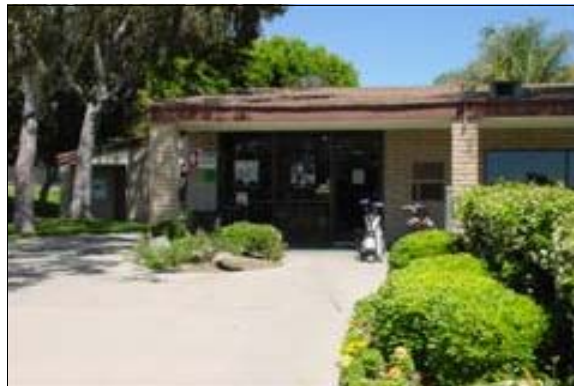
Scholl Canyon Club House

Finding: The main entrance does not have accessible signage mounted on the wall adjacent to the latch side of the door.

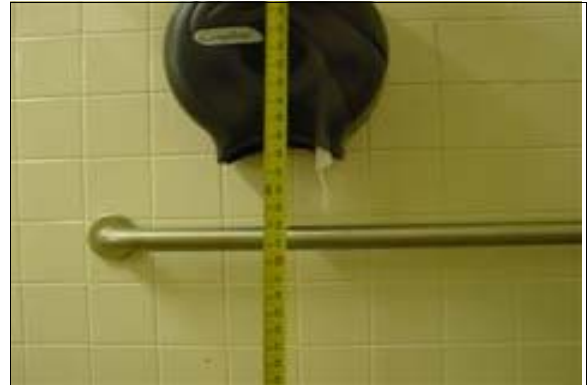
Men's Restroom at the Clubhouse

Finding: The toilet paper dispenser in the stall designated to be accessible in the restroom interferes with the use of the side grab bar. The location of the toilet paper dispenser in the stall designated to be accessible in the restroom is not within 12 inches of the front edge of the toilet seat.

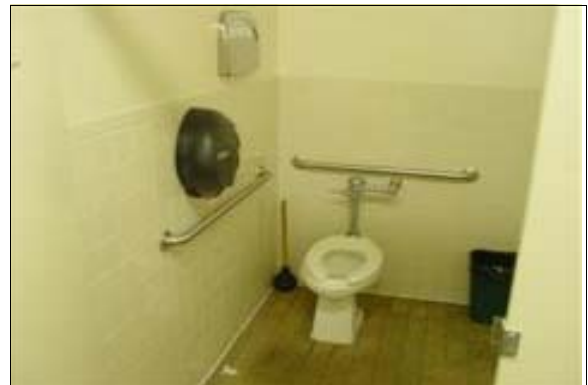
Men's Restroom at the Clubhouse

Finding: The flush control on the toilet in the stall designated to be accessible in the restroom is not on the wide (approach) side of the toilet.

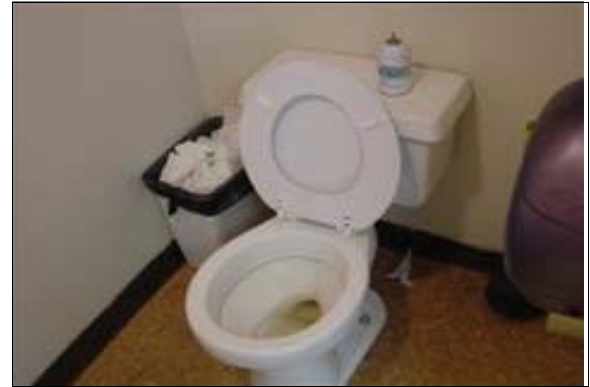
Unisex Restroom at the Maintenance Building

Finding: There are no grab bars in the restroom.

Full Rec: Install one 36-inch back grab bar and one 42/48-inch side grab bar in the restroom. Grab bars shall be mounted at a height of 33 inches above the finished floor. Grab bars must be able to support a point load of at least 250 pounds and shall be less than the allowable shear stress of the grab bar material.

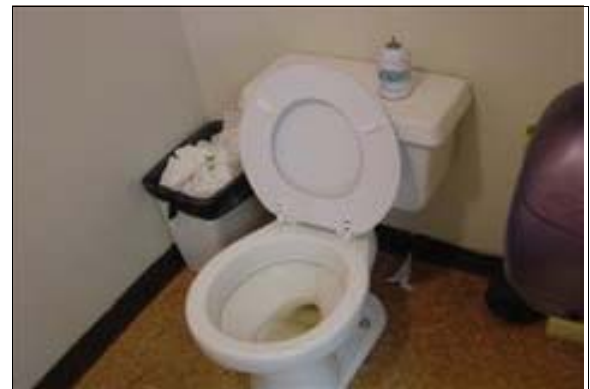
Unisex Restroom at the Maintenance Building

Finding: The flush control on the toilet in the restroom is not on the wide (approach) side of the toilet.

Full Rec: Relocate the flush control on the toilet in the restroom so that it is on the wide (approach) side of the toilet area (see ADAAG 4.16.5). Flush controls shall be hand-operated or automatic mechanisms.

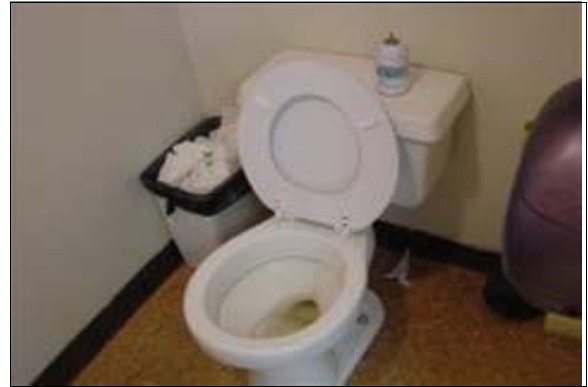
Unisex Restroom at the Maintenance Building

Finding: The height of the toilet seat in the restroom is less than 17 inches above the finished floor.

Full Rec: Remove or modify the toilet in the restroom so that the seat height is between 17 inches and 19 inches above the finished floor (see ADAAG 4.16.3).

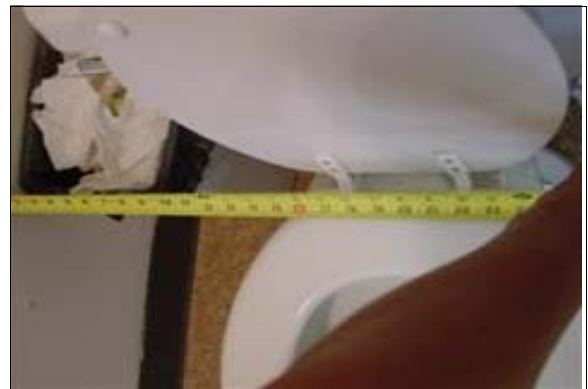
Unisex Restroom at the Maintenance Building

Finding: The distance from the center of the toilet to the nearest side wall in the restroom is greater than 18 inches.

Full Rec: Relocate the toilet so that the distance from the centerline of the toilet to the nearest side wall in the restroom is exactly 18 inches (see ADAAG Figure 28).

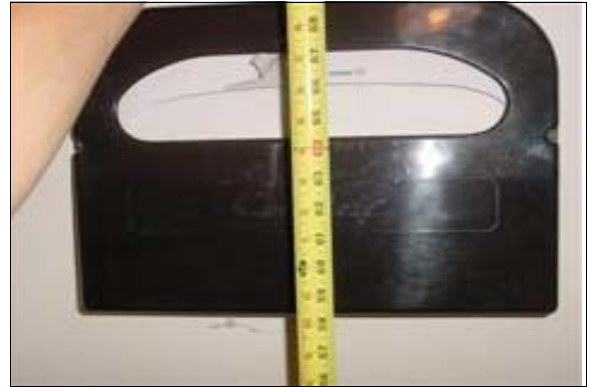
Unisex Restroom at the Maintenance Building

Finding: The seat cover dispenser in the restroom is mounted at a height greater than 40 inches and there is no clear floor space.

Full Rec: Relocate the seat cover dispenser in the restroom so that the height is no greater than 40 inches above the finished floor (see CBC 1115B.9.2). Make certain that the location of the seat cover dispenser does not interfere with the use of a grab bar and provides sufficient clear floor space.

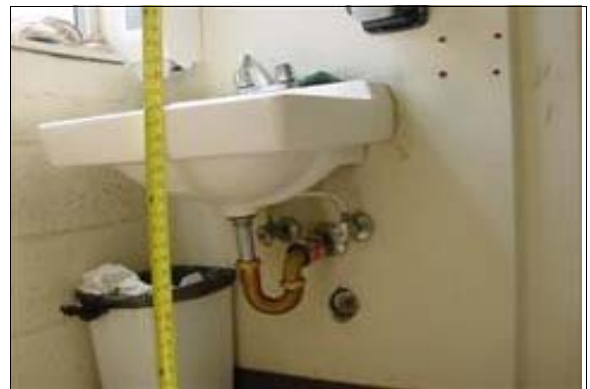
Unisex Restroom at the Maintenance Building

Finding: The faucet controls on the lavatory in the restroom require tight grasping, pinching, or twisting of the wrist and are not accessible.

Full Rec: Install faucet controls complying with ADAAG 4.19.5 on the lavatory designated to be accessible in the restroom. Lever-operated, push-type, touch-type or electronically controlled mechanisms are acceptable elements (see ADAAG 4.19.5). If self-closing valves are used the faucet shall remain open for at least 10 seconds.

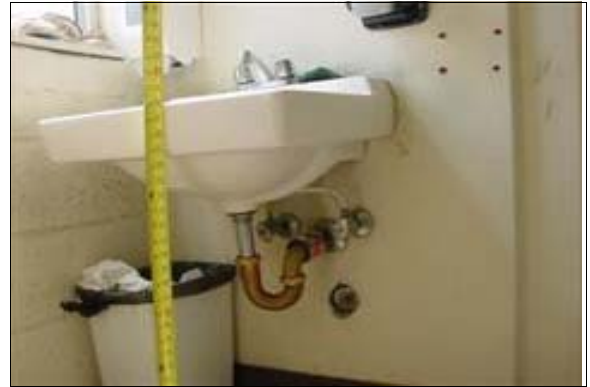
Unisex Restroom at the Maintenance Building

Finding: The knee depth space under the lavatory designated to be accessible in the restroom is less than 27 inches at 8 inches under the lavatory apron.

Full Rec: Raise or replace the lavatory designated to be accessible in the restroom to provide at least 27 inches at 8 inches under the apron. Make sure to provide at least 29 inches of clear knee space between the finished floor and bottom of the lavatory apron and a rim surface height no greater than 34 inches (see ADAAG 4.19.2).

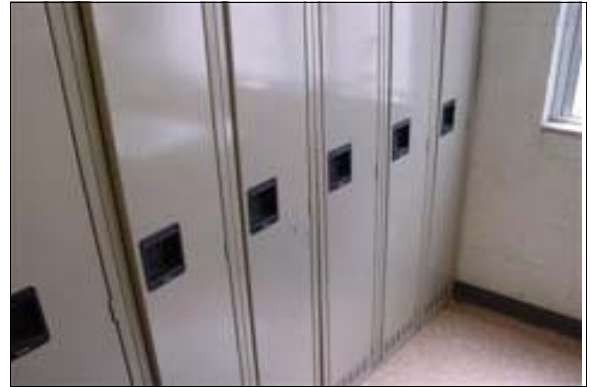
Unisex Restroom at the Maintenance Building

Finding: Lockers are available for use in the restroom.

Full Rec: At least one locker or no less than one percent of the lockers in the restroom shall be made accessible for individuals with disabilities. Make certain that the accessible lockers are located on an accessible path of travel that is at least 36 inches in width (see CBC 1115B.6.4 and ADAAG 4.27).

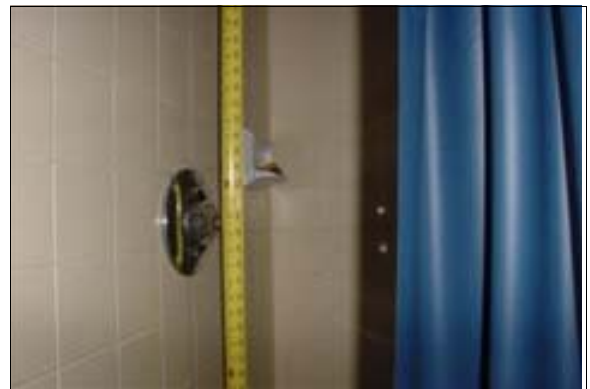
Unisex Restroom at the Maintenance Building

Finding: A showering facility is provided, though is not required. There is no accessible shower stall in the restroom.

Full Rec: Since a shower stall is provided in the restroom, at least one accessible shower stall is required. Install an accessible shower stall complying with CBC 1115B 6.2 and ADAAG 4.21 in the restroom.

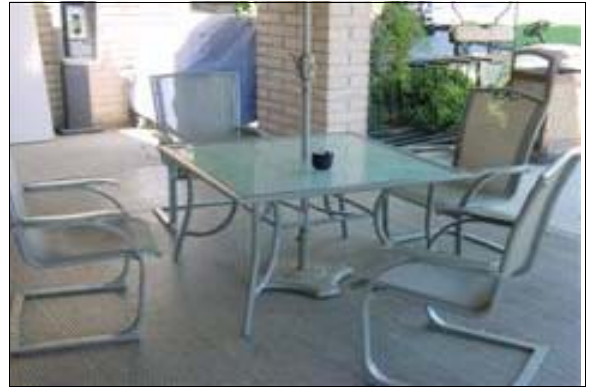
Outdoor Dining Area

Finding: The knee space at the tables in the outdoor dining area outside of the Café is less than 19 inches deep.

Full Rec: Modify or replace one of the tables in the outdoor dining area to provide knee clearance of at least 27 inches in height, 30 inches in width and 19 inches in depth (see CBC 1122B.3, ADAAG 4.32.2 and ADAAG Figure 45). The table top height shall not exceed 34 inches above the finished floor.

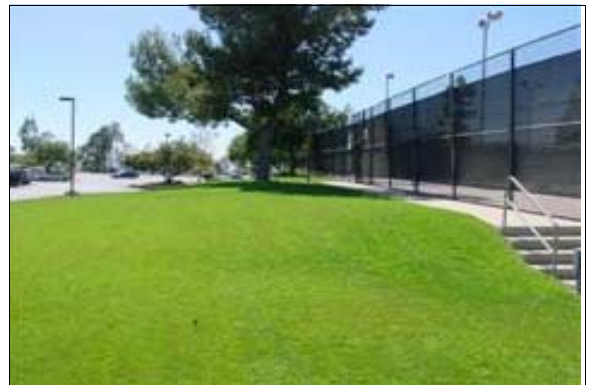
Outdoor Dining Area

Finding: There is no accessible route to the picnic tables in the outdoor dining area next to the tennis courts. The surface under and around the outdoor dining area picnic tables is grass, preventing access of individuals with mobility impairments.

Full Rec: Install a 48-inch wide path to the picnic tables in the outdoor dining area that provides a smooth, stable, firm and slip resistant surface. Provide a maneuvering space sufficient to provide a 60-inch diameter turning radius adjacent to at least one of the picnic tables in the outdoor dining area.

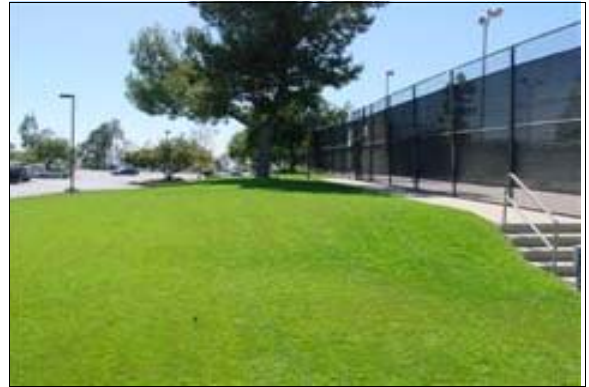
Outdoor Dining Area

Finding: The knee space at the tables in the outdoor dining area next to the tennis courts is less than 19 inches deep.

Full Rec: Modify or replace one of the tables in the outdoor dining area to provide knee clearance of at least 27 inches in height, 30 inches in width and 19 inches in depth (see CBC 1122B.3, ADAAG 4.32.2 and ADAAG Figure 45). The table top height shall not exceed 34 inches above the finished floor.

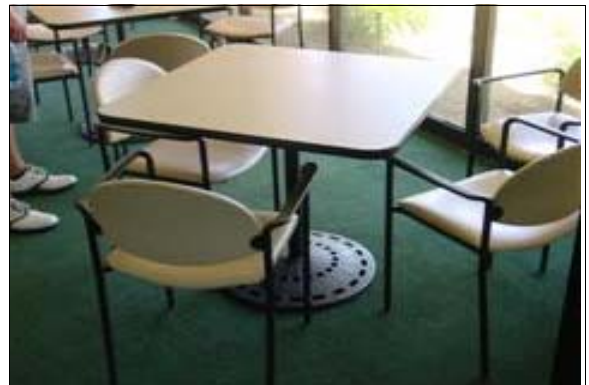
Scholl Canyon Café

Finding: The tables in the Café are nonaccessible by design.

Full Rec: Modify or replace one of the tables in the Café to provide knee clearance of at least 27 inches in height, 30 inches in width and 19 inches in depth (see CBC 1122B.3, ADAAG 4.32.2 and ADAAG Figure 45). The table top height shall not exceed 34 inches above the finished floor.

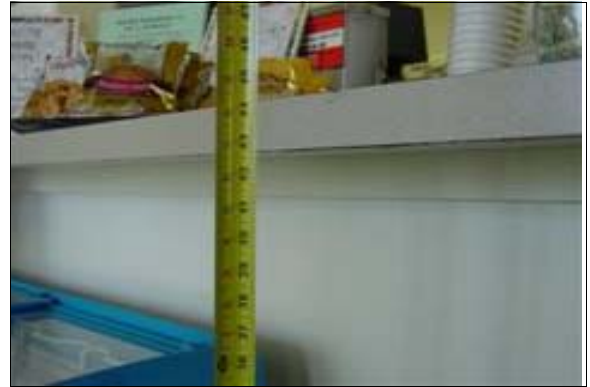
Scholl Canyon Café

Finding: The height of the cashier counter is greater than 34 inches.

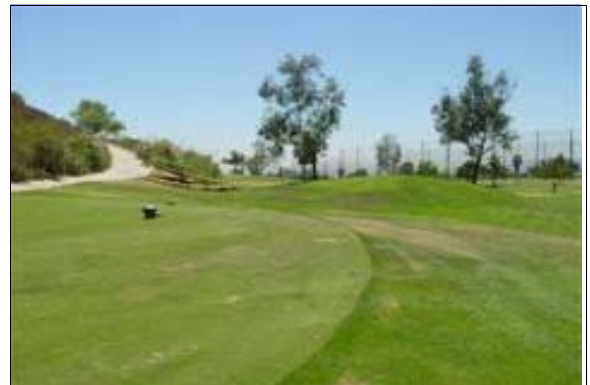
Golf Course

Finding: The grass surface of the golf course at the facility prevents access to individuals with mobility impairments.

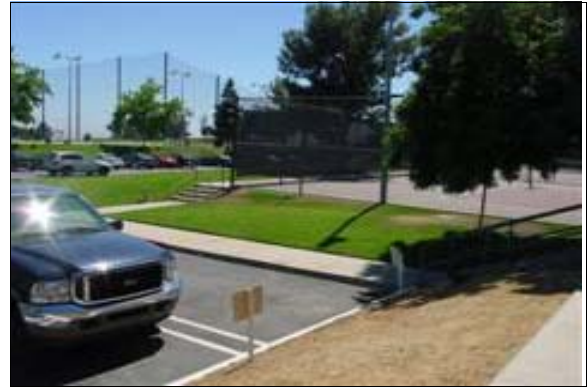
Tennis Courts 1 and 2

Finding: There are only stairs on the path of travel to the tennis courts, preventing access to individuals with mobility impairments.
