Photo Report
Sparr Heights Senior Center Community Building
Programs, Services, and Activities

Finding: The Sparr Heights Senior Center Community Building, located at 1613 Glencoe Way in Glendale California, consists of one single story structure built in July 2004. The facility was inspected by Disability Access Consultants, Inc., on June 7, 2007.

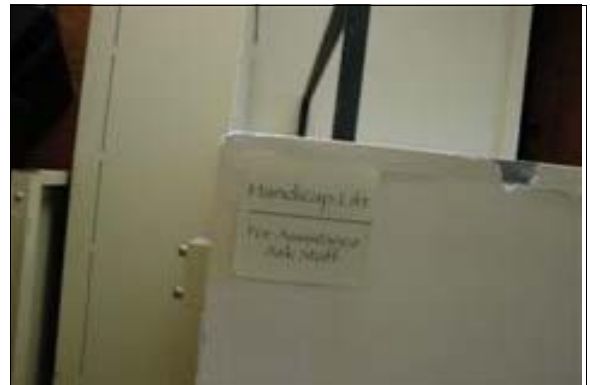
Platform Lift to the Stage in the Verdugo Room

Finding: There is a platform lift to the stage in the Verdugo Room. The platform lift provides accessible vertical path of travel to the stage. The platform lift is capable of providing independent operation.

Full Rec: Platform lifts must be capable of independent operation. Platform lifts shall not be modified in any manner or serve as an accessible means of egress. Platform lifts shall comply with CBC 1105.3, CBC 1104.1.4, ADAAG 4.11 and ASME A17.1 Safety Code for Elevators and Escalators, Section XX, 1990.

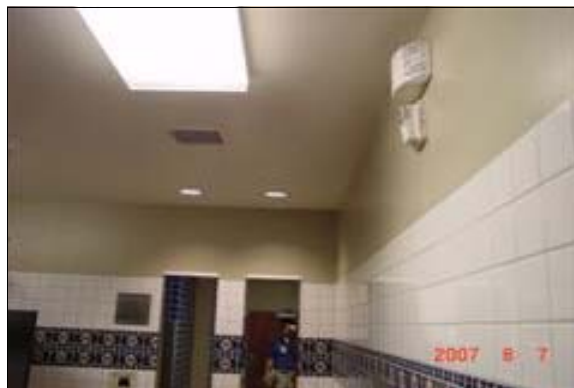
Finding: There are visual warning devices provided in common areas of the facility.

Full Rec: Since visual warning devices are provided in all common areas of the facility, no additional action is required.
