Photo Report
Sports Complex
Programs, Services, and Activities

Finding: The Sports Complex, located at 2200 Fern Lane in Glendale California, was inspected by Disability Access Consultants, Inc., on June 7, 2007. Facilities include the Sports Complex Operations Office and the Maintenance Building.

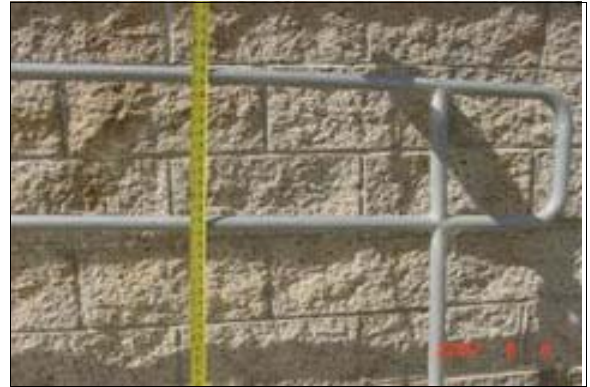
Exterior Ramp Between the Sports Fields

Finding: There are no 12-inch extensions beyond the bottom of the ramp.

Full Rec: Weld pipe extensions on the handrails of the ramp so that they continue 12 inches beyond the end of the ramp parallel to the ground surface and return smoothly to the post or wall (see CBC 1133B.5.5 and ADAAG 4.8.5).

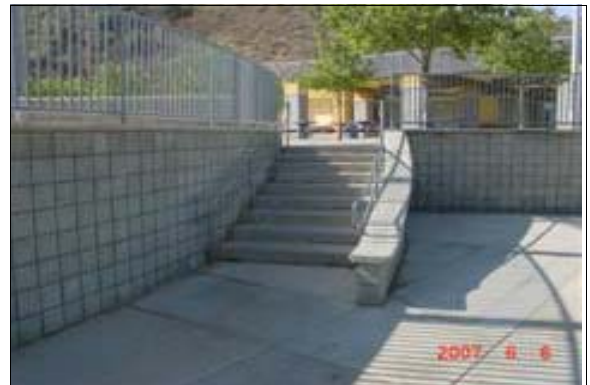
Exterior Stairs to the Outdoor Dining Area

Finding: The handrails are mounted at a height less than 34 inches above the nosing of the treads.

Full Rec: Remount the handrails on the stairway so that the gripping surface of the handrails are at a consistent height between 34 inches and 38 inches above the stair nosings.

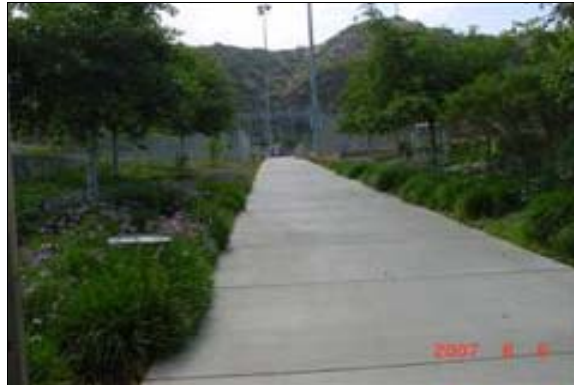
Directional Signage

Finding: There is no directional signage to the accessible entrance from the public right of way or other common use areas.
