**Photo Report**  
**Verdugo Adobe Park**  
**Programs, Services, and Activities**

**Finding:** The Verdugo Adobe Park, located at 2211 Bonita Drive in Glendale California, was inspected by Disability Access Consultants, Inc., on June 12 an 14, 2007.

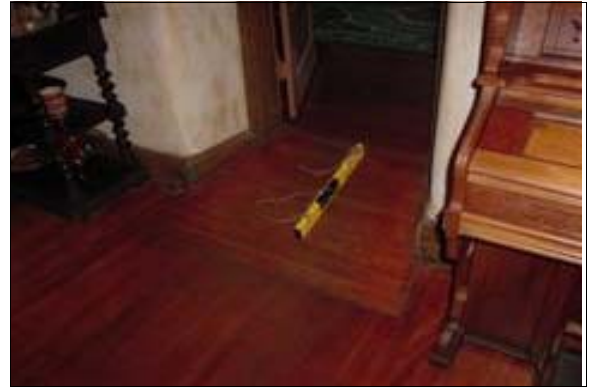
**Interior Door to the Dining Area in the Museum**

**Finding:** The clear opening width of the door is less than 32 inches.

**Full Rec:** Widen the door opening and install a door that provides at least 32 inches of clear width with the door open 90 degrees (see CBC 1133B.2.3.1 and ADAAG 4.13.5).

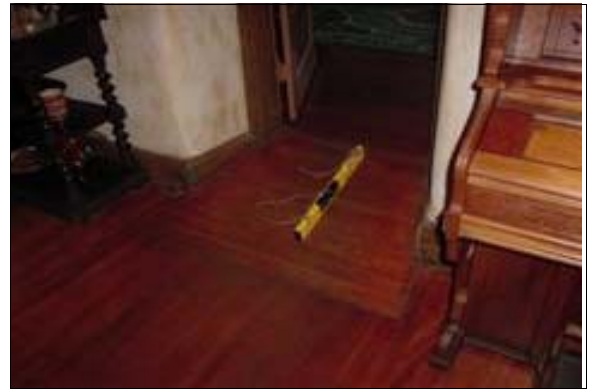
**Interior Door to the Dining Area in the Museum**

**Finding:** There is no level landing provided at the entrance door.

**Full Rec:** Provide a level and clear landing at least 60 inches in length in the direction of the door swing.

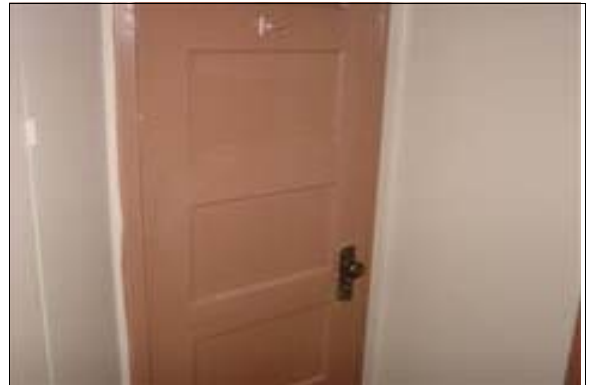
**Unisex Restroom in the Museum**

**Finding:** There is no signage indicating accessibility on the latch side of the entry door of the restroom. There is no Title 24 gender use signage on the entrance door.

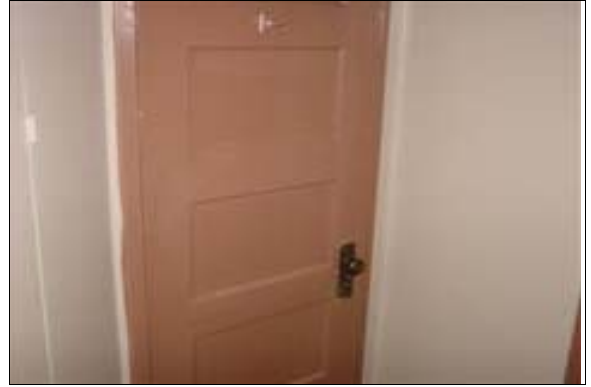
**Unisex Restroom in the Museum**

**Finding:** The entrance door to the restroom has a round doorknob that requires tight grasping or twisting of the wrist to operate.

**Full Rec:** Replace the door hardware mounted on the restroom complying with ADAAG 4.13.9. Make certain accessible door hardware is mounted no higher than 48 inches above the finished floor.

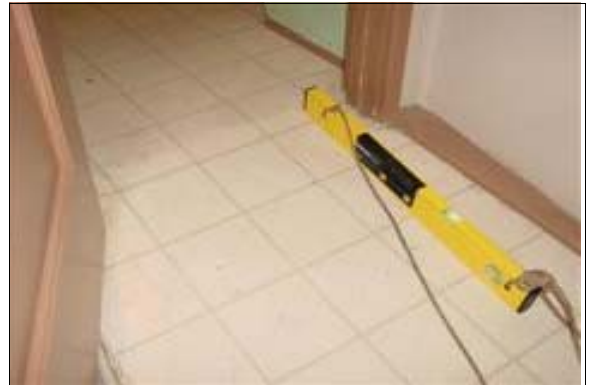
**Unisex Restroom in the Museum**

**Finding:** There is no level landing provided at the entrance door.

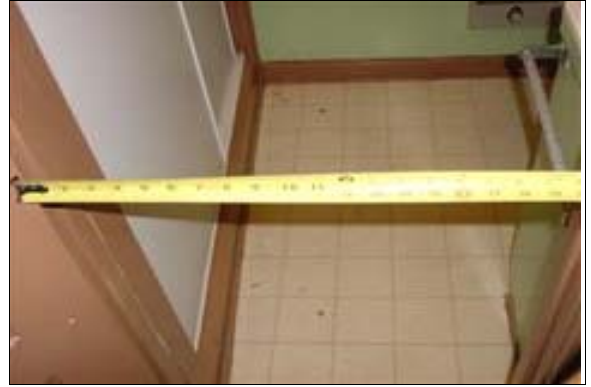
**Unisex Restroom in the Museum**

**Finding:** The clear opening width of the entrance doorway to the restroom is less than 32 inches.

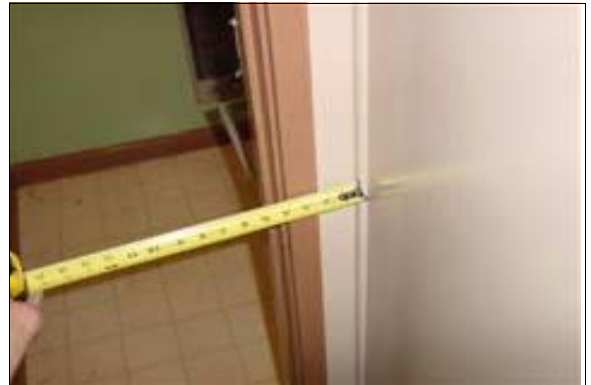
**Unisex Restroom in the Museum**

**Finding:** There is less than 18 inches of latch side clearance from the pull side of the interior entrance door.

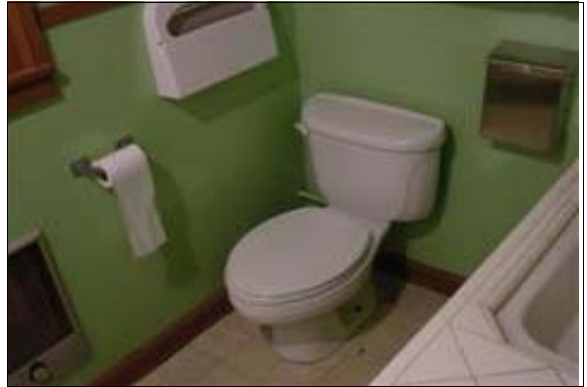
**Unisex Restroom in the Museum**

**Finding:** This restroom is not accessible and cannot be easily altered. There is not sufficient clear floor space in the restroom to accommodate an individual in a wheelchair.

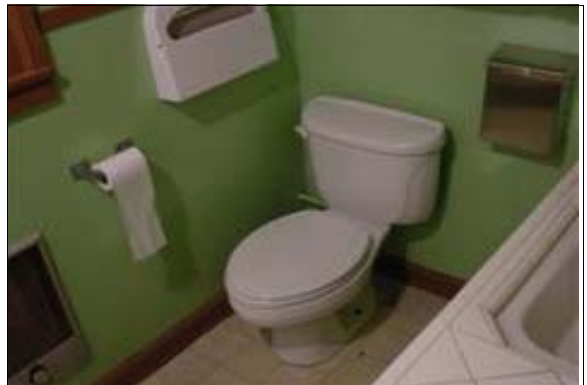
**Unisex Restroom in the Museum**

**Finding:** There are no grab bars in the restroom.

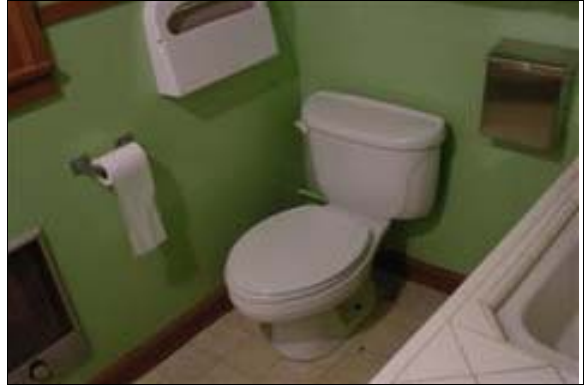
**Unisex Restroom in the Museum**

**Finding:** The flush control on the toilet in the restroom is not on the wide (approach) side of the toilet.

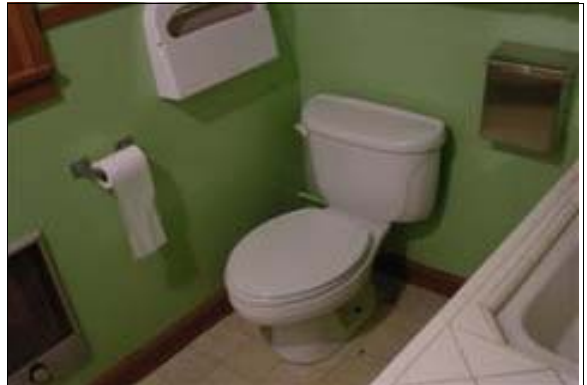
**Unisex Restroom in the Museum**

**Finding:** The height of the toilet seat in the restroom is less than 17 inches above the finished floor.

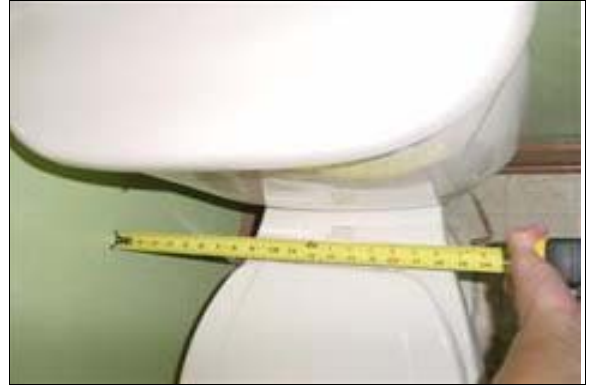
#### ***Unisex Restroom in the Museum***

**Finding:** The distance from the center of the toilet to the nearest side wall in the restroom is less than 18 inches.

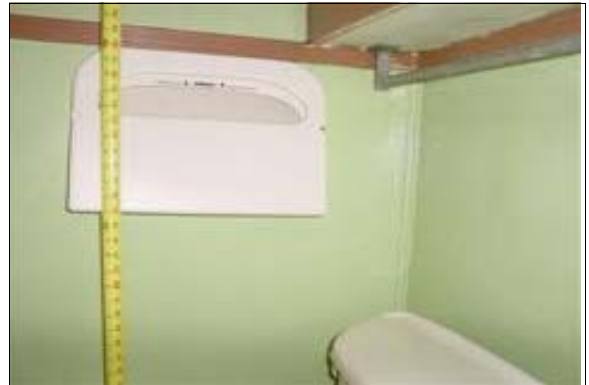
#### ***Unisex Restroom in the Museum***

**Finding:** The seat cover dispenser in the restroom is mounted at a height greater than 40 inches and there is no clear floor space.

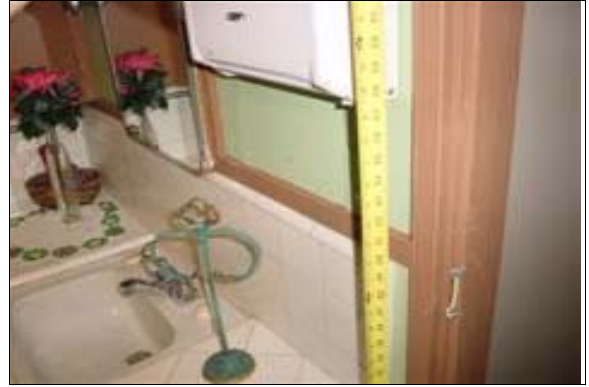
#### ***Unisex Restroom in the Museum***

**Finding:** The bottom edge of the reflecting surface of the mirror in the restroom is greater than 40 inches above the finished floor.

**Full Rec:** Lower the mirror in the restroom so that the bottom edge of the reflecting surface is no higher than 40 inches above the finished floor and the topmost portion of the reflecting surface extends at least 74 inches above the finished floor (see ADAAG A4.19.6). A single, full-length mirror is recommended since it can accommodate all people. Make certain to provide a minimum clear floor space in front of the mirror of 30 inches in width and 48 inches in length.

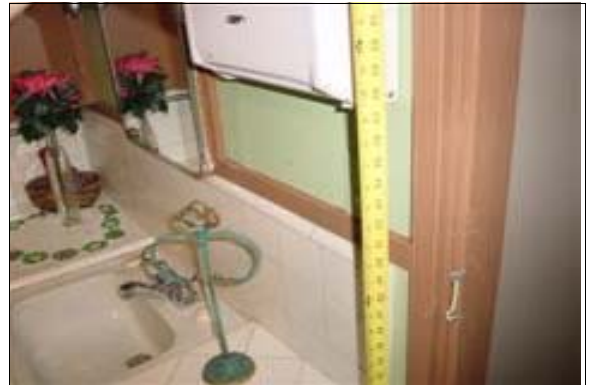
#### ***Unisex Restroom in the Museum***

**Finding:** The height of the controls and operating mechanisms for the paper towel dispenser in the restroom is greater than 40 inches.

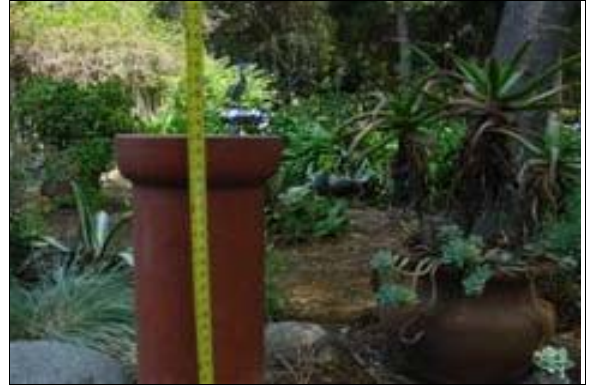
**Finding:** There is one drinking fountain on primary paths of travel.

**Full Rec:** Fifty percent of the drinking fountains on primary paths of travel shall be accessible (see CBC 1117B.1 and ADAAG 4.15). Install a "high-low" fountain design to comply with both state and federal requirement. Fountains not located in alcoves need side rails or wing walls on both sides.

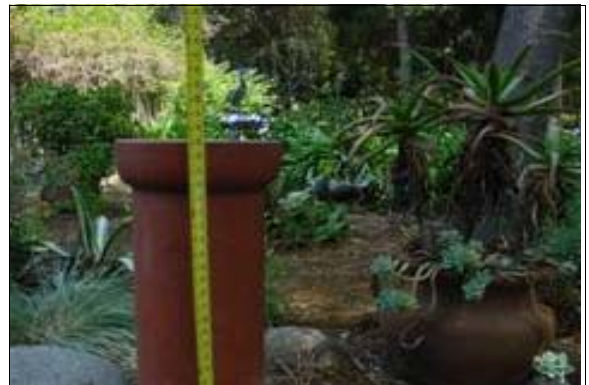
**Finding:** The drinking fountain is not a "high-low" design. The faucet controls require tight grasping or pinching of the wrist to operate. There is less than 27 inches knee clearance height.

**Full Rec:** Fifty percent of the drinking fountains on primary paths of travel shall be accessible (see CBC 1117B.1 and ADAAG 4.15). Install a "high-low" fountain design to comply with both state and federal requirements and install a side rail or wing wall next to each side of the fountain. Fountain controls shall be accessible. Wall-mounted drinking fountains shall provide a minimum knee clearance height of 27 inches, 30 inches in width and between 18 inches and 19 inches in fountain depth.
