**Photo Report**

**Verdugo Park**

**Finding:** The Verdugo Park, located 1621 Canada Boulevard in Glendale California, was inspected by Disability Access Consultants, Inc., on June 5, 2007. Facilities include the Verdugo Park Skate Park Operations Office, Caretaker's House, Food Service Building, Maintenance Building, North and South restrooms, Stengel Field, and the Stengel Field Stadium.

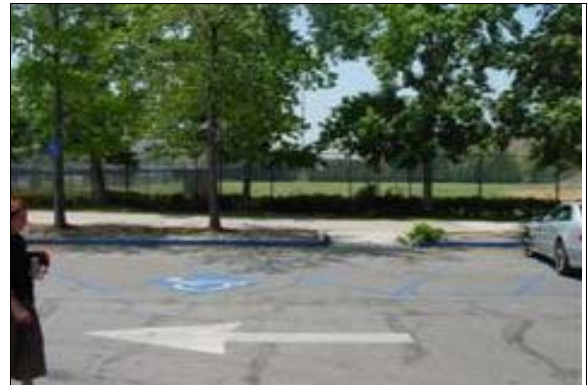
**Finding:** There are three parking lots provided at the facility. The paved parking lots are located next to the Skate Park Operations Office, outside of the Maintenance Building, and at Stengel Field.

**Full Rec:** Accessible paved parking spaces shall be located on the shortest accessible route of travel to the facility and shall coincide with the primary route and primary entrances used by the general public (see CBC 1129B.4, ADAAG 4.3.2(1) and ADAAG 4.14.1).

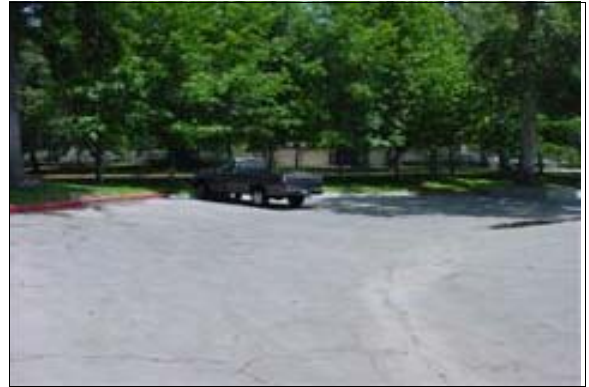
**Parking Lot at Stengel Field**

**Finding:** Parking is provided off-street to the employees at Stengel Field, though no marked spaces are provided. The parking lot can provide approximately three parking spaces.

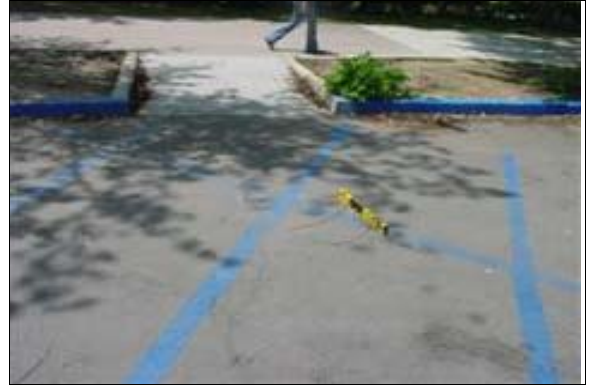
**Parking Lot Next to the Skate Park Operations Office**

**Finding:** The surface of the accessible parking space, at the left, and the access aisle has a slope greater than 2%.

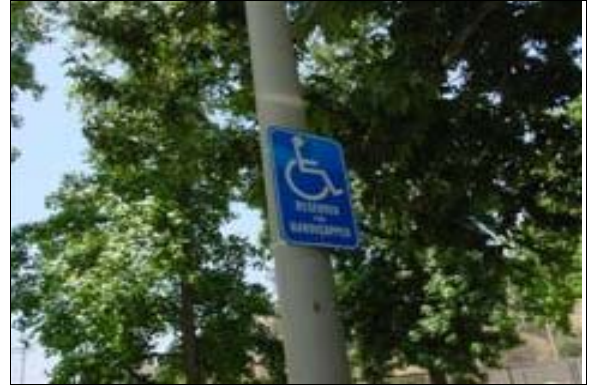
**Parking Lot Next to the Skate Park  
Operations Office**

**Finding:** The vertically-mounted signage at the designated accessible parking space, at the right, uses the word "handicapped".

**Full Rec:** Install a permanently posted reflectorized sign measuring 70 square inches that includes an ISA symbol adjacent to and visible from the accessible parking space (see CBC 1129B.5). The bottom edge of the sign must be mounted 80 inches from the ground surface so that it cannot be obscured by a parked vehicle (see CBC 1129B.5). The "van-accessible" parking space shall provide an additional sign marked "van-accessible" mounted below the sign (see CBC 1129B.5 and ADAAG 4.6.4).

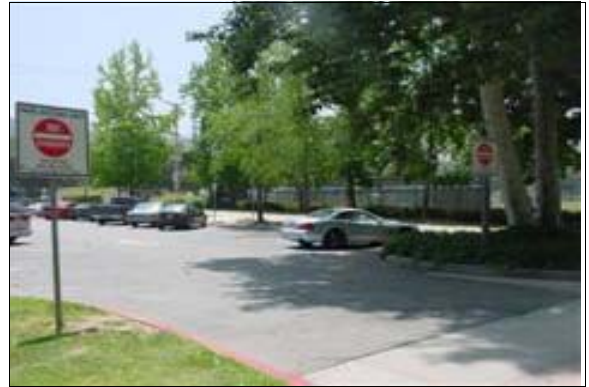
**Parking Lot Next to the Skate Park  
Operations Office**

**Finding:** There is no warning signage posted at the entrance to the parking lot regarding unauthorized use of accessible parking spaces in the parking lot.

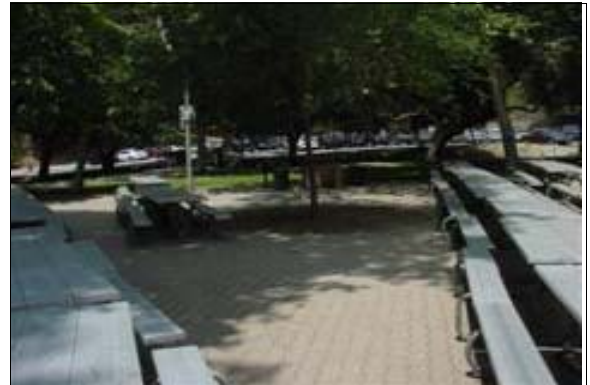
**Open Tree Wells**

**Finding:** There are open tree wells along the path of travel at the outdoor dining area with a change in elevation greater than 1/2 inch, creating a tripping hazard.

**Full Rec:** Install edge protection on each side of the open tree well consisting of 3-inch high guide curb above the surface of the path of travel (see CBC 1133B.7.1 and ADAAG 4.3.8).

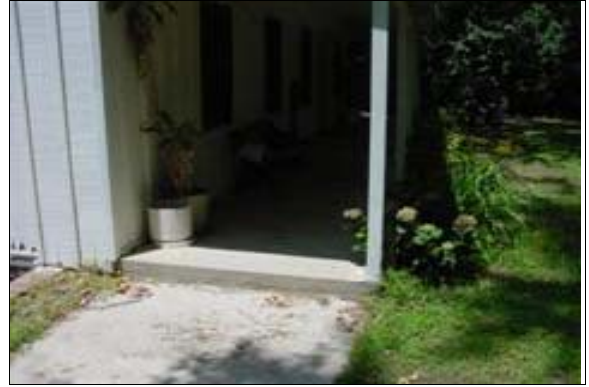
***Path of Travel to the Caretaker's House***

**Finding:** There is a step on the primary path of travel to the main entrance of the Caretaker's House, preventing access to individuals with mobility impairments.

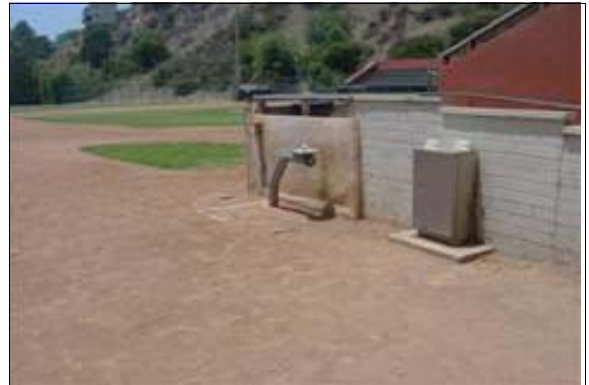
***Path of Travel to the Drinking Fountain at Stengel Field***

**Finding:** The path of travel to the drinking fountain at Stengel Field is dirt, preventing access to individuals with mobility impairments.

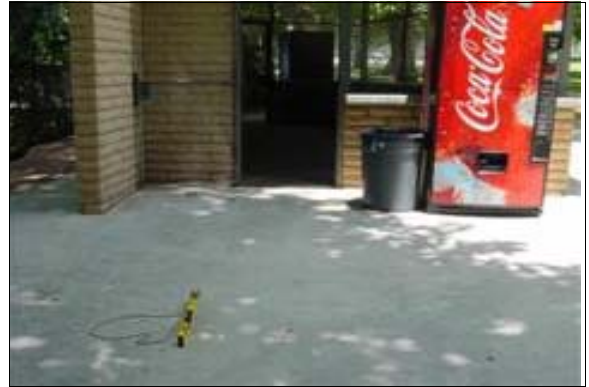
***Path of Travel to the Food Service Building***

**Finding:** There are slopes greater than 5% on the primary path of travel to the Food Service Building.

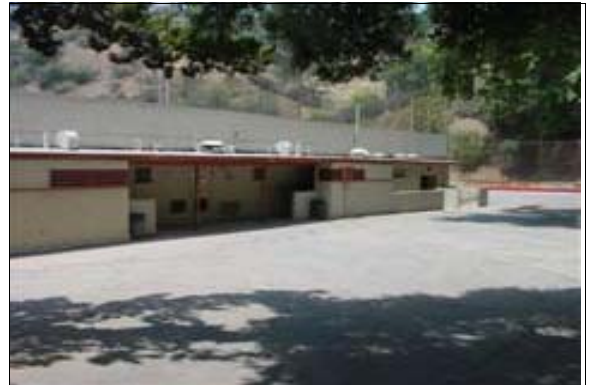
***Path of Travel to the Locker Room and Restrooms at Stengel Field***

**Finding:** There is no crosswalk provided on the path of travel to the locker room and restrooms at Stengel Field. The required accessible route crosses a vehicular way.

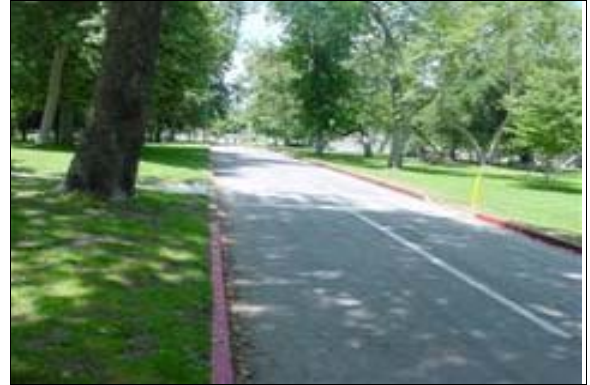
***Path of Travel to the North Restrooms***

**Finding:** There is a crosswalk provided on the path of travel to the north restrooms, the crosswalk does not provide detectable warnings at the entrance and exit of the crosswalk.

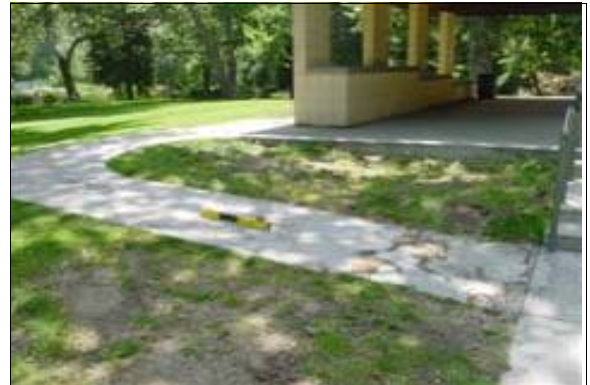
***Path of Travel to the North Restrooms***

**Finding:** There are slopes greater than 5% on the primary path of travel to the north restrooms.

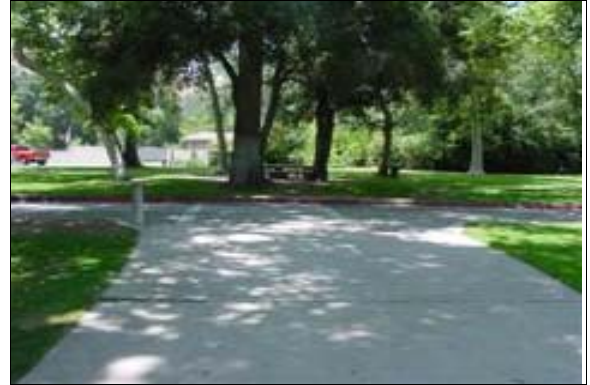
***Path of Travel to the Outdoor Dining Area***

**Finding:** There is a crosswalk provided on the path of travel to the outdoor dining area next to the Maintenance Building, the crosswalk does not provide detectable warnings at the entrance and exit of the crosswalk.

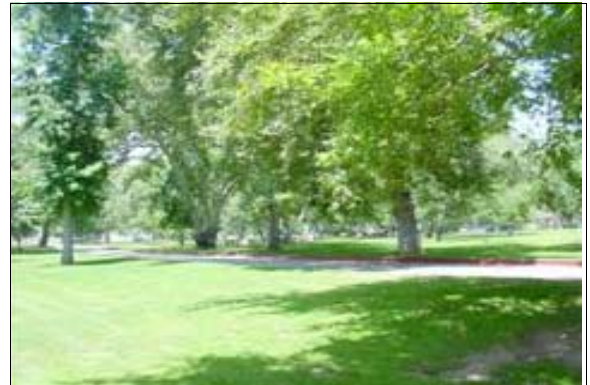
***Path of Travel to the Outdoor Dining Area***

**Finding:** There is no crosswalk provided on the path of travel to the outdoor dining area at the north end of the park. The required accessible route crosses a vehicular way.

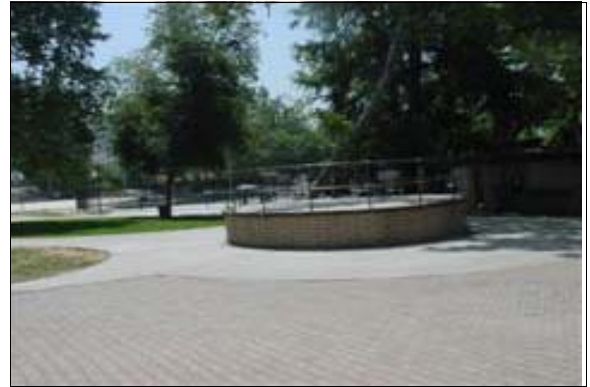
***Path of Travel to the Outdoor Stage***

**Finding:** There are only stairs to the primary functions provided on the stage, preventing access to individuals with mobility impairments.

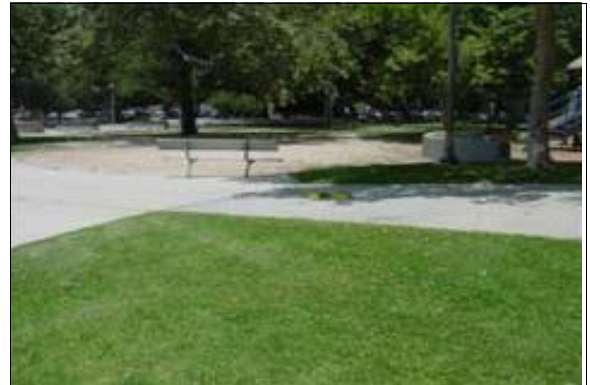
***Path of Travel to the Play Equipment***

**Finding:** There are slopes greater than 5% on the primary path of travel to the play equipment next to the Skate Park.

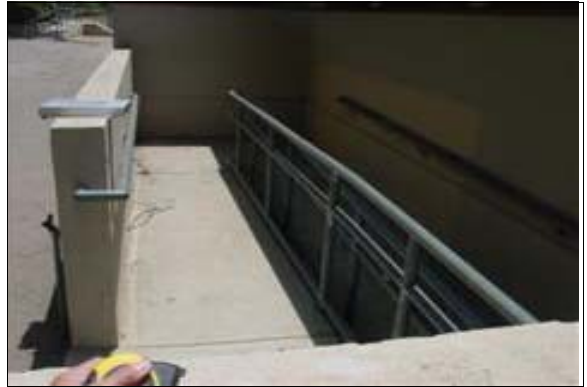
***Path of Travel to the Restrooms at Stengel Field***

**Finding:** The concrete walkway serves as a primary path of travel. The width of the concrete walkway is less than 48 inches in width.

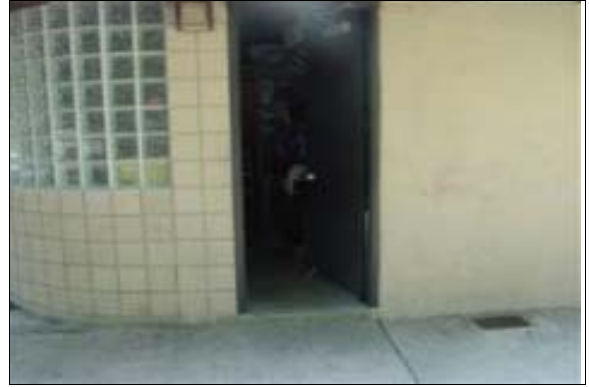
***Path of Travel to the Skate Park Operations Office***

**Finding:** There is a step on the primary path of travel to Skate Park Operations Office, preventing access to individuals with mobility impairments.

**Full Rec:** Since programs, services and activities to staff and the public (volunteers, etc.) are provided in this location, those programs, services and activities are required to be made accessible. It is recommended that a ramp be installed or other means of vertical access.

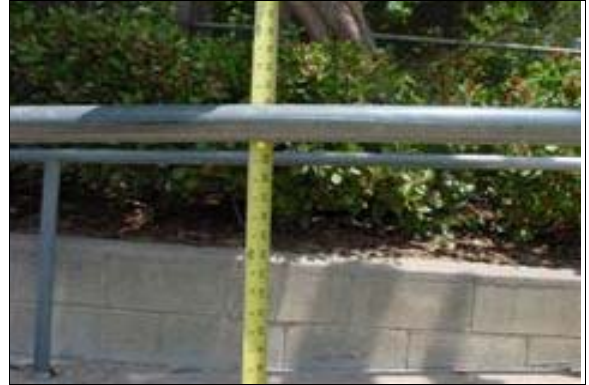
**Exterior Ramp to Stengel Field**

**Finding:** The handrails are mounted at a height less than 34 inches. There are no 12-inch extensions beyond the top and bottom of the ramp.

**Full Rec:** Replace the handrails on each side of the ramp to provide a height between 34 inches and 38 inches. The handrails shall provide 12-inch extensions, extending beyond the top and bottom of the ramp, that are parallel to the ground surface and return smoothly to the post or wall.

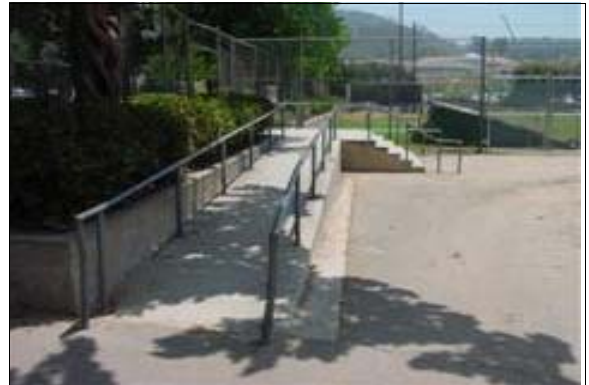
**Exterior Ramp to Stengel Field**

**Finding:** The ramp is not bounded by a wall or fence, thus not providing any edge protection to prevent individuals from slipping off the ramp.

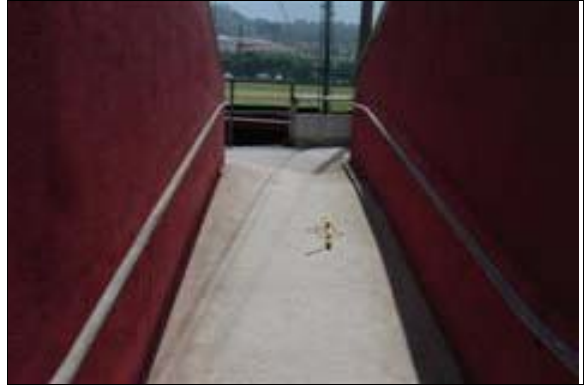
**Exterior Ramp to the Stengel Field Stadium  
(Right)**

**Finding:** The slope of the concrete ramp is greater than 8.33%.

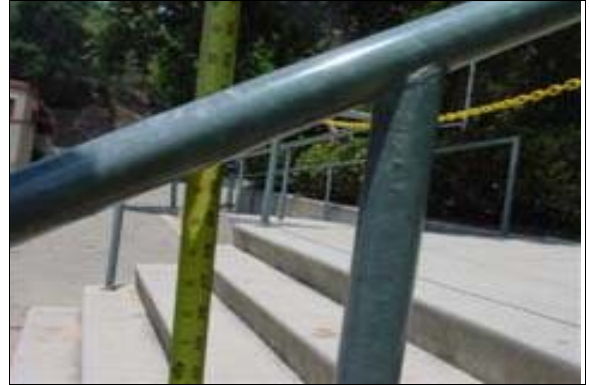
**Exterior Stairs to Stengel Field**

**Finding:** The handrails are mounted at a height less than 34 inches above the nosing of the treads.

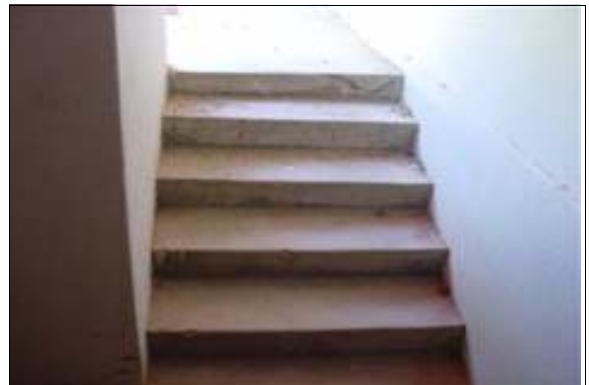
**Exterior Stairs to the Locker Rooms at Stengel Field**

**Finding:** There is no detectable striping on each tread of the exterior stairway.

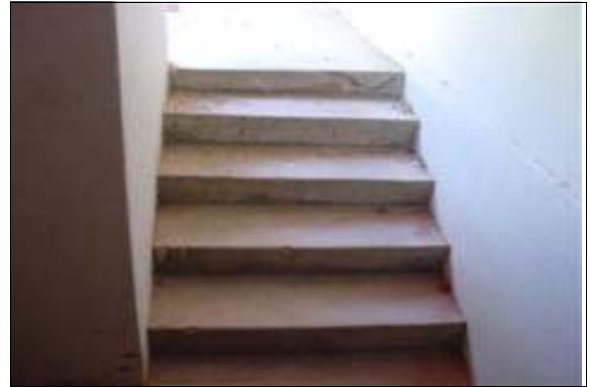
**Exterior Stairs to the Locker Rooms at Stengel Field**

**Finding:** The width of the exterior stairway is less than 48 inches.

**Full Rec:** Install an exterior stairway with a minimum width of 48 inches (see CBC 1006.2).

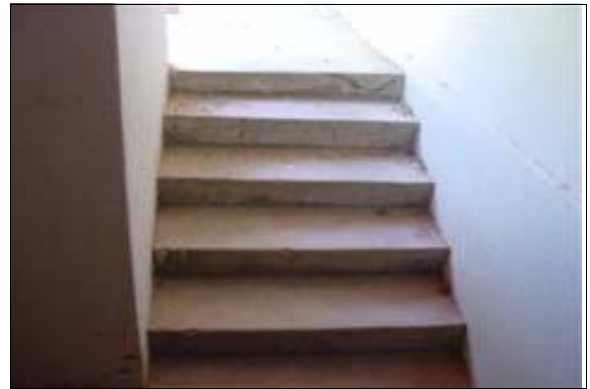
**Exterior Stairs to the Locker Rooms at Stengel Field**

**Finding:** There are no handrails provided on the stairway.

**Full Rec:** Install pipe rail handrails on each side of stairway that provide a gripping surface between 1 1/4 to 1 7/8 inches with 12-inch top and bottom handrail extensions that extend beyond the top and bottom treads of the stairway which are parallel to the floor surface. Handrails shall be mounted at a height between 34 and 38 inches at a distance no less than 1 1/2 inches from the adjacent wall.

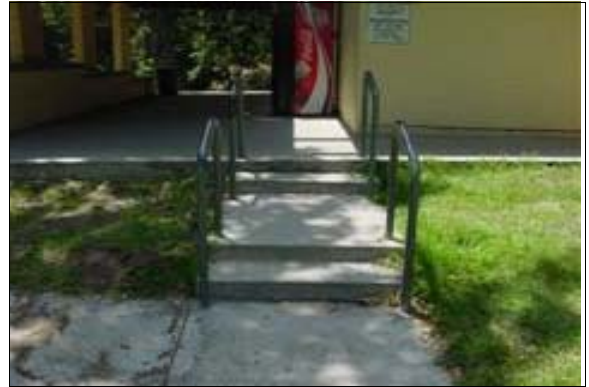
**Exterior Stairs to the North Restrooms**

**Finding:** The handrails do not provide 12-inch extensions beyond the top and bottom treads. The handrails are mounted at a height less than 34 inches.

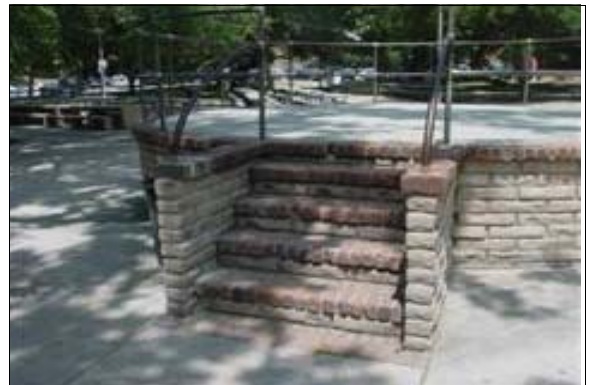
**Exterior Stairs to the Outdoor Stage**

**Finding:** There is no detectable striping on each tread of the exterior stairway.

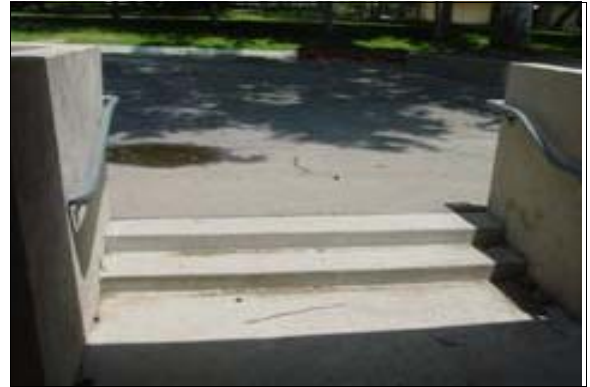
***Exterior Stairs to the Restrooms at Stengel Field***

**Finding:** The width of the stairway is greater than 88 inches.

**Full Rec:** Provide one intermediate handrail for each 88 inches of stairway width. Space intermediate handrails equally across the entire width of the stairway.

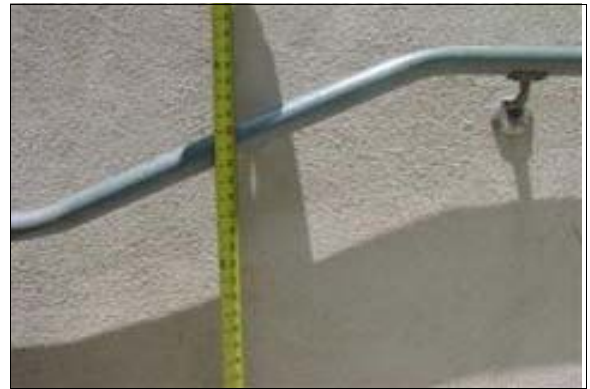
***Exterior Stairs to the Restrooms at Stengel Field***

**Finding:** The handrails are mounted at a height less than 34 inches above the nosing of the treads.

**Full Rec:** Remount the handrails on the stairway so that the gripping surface of the handrails are at a consistent height between 34 inches and 38 inches above the stair nosings.

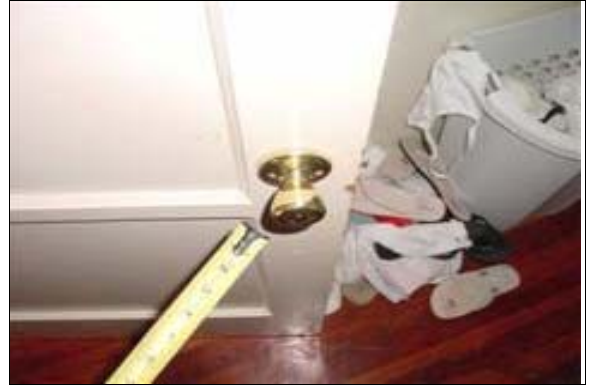
**Caretaker's House**

**Finding:** Interior passage doors have round doorknobs, which require twisting of the wrist to operate.

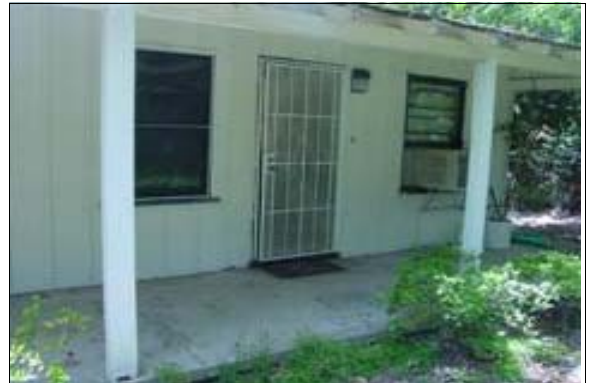
**Caretaker's House**

**Finding:** The exterior passage door has a round doorknob, which requires twisting of the wrist to operate.

**Full Rec:** Replace the existing door hardware with accessible hardware (see ADAAG 4.13.9).

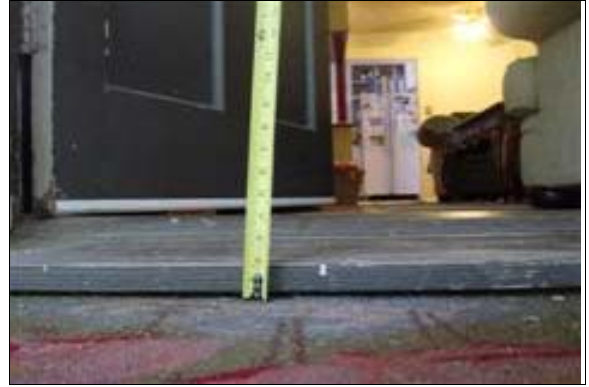
#### ***Caretaker's House***

**Finding:** The height of the threshold at the entrance door is greater than 1/2 inch.

**Full Rec:** Modify or replace the threshold to provide a smooth transition. The threshold should not exceed a beveled 1/2 inch. Provide a 60 inch level landing in the direction of the door swing.

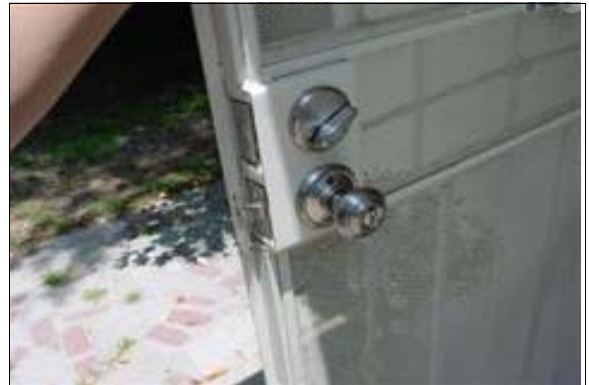
#### ***Caretaker's House (Rear Entrance)***

**Finding:** The exterior passage door has a round doorknob, which requires twisting of the wrist to operate.

**Full Rec:** Replace the existing door hardware with accessible hardware (see ADAAG 4.13.9).

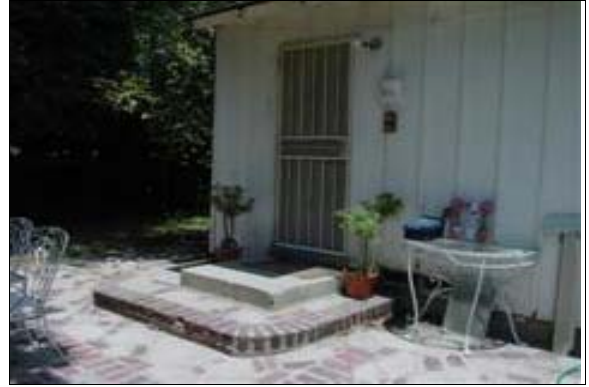
**Caretaker's House (Rear Entrance)**

**Finding:** The clear opening width of the door is less than 32 inches.

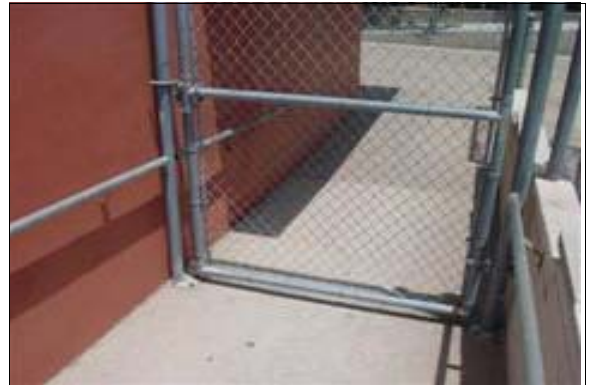
**Entrance Gate to the Stengel Field Stadium (Left)**

**Finding:** There is less than 24 inches of clearance on the latch side of the exterior entrance gate.

**Full Rec:** Consult a design professional to determine if it is technically feasible to provide at least 24 inches of latch side clearance at the entrance door (see ADAAG 4.13.6 and Figure 25). Otherwise, install an automatic door opening device to the primary entrance complying with ADAAG 4.13.12 and ANSI/BHMA A156.10, 1985, standards.

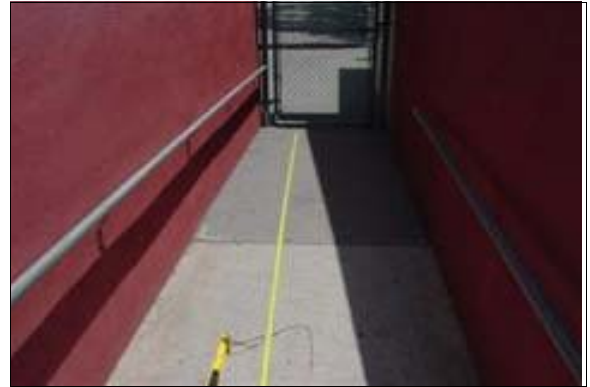
**Entrance Gate to the Stengel Field Stadium (Right)**

**Finding:** There is less than 24 inches of clearance on the latch side of the exterior entrance gate.

**Full Rec:** Consult a design professional to determine if it is technically feasible to provide at least 24 inches of latch side clearance at the entrance door (see ADAAG 4.13.6 and Figure 25). Otherwise, install an automatic door opening device to the primary entrance complying with ADAAG 4.13.12 and ANSI/BHMA A156.10, 1985, standards.

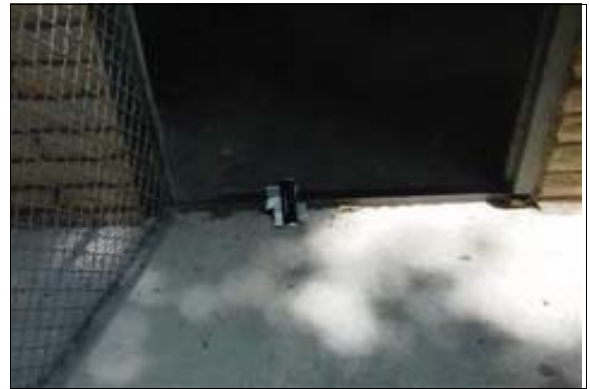
**Food Service Building**

**Finding:** The height of the threshold at the entrance door is greater than 1/2 inch.

**Full Rec:** Modify or replace the threshold to provide a smooth transition. The threshold should not exceed a beveled 1/2 inch. Provide a 60 inch level landing in the direction of the door swing.

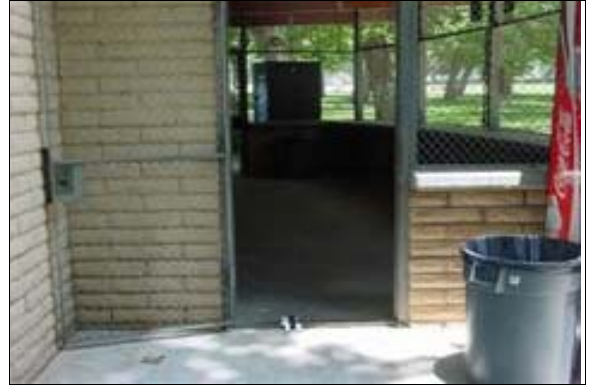
**Food Service Building**

**Finding:** The exterior entrance door does not provide accessible hardware.

**Full Rec:** Replace the existing door hardware with accessible hardware (see ADAAG 4.13.9).

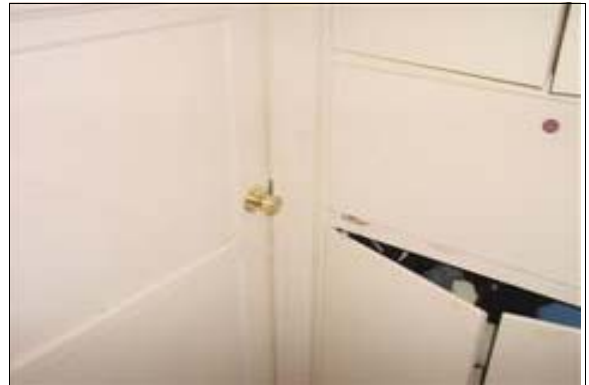
**Interior Doors in the Caretaker's House**

**Finding:** There is less than 18 inches of latch side clearance from the pull side of the interior entrance door.

**Full Rec:** Consult a design professional to determine if it is technically feasible to provide at least 18 inches of latch side clearance at the entrance door from the pull side (see ADAAG 4.13.6 and Figure 25).

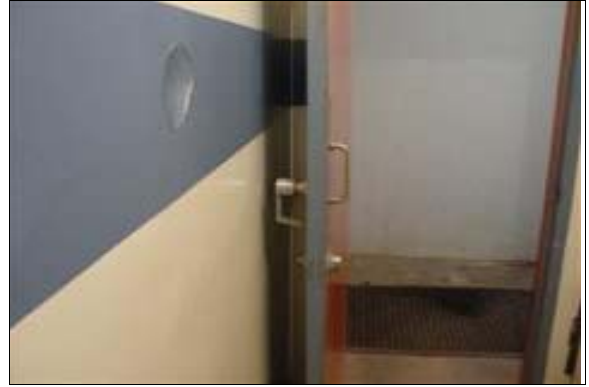
**Finding:** There is less than 18 inches of latch side clearance from the pull side of the interior entrance door.

**Full Rec:** Consult a design professional to determine if it is technically feasible to provide at least 18 inches of latch side clearance at the entrance door from the pull side (see ADAAG 4.13.6 and Figure 25).

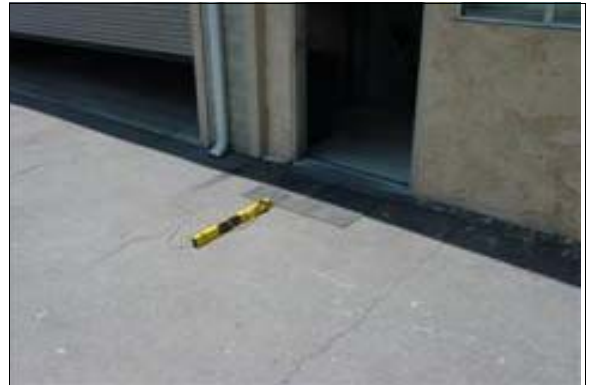
**Finding:** There is no level landing provided at the entrance door.

**Full Rec:** Provide a level and clear landing at least 60 inches in length in the direction of the door swing.

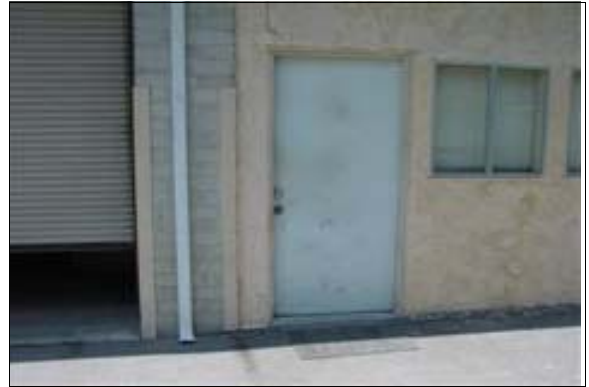
#### **Maintenance Building**

**Finding:** The exterior passage door has a round doorknob, which requires twisting of the wrist to operate.

**Full Rec:** Replace the existing door hardware with accessible hardware (see ADAAG 4.13.9).

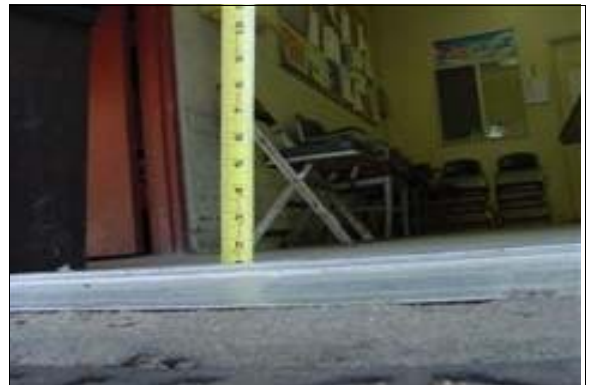
#### **Maintenance Building**

**Finding:** The height of the threshold at the entrance door is greater than 1/2 inch.

**Full Rec:** Modify or replace the threshold to provide a smooth transition. The threshold should not exceed a beveled 1/2 inch. Provide a 60 inch level landing in the direction of the door swing.

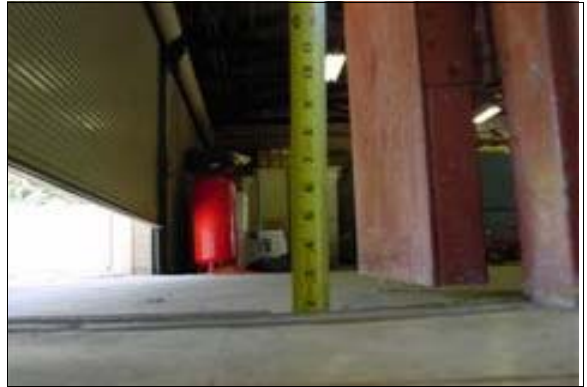
#### **Maintenance Building**

**Finding:** The height of the threshold at the entrance door to the garage in the Maintenance Building is greater than 1/2 inch.

**Full Rec:** Modify or replace the threshold to provide a smooth transition. The threshold should not exceed a beveled 1/2 inch. Provide a 60 inch level landing in the direction of the door swing.

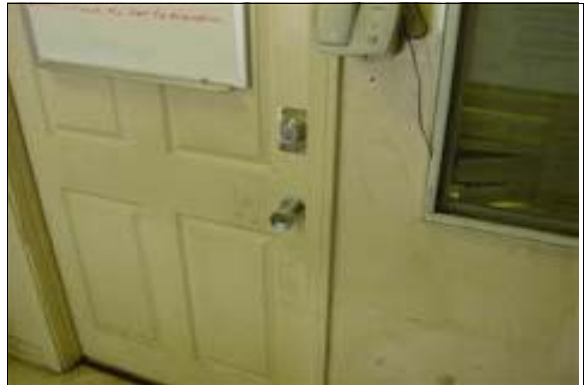
#### **Maintenance Building**

**Finding:** Interior passage doors have round doorknobs, which require twisting of the wrist to operate.

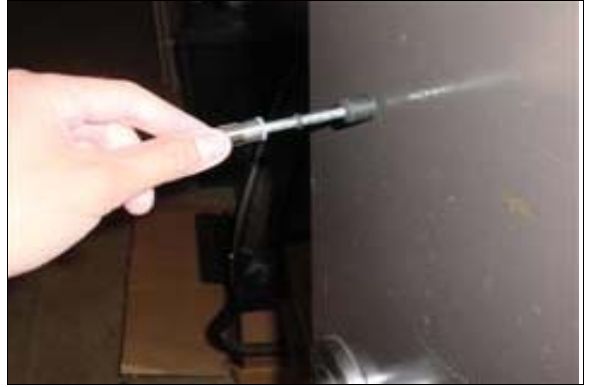
#### **Skate Park Operations Office**

**Finding:** The door opening force for the exterior door is greater than 5 pounds of force.

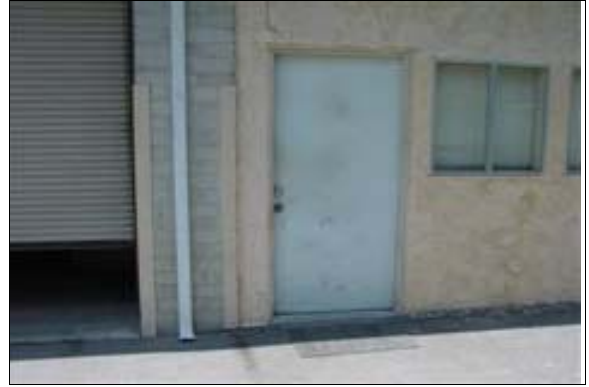
**Maintenance Building**

**Finding:** The main entrance does not have accessible signage mounted on the wall adjacent to the latch side of the door.

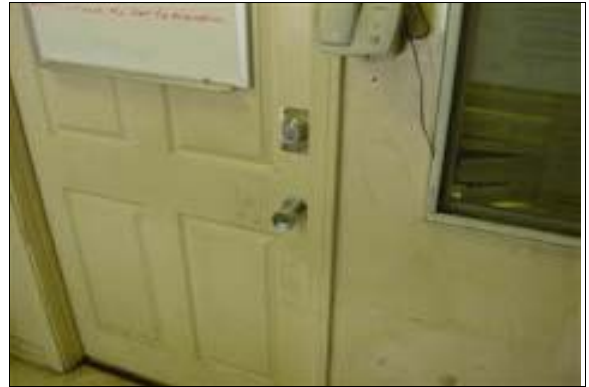
**Room Signage**

**Finding:** Rooms do not have accessible signage mounted on the wall adjacent to the latch side of the doors.

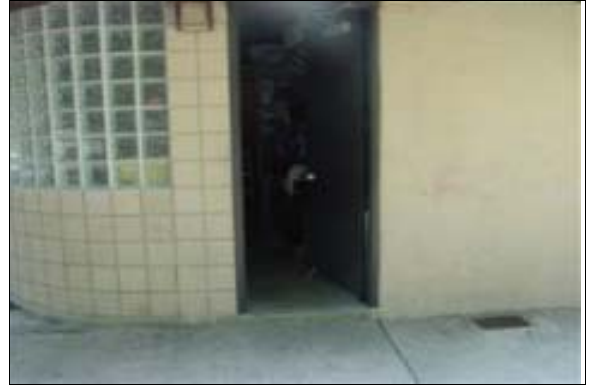
**Skate Park Operations Office**

**Finding:** There is no signage with the International Symbol of Accessibility on the entrance door to the facility designating it as accessible.

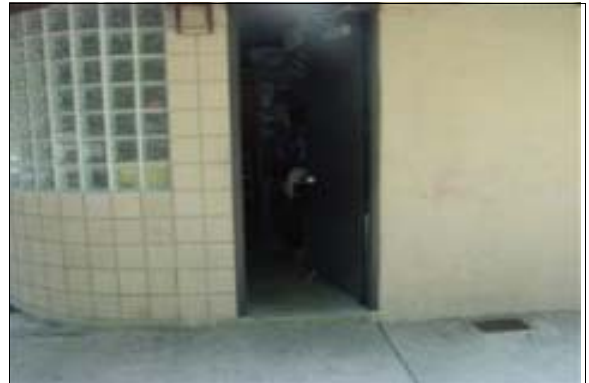
**Skate Park Operations Office**

**Finding:** The main entrance does not have accessible signage mounted on the wall adjacent to the latch side of the door.

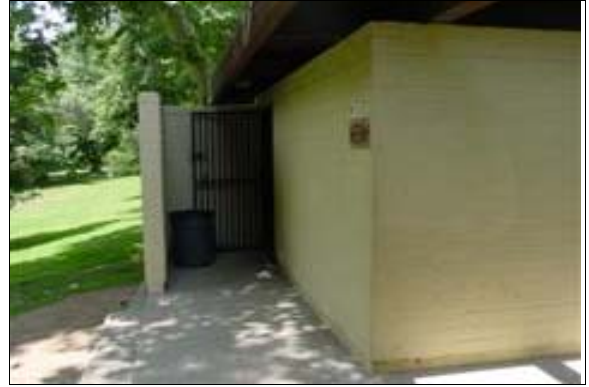
**Men's North Restrooms**

**Finding:** There is no signage indicating accessibility on the latch side of the entry door of the restroom. There is no Title 24 gender use signage on the entrance door.

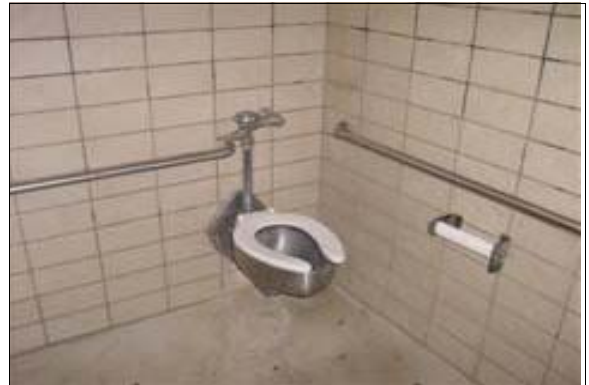
**Men's North Restrooms**

**Finding:** There is no door on the stall designated to be accessible in the restroom.

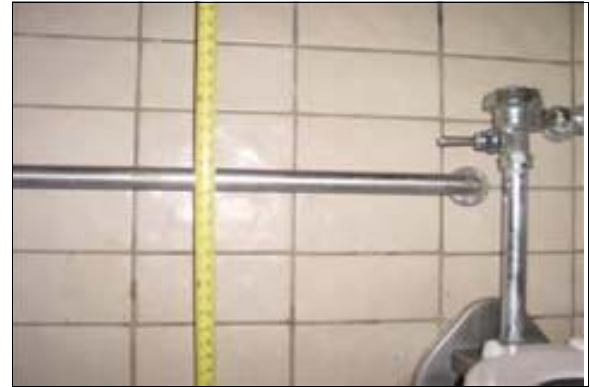
**Men's North Restrooms**

**Finding:** The height of the back grab bar in the stall designated to be accessible of the restroom is less than 33 inches above the finished floor. The height of the side grab bar in the stall designated to be accessible of the restroom is greater than 33 inches above the finished floor.

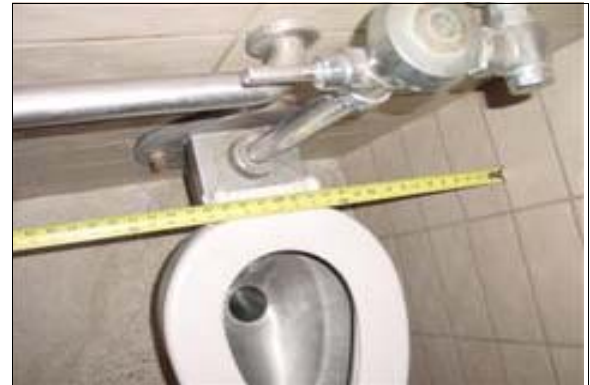
**Men's North Restrooms**

**Finding:** The distance from the center of the toilet to the nearest side wall in the stall designated to be accessible in the restroom is less than 18 inches.

**Full Rec:** Relocate the toilet or stall side wall so that the distance from the centerline of the toilet to the nearest side wall in the stall designated to be accessible in the restroom is exactly 18 inches (see ADAAG Figure 28).

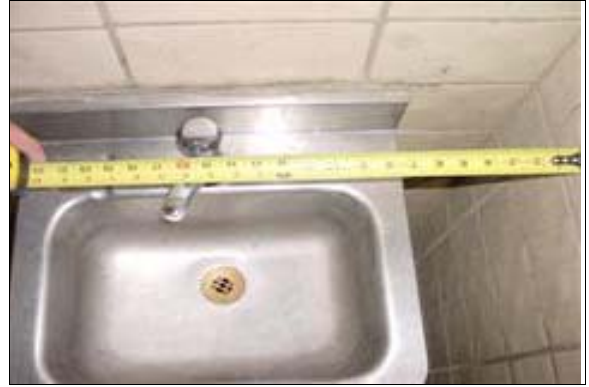
**Men's North Restrooms**

**Finding:** The distance from the center of the lavatory to the adjacent side wall in the restroom is less than 18 inches.

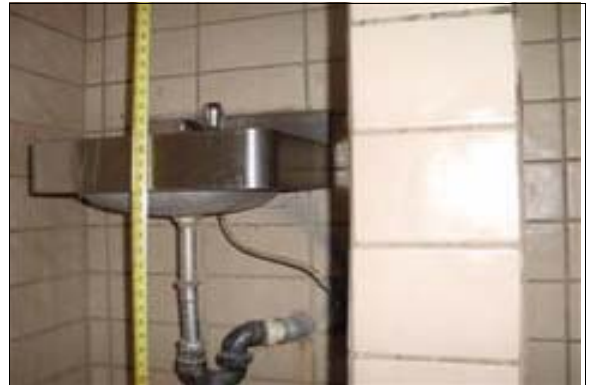
**Men's North Restrooms**

**Finding:** The pipes under the lavatory in the restroom do not provide protection against contact.

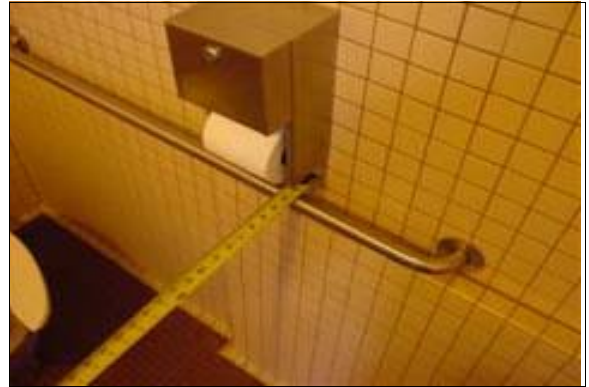
#### **Men's Restroom at Stengel Field**

**Finding:** The toilet paper dispenser in the stall designated to be accessible in the restroom interferes with the use of the side grab bar.

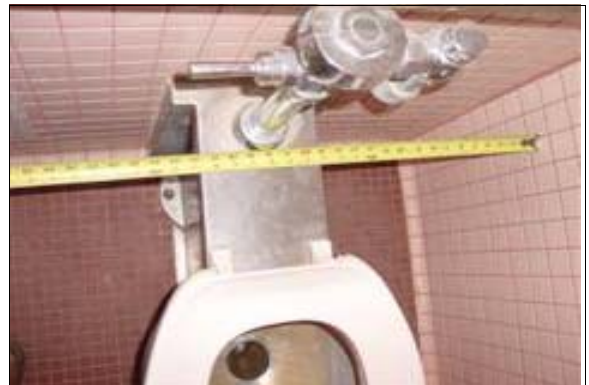
#### **Men's Restroom at Stengel Field**

**Finding:** The distance from the center of the toilet to the nearest side wall in the stall designated to be accessible in the restroom is greater than 18 inches.

**Full Rec:** Relocate the toilet or stall side wall so that the distance from the centerline of the toilet to the nearest side wall in the stall designated to be accessible in the restroom is exactly 18 inches (see ADAAG Figure 28).

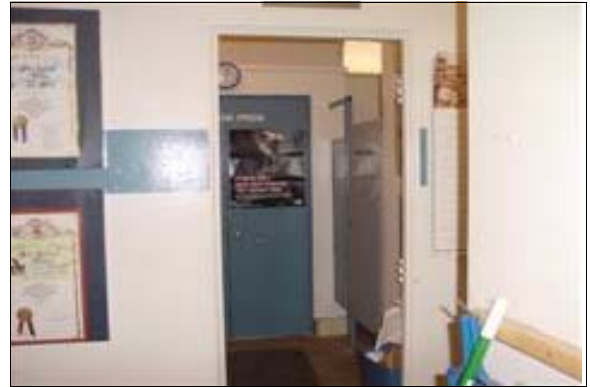
**Men's Restroom in the High School Locker Room at Stengel Field**

**Finding:** There is no signage indicating accessibility on the latch side of the entry door of the restroom. There is no Title 24 gender use signage on the entrance door.

**Full Rec:** The restroom is designated accessible and should be made accessible for the facility. Post signage centered 60 inches above the ground surface on the latch side of the entrance door identifying the restroom as accessible upon completion of the following items (see CBC 1115B., ADAAG 4.1.2(7) and ADAAG 4.1.6(3)(e)). Signage shall include Braille and raised lettering, the gender or unisex use symbol and the ISA symbol. Post Title 24 gender use signage on the door @ 60" o.c. a.f.f.

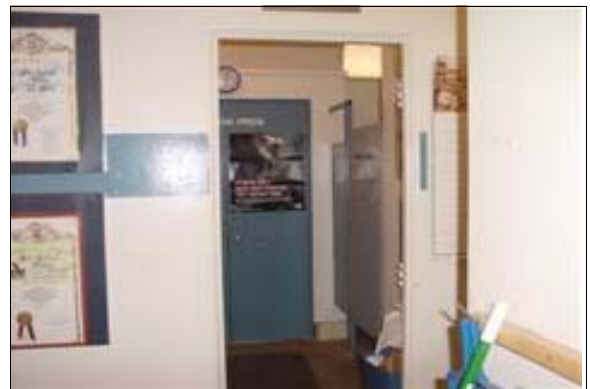
**Men's Restroom in the High School Locker Room at Stengel Field**

**Finding:** The clear opening width of the entrance doorway to the restroom is less than 32 inches.

**Full Rec:** Widen the entrance doorway to the restroom to provide a clear opening width of at least 32 inches when the door is open 90 degrees (see ADAAG 4.13.5).

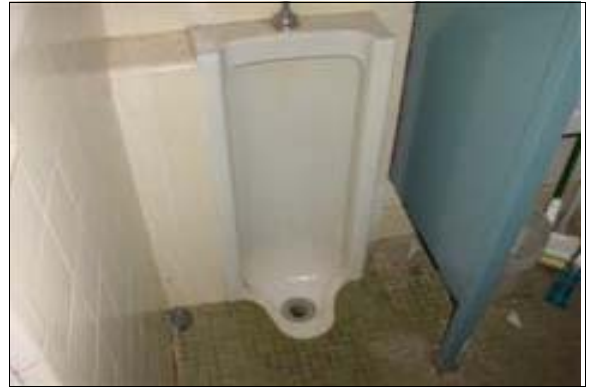
**Men's Restroom in the High School Locker Room at Stengel Field**

**Finding:** The urinal in the restroom is floor mounted and does not provide a tapered, elongated rim. The flush control valve on the urinal is greater than 44 inches above the finished floor.

**Full Rec:** Replace the urinal designated to be accessible in the restroom with a wall-mounted or stall-type tapered, elongated rim unit complying with ADAAG 4.18.2. The height of the rim surface of the urinal designated to be accessible shall not exceed 17 inches above the finished floor and the flush control valve shall not exceed a height of 44 inches above the finished floor.

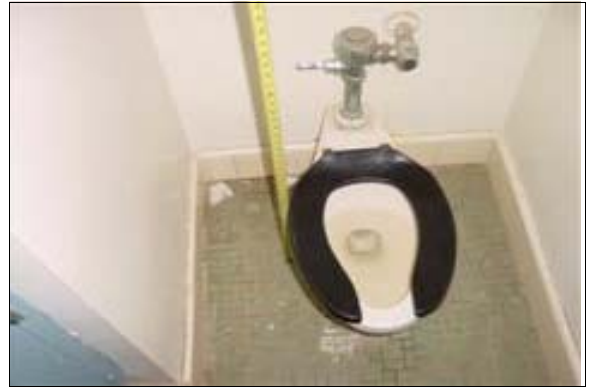
**Men's Restroom in the High School Locker Room at Stengel Field**

**Finding:** The height of the toilet seat in the stall designated to be accessible in the restroom is less than 17 inches above the finished floor.

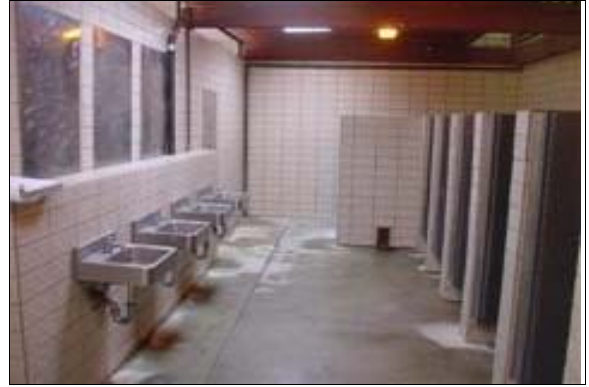
**Men's South Restroom**

**Finding:** There are six stalls located in the multiple accommodation restroom.

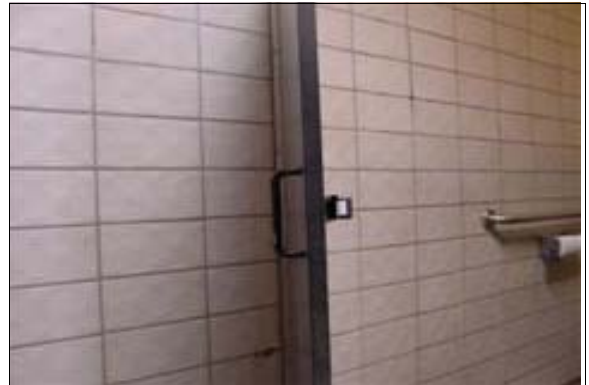
**Men's South Restroom**

**Finding:** The door in the stall designated to be accessible in the restroom does not have appropriate accessible hardware.

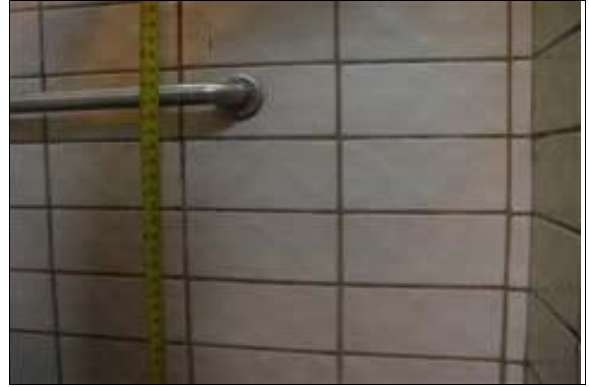
**Men's South Restroom**

**Finding:** The height of the back grab bar in the stall designated to be accessible of the restroom is greater than 33 inches above the finished floor.

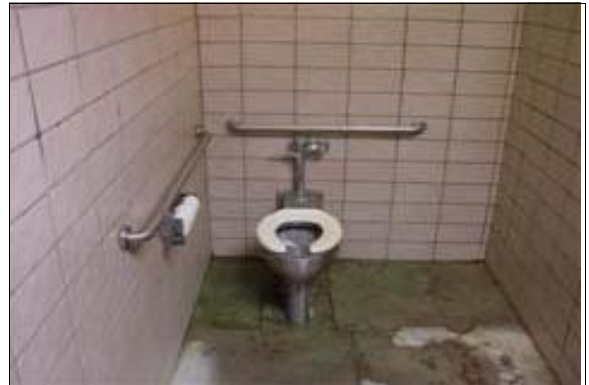
**Men's South Restroom**

**Finding:** The flush control on the toilet in the stall designated to be accessible in the restroom is not on the wide (approach) side of the toilet.

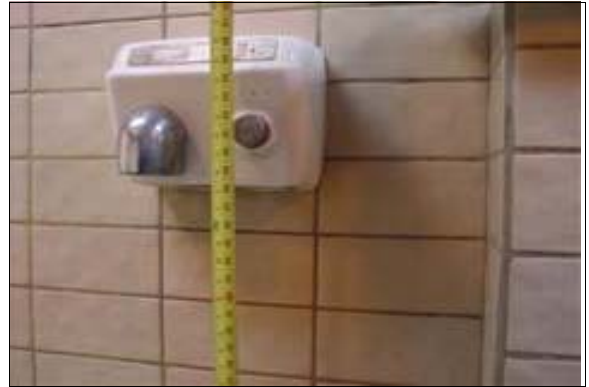
**Men's South Restroom**

**Finding:** The height of the controls and operating mechanisms for the hand dryer in the restroom is greater than 40 inches in height.

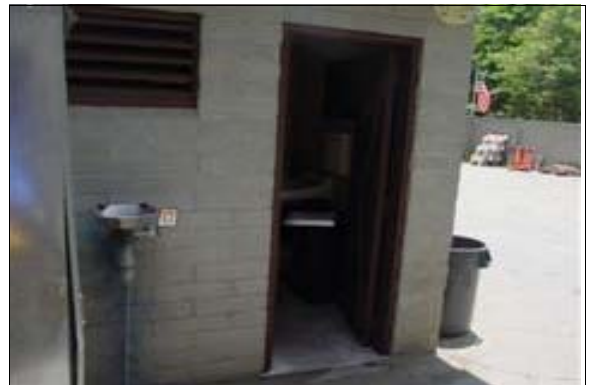
**Unisex Restroom at the Maintenance Building**

**Finding:** There is no signage indicating accessibility on the latch side of the entry door of the restroom. There is no Title 24 gender use signage on the entrance door.

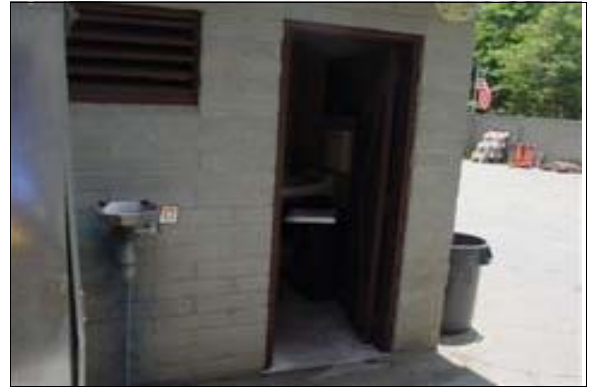
***Unisex Restroom at the Maintenance Building***

**Finding:** The clear opening width of the entrance doorway to the restroom is less than 32 inches.

**Full Rec:** Widen the entrance doorway to the restroom to provide a clear opening width of at least 32 inches when the door is open 90 degrees (see ADAAG 4.13.5).

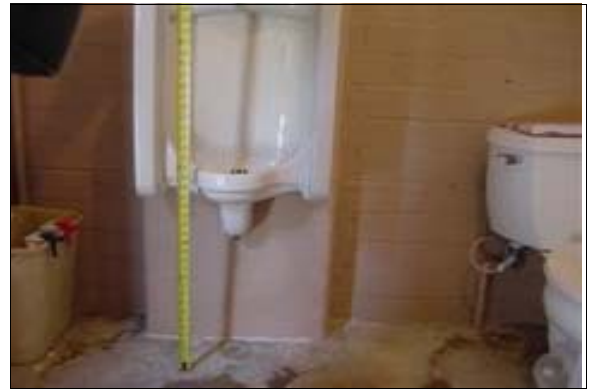
***Unisex Restroom at the Maintenance Building***

**Finding:** The height of the urinal rim in the restroom is greater than 17 inches above the finished floor.

**Full Rec:** Lower the urinal designated to be accessible in the restroom so that the rim height is not more than 17 inches above the finished floor.

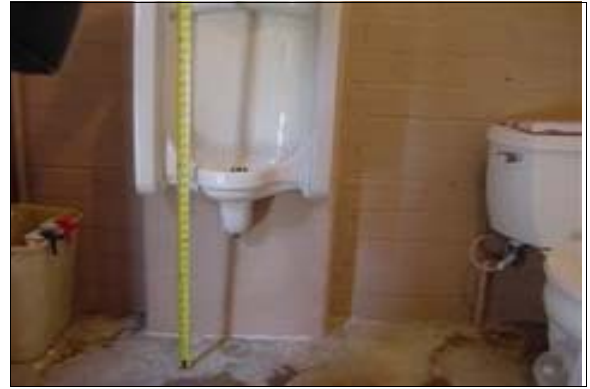
***Unisex Restroom at the Maintenance Building***

**Finding:** The height of the urinal flush control in the restroom is greater than 44 inches above the finished floor.

**Full Rec:** Lower the flush control valve on the urinal designated to be accessible in the restroom to a height not greater than 44 inches above the finished floor (see ADAAG 4.18.4).

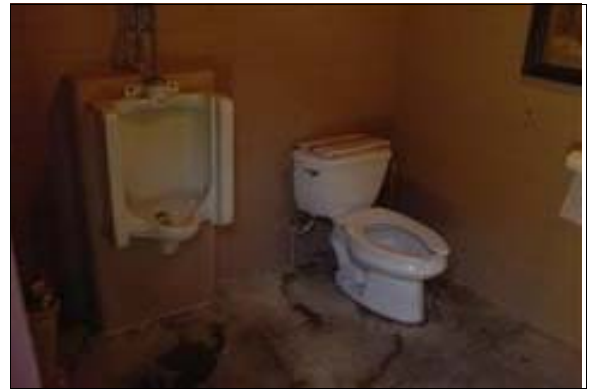
***Unisex Restroom at the Maintenance Building***

**Finding:** There are no grab bars in the restroom.

**Full Rec:** Install one 36-inch back grab bar and one 42/48-inch side grab bar in the restroom. Grab bars shall be mounted at a height of 33 inches above the finished floor. Grab bars must be able to support a point load of at least 250 pounds and shall be less than the allowable shear stress of the grab bar material.

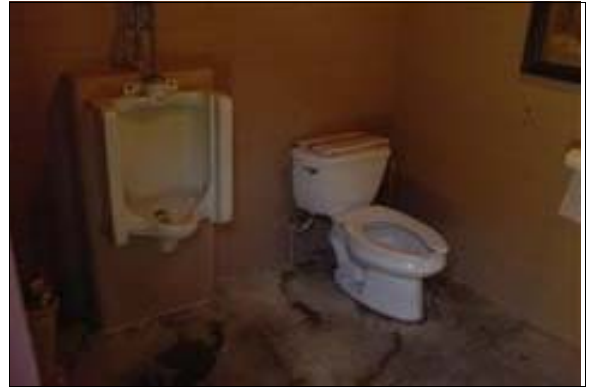
**Unisex Restroom at the Maintenance Building**

**Finding:** The height of the toilet seat in the restroom is less than 17 inches above the finished floor.

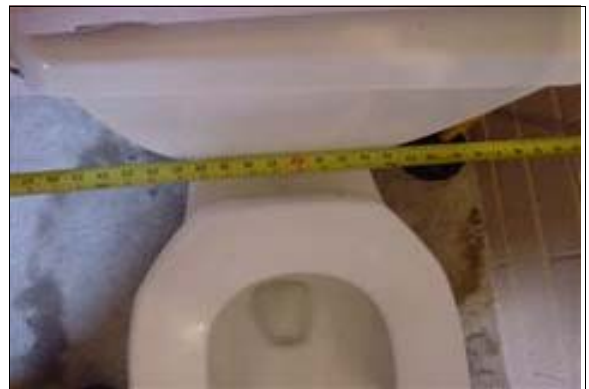
**Unisex Restroom at the Maintenance Building**

**Finding:** The distance from the center of the toilet to the nearest side wall in the restroom is less than 18 inches.

**Full Rec:** Relocate the toilet so that the distance from the centerline of the toilet to the nearest side wall in the restroom is exactly 18 inches (see ADAAG Figure 28).

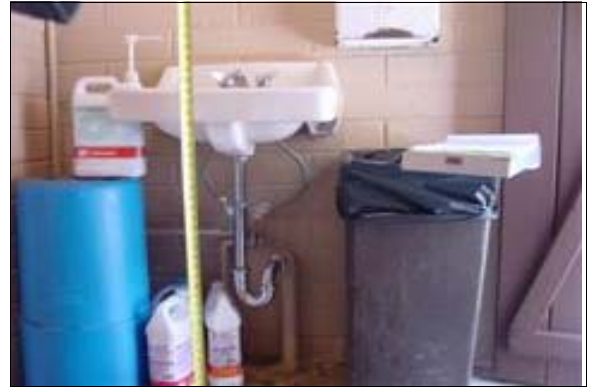
**Unisex Restroom at the Maintenance Building**

**Finding:** The pipes under the lavatory in the restroom do not provide protection against contact.

**Full Rec:** Insulate or otherwise configure pipes under the lavatory designated to be accessible in the restroom to protect against contact (see ADAAG 4.19.4). Make certain there are no sharp or abrasive surfaces under the lavatory.
