**Photo Report**

**Verdugo Park**

**Finding:** The Verdugo Park, located 1621 Canada Boulevard in Glendale California, was inspected by Disability Access Consultants, Inc., on June 5, 2007. Facilities include the Verdugo Park Skate Park Operations Office, Caretaker's House, Food Service Building, Maintenance Building, North and South restrooms, Stengel Field, and the Stengel Field Stadium.

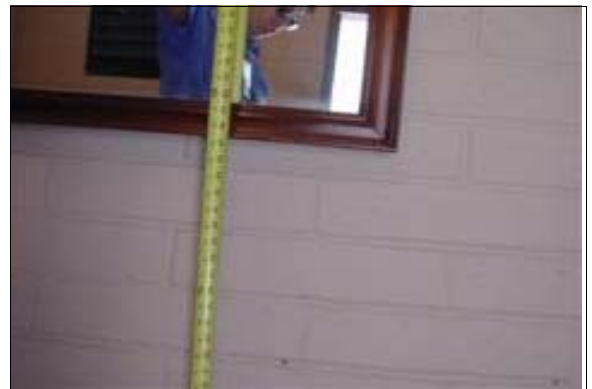
**Unisex Restroom at the Maintenance Building**

**Finding:** The bottom edge of the reflecting surface of the mirror in the restroom is greater than 40 inches above the finished floor.

**Full Rec:** Lower the mirror in the restroom so that the bottom edge of the reflecting surface is no higher than 40 inches above the finished floor and the topmost portion of the reflecting surface extends at least 74 inches above the finished floor (see ADAAG A4.19.6). A single, full-length mirror is recommended since it can accommodate all people. Make certain to provide a minimum clear floor space in front of the mirror of 30 inches in width and 48 inches in length.

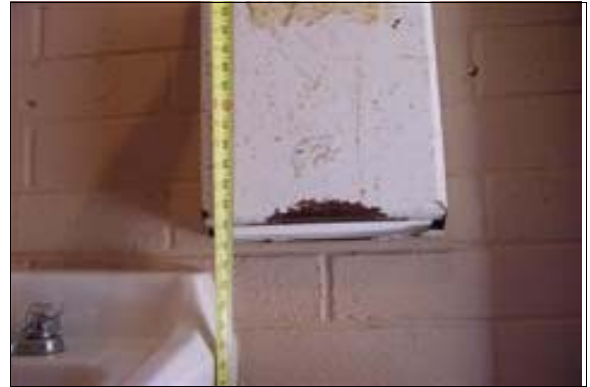
**Unisex Restroom at the Maintenance Building**

**Finding:** The height of the controls and operating mechanisms for the paper towel dispenser in the restroom is greater than 40 inches.

**Full Rec:** Relocate the paper towel dispenser in the restroom to a maximum height of 40 inches for all the controls and operating mechanisms (see CBC 1115B.9.2).

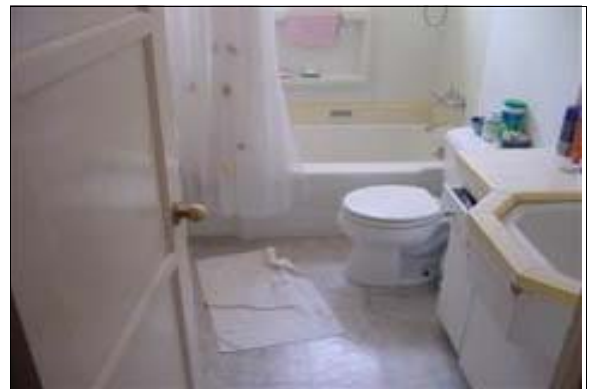
**Unisex Restroom in the Caretaker's House**

**Finding:** There is no signage indicating accessibility on the latch side of the entry door of the restroom. There is no Title 24 gender use signage on the entrance door.

**Full Rec:** The restroom is designated accessible and should be made accessible for the facility. Post signage centered 60 inches above the ground surface on the latch side of the entrance door identifying the restroom as accessible upon completion of the following items (see CBC 1115B., ADAAG 4.1.2(7) and ADAAG 4.1.6(3)(e). Signage shall include Braille and raised lettering, the gender or unisex use symbol and the ISA symbol. Post Title 24 gender use signage on the door @ 60" o.c. a.f.f.

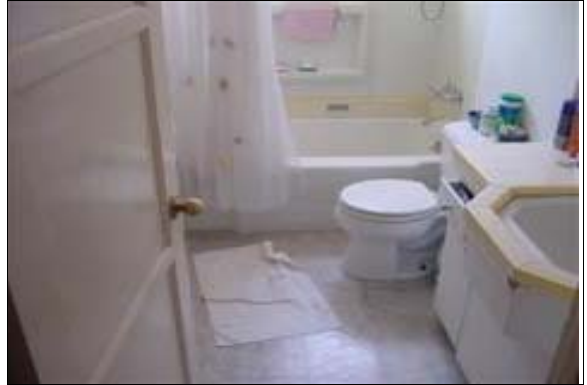
***Unisex Restroom in the Caretaker's House***

**Finding:** The clear opening width of the entrance doorway to the restroom is less than 32 inches.

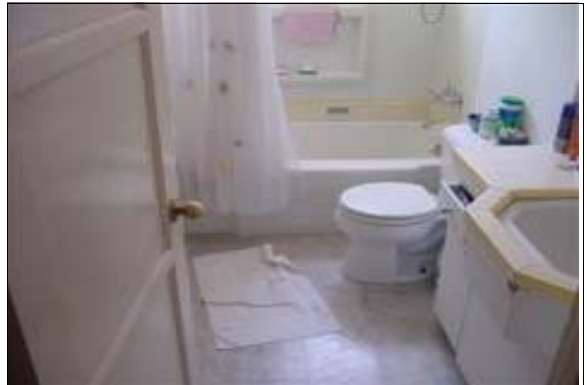
***Unisex Restroom in the Caretaker's House***

**Finding:** The entrance door to the restroom has a round doorknob that requires tight grasping or twisting of the wrist to operate.

**Full Rec:** Replace the door hardware mounted on the restroom complying with ADAAG 4.13.9. Make certain accessible door hardware is mounted no higher than 48 inches above the finished floor.

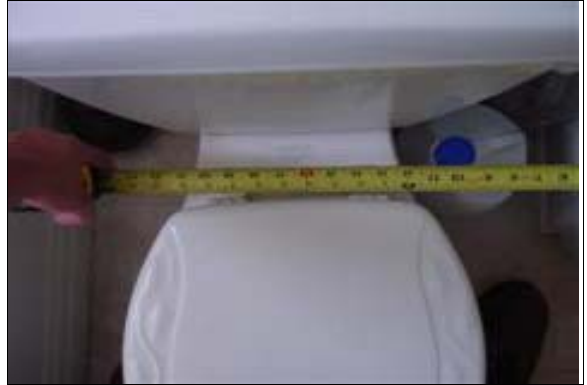
**Unisex Restroom in the Caretaker's House**

**Finding:** The distance from the center of the toilet to the nearest side wall in the restroom is less than 18 inches.

**Full Rec:** Relocate the toilet so that the distance from the centerline of the toilet to the nearest side wall in the restroom is exactly 18 inches (see ADAAG Figure 28).

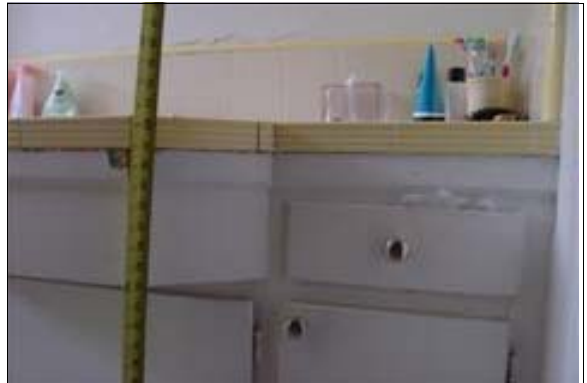
**Unisex Restroom in the Caretaker's House**

**Finding:** The lavatory in the restroom is in an enclosed cabinet, thereby preventing an accessible forward approach.

**Full Rec:** Lavatories in restrooms must provide clear floor space in front of the lavatory for an accessible forward approach and shall provide at least 29 inches clear knee space and a minimum of nine inches clear toe space (see ADAAG 4.19.2). If neither clear floor space and knee and toe clearance can be provided, remove the lavatory cabinet and replace with an accessible wall-mounted lavatory unit.

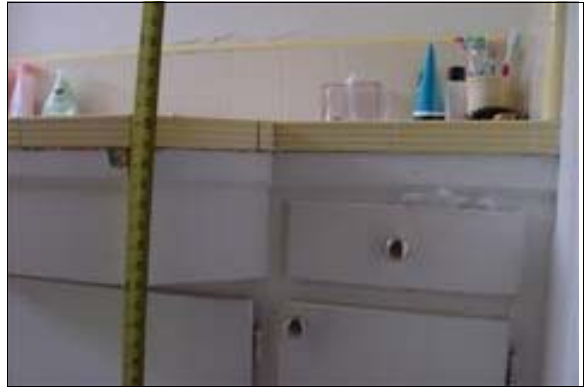
**Unisex Restroom in the Caretaker's House**

**Finding:** The faucet controls on the lavatory in the restroom require tight grasping, pinching, or twisting of the wrist and are not accessible.

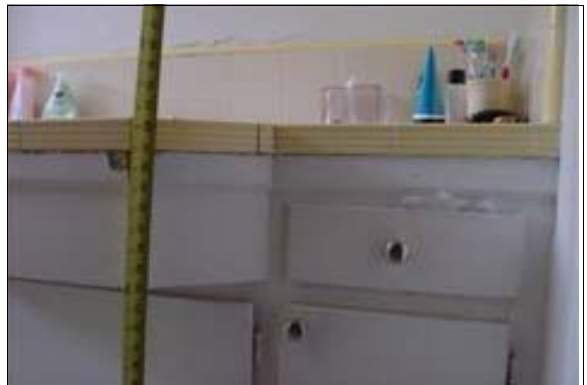
**Unisex Restroom in the Caretaker's House**

**Finding:** The pipes under the lavatory in the restroom do not provide protection against contact.

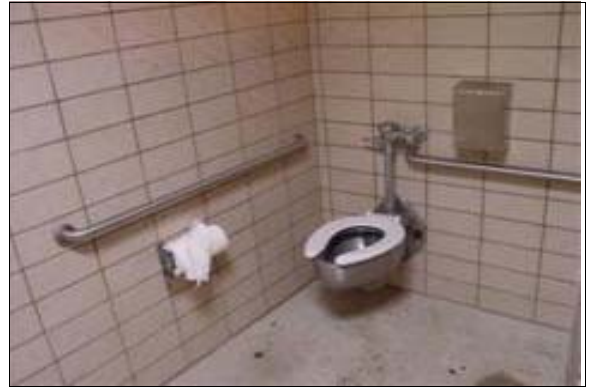
**Women's North Restrooms**

**Finding:** The distance from the end of the back grab bar to the nearest side wall in the stall designated to be accessible of the restroom is greater than 6 inches.

**Full Rec:** Remount the back grab bar in the stall designated to be accessible in the restroom so that it is not more than 6 inches from the nearest side wall (see ADAAG 4.26 and CBC Figure 11B.1A-1C). Grab bars must be able to support a point load of at least 250 pounds and shall be less than the allowable shear stress of the grab bar material.

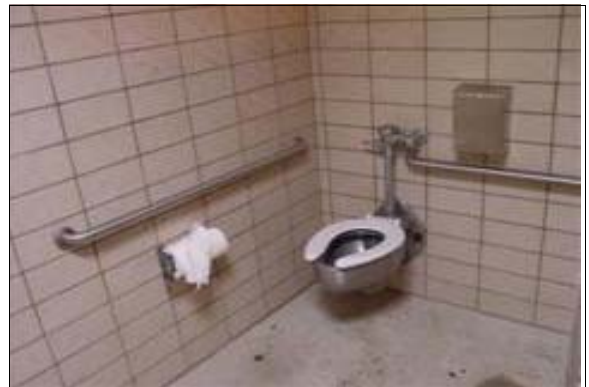
**Women's North Restrooms**

**Finding:** The side grab bar in the stall designated to be accessible in the restroom does not extend 54 inches from the back wall.

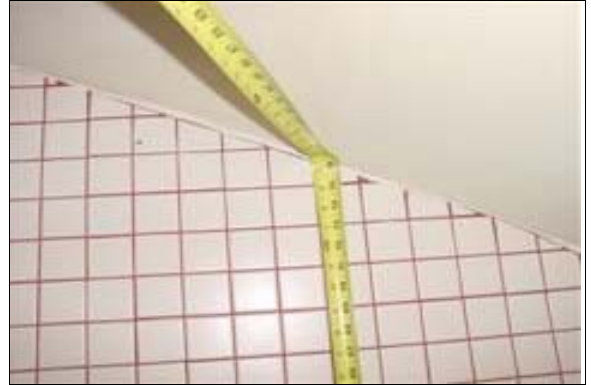
#### **Women's Restroom at Stengel Field**

**Finding:** The vertical headroom clearance above the water closet is less than 80 inches in height.

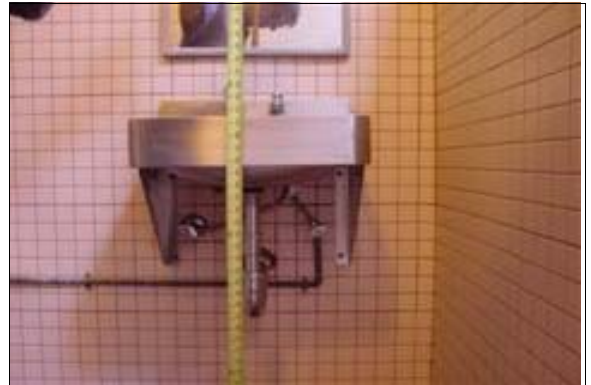
#### **Women's Restroom at Stengel Field**

**Finding:** The pipes under the lavatory in the restroom do not provide protection against contact.

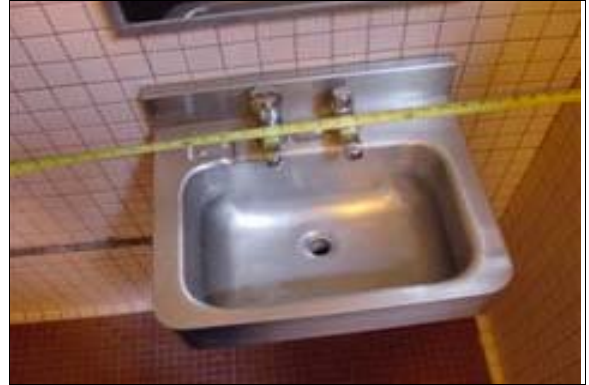
**Women's Restroom at Stengel Field**

**Finding:** The distance from the center of the lavatory to the adjacent side wall in the restroom is less than 18 inches.

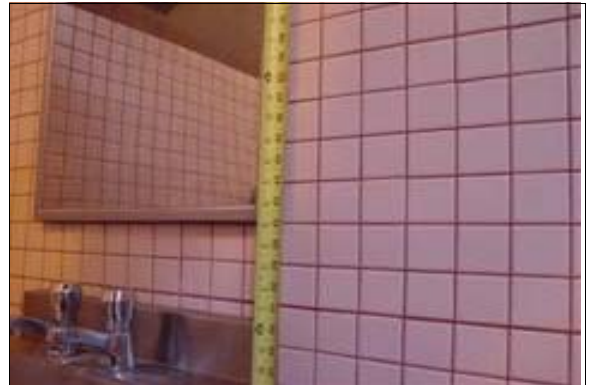
**Women's Restroom at Stengel Field**

**Finding:** The bottom edge of the reflecting surface of the mirror in the restroom is greater than 40 inches above the finished floor.

**Full Rec:** Lower the mirror in the restroom so that the bottom edge of the reflecting surface is no higher than 40 inches above the finished floor and the topmost portion of the reflecting surface extends at least 74 inches above the finished floor (see ADAAG A4.19.6). A single, full-length mirror is recommended since it can accommodate all people. Make certain to provide a minimum clear floor space in front of the mirror of 30 inches in width and 48 inches in length.

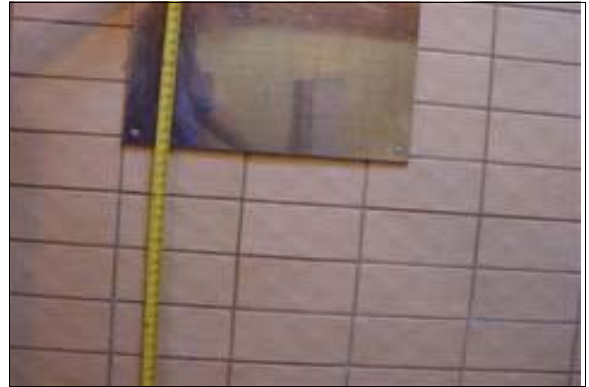
**Women's South Restroom**

**Finding:** The bottom edge of the reflecting surface of the mirror in the restroom is greater than 40 inches above the finished floor.

**Full Rec:** Lower the mirror in the restroom so that the bottom edge of the reflecting surface is no higher than 40 inches above the finished floor and the topmost portion of the reflecting surface extends at least 74 inches above the finished floor (see ADAAG A4.19.6). A single, full-length mirror is recommended since it can accommodate all people. Make certain to provide a minimum clear floor space in front of the mirror of 30 inches in width and 48 inches in length.

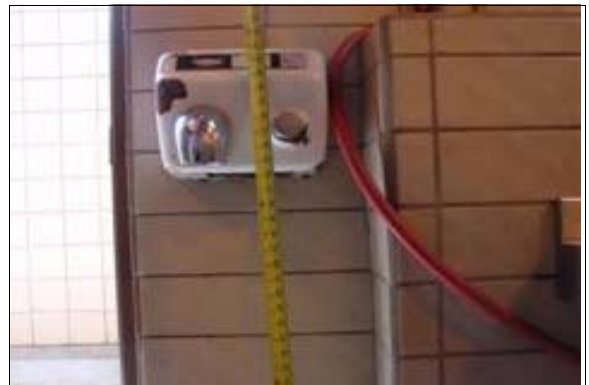
**Women's South Restroom**

**Finding:** The height of the controls and operating mechanisms for the hand dryer in the restroom is greater than 40 inches in height.

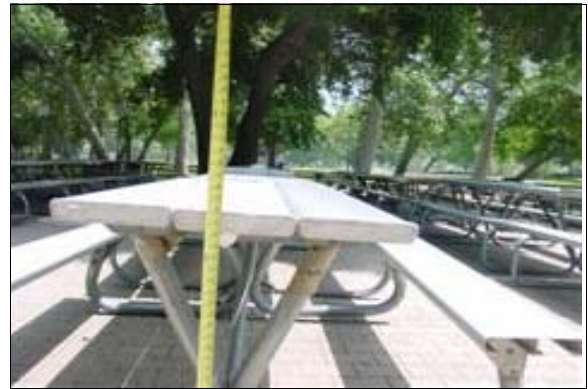
**Outdoor Dining Area Next to the Food Service Building**

**Finding:** The knee space at the tables in the outdoor dining area is less than 27 inches high and 19 inches deep.

**Full Rec:** Modify or replace one of the tables in the outdoor dining area to provide knee clearance of at least 27 inches in height, 30 inches in width and 19 inches in depth (see CBC 1122B.3, ADAAG 4.32.2 and ADAAG Figure 45). The table top height shall not exceed 34 inches above the finished floor.

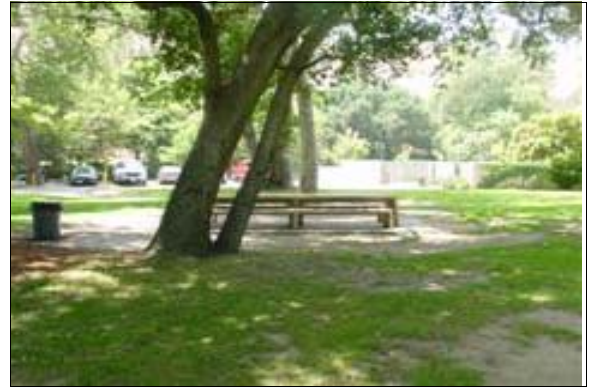
**Outdoor Dining Area Next to the Maintenance Building**

**Finding:** The knee space at the tables in the outdoor dining area is less than 19 inches deep.

**Full Rec:** Modify or replace one of the tables in the outdoor dining area to provide knee clearance of at least 27 inches in height, 30 inches in width and 19 inches in depth (see CBC 1122B.3, ADAAG 4.32.2 and ADAAG Figure 45). The table top height shall not exceed 34 inches above the finished floor.

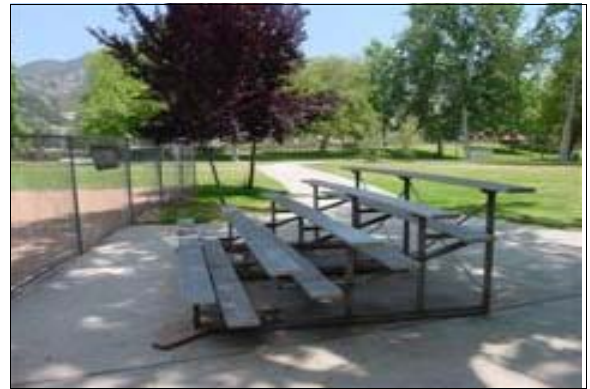
**Baseball Field**

**Finding:** The surface under the bleachers is concrete. No wheelchair seating is provided next to the bleachers.

**Full Rec:** Provide accessible wheelchair seating areas adjacent to the bleachers with equivalent line of sight as provided to members of the general public, if technically feasible; otherwise provide accessible wheelchair seating areas adjacent to the bleachers where unobstructed sight lines can be provided (see CBC 1104B.4 and ADAAG 4.33.3). The wheelchair seating area should be outlined, and have the International Symbol of Accessibility to reserve it for wheelchair users.

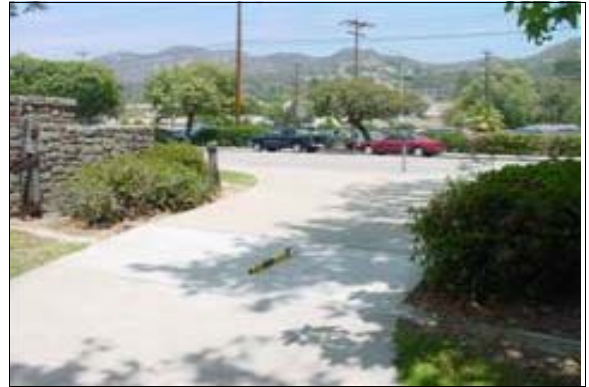
**Baseball Field**

**Finding:** There are slopes greater than 6.33% along the path of travel to the baseball field.

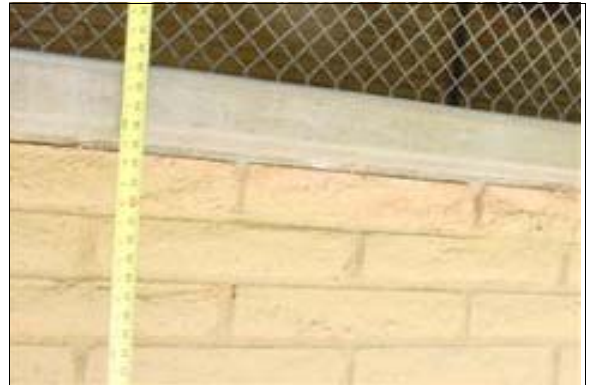
**Food Service Building**

**Finding:** The height of the concession counter at the Food Service Building is greater than 36 inches.

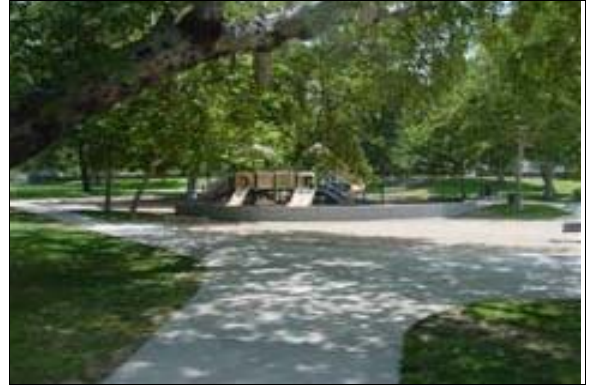
**Play Area Next to the Skate Park**

**Finding:** The surface at the play area is sand, making the area nonaccessible to individuals with mobility impairments.

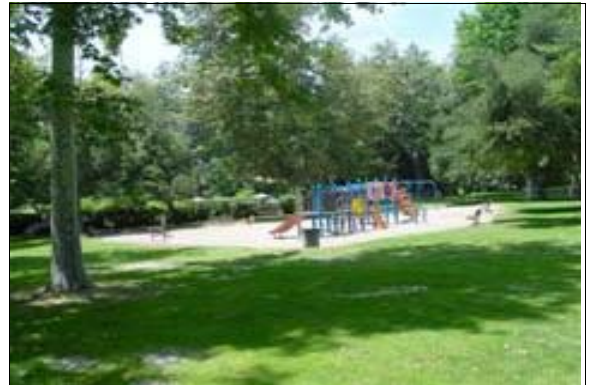
**Play Equipment at the North End of the Park**

**Finding:** The path of travel to the play area consists of grass, making the area nonaccessible to individuals with mobility impairments. The surface beneath the play area is sand, making the area nonaccessible to individuals with mobility impairments.

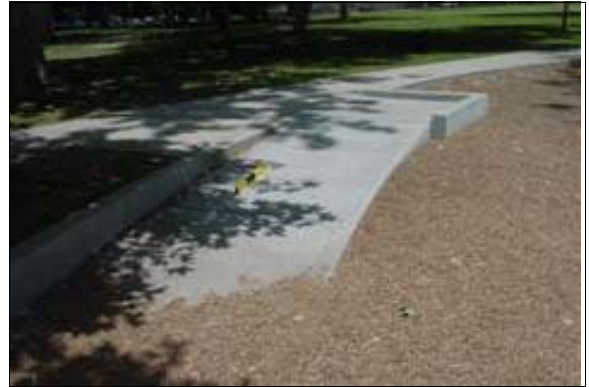
#### ***Play Equipment Next to the Skate Park***

**Finding:** There are slopes greater than 6.33% along the path of travel to the play area.

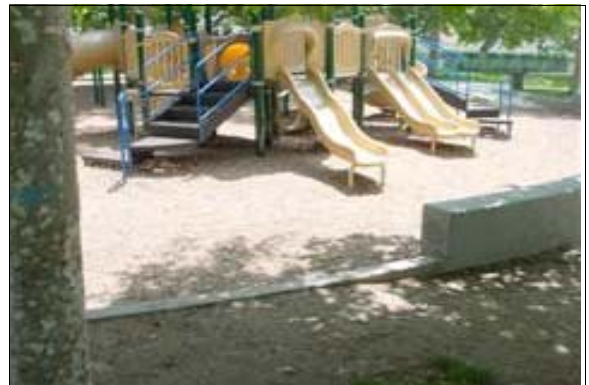
#### ***Play Equipment Next to the Skate Park***

**Finding:** The surface beneath the play equipment is wood chips, making the area nonaccessible to individuals with mobility impairments.

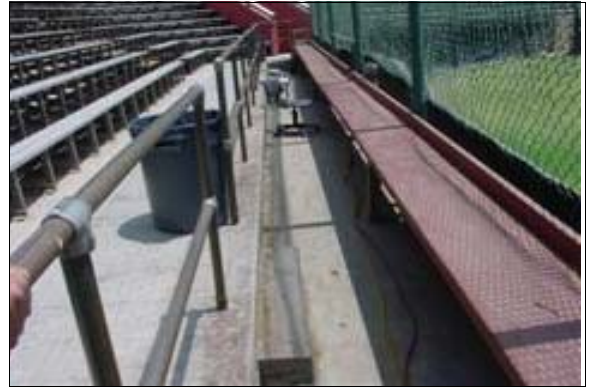
**Stengel Field Stadium**

**Finding:** The press box at the stadium is stair-access only and is not accessible to individuals with mobility impairments.

**Alternative Rec:** There are ways to provide access to the programs, services and activities at the press box without installing accessible vertical means to the press box area, to include electronic relay devices with electronic visual components (video camera or television) that offer the equivalent sight line provided from inside the press box. The electronic relays may be cabled to an accessible location where individuals with mobility impairments can access.

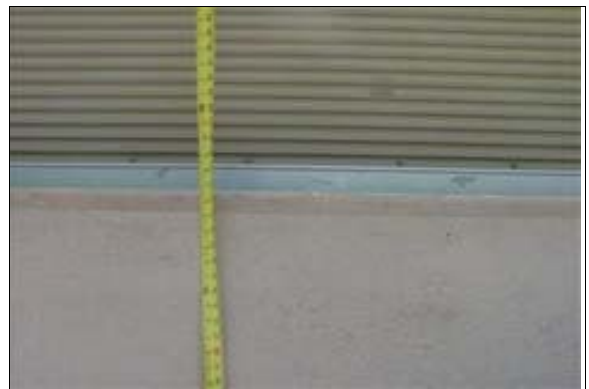
**Stengel Field Stadium**

**Finding:** The height of the concession counter at the Stengel Field Stadium is greater than 36 inches.
