Accessibility Survey

Americans with Disabilities Act And Title 24 of the California Building Code

Montrose Parking Lot #3

Inspected January 2008

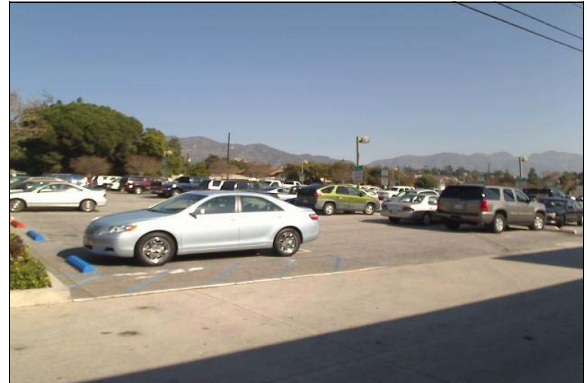
Finding: Parking Lot #3 is located at the intersection of Florencita Avenue and Oceanview Boulevard in Glendale, California. The parking lot was inspected by Disability Access Consultants, Inc., on January 17, 2008.

Full Rec: Any renovation or new construction that occurred after January 26, 1992, is subject to meet full code specifications for the California Building Code and ADAAG requirements. All recommendations in this report are based on ADAAG and CBC Title 24 requirements. Consult with your design professional to determine which elements are affected by these requirements. It is recommended that Disability Access Consultants, Inc. is consulted for inspection of any new construction or renovation at the facility.
