Photo Report

Elk Mini Park

Finding: The Elk Mini Park, located at 800 East Elk Avenue in Glendale California, was inspected by Disability Access Consultants, Inc., on June 14, 2007.

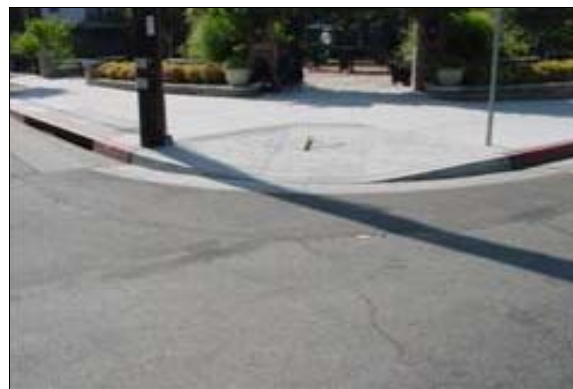
Curb Ramp at the Corner of Elk and Evret

Finding: The slope at the bottom landing is greater than 2%. The width of the curb-cut ramp is less than 48 inches. The concrete curb ramp does not provide a detectable warning surface which includes truncated domes.

Full Rec: Replace the curb ramp with a compliant curb ramp at least 48 inches in width that provides a slope no greater than 8.33%. Install a detectable warning surface which extends the full length and width of the concrete curb ramp and its side flares with truncated domes that contrast visually by either light on dark or dark on light which is an integral part of the concrete curb ramp. The truncated domes may be cast in place or stamped or of a prefabricated surface treatment (see CBC 1127B.5.8).

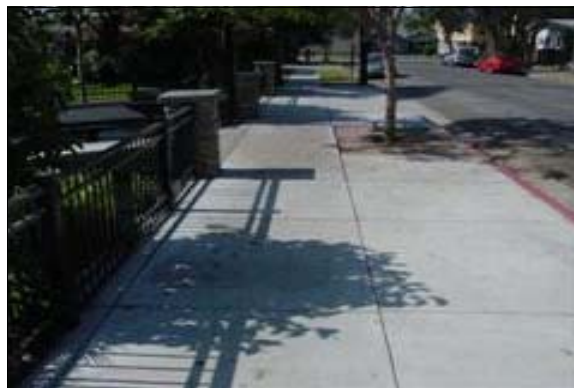
Accessible Route from the Public Right of Way

Finding: There is an accessible route from the public right of way to the accessible entrance of the facility.

Full Rec: Post directional signage. Make certain to post signage indicating the direction to accessible building entrances at every major junction along the accessible route. Signs shall include the International Symbol of Accessibility.

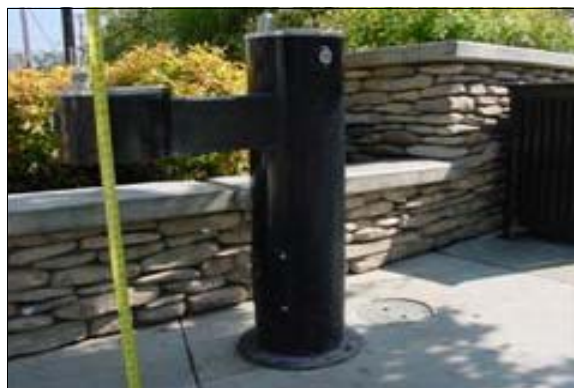
Drinking Fountains Next to the Outdoor Dining Area

Finding: The leading edge of the drinking fountain is more than 4 inches from the wall and greater than 27 inches from the floor and protrudes into the primary path of travel.

Full Rec: Fifty percent of the drinking fountains on primary paths of travel shall be accessible (see CBC 1117B.1 and ADAAG 4.15). Install a side rail or wing wall next to each side of the fountain.

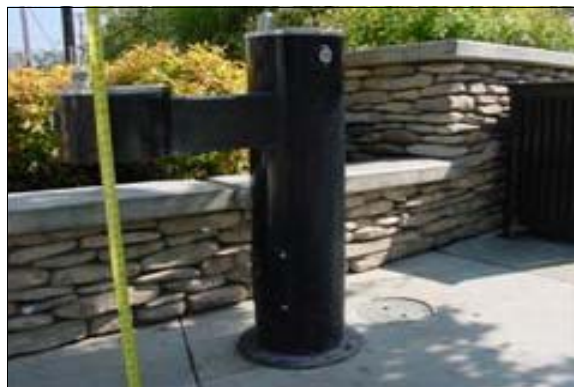
Finding: There are two drinking fountains on primary paths of travel.

Full Rec: Fifty percent of the drinking fountains on primary paths of travel shall be accessible (see CBC 1117B.1 and ADAAG 4.15). Install a "high-low" fountain design to comply with both state and federal requirement. Fountains not located in alcoves need side rails or wing walls on both sides.

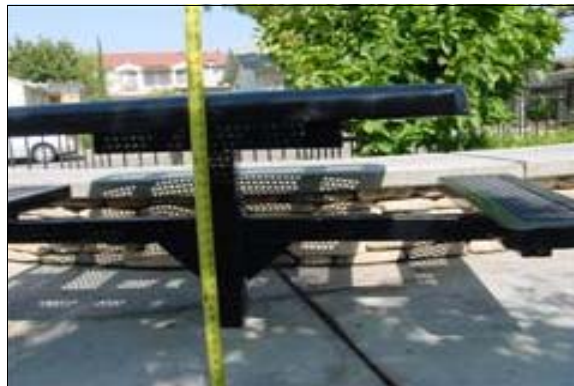
Outdoor Dining Area

Finding: The knee space at the tables in the outdoor dining area is less than 27 inches high.

Full Rec: Modify or replace one of the tables in the outdoor dining area to provide knee clearance of at least 27 inches in height, 30 inches in width and 19 inches in depth (see CBC 1122B.3, ADAAG 4.32.2 and ADAAG Figure 45). The table top height shall not exceed 34 inches above the finished floor.

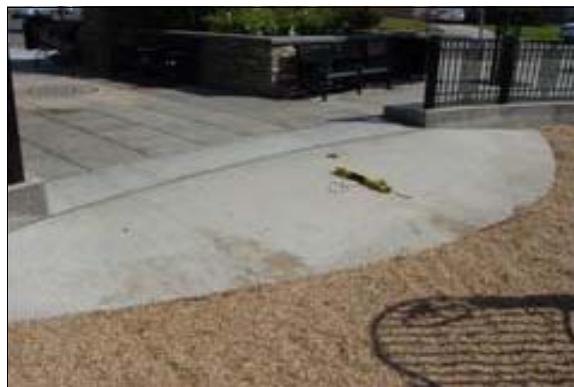
Play Equipment

Finding: There are slopes greater than 6.33% along the path of travel to the play equipment. The surface beneath the play area is wood chips, making the area nonaccessible to individuals with mobility impairments.

Full Rec: Provide an accessible route to the play area (CBC 1104B.1.2 and ADAAG 4.3.2). The minimum width of the path of travel is 48 inches with 60 inch by 60 inch passing spaces provided every 200 feet and shall not exceed a slope greater than 6.33%. Provide a maneuvering space with an accessible resilient surface beneath the play components and adjacent to the play components where technically feasible. An adequate maneuvering space has an accessible surface and is not less than 60 inches by 60 inches where an individual with a mobility impairment can be a part of the activities provided at the play components.
