Accessibility Survey

Americans with Disabilities Act And Title 24 of the California Building Code

Downtown Parking Lot #6

Inspected January 2008

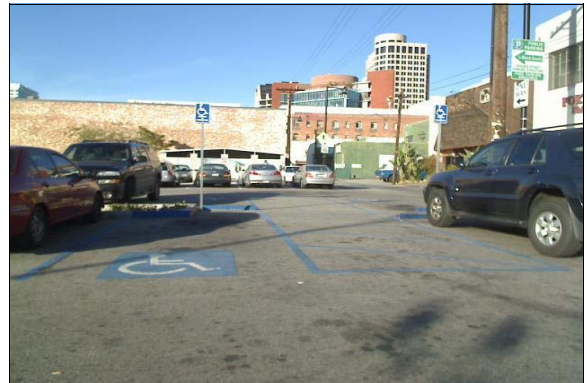
Finding: There are 6 accessible parking spaces out of 123 parking spaces which is one more space than the minimum number for compliance. The accessible parking spaces do not measure at least 108 inches wide and 216 inches long. The right accessible space at Orange Street is not outlined on the right. There is no "van-accessible" parking space and the access aisles does not contain "NO PARKING" in 12" high white letters.

Full Rec: Restripe the existing accessible spaces so each measures at least 108 inches wide and 216 inches long. Designate one parking space as "van-accessible". The van-accessible space shall provide a 96 inch wide passenger side access aisle. Add the words NO PARKING in 12 inch high white letters at the entrance to each accessible parking access aisle.

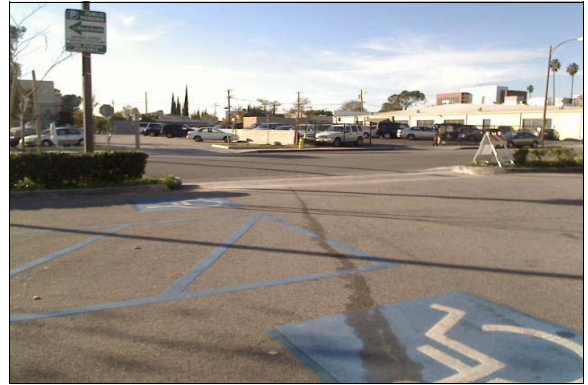
Finding: There is no accessible route between the accessible parking space and the public right of way. Three of the accessible spaces require travel behind vehicles other than the wheelchair users space.

Full Rec: Install a compliant path of travel from the sidewalk (public right of way) to the accessible parking space. Wheelchair users must not be forced to go behind parked cars other than their own.

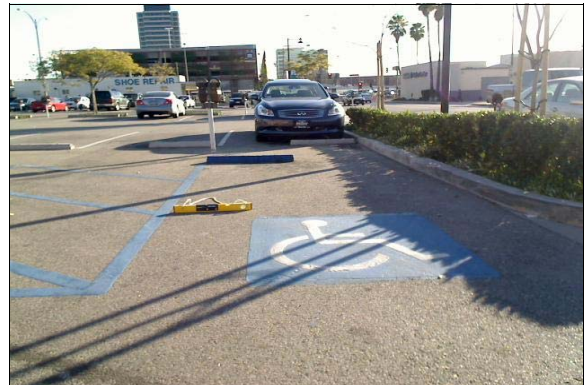
Finding: The surface of the accessible parking spaces has slopes greater than 2%.

Full Rec: Pave the parking lot at the accessible spaces to provide a level surface. Parking surfaces and access aisles shall be located in areas not exceeding 2% slope in all directions (see CBC 1129B and ADAAG 4.6.3).

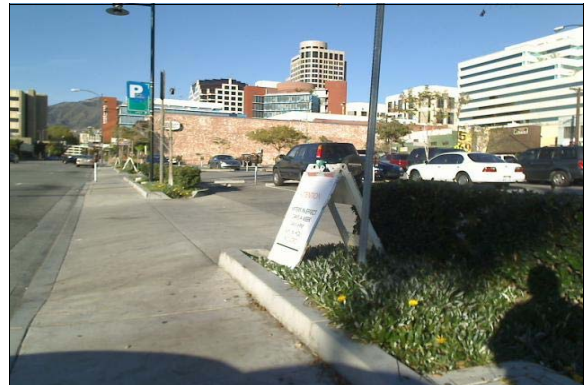
Finding: There is no warning signage posted at the entrance from North Orange Street regarding unauthorized use of accessible parking spaces in the parking lot.

Full Rec: Post a sign in a conspicuous place at the entrance of the parking lot, or immediately adjacent to and visible from each accessible space. The warning sign shall measure at least 17 inches by 22 inches in size and consist of lettering at least 1 inch in height that states the following; "Unauthorized vehicles parked in designated accessible spaces not displaying distinguishing placards or license plates issued for persons with disabilities may be towed away at owner's expense. Towed vehicles may be reclaimed at _____ or by telephoning ____ ." Fill in the blank spaces with appropriate information as a permanent part of the sign and be sure to add the CVC 22511.8(a)(d) to the sign.

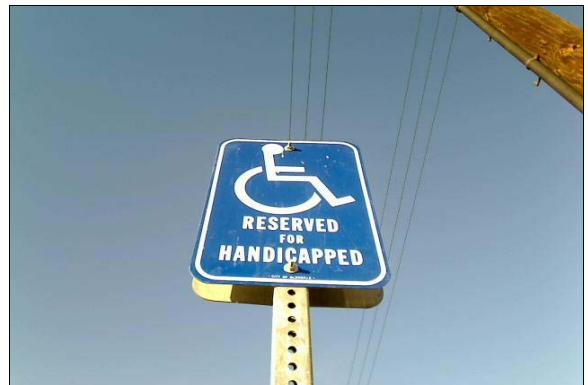
Finding: There is vertically-mounted signage at the accessible parking spaces located next to the café and bakery. There is no signage at the accessible spaces at North Orange Street. All of the signs use the word "Handicapped".

Full Rec: Install a permanently posted reflectorized sign measuring 70 square inches that includes an ISA symbol adjacent to and visible from the accessible parking space (see CBC 1129B.5). The bottom edge of the sign must be mounted 80 inches from the ground surface so that it cannot be obscured by a parked vehicle (see CBC 1129B.5). The "van-accessible" parking space shall provide an additional sign marked "van-accessible" mounted below the sign (see CBC 1129B.5 and ADAAG 4.6.4).

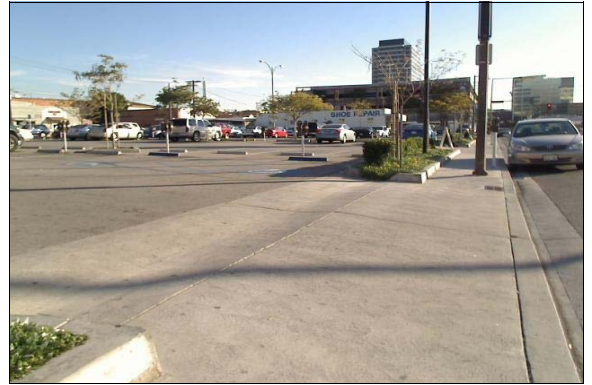
Finding: There is no accessible route from the public right of way to the parking lot or to the accessible parking space.

Full Rec: Provide at least one accessible route from the public right of way to the parking lot and to the accessible parking spaces. Make certain to post signage indicating the direction of the accessible route to the public right of way. Signs shall include the International Symbol of Accessibility.
